Technical Note 05 – Response of Buried Assets other than Water Pipelines

Technical Note 05 – Response of Buried Assets Other Than Water Pipelines

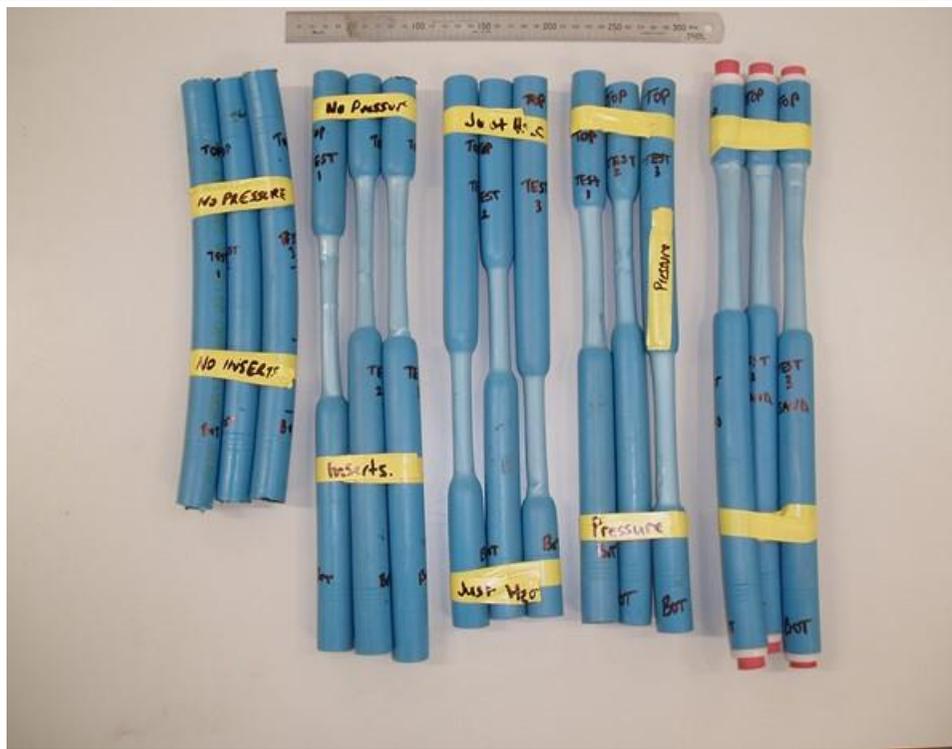
PE is capable of sustaining sub-critical damage, such as over-extension and deformation that could increase likelihood of future failure or degrade operability [13], Figure 4. Because sub-critical damage does not require immediate repair it may not be recorded as earthquake damage when the problem is eventually detected. This means that reported repair rates for PE are likely to underestimate the true damage rates. As sub-critical damage is usually a response to Permanent Ground Displacement, most sub-critical damage in PE pipelines will mainly be confined to areas subjected to lateral spreading.

Figure 4: PE pipes deformed in laboratory tensile testing.

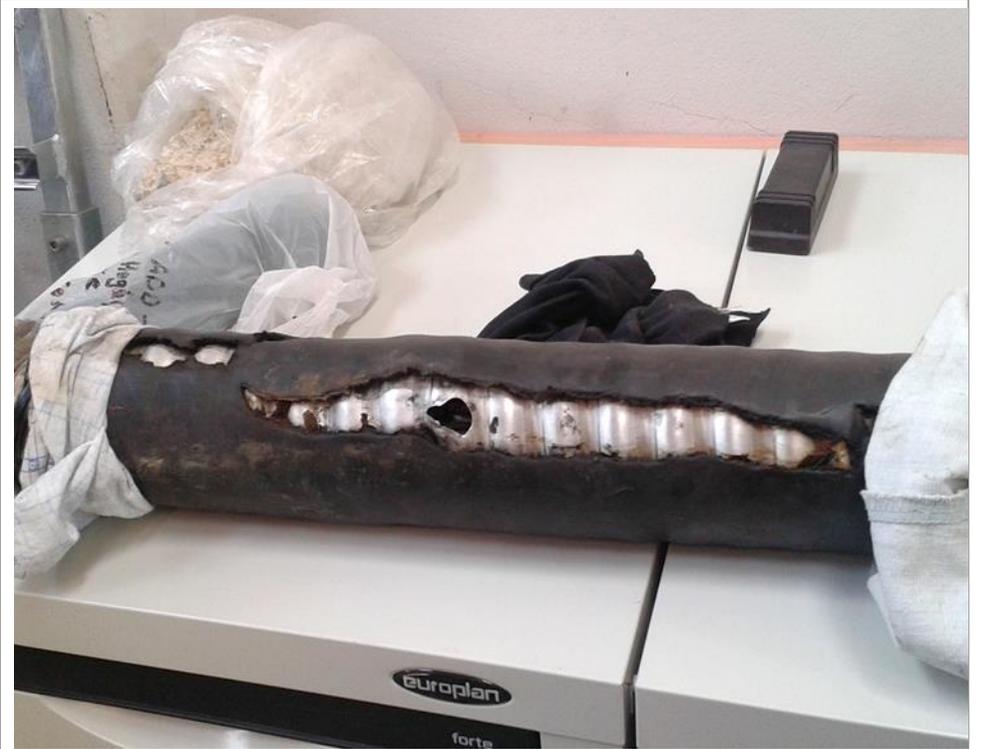
Eidinger's work [16] showed that liquefaction-induced bending failure of concrete slabs used in the trench construction first resulted in the cables acting as reinforcement, and then caused local crushing of the metal cable sheath leading to shorts.

Figure 5: Damaged aluminium sheath on electrical cable damaged in Christchurch, and recovered December 2012.

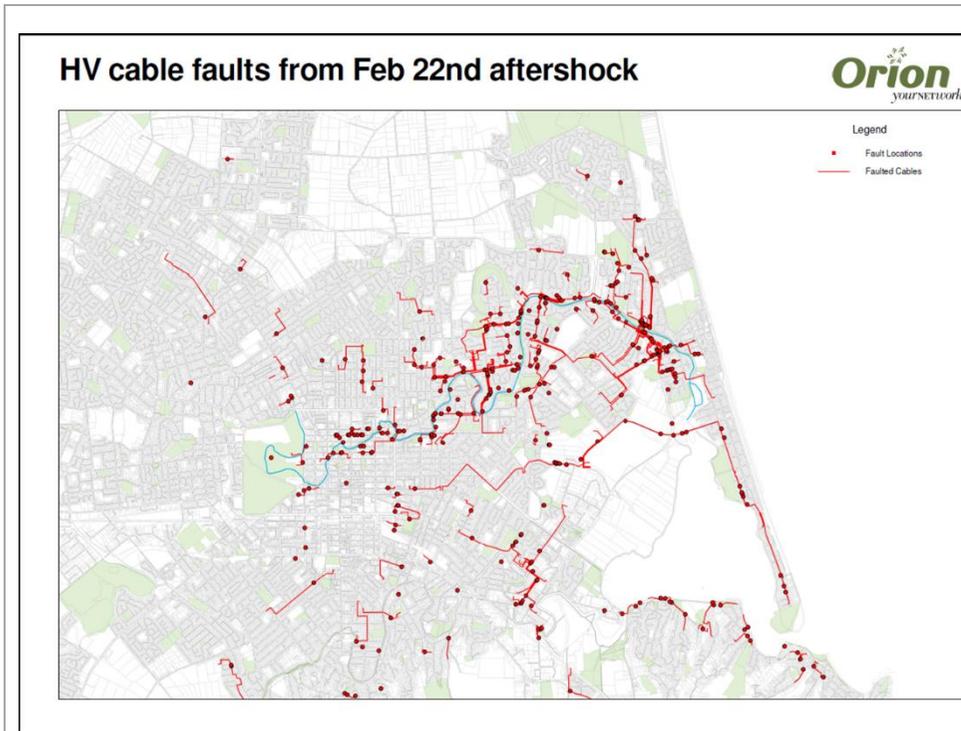
Orion had more than 2,000 km of 11 kV cables in Christchurch that were affected by the September 2010 and February 2011 events [6]. Breaks in cables included failure of couplings in tension, failure of cables in compression (Figure 6) and damage resulting from failure of concrete slabs used to support cables [16]. Damage included critical 66 kV cables. While many failures occurred in areas that experienced liquefaction and lateral spread, failure also occurred in areas that were only affected by shaking [19].

Figure 6: HV Cable faults identified in Orion High Voltage Cables after 22 February 2011.

The break rate in buried electrical cables could be reduced by eliminating the use of concrete beams and by encouraging the use of good installation practice. Use of post-installation testing will help improve or maintain good jointing practice [5] and is likely to also encourage good installation practice where the installation and jointing teams use the same people.

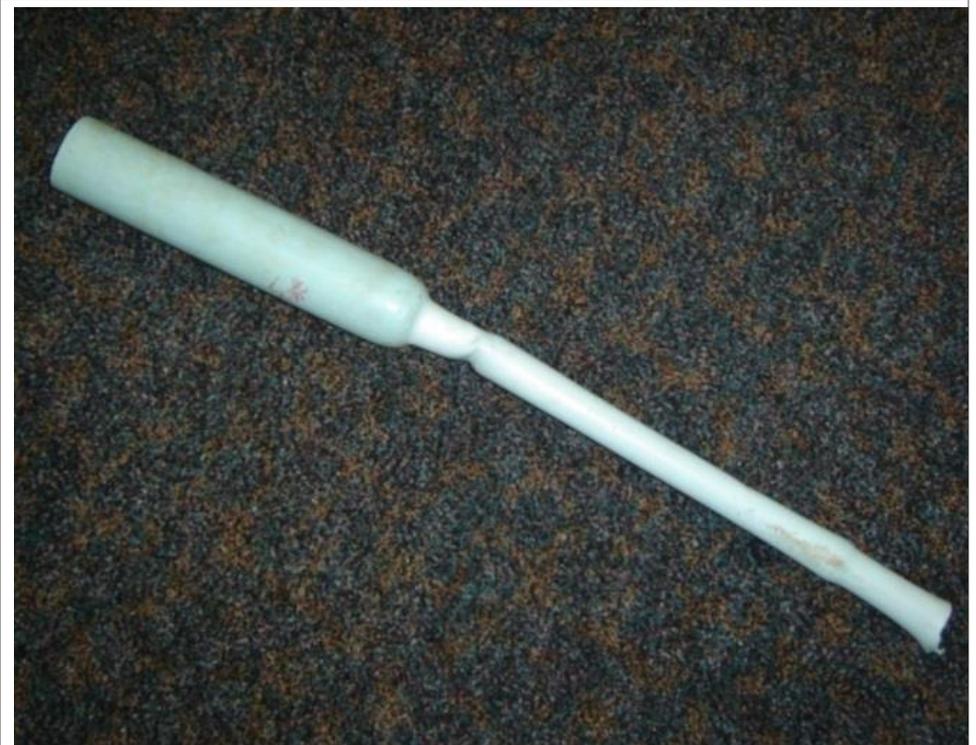
PE ducts can experienced over extension (Figure 7). PVC ducts generally do not have end-load resistant joints and can be expected to pull apart when subjected to tension, as with PVC pipelines. Similarly compression will tend to result in buckling, bending or over-insertion of the pipe into the socket of the joint.

Figure 7: Telecommunications cable duct damaged in one of the Christchurch earthquakes. It is believed to be PE100 DN 25. Yielded and hyper-extended to fracture at RHS. It is unclear if the feature at the LHS is due to compressive buckling or bending. Image provided by Frank O'Callaghan.
