Technical Note 7 – Kaiapoi Wastewater Damage

In September 2010 the Darfield earthquake caused extensive damage to wastewater reticulation system in parts of Kaiapoi and ProjectMax Ltd completed damage assessments in 2010. This report discusses the evaluation of these to determine damage trends and the frequency of damage.

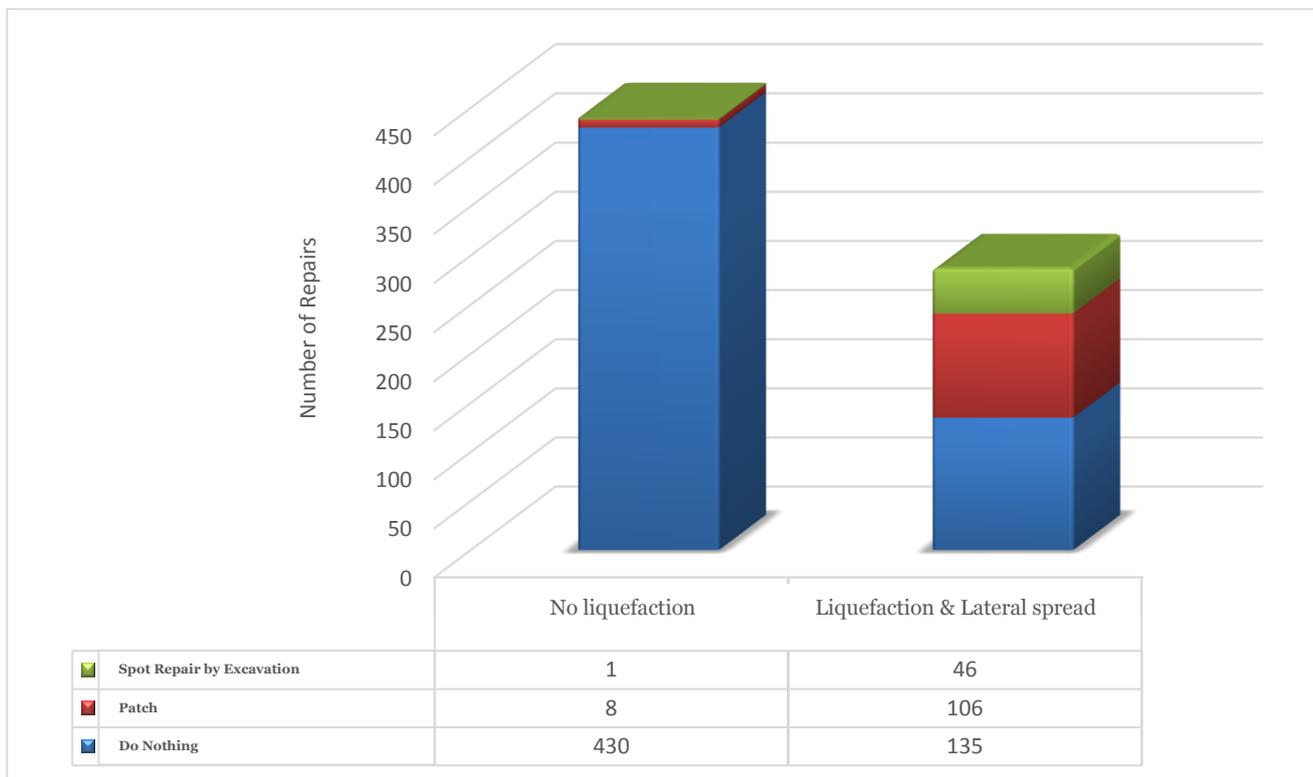
Figure 3-1: Restoration Works (Based on Liquefaction Areas Recorded by Tonkin & Taylor)

Figure 3-1 shows the number of repairs required to restore service. The vast majority of the repairs were undertaken in areas where Tonkin & Taylor observed liquefaction or lateral spread.

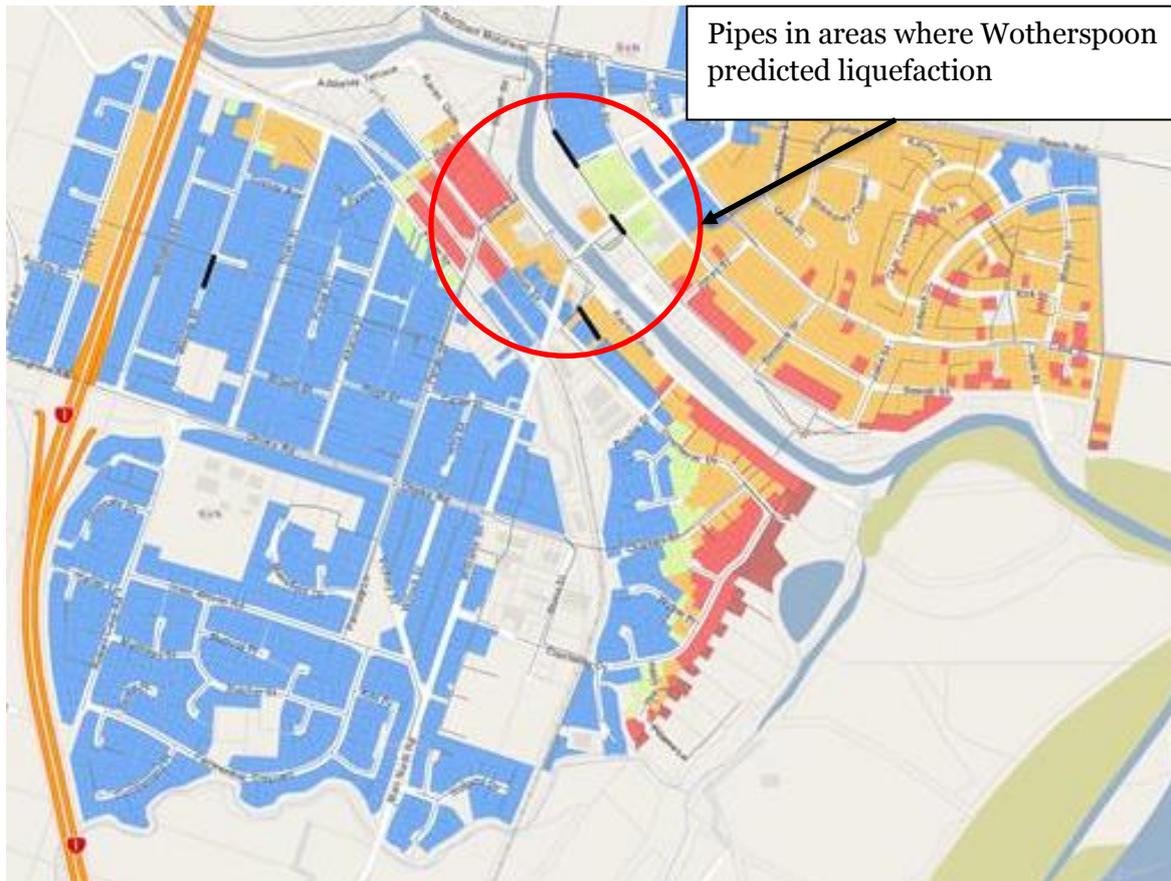
Figure 3-2: Damage in Areas where Tonkin & Taylor did not record liquefaction

Only four of the pipes that required repair to restore service were located in areas where Tonkin & Taylor did not observe liquefaction or lateral spread. One of these pipes required multiple repairs. Figure 3-2 shows the location of these pipes. The pipes were all concrete.

Three of these pipes were located in areas where Wotherspoon noted liquefaction. Therefore, for analysis purposes these three pipes have been treated as being within areas of liquefaction.

Only one of these pipes, at Wesley Street, was located where neither party observed liquefaction or lateral spread. This pipe required a patch to be installed to seal a faulty joint with running infiltration. The damage to this pipe represents a damage rate of 0.3 breaks per 10km.

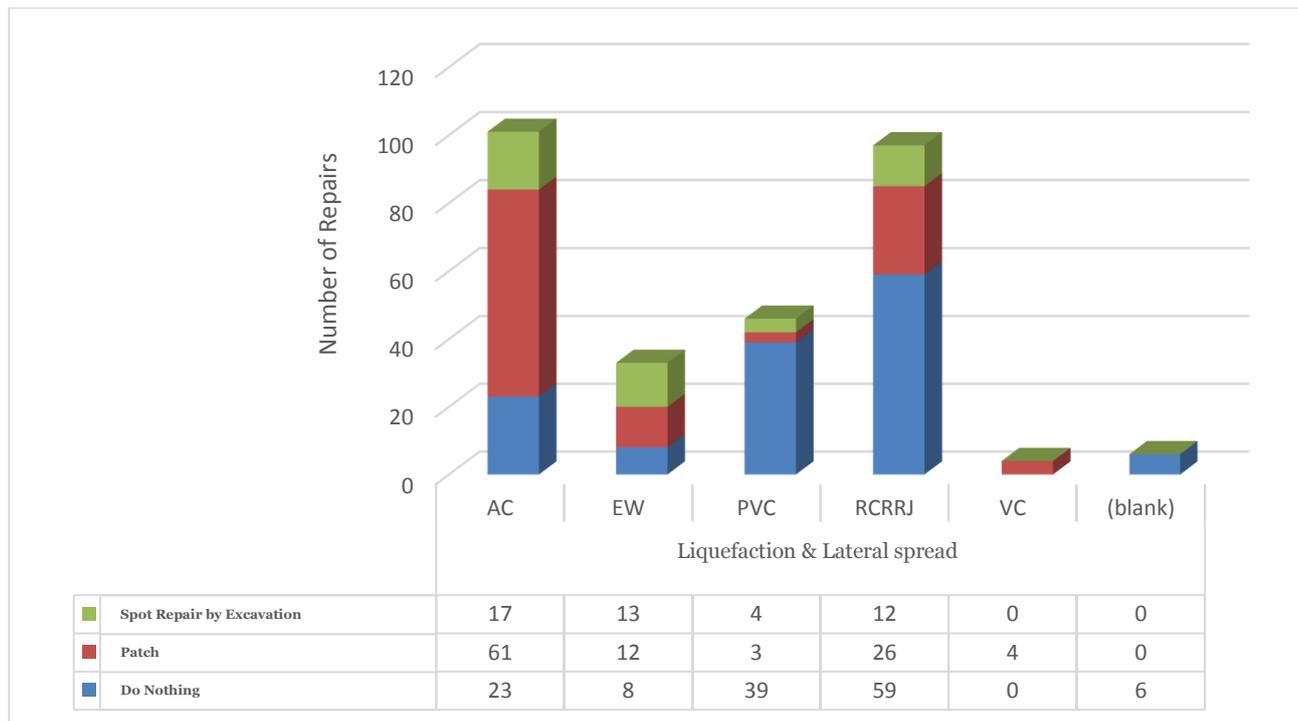
Figure 3-3: Restoration Works in Areas Where Liquefaction or Lateral spread occurred

The majority of repairs (85%) were undertaken on asbestos cement or earthenware (AC/EW) pipes, even though these pipes make up only 38% of the network. 77% of the asbestos cement and earthenware pipes required repair, compared to 39% of reinforced concrete pipes and only 15% of PVC pipes.

The damage sustained on asbestos cement and earthenware pipes that was required to be repaired to restore service represents a break rate of 255 breaks per 10km. All of this damage was sustained in areas subjected to liquefaction. There were no asbestos cement or earthenware pipes installed in areas where lateral spread occurred.

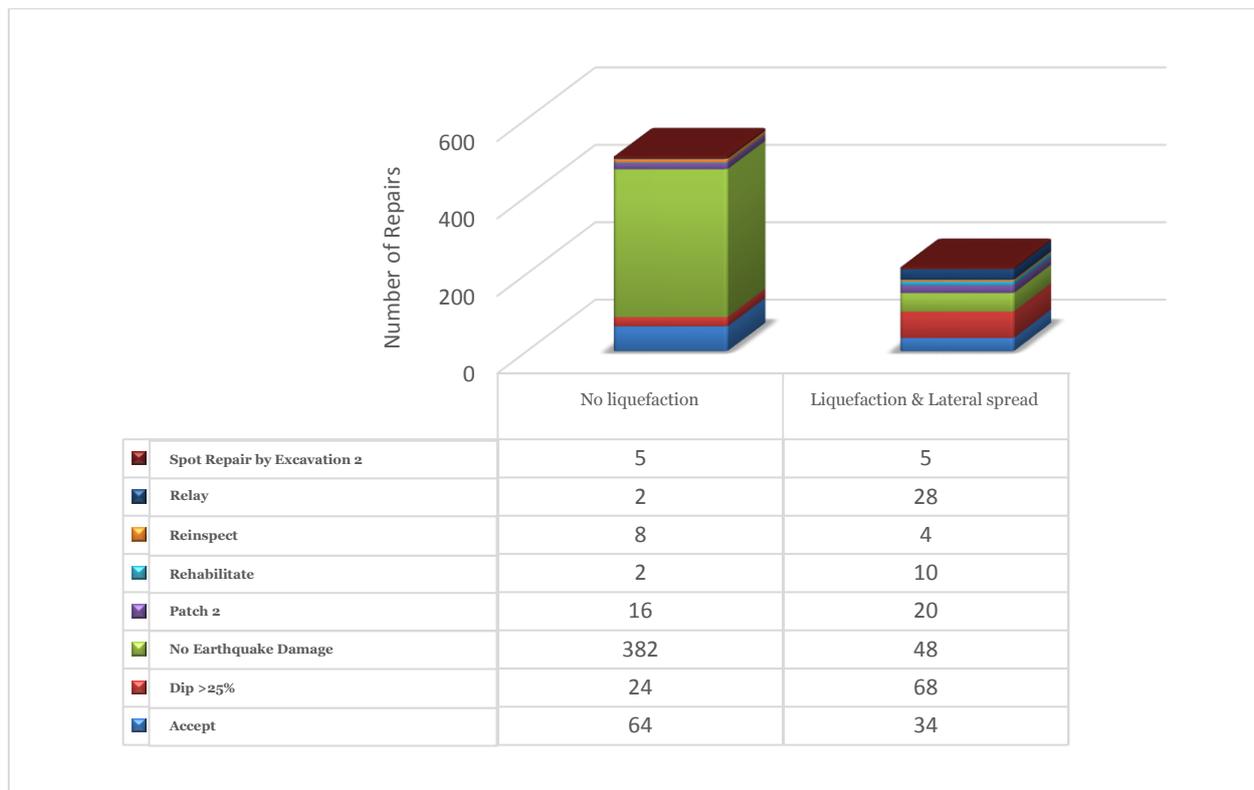
Figure 4-1: Total works Required to Reinststate to Pre-Earthquake Condition

Figure 4-1 shows the quantum of further works required to reinstate the system to pre-earthquake condition.

The vast majority of damage occurred in areas where liquefaction or lateral spread occurred.

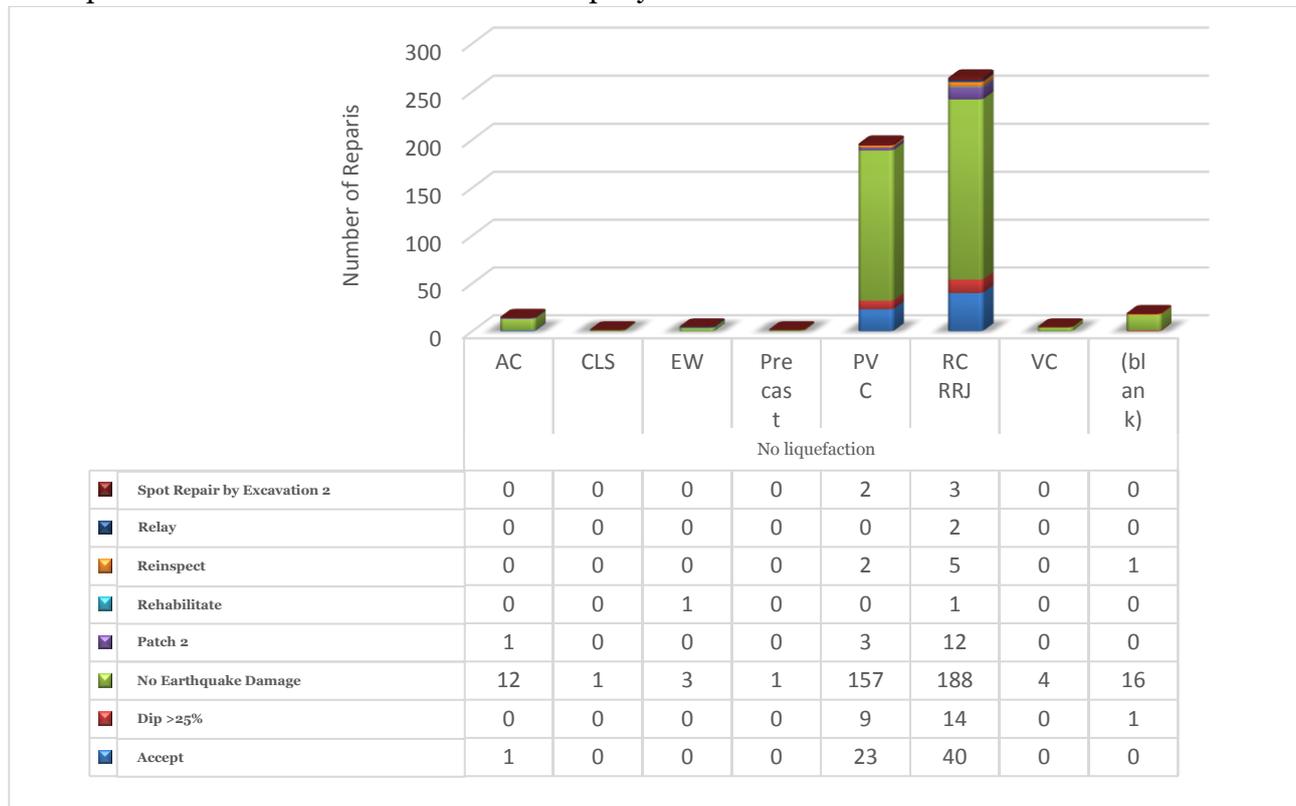
Figure 4-2: Works Required to Reinstatement to Condition in Areas that did not liquefy

Figure 4-2 shows the quantum and category of works required to reinstate the network to its pre-earthquake condition in areas that did not liquefy.

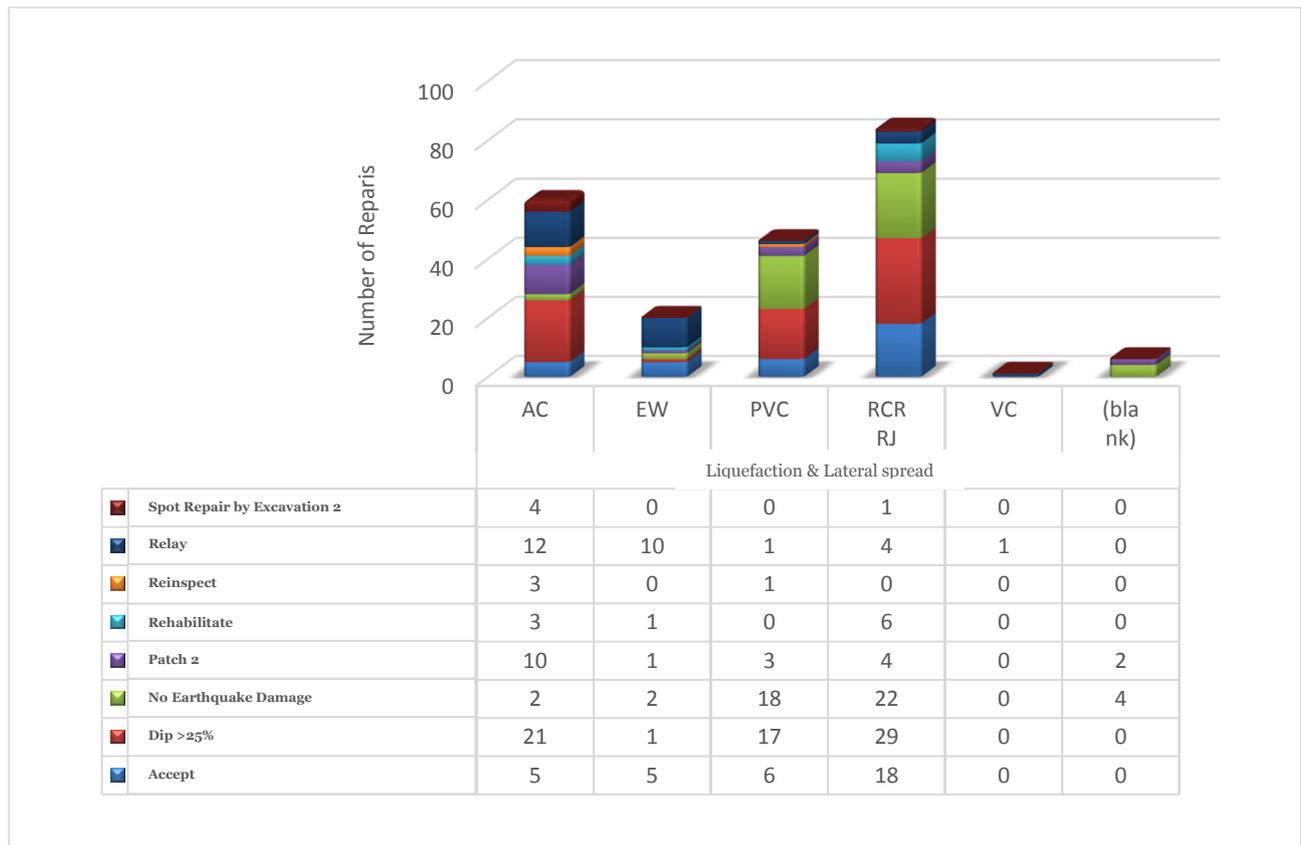
Figure 4-3: Works to Reinstatement Condition in Areas of Liquefaction or Lateral Spread

Figure 4-3 shows the quantum and category of further works required to reinstate the network to the pre-earthquake condition in areas where liquefaction or lateral spread occurred.
