Technical Note 09 – Photobook of Damaged Underground Utilities

1. Introduction

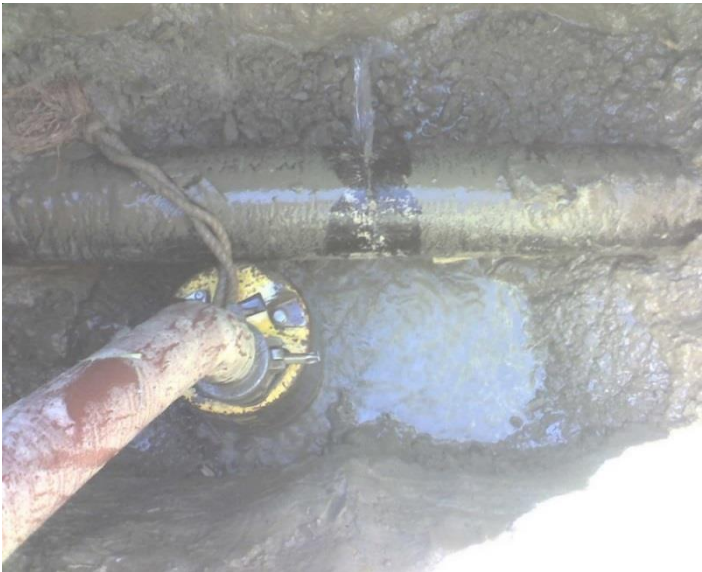
Reference: PI001

Material: Asbestos cement

Description: Circumferential crack.

Cause: Compression or bending.

Comment: Relatively low beam stiffness of smaller diameter AC pipes can result in circumferential fracture even in normal service. These breaks can often be repaired by reconnecting the two halves.

Repair: Reconnect with repair clamp.

Modern materials are more resistant to this kind of damage and good installation practice provides better support for all materials.

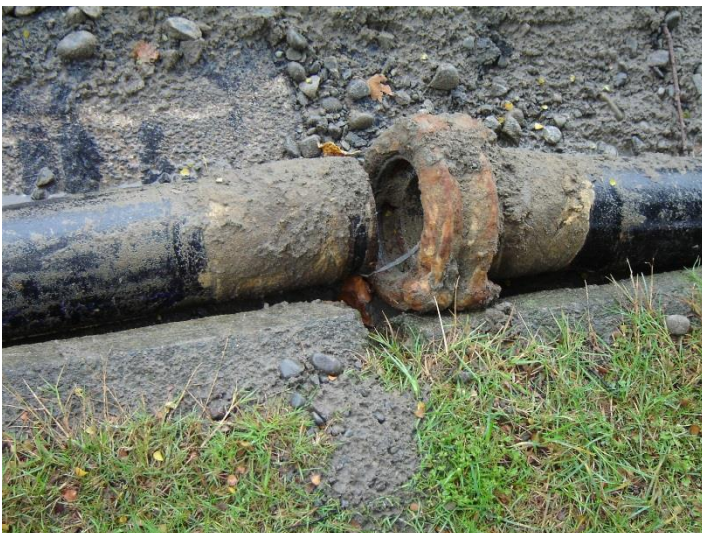
Reference: PI003

Material: Cast iron

Description: Circumferential crack.

Cause: Probably bending or lateral displacement.

Comment: The gibault joint can accommodate some displacement but the pipe has fractured when the joint ran out of travel.

Repair: Repair with flexible couplings.

Use modern materials and flexible joints to avoid failure.

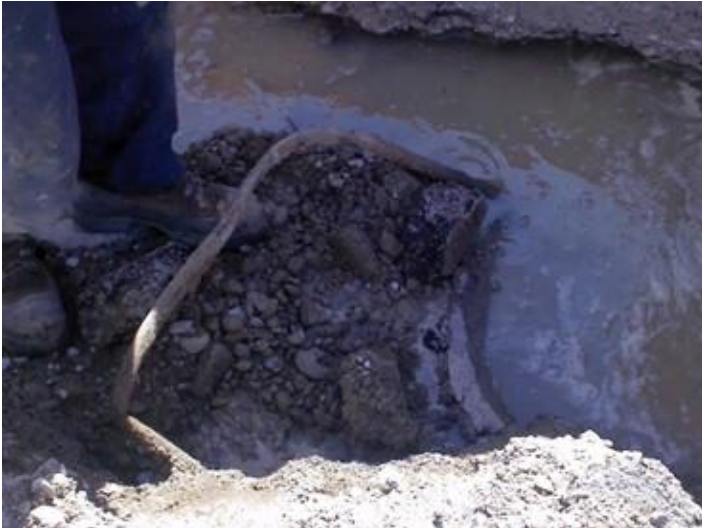
Reference: PI004

Cause: Compression

Comment: Small diameter pipes are vulnerable to bending and the risks of bending increase when the pipe is near the surface. Most alternative materials would also bend but modern plastics are more likely to provide some (limited) service when damaged.

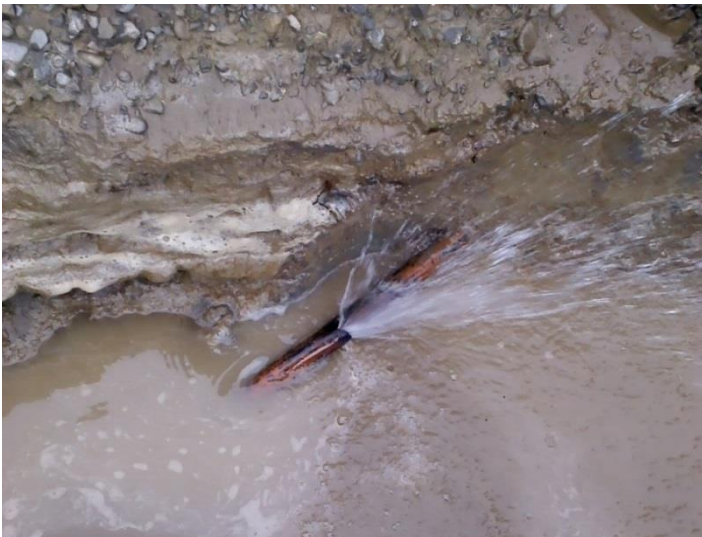
Reference: PI005

Description: Crack

Cause: Probably compression.

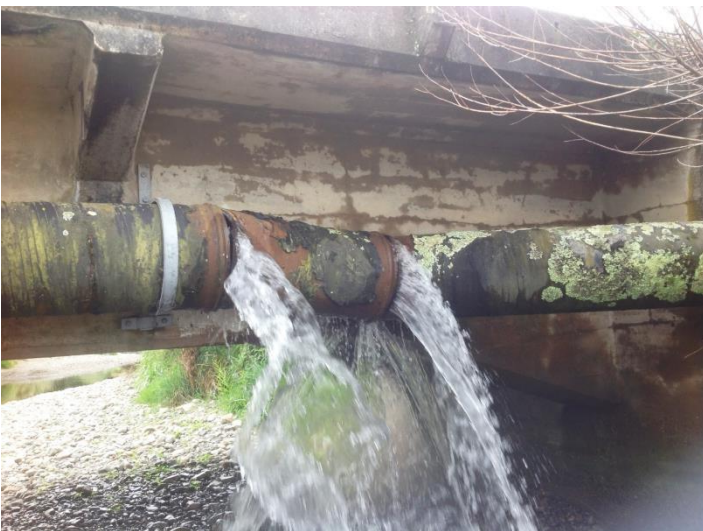
Reference: PI009

Description: Pipe and/or joint failure.

Cause: Compression

Comment: Compression of the line appears to have caused failure at welded joints, but there may also be buckling failure of the steel pipe. Buckling may still occur in modern welded steel, but some function is likely to remain due to improved strength and ductility of current welded joints.

Repair: Replace damaged section.

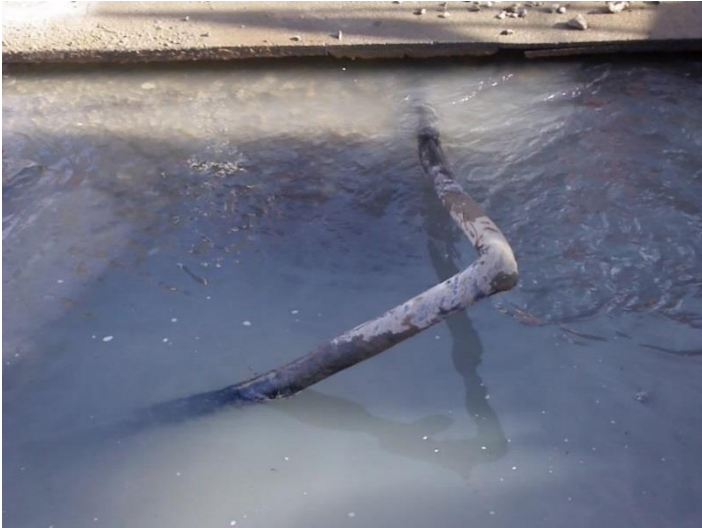
Reference: PI010

Material: PE

Cause: Compression of shallow-buried pipeline.

Comment: Deeper burial will result in compressive buckling rather than bending. Most materials would also bend but modern plastics are more likely to provide some limited service when damaged.

Repair: Replace

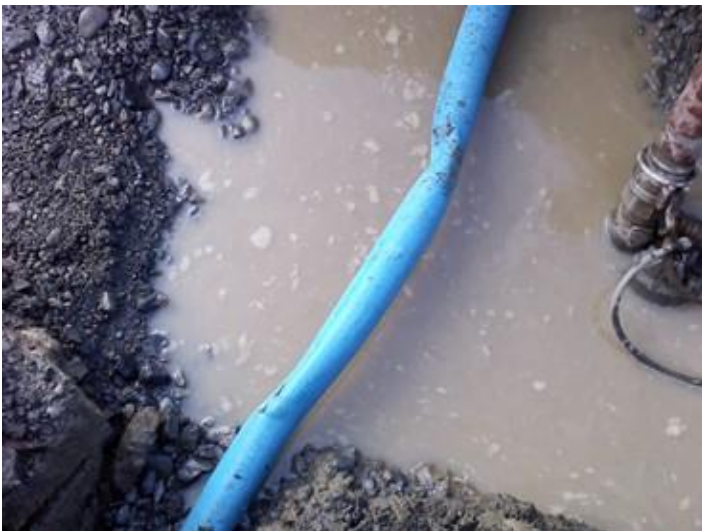
Reference: PI011

Cause: Probably compression, but possibly relative movement of pipe and a solid object.

Comment: Most alternative materials would also bend but modern plastics are more likely to provide some limited service when damaged.

Pipes have been observed to fail like this when compressed in laboratory tests.

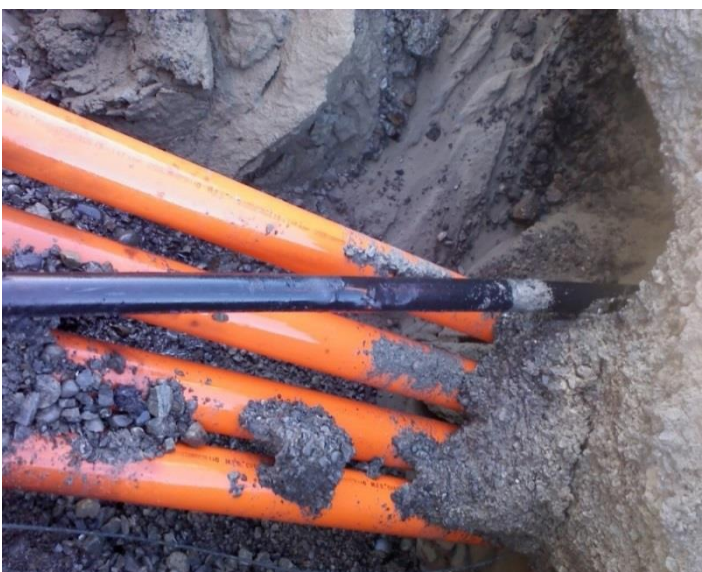
Reference: PI012

Cause: Compression

Comment: The larger electrical ducts appear undamaged. Even if the ducts had deformed, the cables inside may not be damaged if there is sufficient clearance, even though it may affect future operations such as installation of new cables or removal of existing ones.

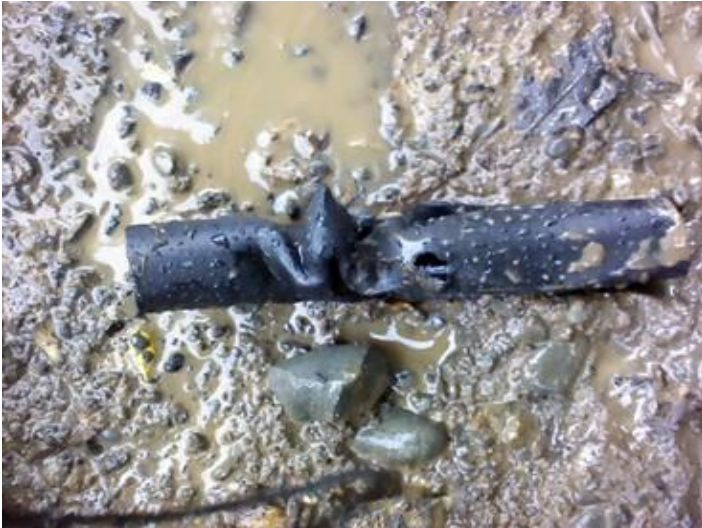
Reference: PI013

Cause: Compression

Comment: Most alternative materials would also buckle and fail but modern plastics are more likely to provide some limited service when damaged.

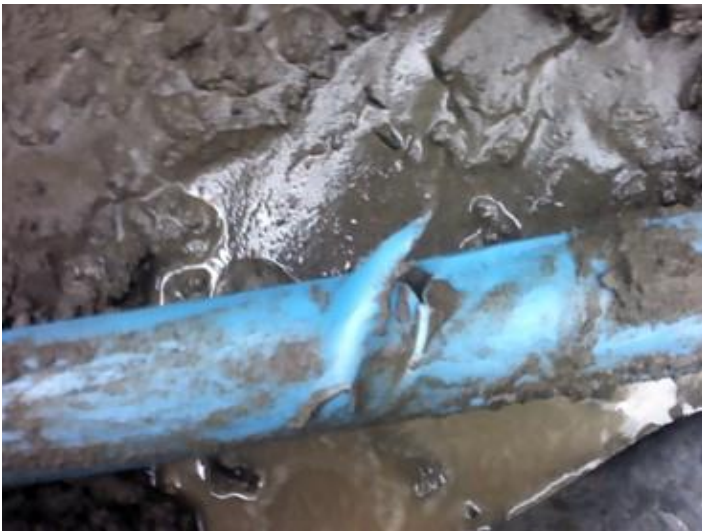
Reference: PI014

Description: Buckling and tear or third party damage.

Cause: Compression

Comment: The damage could have been caused by compressive buckling or by third party damage (struck by a tool or digger). Most alternative materials would also buckle and fail but modern plastics are more likely to provide some limited service when damaged.

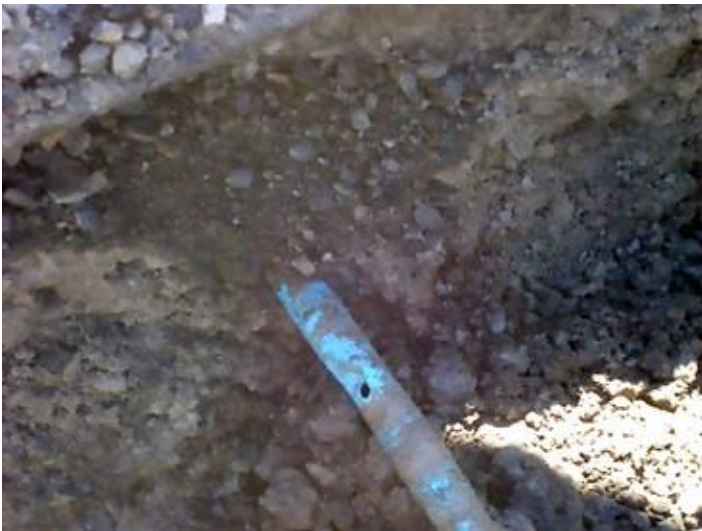
Reference: PI017

Cause: Probably compression.

Comment: The pipe appears to have buckled. Subsequent leakage then eroded away material around the leak, leaving the relatively round hole.

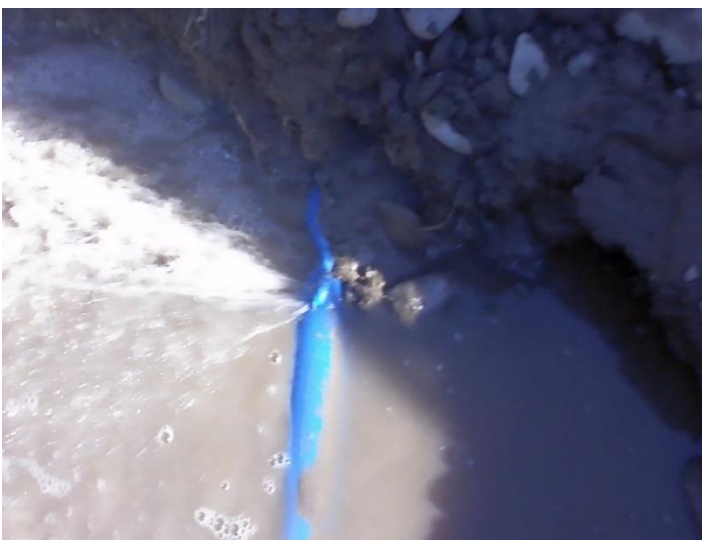
Reference: PI018

Cause: Compression.

Comment: The pipe has buckled and torn. Most alternative materials would also buckle and fail but modern plastics are more likely to provide some limited service when damaged.

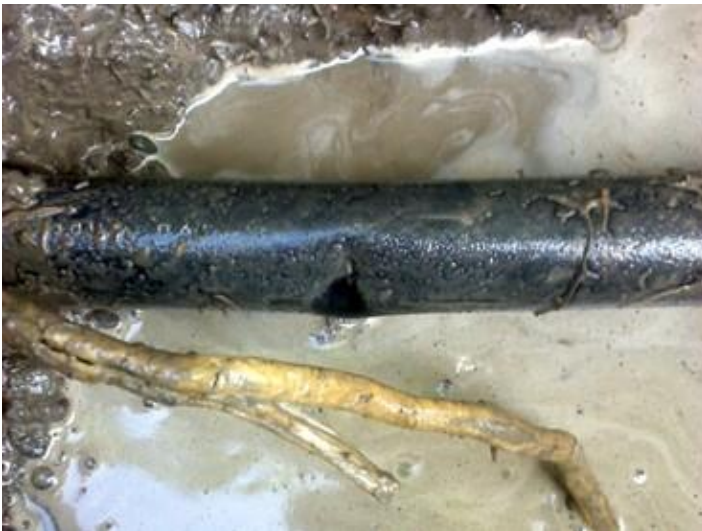
Reference: PI020

Cause: Probably compression.

Comment: The pipe appears to have buckled, causing a tear in the pipe wall. Subsequent leakage then eroded away material around the leak leaving the relatively round hole.

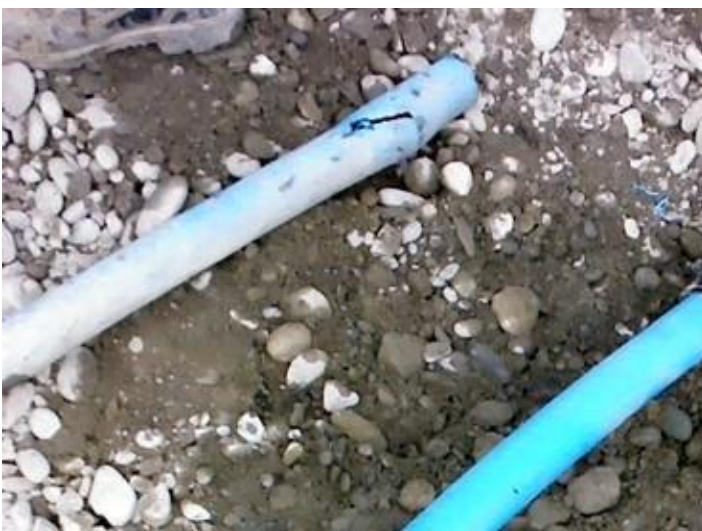
Reference: PI021

Cause: Probably compression

Comment: The pipe appears to have split, most probably because of buckling that caused a local tear.

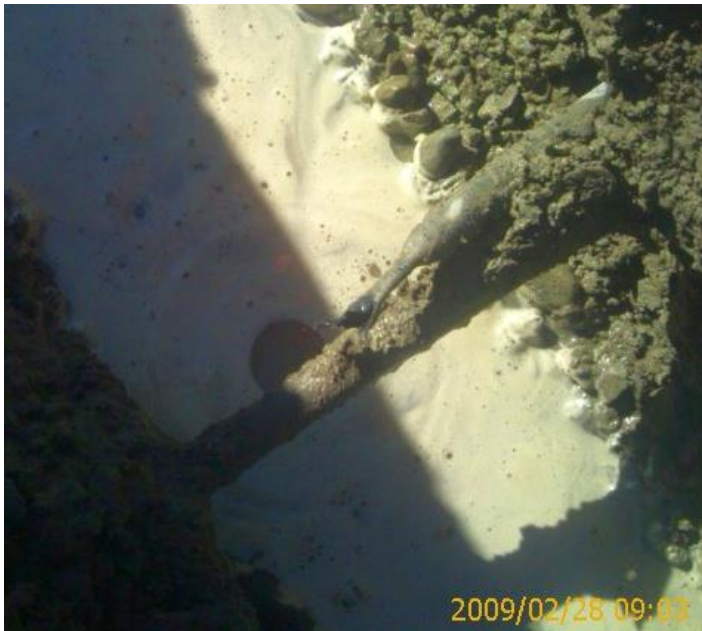
Reference: PI022

Description: Pipe failed.

Cause: Tension

Comment: This type of failure only occurs when there has been severe tensile displacement. Snaking the pipe in the trench and using modern ductile pipeline systems will reduce the risk. While risks can be reduced by construction practices, it is not practical to eliminate all risks in service connections.

Repair: Replace damaged pipe.

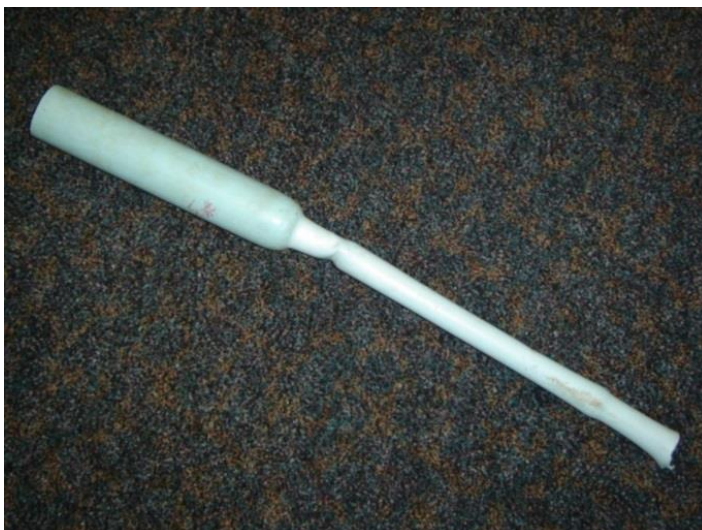
Reference: PI023

Description: Pipe failed.

Cause: Tension

Comment: This is a telecommunications cable duct. This type of failure only occurs when there has been severe tensile displacement. Snaking the pipe in the trench and using modern ductile pipeline systems will reduce the risk. While risks can be reduced by construction practices, it is not practical to eliminate all risks in service connections.

Repair: Replace damaged duct

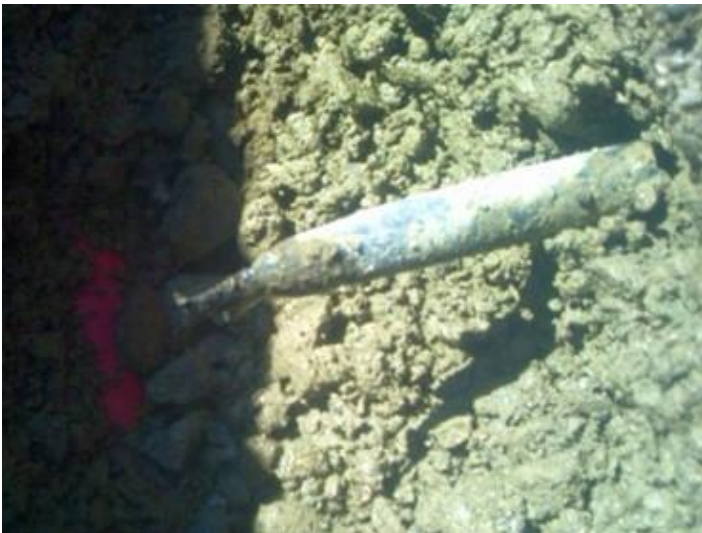
Reference: PI026

Description: Pipe failed.

Cause: Tension

Comment: This type of failure only occurs when there has been severe tensile displacement. Snaking the pipe in the trench and using modern ductile pipeline systems will reduce the risk. While risks can be reduced by construction practices, it is not practical to eliminate all risks in service connections.

Repair: Replace damaged pipe.

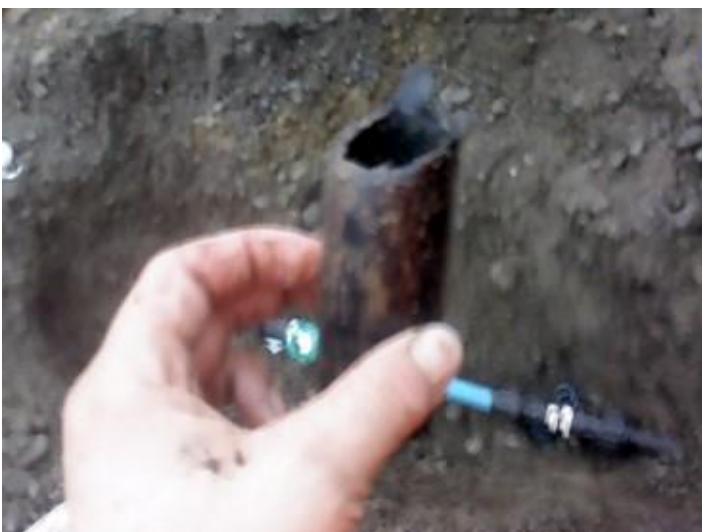
Reference: PI027

Description: Pipe failed.

Cause: Tension

Comment: This appears to be a failure in an older PE pipe with relatively low ductility. A modern PE may have been able to accommodate displacement by deforming rather than failing.

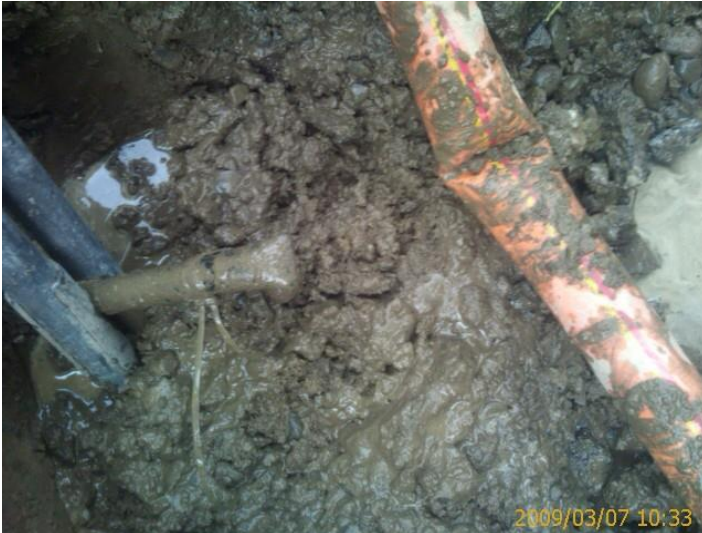
Reference: PI028

Cause: Compression of shallow-buried duct.

Comment: Given the severity of bending, there is a strong likelihood of damage to the cable housed inside the duct. The orange colour indicates that the duct probably houses an electrical cable. The smaller diameter black PE pipe to the left has been squeezed off to stop leakage.

Repair: Replace.

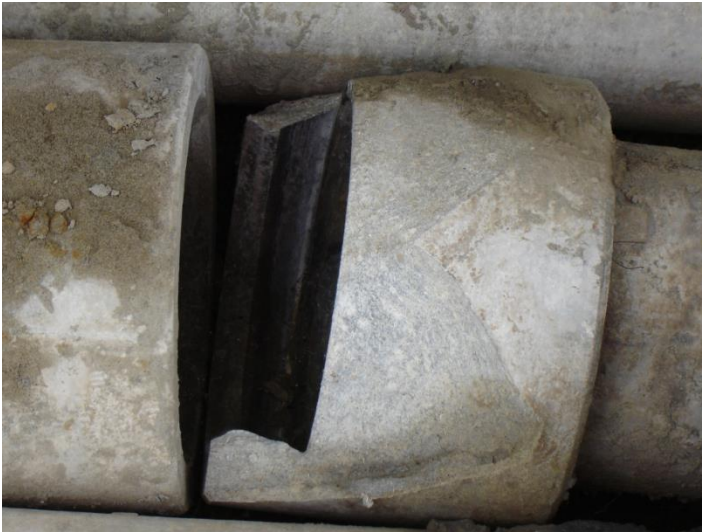
Reference: J002

Cause: Compression or bending causing socket to fracture.

Comment: Fracture pattern indicates failure could be due to bending, compression or lateral shear. Modern pipeline systems have more tolerance to this kind of loading.

Repair: Replace collar and damaged pipe.

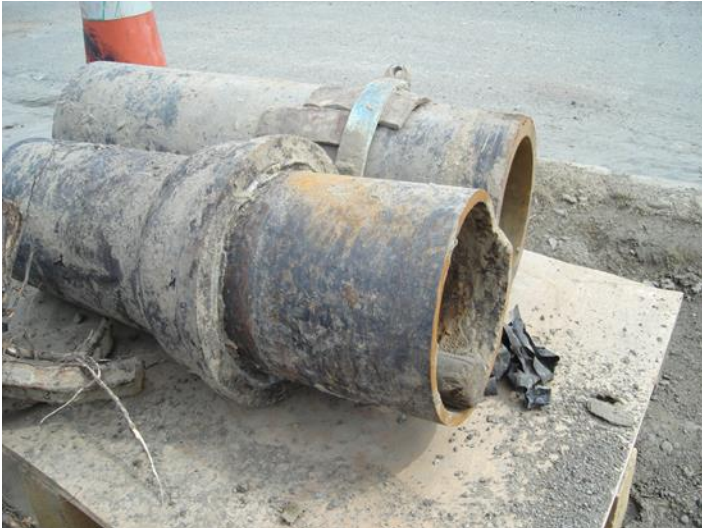
Reference: J004

Description: Leaking joint.

Cause: Compression or bending.

Comment: These joints have very low sealing capacity when deflected. Minor displacement results in leakage. In some cases, the joint can be resealed by repositioning the lead seal. Use modern pipeline systems to avoid failure.

Repair: If pipe undamaged, cut out joint and repair. For minor displacements, may be able to repack lead.

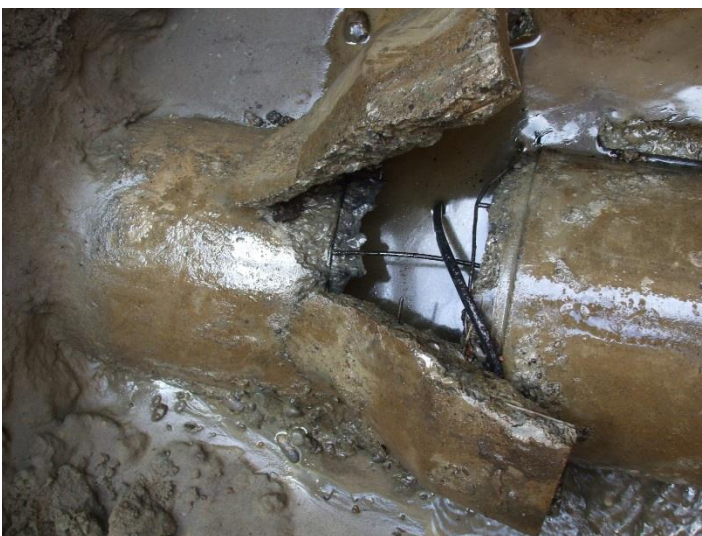
Reference: J006

Description: Joint failure.

Cause: Compression

Comment: Some other materials can survive limited compression. Otherwise accept risk and plan for repair.

Repair: If localised damage, may be able to use repair patch or line affected section. Otherwise, cut out and repair.

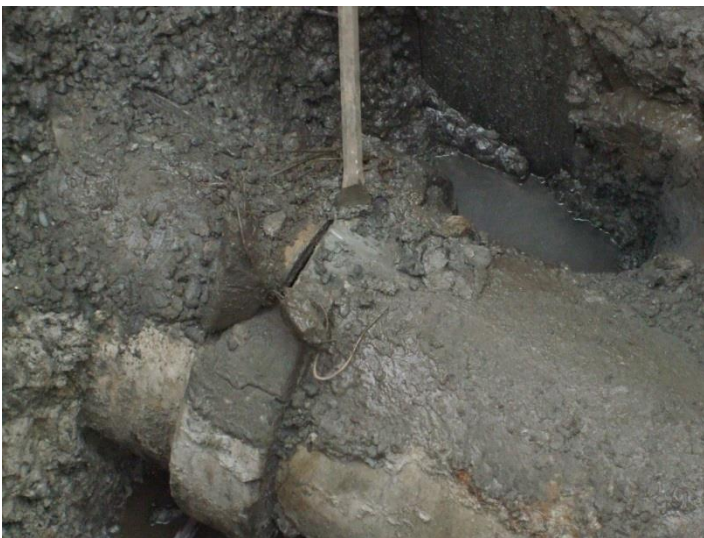
Reference: J008

Description: Joint failure.

Cause: Lateral shear or bending

Comment: Modern pipeline systems may be more tolerant.

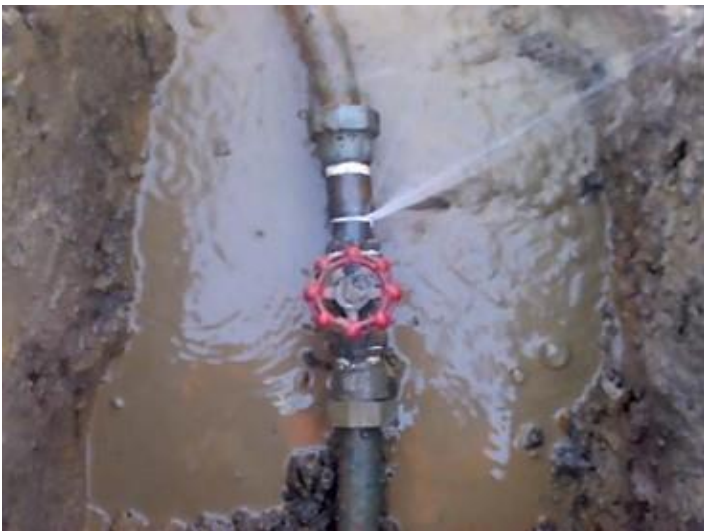
Reference: J009

Description: Leaking joint.

Cause: Possibly bending.

Comment: More flexible modern pipelines have better tolerance to displacement and deflection.

Repair: May be able to remake joint otherwise replace damaged components.

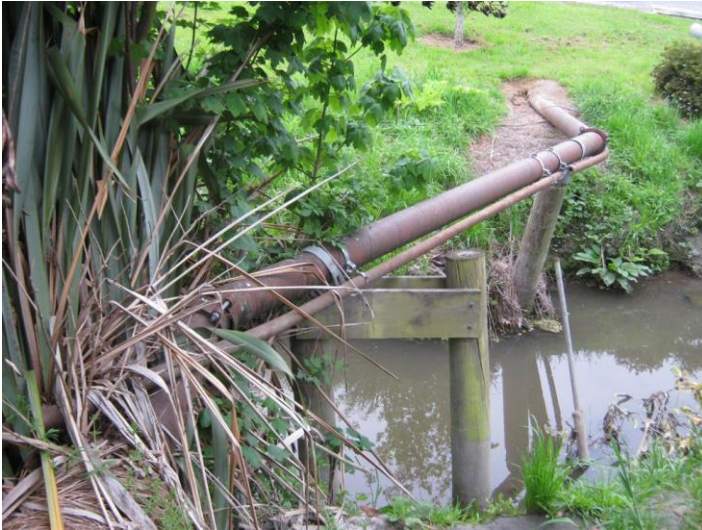
Reference: J010

Description: Joint failure.

Cause: Lateral spread.

Comment: The only practicable way to avoid this is avoid locating system where lateral spread is a hazard. Modern plastics may have remained intact though deformed.

Repair: Replace damaged joints. It may be possible to reuse the pipes if the ends are undamaged, but the joint will probably need replacement.

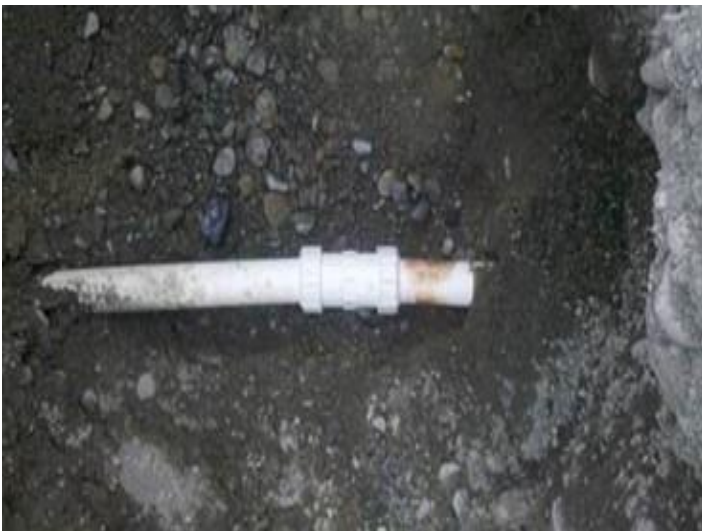
Reference: J011

Description: Leaking joint.

Cause: Leaking PE or PP bodied compression fitting on PVC pipe.

Comment: Modern PE pipe and joints have better tolerance to displacement.

Repair: May be able to re-make joint, but will usually need to replace connector and any damaged pipe.

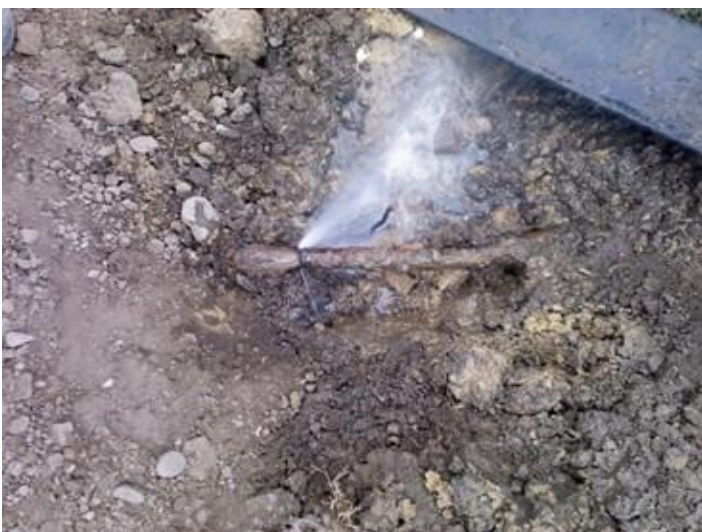
Reference: J012

Description: Leaking threaded joint.

Repair: Replace joint .

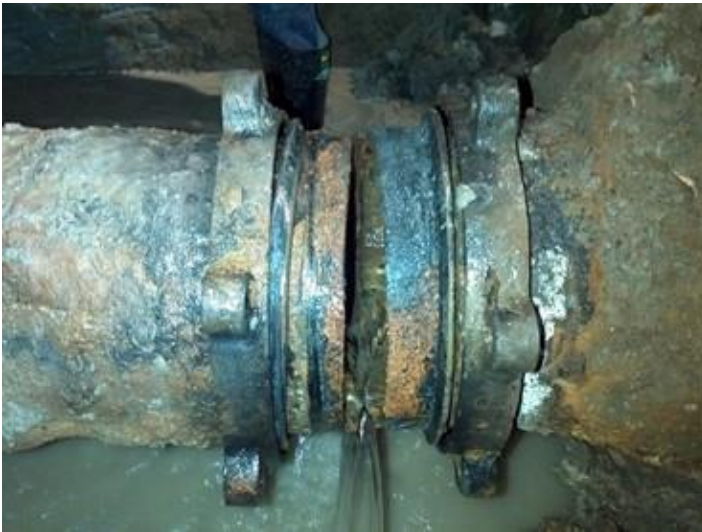
Reference: FT001

Description: Gibault failure.

Cause: Probably tension or bending, but possibly large amplitude shaking.

Comment: Modern pipeline systems are more tolerant of displacement.

Repair: Reconnect pipes with replacement coupler if not badly damaged, otherwise replace damaged pipes and repair.

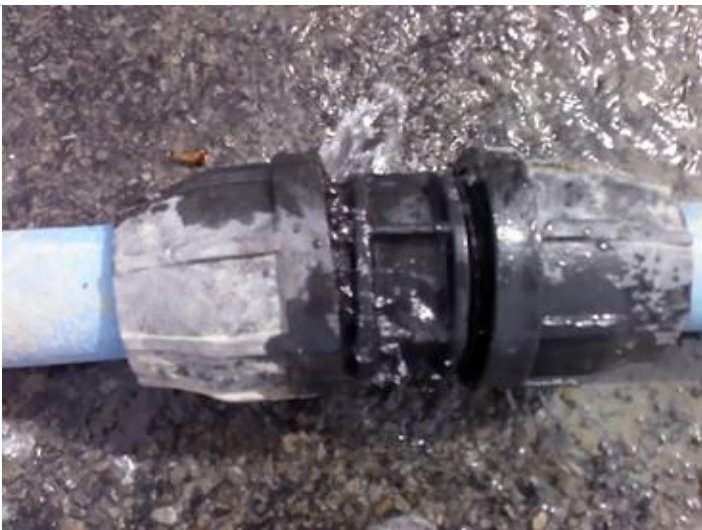
Reference: FT002

Description: Compression fitting leaking.

Cause: Probably failed in tension, possibly bending.

Comments: The left hand cone appears to have been displaced. Use of an insert may have helped transfer displacement into the pipe barrel, preventing failure.

Repair: Replace damaged fitting

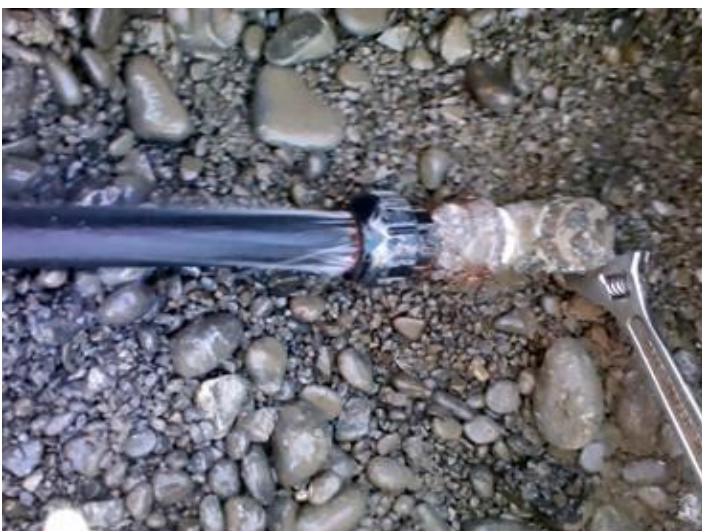
Reference: FT003

Description: Compression fitting leaking.

Cause: Tension or bending

Comments: Use of an insert may have helped transfer displacement into the pipe barrel and prevented failure.

Repair: Replace damaged fitting.

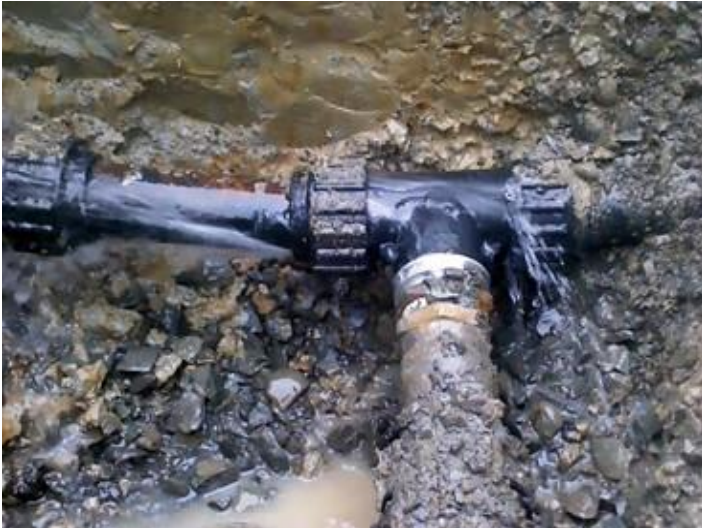
Reference: FT004

Description: Compression fitting leaking.

Cause: Tension or bending

Comments: Use of an insert may have helped transfer displacement into the pipe barrel and prevented failure.

Repair: Replace damaged fitting.

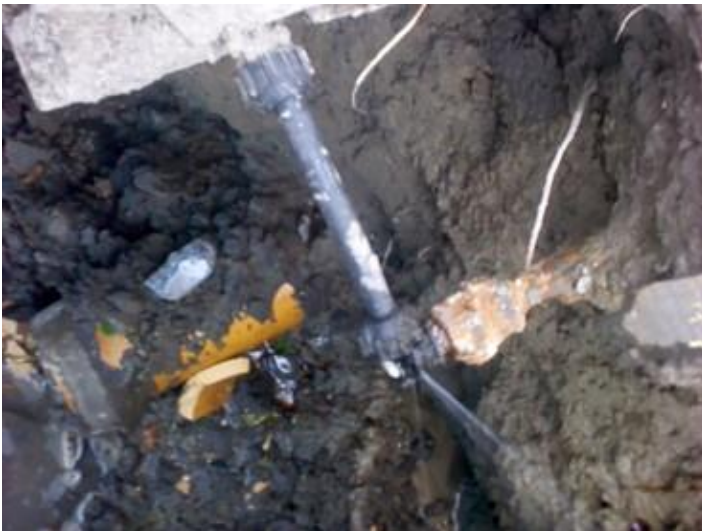
Reference: FT005

Description: Compression fitting leaking.

Cause: Tension or bending

Comments: Use of an insert may have helped transfer displacement into the pipe barrel and prevented failure.

Repair: Replace damaged fitting.

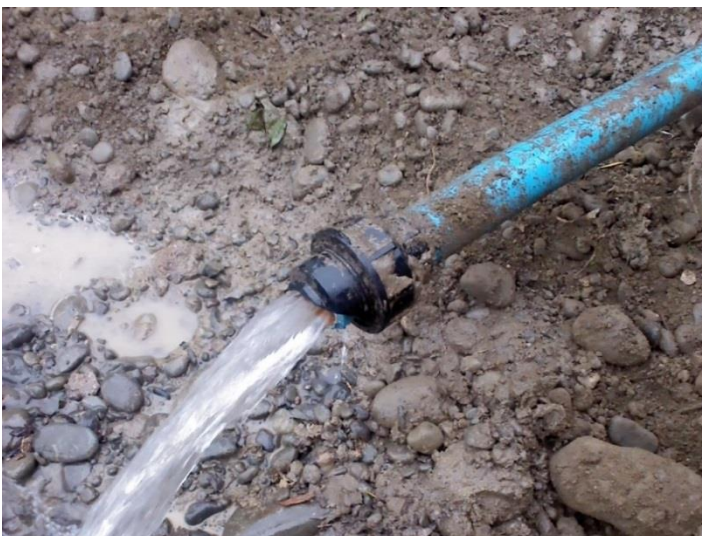
Reference: FT006

Description: Compression fitting failed

Cause: Ground movement

Comment: Modern PE with inserts in mechanical joints is more tolerant of deformation and can transfer deformation away from fittings into the pipe barrel.

Repair: Replace damaged fitting.

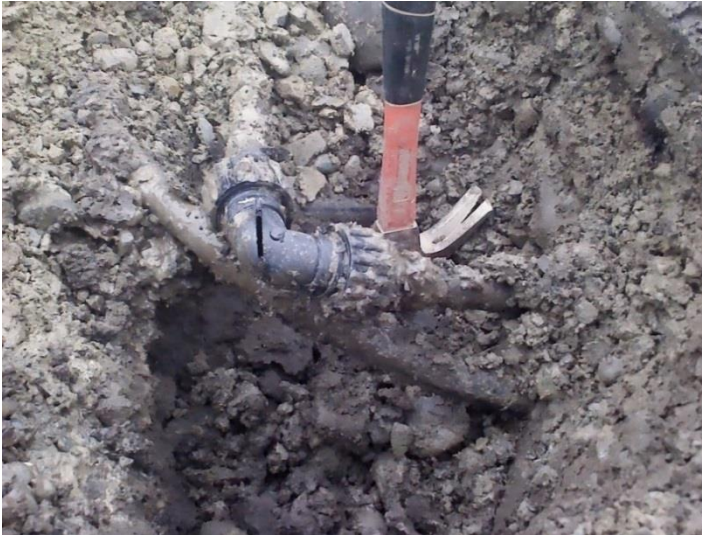
Reference: FT007

Description: Compression fitting failed.

Cause: Ground movement

Comment: Modern PE with inserts in mechanical joints is more tolerant of deformation and can transfer deformation away from fittings into the pipe barrel.

Repair: Replace damaged fitting

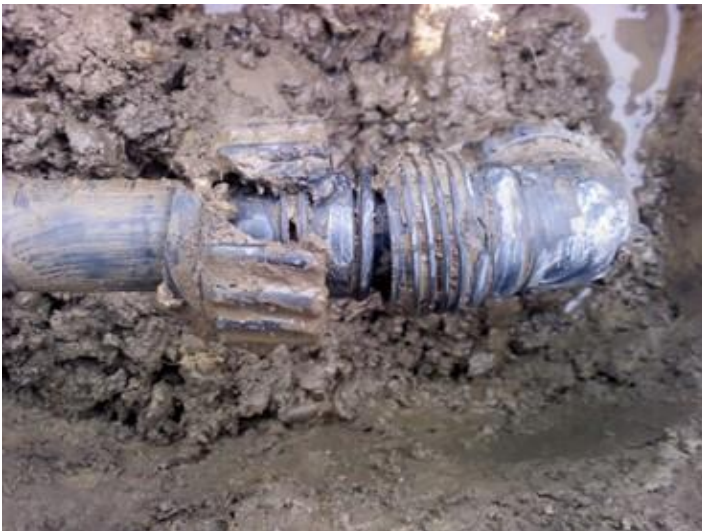
Reference: FT008

Description: Compression fitting failed.

Cause: Ground movement

Comment: Modern PE with inserts in mechanical joints is more tolerant of deformation and can transfer deformation away from fittings into the pipe barrel.

Repair: replace damaged fitting

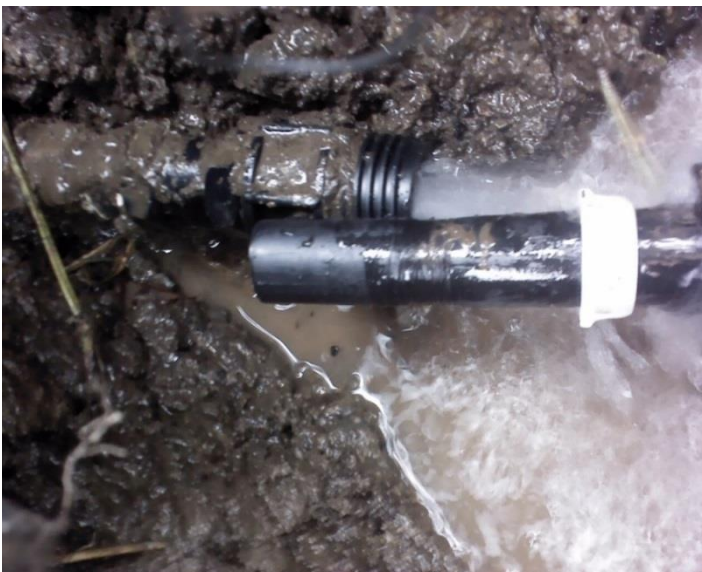
Reference: FT009

Description: Compression fitting failed.

Cause: Ground movement

Comment: Modern PE with inserts in mechanical joints is more tolerant of deformation and can transfer deformation away from fittings into the pipe barrel.

Repair: replace damaged fitting

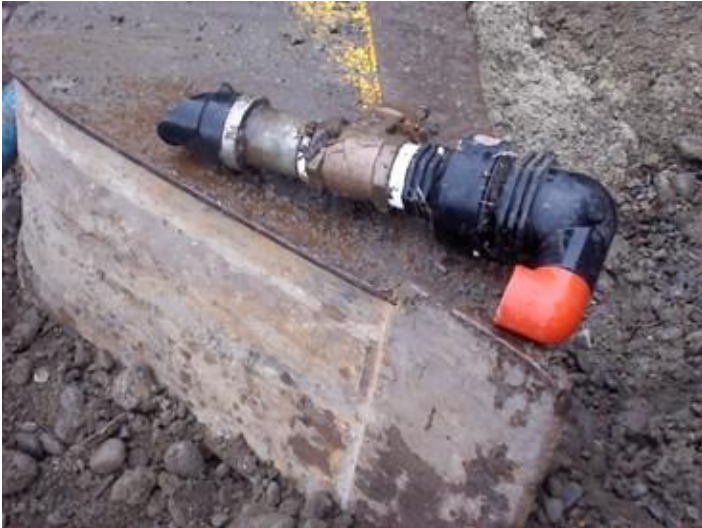
Reference: FT010

Description: Compression fitting failed.

Cause: Ground movement

Comment: Modern PE with inserts in mechanical joints is more tolerant of deformation and can transfer deformation away from fittings into the pipe barrel.

Repair: replace damaged fitting

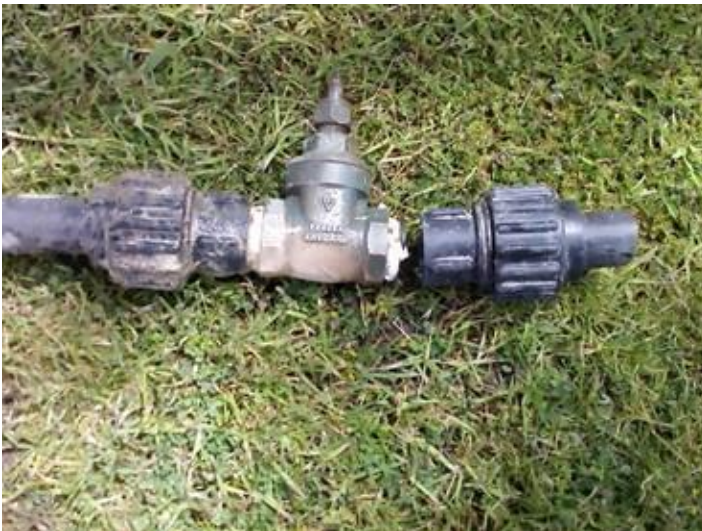
Reference: FT011

Description: Threaded fitting failed.

Cause: Tension or bending

Comments: Threaded fittings have low tolerance to displacement. If alternative stop taps and fittings cannot be used, may need to accept risk.

Repair: Replace damaged fitting.

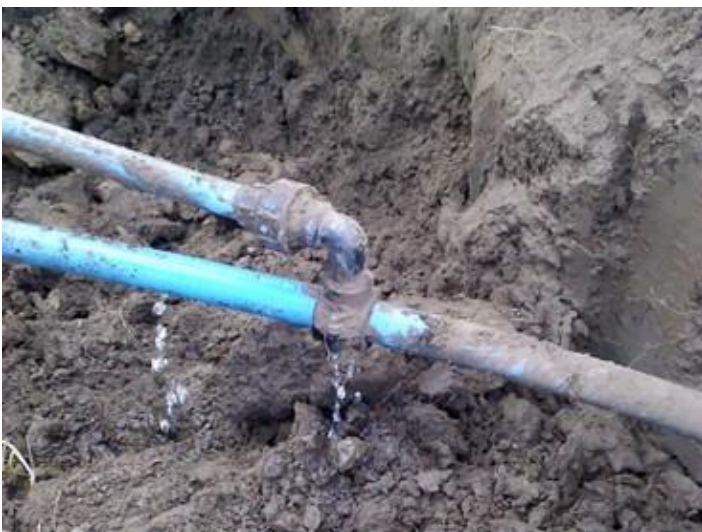
Reference: FT012

Description: Saddle leaking.

Cause: Unknown, could be shaking, compression or bending.

Repair: May be able to re-make joint. Otherwise cut out and replace.

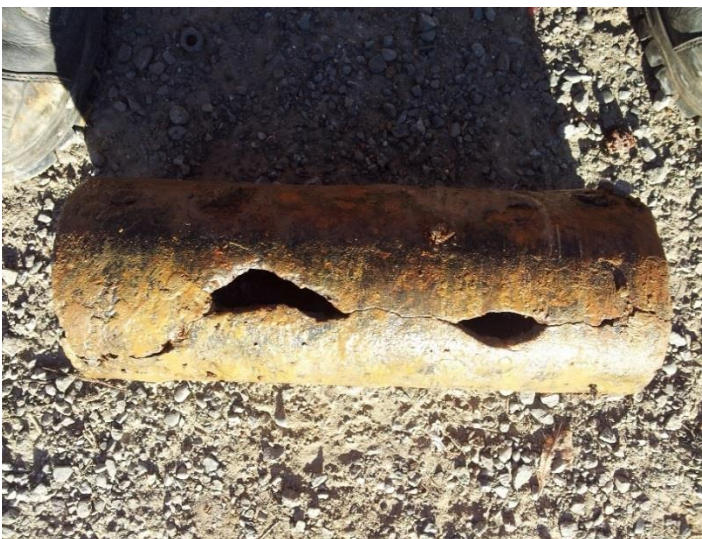
Reference: EX003

Comment: Requires degraded pipe wall, but triggered by ground movement or pressure surge.

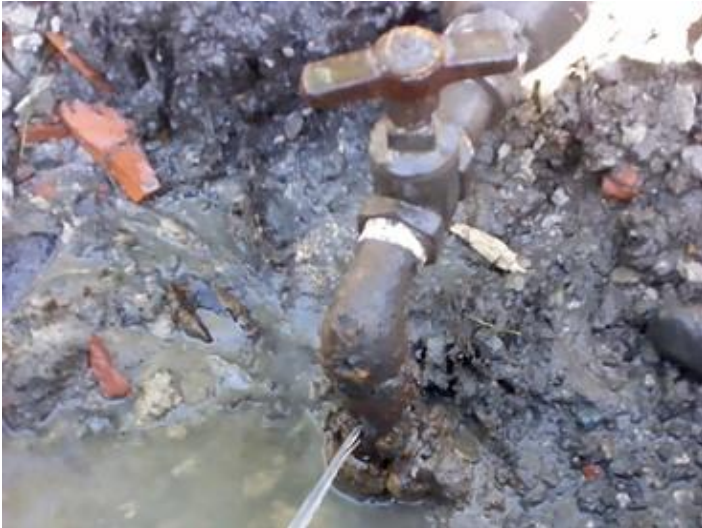
Reference: EX004

Comment: The copper pipe had perforated, but the hole was blocked by a plug of corrosion product. Shaking probably displaced the plug causing the leak to open up.

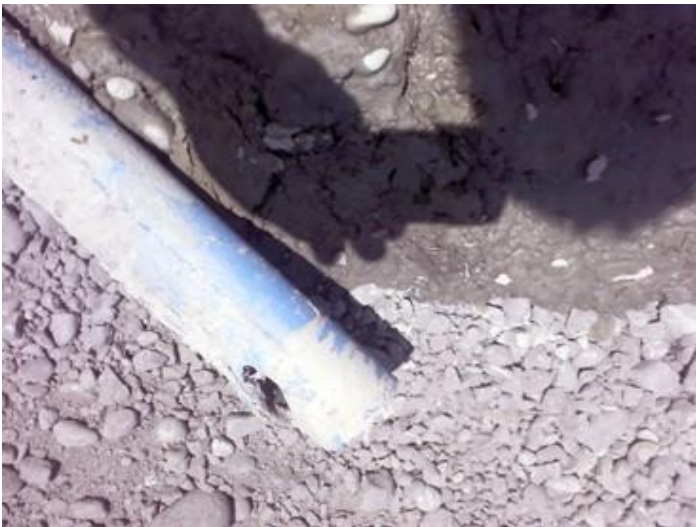
Reference: EX005

Comment: Appears to have been damaged by a drill or pole.

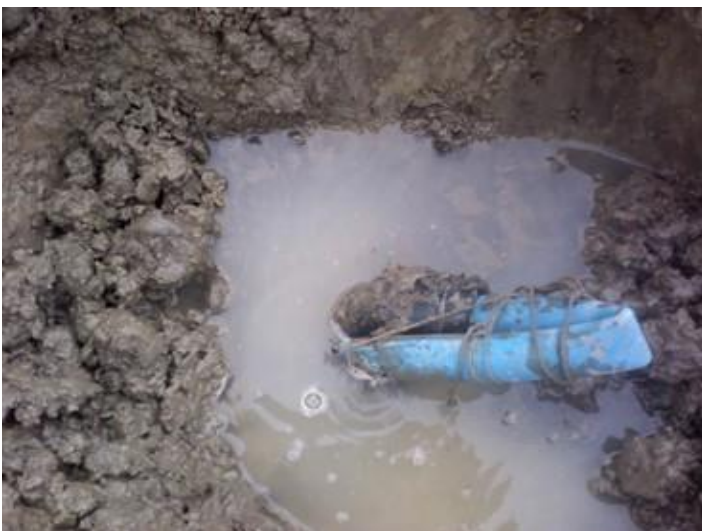
Reference: EX006

Comment: Temporary repair method.

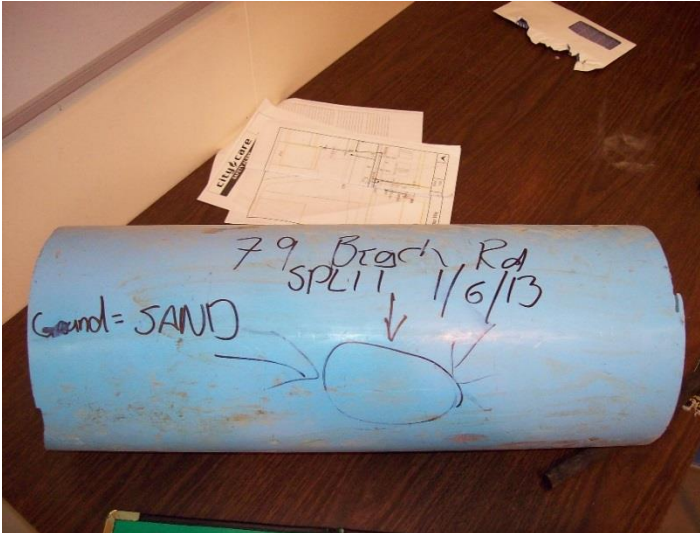
Reference: EX007

Comment: Typically caused by local point load (eg from stone) leading to slow crack growth but actual failure could be triggered by additional stress during a surge or shaking from earthquake.

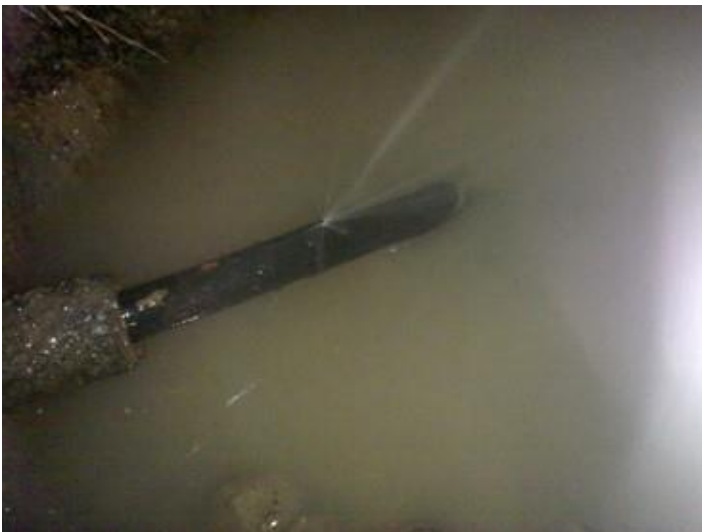
Reference: EX010

Comment: Leaking steel pipe next to coupling.

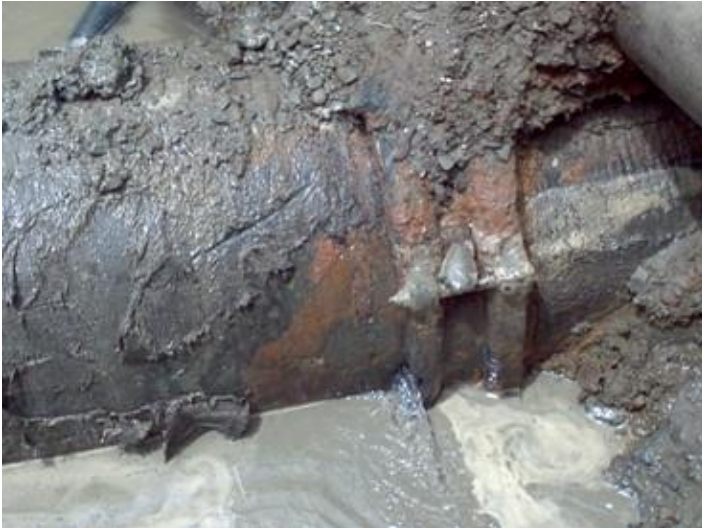
Reference: EX011

Comment: Leaking steel pipe next to gibault. Similar failures are seen in normal service in bitumen coated steel pipes where the coating has been damaged when the fitting was installed.

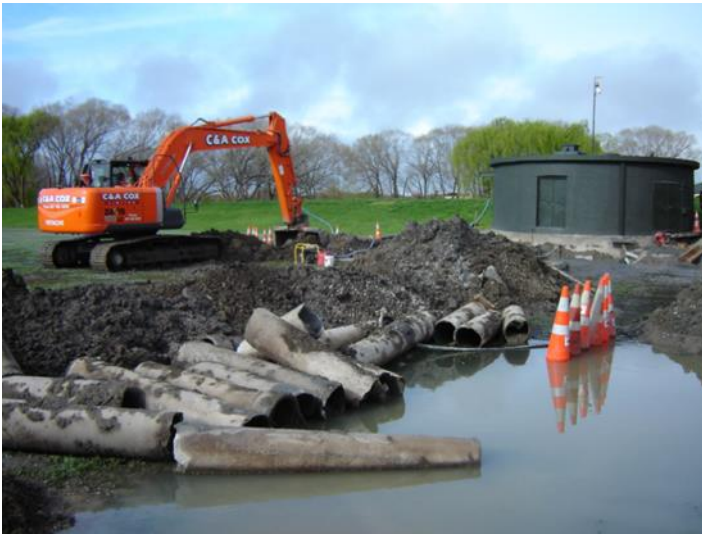
Reference: OT001

Comment: A combination of rigid pipe barrel and joints with limited capacity to accommodate deflection has resulted in widespread damage due to flotation. If the pump station was undamaged and retained some functionality or could be re-levelled, it may be possible to either make a temporary connection. Avoid similar problems in future by design to avoid flotation or locate away from liquefiable ground. A flexible modern pipeline system with end load resistant joints might have tolerated this displacement.

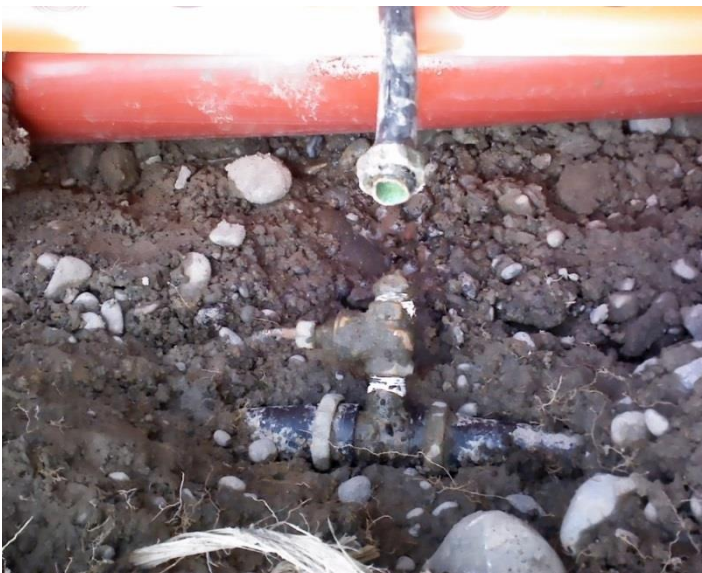
Reference: OT002

Comment: May have been corroded at time of failure but threaded fittings have low tolerance to displacement even when new.

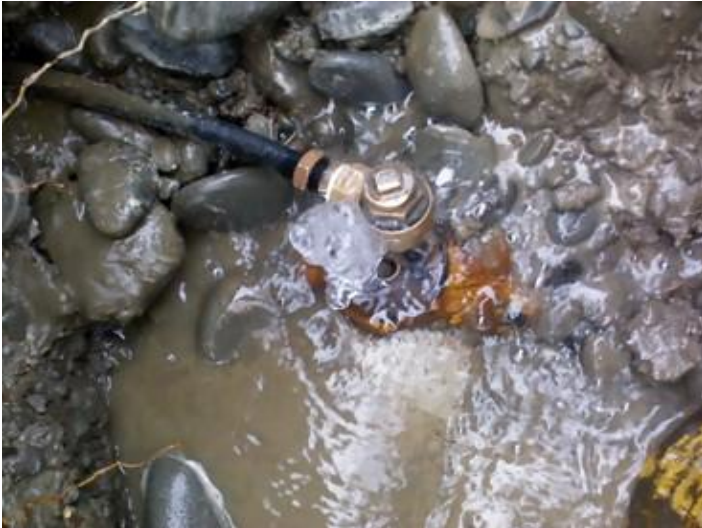
Reference: OT003

Comment: May have been due to corrosion. Snaking the service pipe and taking it off at a slight angle may have reduced vulnerability.

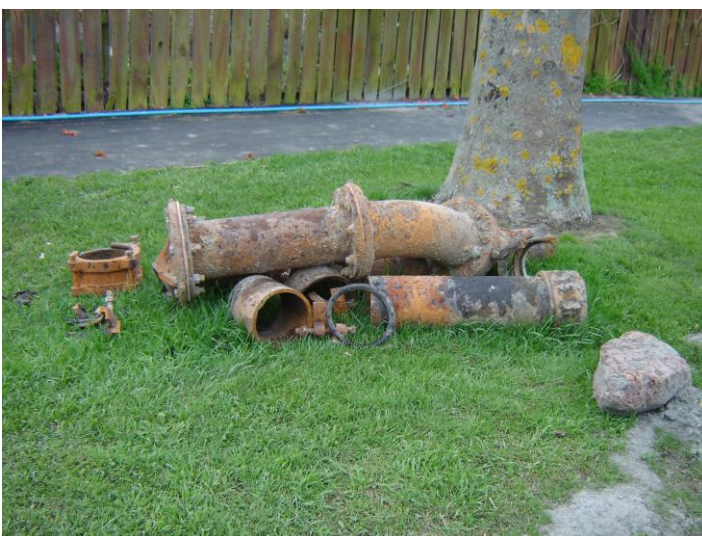
Reference: OT005

Comment: Cast iron has limited ability to accommodate deflection, especially when deteriorated. Casting defects in bends and other fittings increase the risk of local weak points. Modern pipeline systems would be more tolerant.

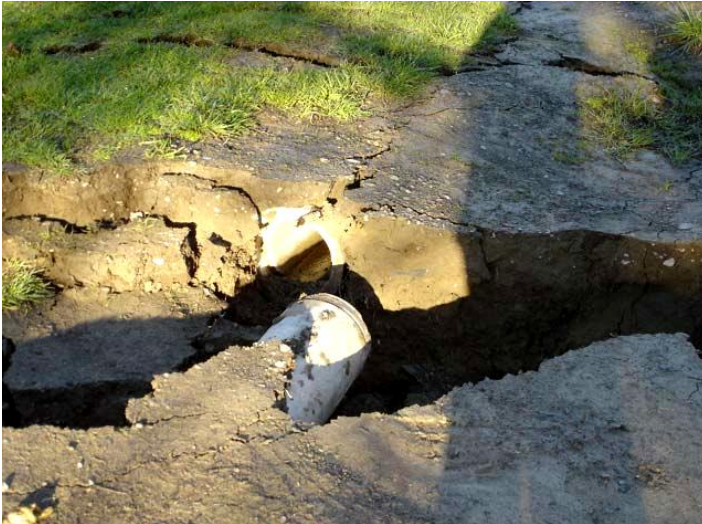
Reference: OT006

Comments: Rubber ring jointed pipes have minimal resistance to end loads. A flexible pipe barrel would also be needed to withstand the lateral displacement in this condition. Where possible, avoid ground at risk of lateral spread. A flexible modern pipeline system with end load resistant joints may have tolerated this displacement.
