Technical Note 09 – Photobook of Damaged Underground Utilities

1. Introduction

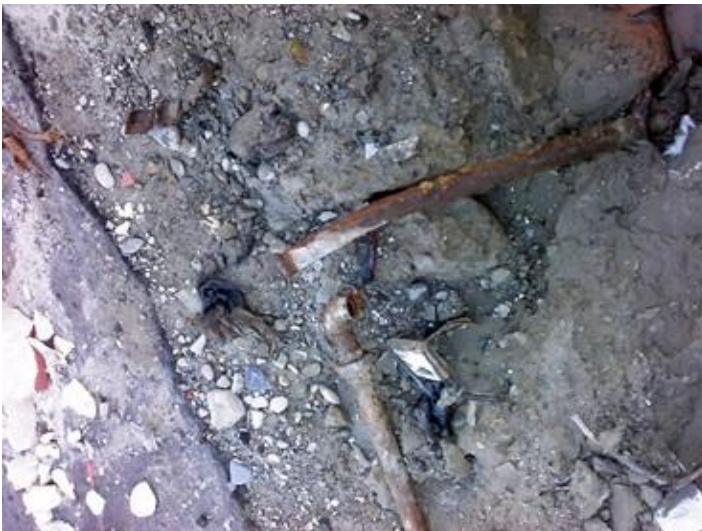
Reference: OT007

Comment: Galvanized pipes performed poorly in Christchurch and Kaiapoi. Replacement is probably better than repair. Modern service pipe materials with inserts in mechanical joints would perform better.

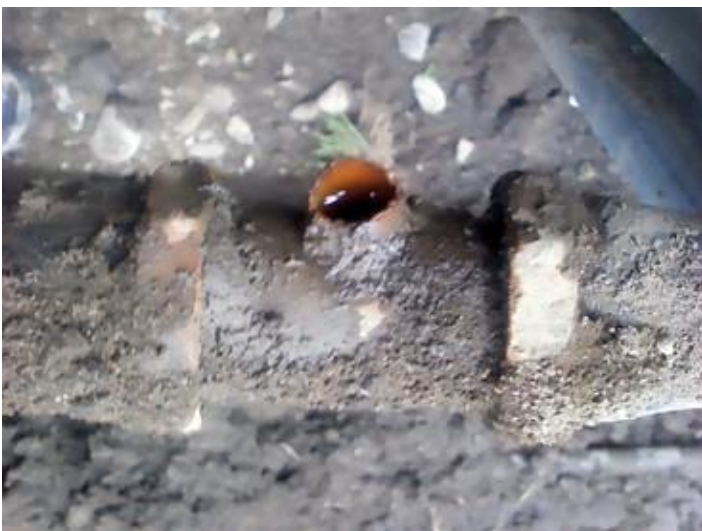
Reference: OT08

Comment: Modern service pipe materials with inserts in mechanical joints would perform better.

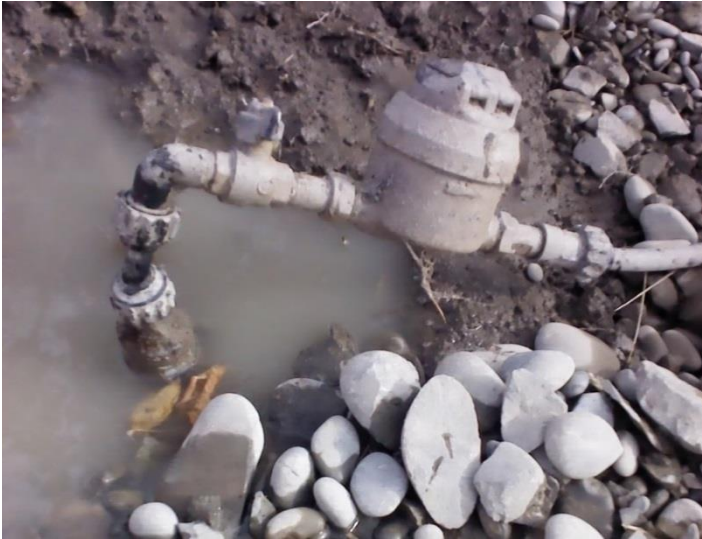
Reference: OT009

Comment: While modern PE with inserts in mechanical joints is more tolerant of deformation, the short section of pipe between fittings does not allow room for substantial deformation.

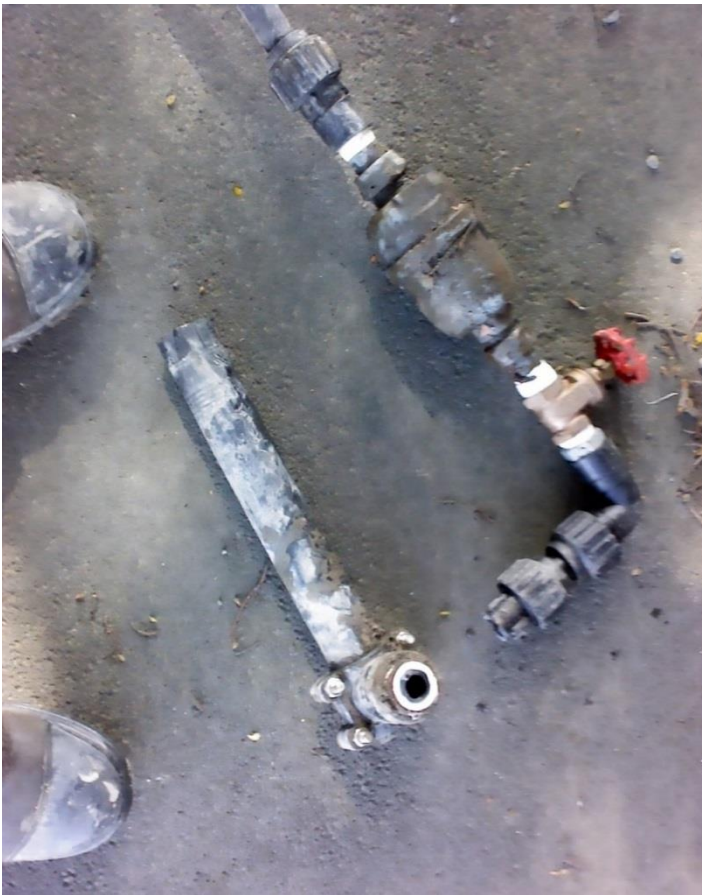
Reference: OT010

Comment: While modern PE with inserts in mechanical joints is more tolerant of deformation, the short section of pipe between fittings does not allow room for substantial deformation.

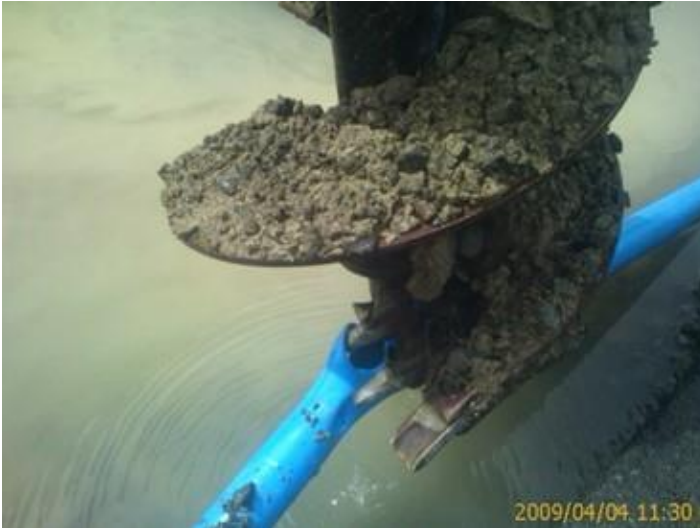
Reference: OT011

Comment: Good installation practice including warning tapes and detection wires will reduce the risk.

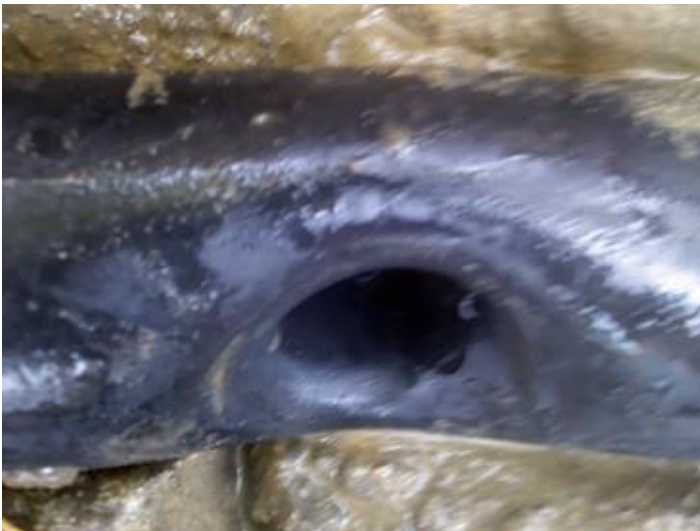
Reference: OT012

Comment: Good installation practice including warning tapes and detection wires will reduce the risk.

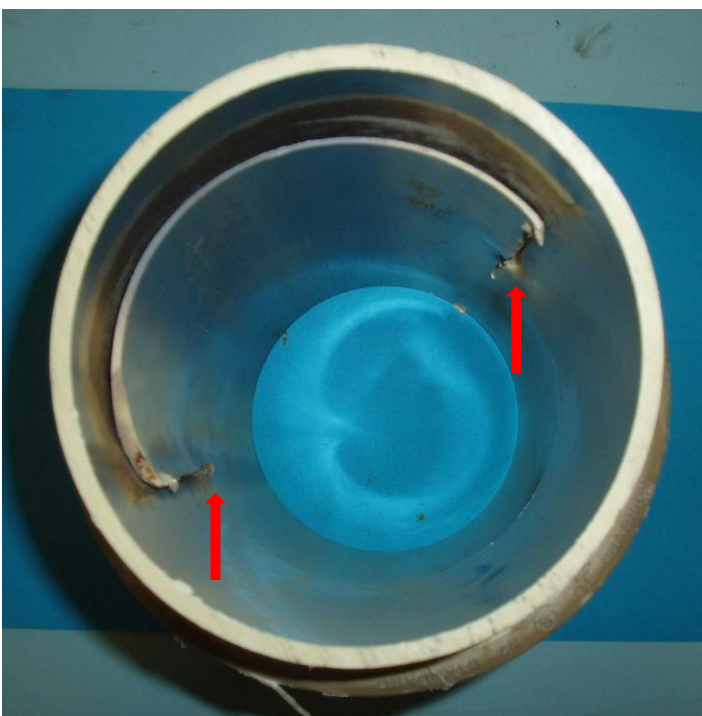
Reference: OT019

Comments: End on view of the PVC socket shown above. The red arrows mark where the pipe walls have cut through each other.
