# RETROFITTING RESILIENCE – RICHMOND RESERVOIRS

*Avik Halder, MWH Global and Chris Blythe, Tasman District Council*

## ABSTRACT

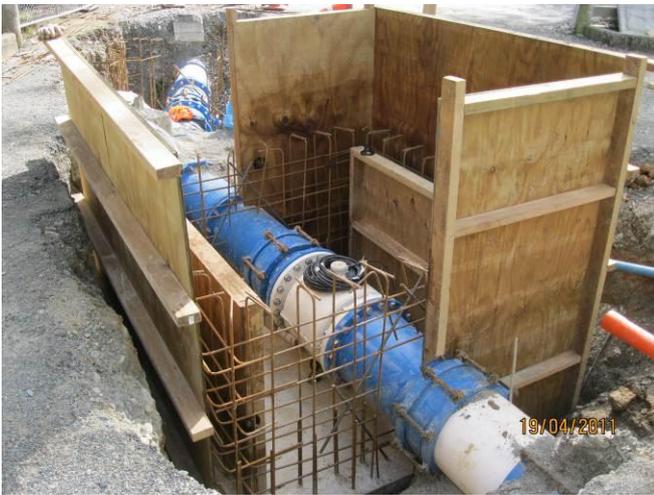
For example, at the Champion Road reservoir, the first to have works undertaken, on-site delays were encountered where a number of line and level adjustments had to be made iteratively to account for the change in direction in the pipework (as shown in photograph 1). This meant the overall duration of the construction works was a number of hours longer than anticipated. To mitigate this, subsequent designs included for more flexible fittings to allow for easier adjustments to the line and level of any pipework connections.

*Photographs 1 and 2: Installation at Champion Road (left) and Queen Street (right) reservoirs*

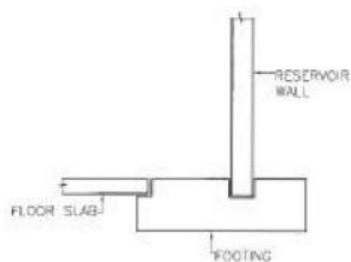
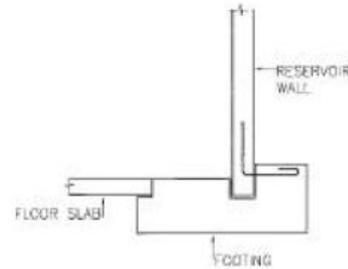
As part of the flow control valve and meter installation, the existing as-built drawings were reviewed. The review highlighted a connection deficiency in the wall to floor connection and wall to roof connection in these concrete reservoirs. This was common in concrete tanks that were constructed before the mid 1970's where in some circular precast reservoirs the base of the precast wall panels simply rested in a slot with no reinforcement connecting the components together (see Figure 5).

These connection details were developed for static loading only (which is satisfactory under normal conditions since forces are radial). During a seismic event however, some of these tanks are susceptible to lateral forces resulting in the wall moving and causing failure. More recent designs have the walls physically fixed into the slab or the ring beam to prevent failure.

Figure 5:  
Wall in a  
no floor  
connection (left)  
connected in slot  
floor connection

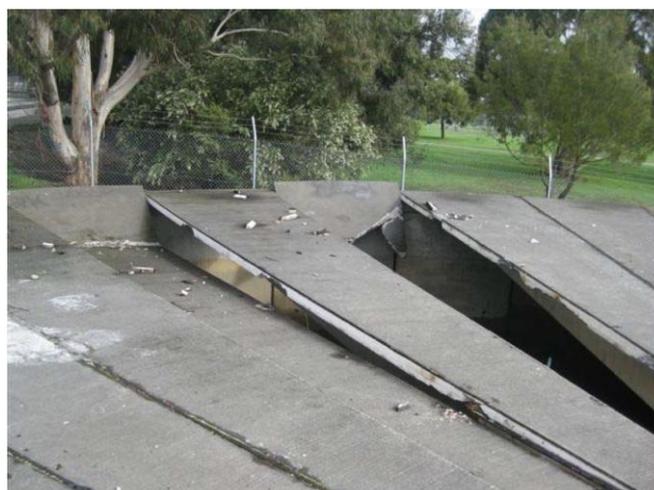
During a seismic event, the horizontal earthquake acceleration causes the water in the tank to slosh and creates waves in the tank. If the freeboard of the tank is less than the convective wave height, a hydrodynamic pressure will be generated leading to uplift forces on the roof. This is illustrated in the photograph below of a Christchurch reservoir following the September 2010 earthquake.

Photograph 3: Damaged Denton Park reservoir roof in September 2010 Christchurch earthquake

To comply with current codes, the reservoir roofs needed to be retrofitted with suitable connections to prevent roof uplift. Connections such as steel brackets could be bolted onto the roof slab and the wall panels.

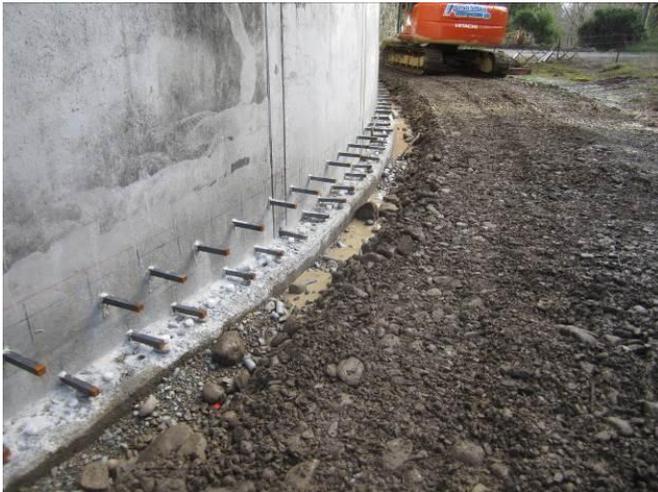
*Photographs 4 and 5: Inserted dowels at Champion Road (left) and beam construction at Queen Street (right)*

It was subsequently agreed that strengthening the wall to floor connection ahead of the wall to roof connection was the priority as tank failure at ground level had a greater consequences than that at roof level. By prioritising this deficiency, Council were able to undertake strengthening work at all three reservoirs within the allocated budget and still significantly improve the seismic resilience of each reservoir.

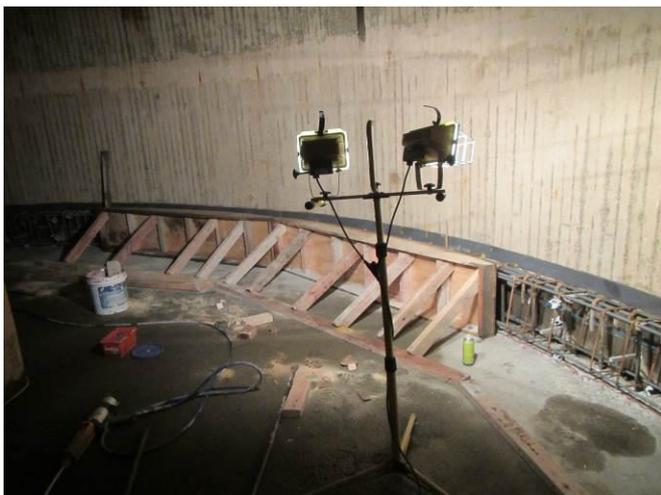
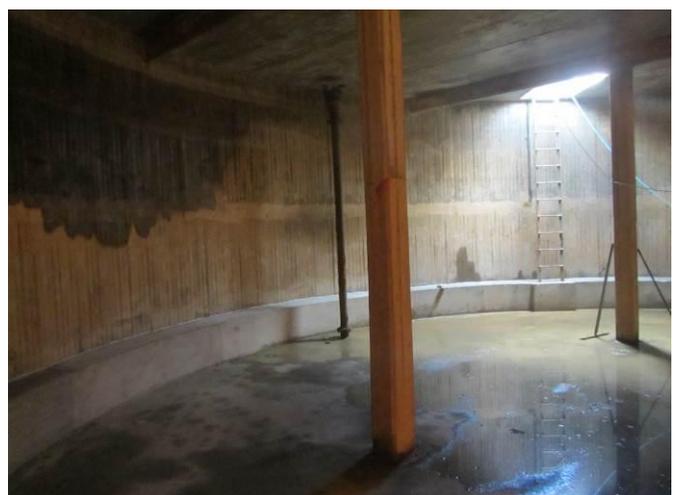
The repetitive nature of the work was further complicated at Valhalla Lane reservoir. As previously mentioned, the concrete footing of this reservoir was 1.5m below ground and so the strengthening work was undertaken internally.

This created a confined spaces work environment for the construction team, and generated issues such as noise and dust. In this instance, the construction team were keen to complete the works in as short a time period as possible, which was also beneficial from a reservoir shut down perspective, and so Council approved extended work hours, including the weekend.

*Photographs 6 and 7: Internal strengthening works at Valhalla Lane reservoir*
