CIPP A North American
Perspective: Assessing the
Performance of 40 Years of CIPP
Lining Rehabilitation in Winnipeg,

MB Canada

Chris Macey

Water New Zealand
Conference & Expo
2018 Hamilton, NZ

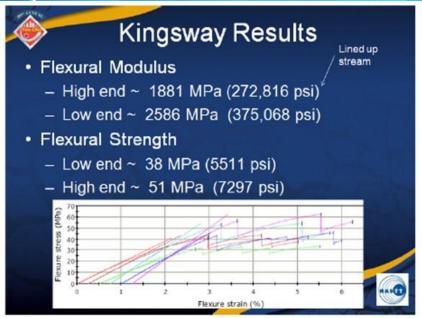
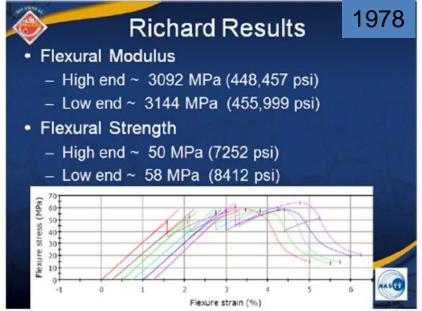
## Mechanical Properties of the oldest liners are impressive

### Average flexural modulus

1984

- 2621 MPa (380,186 psi)
- Average flexural strength (ultimate)
  - 32.8 MPa (4758 psi)

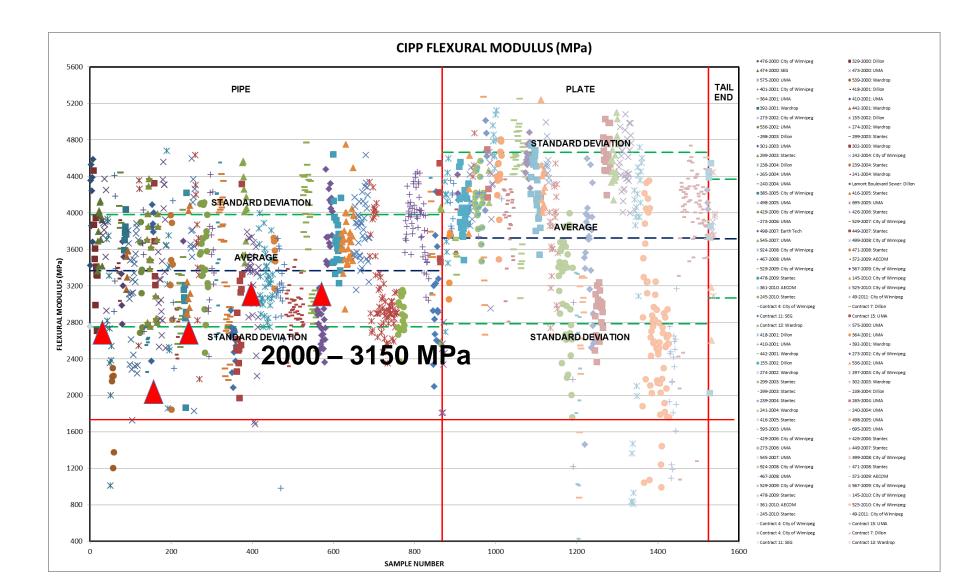
### Mechanical properties of the oldest liners look just like the newer liners – typical of a new unfilled polyester resin
