PIPELINE PERFORMANCE EXPERIENCES DURING SEISMIC EVENTS IN NEW ZEALAND, 1987 TO 2015

Frank W. O'Callaghan, Iplex Pipelines NZ Ltd, New Zealand

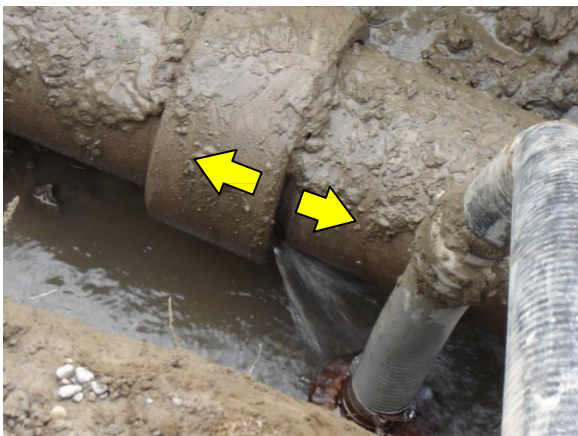
Figure III - Tension effects in AC pipe joint, Sewell Street Kaiapoi, axially aligned with the Darfield epicenter, 2010

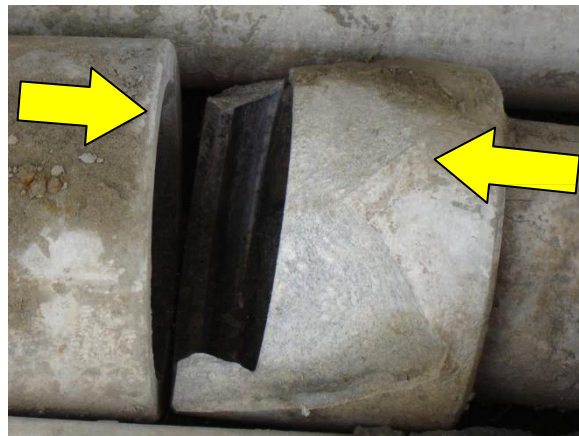
Figure IV - Compression effects in AC pipe joint, Sewell Street, Kaiapoi, axially aligned with the Darfield epicenter, 2010

Pipe/joint type	Compressive Phase movement in Liquefiable ground	Location/ Seismic Event
AC pressure and sewer	Localised 45 deg compression fracture of rubber ring coupling joints and crushed pipe spigots. (Figure IV and Figure VI)	Edgecumbe Christchurch Kaiapoi
EW sewer	Disintegration of whole pipe into random shards, or localised brittle ring fracture of mortar sealed bell and spigot joints.	Edgecumbe Christchurch Kaiapoi
VC sewer	Disintegration of whole pipe into random shards localised brittle fracture of rubber ring bell and spigot joints.	Christchurch Kaiapoi
RRRC sewer	Localised “telescoped” brittle fracture of rubber ring bell and spigot joints.	Christchurch Kaiapoi
PVC pressure and sewer	Localised ductile pipe barrel section folding/buckling. Localised “telescoping” of joints (Figure X), (caused by the pipe spigot being driven through the socket bell, and beyond into the pipe bore itself). Ductile fracture of sewer service lateral junctions, ductile tearing at socket joints,	Christchurch Kaiapoi

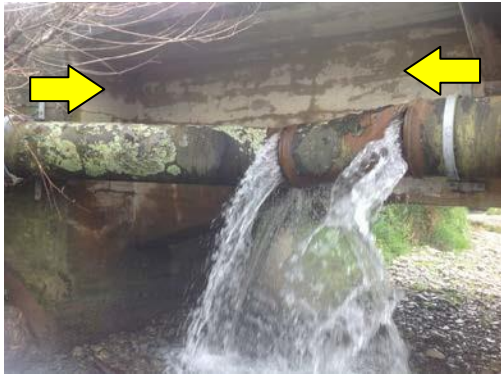
Figure V - Compression distortion and separation of RRJ joints in CLS watermain, axially aligned with the Eketahuna epicenter, 2014

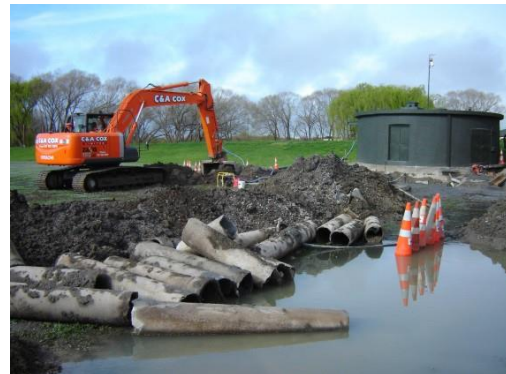
Figure VI – Compression fractures of pipe ends and joints in AC sewer rising main, Charles St, Kaiapoi, axially aligned with the Darfield epicentre, 2010 (Replaced with Biaxially Orientated PVC (PVC-O))

Biaxially orientated PVC (PVC-O) pressure pipe installed in 2010 to replace the destroyed AC sewer rising main at Charles St in Kaiapoi, (Figure VI) remained undamaged, during the Christchurch and Lyttelton events of 2011 and all subsequent aftershocks.

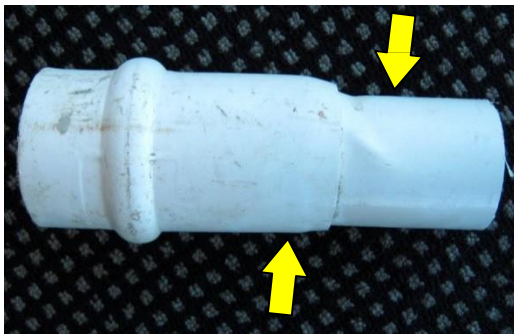
Figure VII – Shear effects with ductile response, in RRJ PVC-U of late 1970’s age, Christchurch, 2010

EW, VC, RRRC	Localised fracture and separation of bell and pipe barrel.	Gisborne Palmerston Nth Dannevirke Christchurch
PVC	Ductile distortion of pipe and joint, no leaking. (Figure VII and Figure XI)	Gisborne Kaiapoi Christchurch
CI	Fracture of pipe barrel at flange connections.	Christchurch
DI	Localised distortion/disorientation of coupled barrel sections with DI coupling fractures, (in an aerial pipe bridge application), movement beyond compressive capacity of material.	Christchurch
CLS	CLS pressure pipe systems: Localized “telescoping” of joints, tearing and “unraveling” of the spiral weld in the pipe barrel from movement beyond compressive capacity of material.	Christchurch Carterton (Eketahuna)
	Slumping or Lateral Spread in Liquefiable ground	
RRRC	Settlement off grade, pipe barrel fracture, joint fracture, lateral separation, separation from structures	Christchurch
PE-100 pipe systems	Tensile separation at electrofusion joints where movement beyond tensile capacity of joint at the fitting. Tensile separation (yield and break) of pipe, used as a liner in rehabilitation of CI watermain, where movement was beyond tensile capacity of pipe barrel.	Christchurch

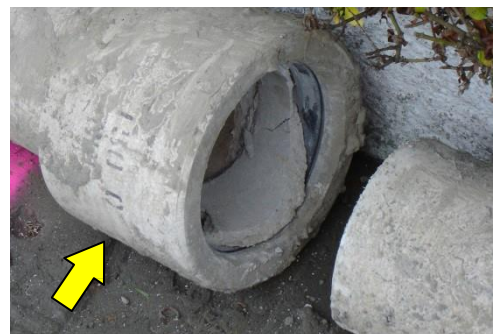
Figure VIII – Shear effects in AC pipe joint, Jollie Street, Kaiapoi, with tangential alignment to the Darfield epicenter, 2010

axial movement did not exceed spigot insertion length), movement beyond tensile capacity of material. (Figure X)	
CI pressure	Localised pull-out of couplers, displacement of screw gland joints and lead wool packed joints.	Christchurch
DI pressure	Joint separation, movement beyond tensile capacity of material.	Christchurch
CLS, GS	Separation where movement beyond tensile capacity of material.	
PE-100	Separation at Electrofusion joints where movement beyond tensile capacity of material.	Christchurch
PE-80, HDPE	Separation of service laterals at restrained mechanical joints where movement beyond tensile capacity of material. Tensile separation of pipe barrel where lateral spread movement beyond tensile capacity of material.	Christchurch
	Lateral Shear movement in Liquefiable ground	
AC	Localised shearing of spigot inside the bell assembly. Pipe barrel often left in reasonable condition, but with the end cracked off and separated. (Figure VIII)	Kaiapoi Christchurch Edgumbe

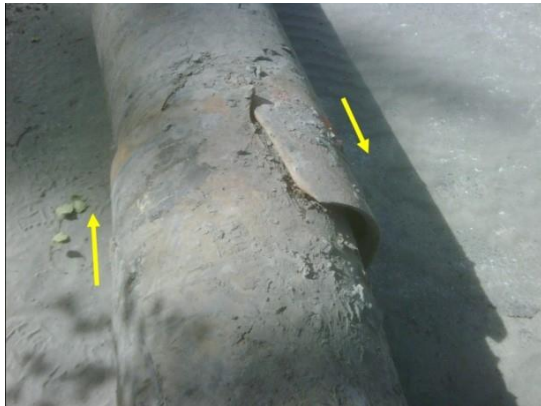
Figure IX - Compressed joint movement in CLS water main, Christchurch

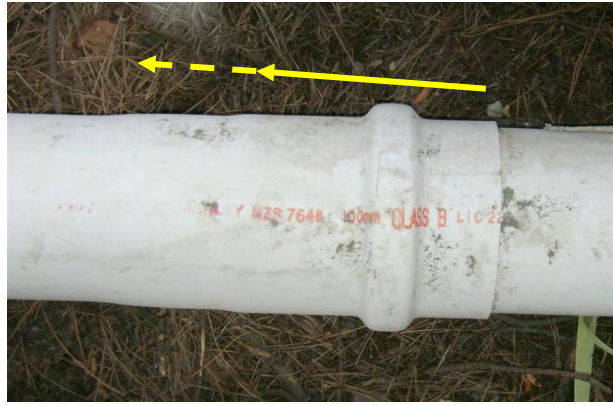
Figure X – Compressed ductile joint movement in PVC-u water main, Christchurch

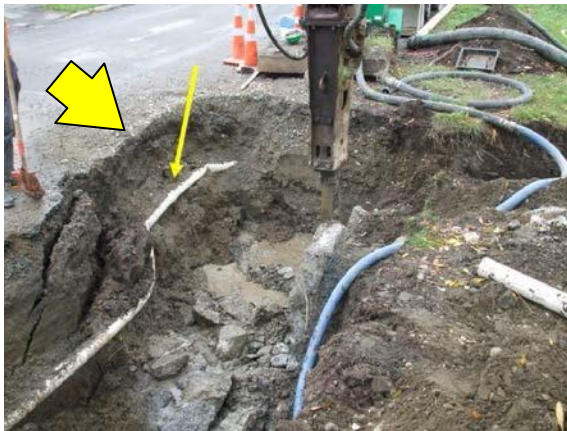
Pipe material behaved in surprising ways. In Christchurch, DN 100 PVC-M pressure pipe, manufactured in 1996, was displaced by sudden lateral spread and squashed behind a large concrete sewer chamber in the Avon river bank (Figure XI). The pipe was found to be still under pressure with reduced flow. The RRJ “Z” joint in the middle of the displaced pipe section which had “pulled” longitudinally about 15 mm, but had permitted the expansive movement, undamaged.

Figure XI - Distorted but still operational, DN100 PVC-M water pipe with joint, Christchurch

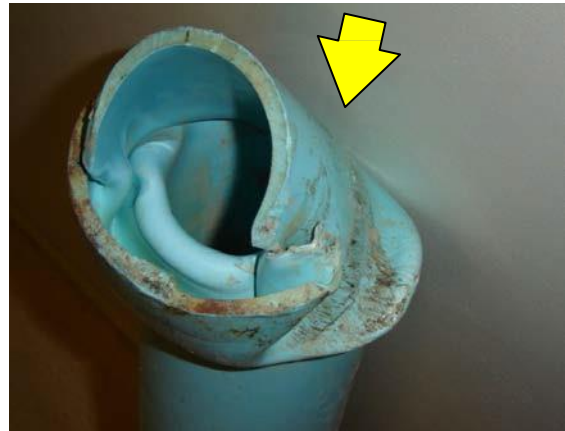
Figure XII - Ductile axial compression folding in PVC-U pipe, Gayhurst Road overbridge

At the Gayhurst Road over bridge crossing the Avon River in Avonside, Christchurch, lateral spread rapidly drove PVC-U watermain axially into the bridge abutment, to cause ductile axial buckling (Figure XII), and disintegration of the CI pipe and joints in the bridge. The crossing connections were quickly repaired with PVC pipe and mechanical couplers, requiring low operator skill, and no electricity to install.
