RESPONDING TO ACTS OF GOD

I. McComb, S. Jellyman, M. Doyle, L. Pigott, M. Croxford, S. Markham, A. Humphries: All authors from Tasman District Council

The adjacent urban areas of Richmond and Stoke within the adjoining Tasman and Nelson Districts suffered from an extreme rainfall event on 21 April 2013 causing approximately \$35 million damage within a few hours.

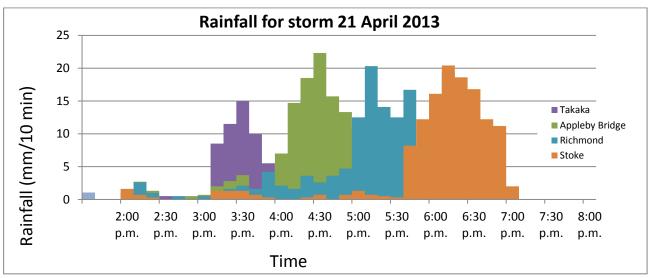
Figure 1 - Timing of rainfall across the Tasman District

About 4pm, heavy rain commenced in the Hope area just south of Richmond. Waves of intense rain and thunderstorms tracked down a narrow band from the north east to this area. The heavy rain band slowly shifted north to lie over central Richmond, with the worst rain occurring there from 5:00pm until 6:15pm. As the rain band continued north, the Stoke area was battered by similar intensities over the period 5:40pm – 7:00pm. The progression of rain from Hope (Appleby Bridge) to Stoke can be seen in figure 2. The Takaka rainfall recorded earlier in the day is also shown on the graph for interest. Each step on the horizontal time axis is 10 minutes.

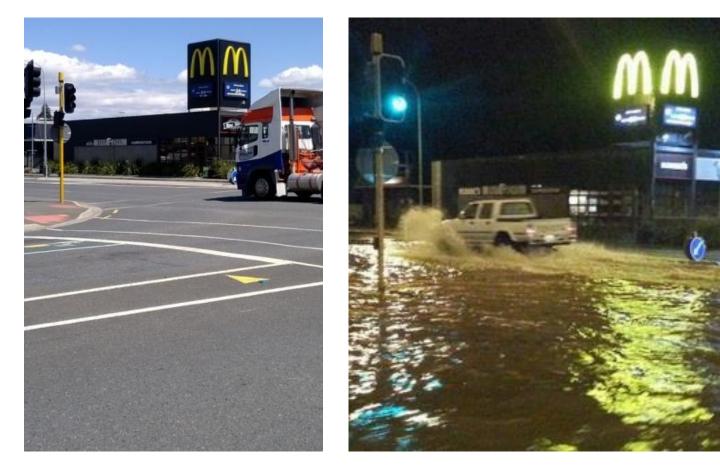
Photograph 1 A & B: Gladstone and Queen intersection in Richmond dry and wet

So what does 130-160mm of rain on the ground within a short period of time look like? The following photographs 1-3 show locations under normal conditions and during the event.
