# **Technical Note 10 – Effect of Deterioration on Seismic Resistance of Underground Pipelines Systems**

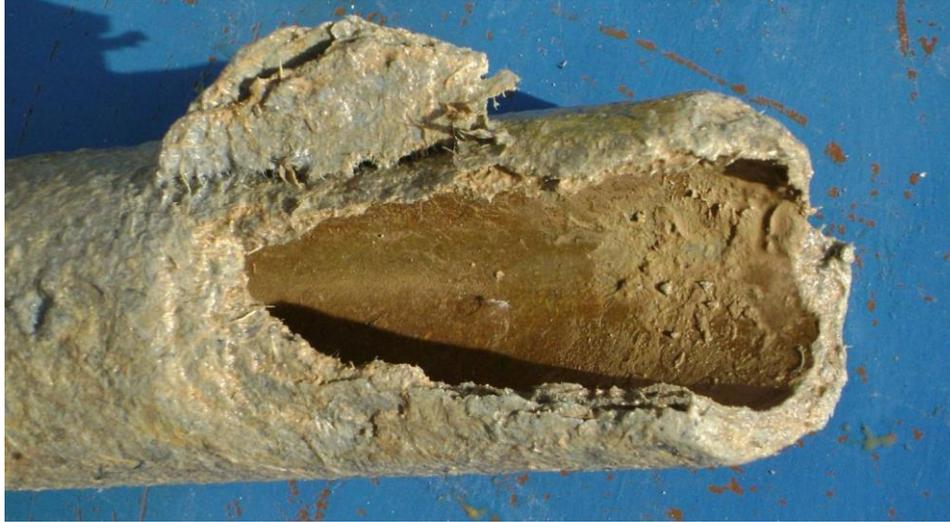
Figure 1: DN50 Asbestos Cement pressure pipe that remained serviceable for several years due to support from the surrounding soil despite being fully degraded.

The impact of deterioration can be different for gravity and pressure systems. In a pressure system, the pressure acts all along and around the pipe, so failure can usually be expected at the weakest point wherever it is. However, fully degraded pipes with negligible remaining strength can occasionally remain serviceable if the surrounding soil provides sufficient support to prevent failure (Figure 1).

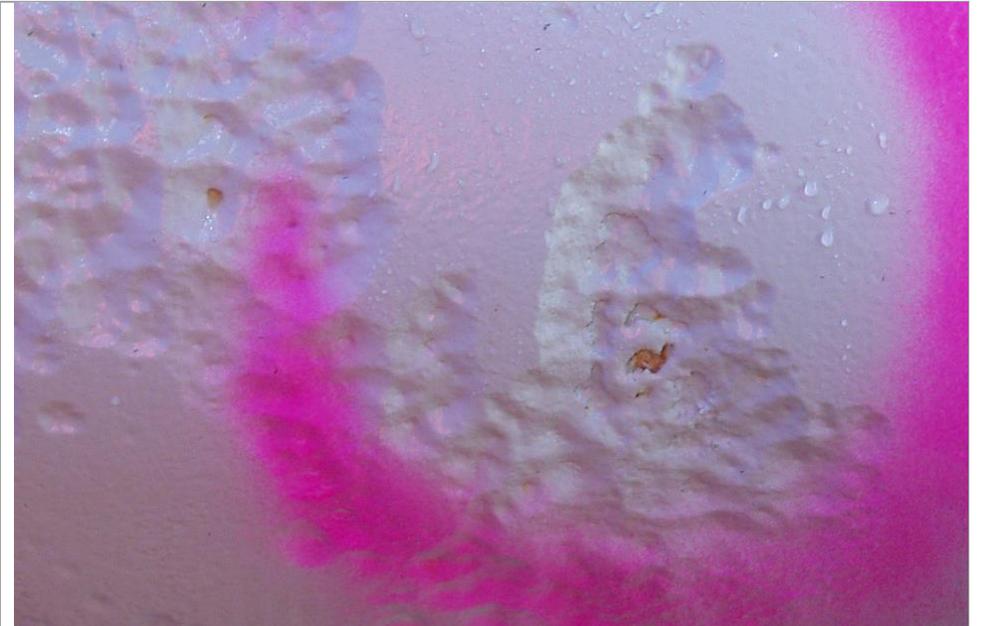
Figure 2: Concrete lining showing through perforated steel after blasting in preparation for re-coating in 2014. The perforation is approximately 6 mm in the largest dimension. The line was cathodically protected in the late 1980s, so the perforation was present before then. The combination of a plug of corrosion product and concrete lining has minimised any leakage in perforations up to at least 15 mm across.

A concrete lining can prevent leakage from a steel pipeline even when the steel has perforated (Figure 2). While a brittle concrete lining could be expected to fail more readily than the ductile steel pipeline it is lining, evidence from Christchurch shows that concrete linings can remain bonded and relatively undamaged when steel is subjected to seismic loads (Figure 3). Laboratory tests have confirmed that linings can remain bonded even when the pipe is severely deformed (Figure 4).

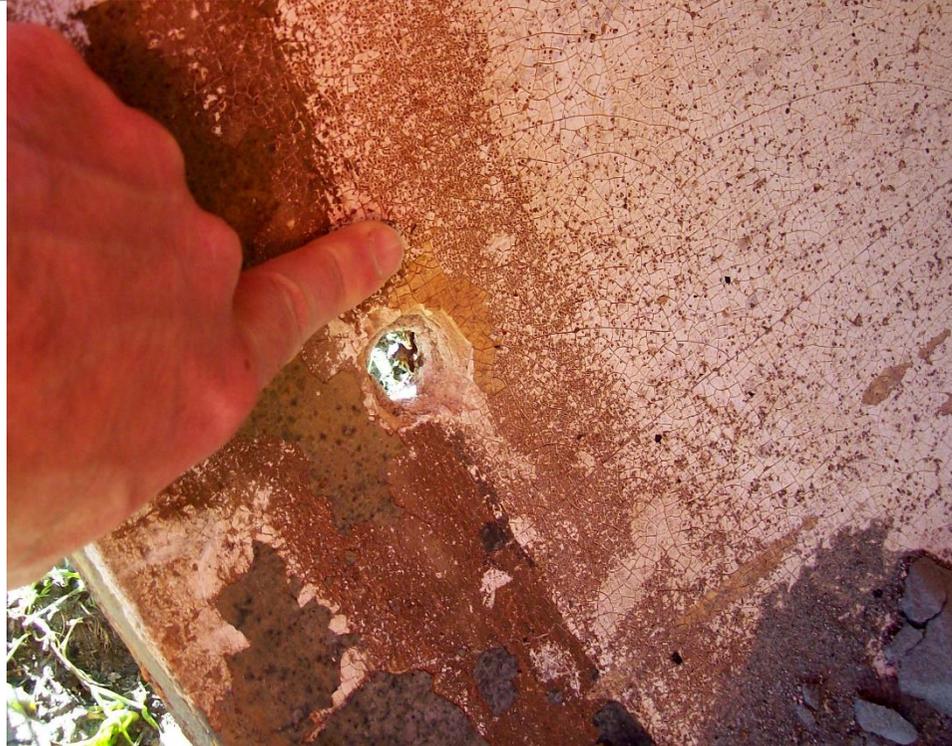
Figure 3: Concrete lining in a steel pipe subjected to seismic loads and a pre-existing perforation. The perforation has probably been present for decades and was either blocked by corrosion product or was not detected because it leaked into the body of a gibault coupling.

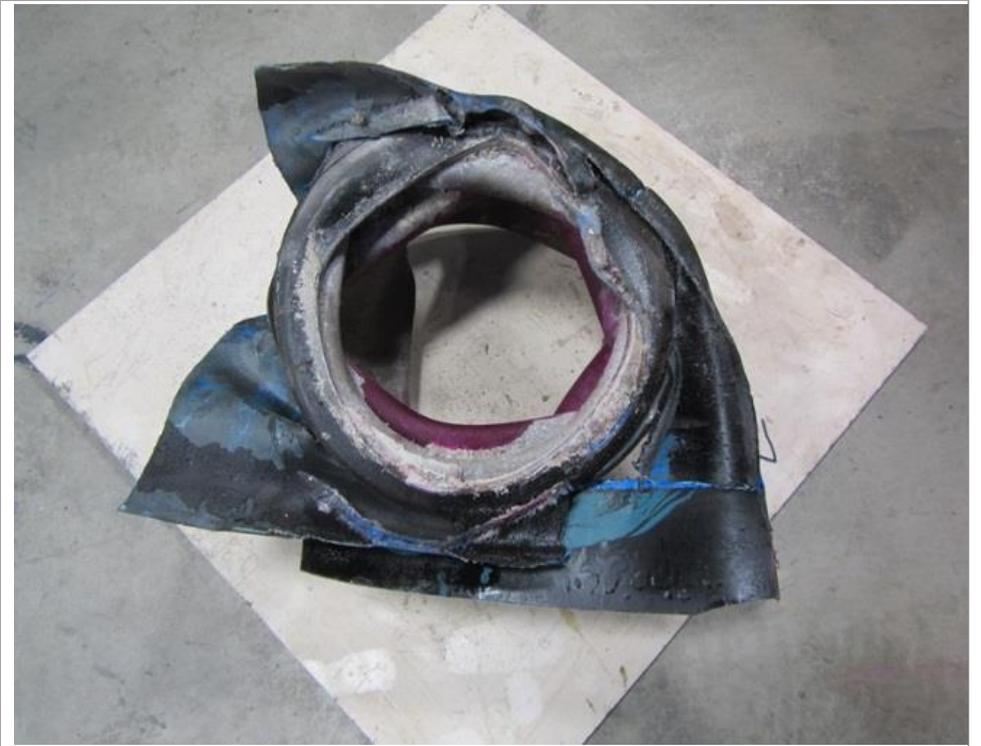
Figure 4: Parts of the concrete lining have remained bonded to the steel despite severe compressive deformation of the pipe during testing.

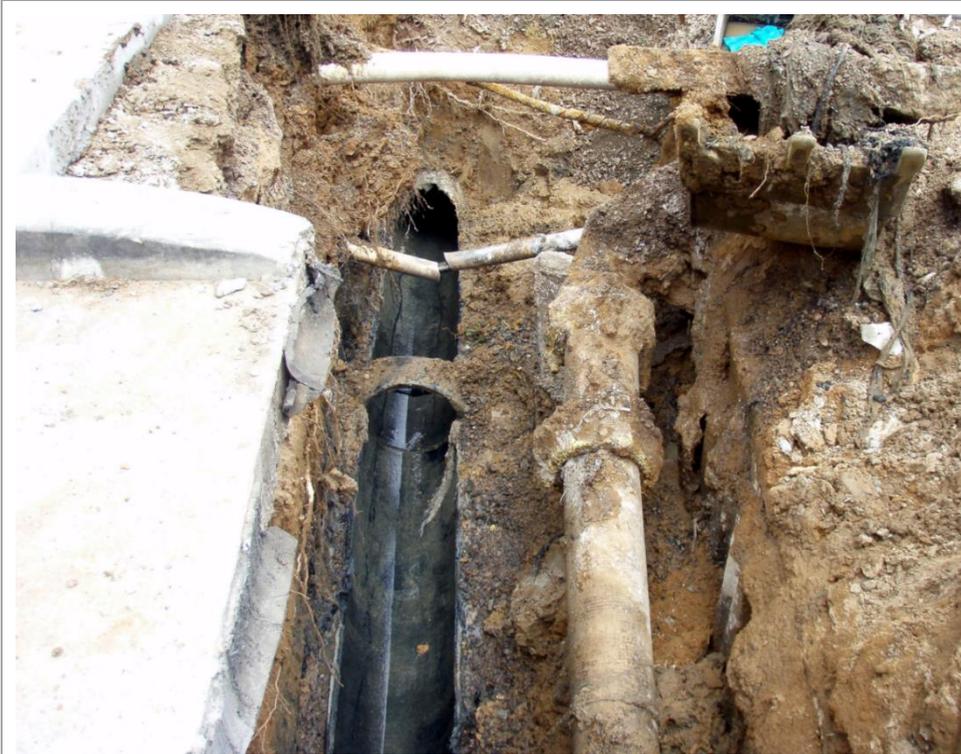
Figure 5: The black channel is the remains of and AC wastewater pipe that had remained serviceable for years in stable soil after total destruction of the cementitious binder in aggressive conditions. The thicker collars still remain present. The damage was only detected when a pipe above them collapsed.

In contrast, the load in unpressurised systems varies around the perimeter and for gravity flow systems installed at grade it can also vary along the length. As a result, a local weak point may not be subjected to high loading. In some cases the soil is self-supporting and a completely degraded pipe may remain functional until the surrounding soil collapses (Figure 5).

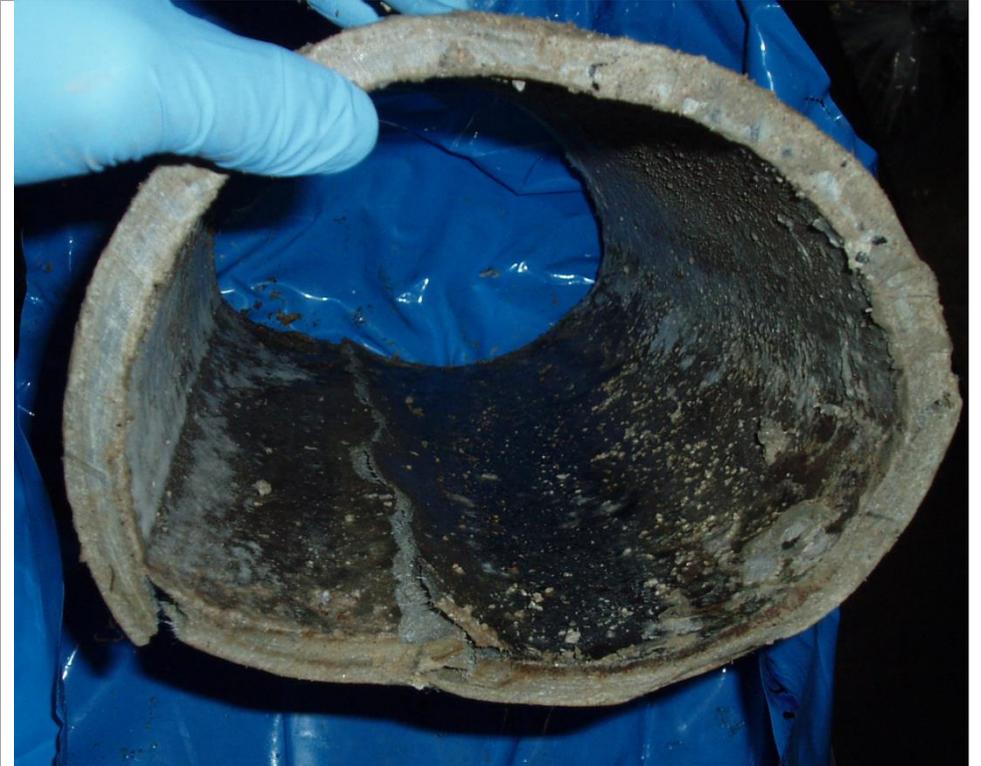
Figure 6: AC pipe after testing in compression. Despite experiencing a four point break, the pipe is still capable of performing as a flexible pipeline for at least a short time.

Degraded gravity pipelines that fail due to overloading can sometimes continue to operate as flexible pipelines. Observations from the UK during research into sewer repair systems (Morris, 1989 to 1999) indicated that some rigid earthenware pipelines that had experienced a four-point break due to construction loads had continued to operate as flexible pipelines for approximately 60 years. Figure 6 shows how an AC pipe could potentially remain serviceable as a flexible pipe after compressive overload.

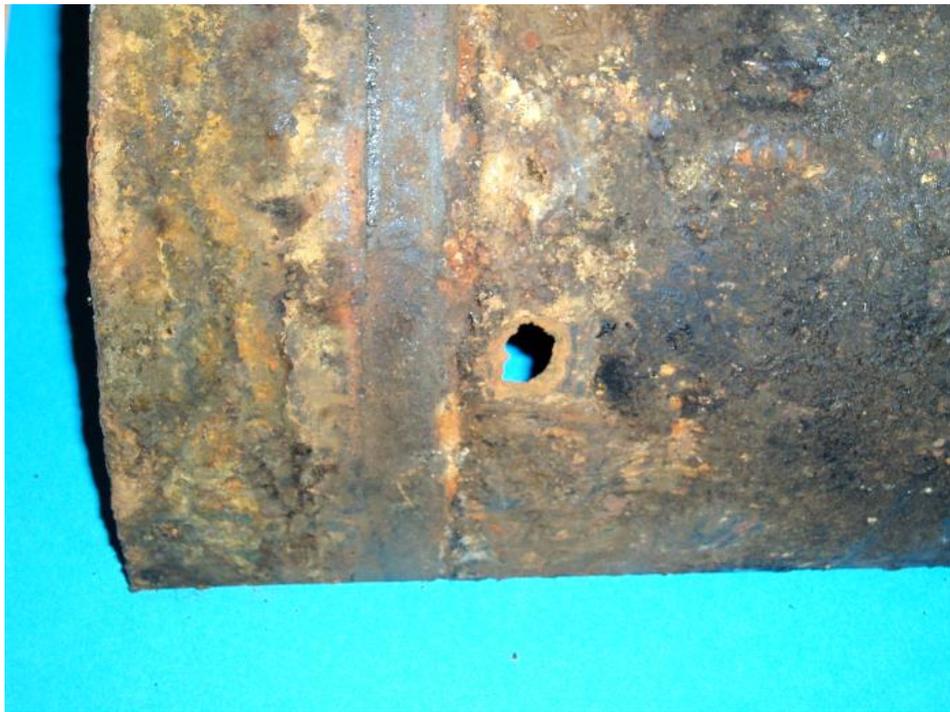
Figure 7: Perforation in a steel pipe. This pipe was recovered from service as part of condition assessment programme. The perforation was located just inside the outer edge of the gibault sealing ring and had remained undetected in service for many because the space between the pipe and gibault was blocked by corrosion product.

Because pitting corrosion is so much faster than general corrosion, local perforation will normally occur well before substantial general corrosion has occurred. Fracture mechanics analysis to AS/NZS 3788 indicates that in most metallic water pipelines, perforation will always occur well before the pipe is at risk of breakage which confirms this expectation and matches what is observed (Figure 7 to Figure 10).

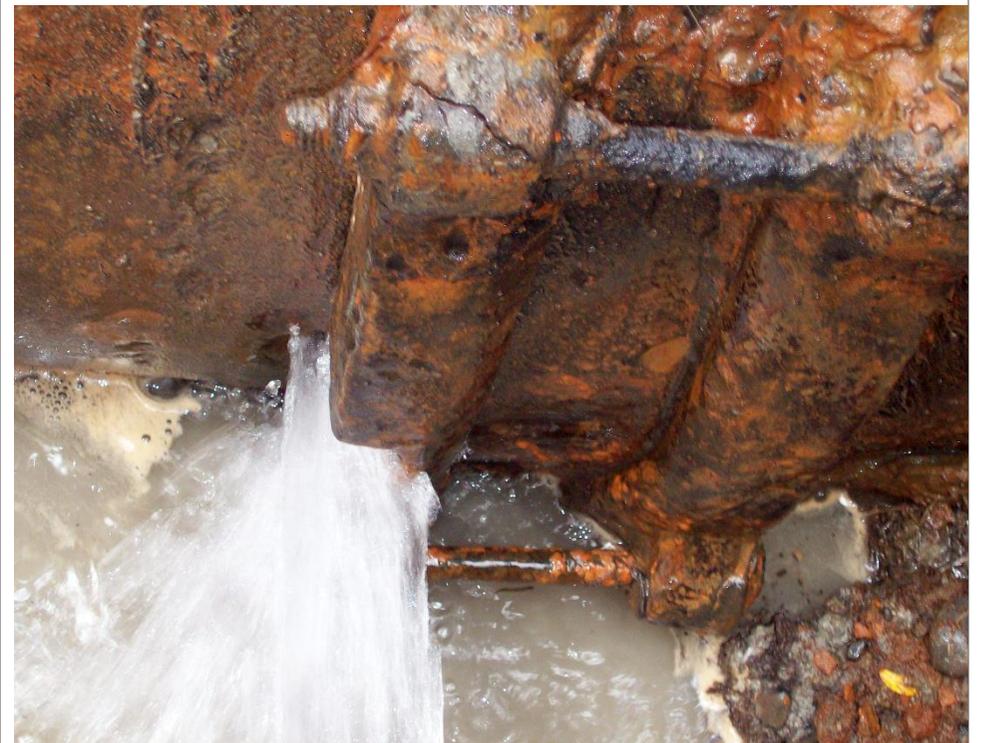
Figure 8: Perforation next to a gibault fitting in a DN600 Concrete lined steel pipeline. The leak was discovered after the seismic events but the perforation had been in place for some years. It is possible the leak had been blocked by a plug of corrosion product that was displaced by the shaking.

In the case of older steel pipes, failure can occur at riveted, lockbar or gas welded seams and along lap welded joints (Figure 8). These are points of inherent weakness within the pipeline and corrosion is not required to cause failure, although it may increase the likelihood and extent of failure.

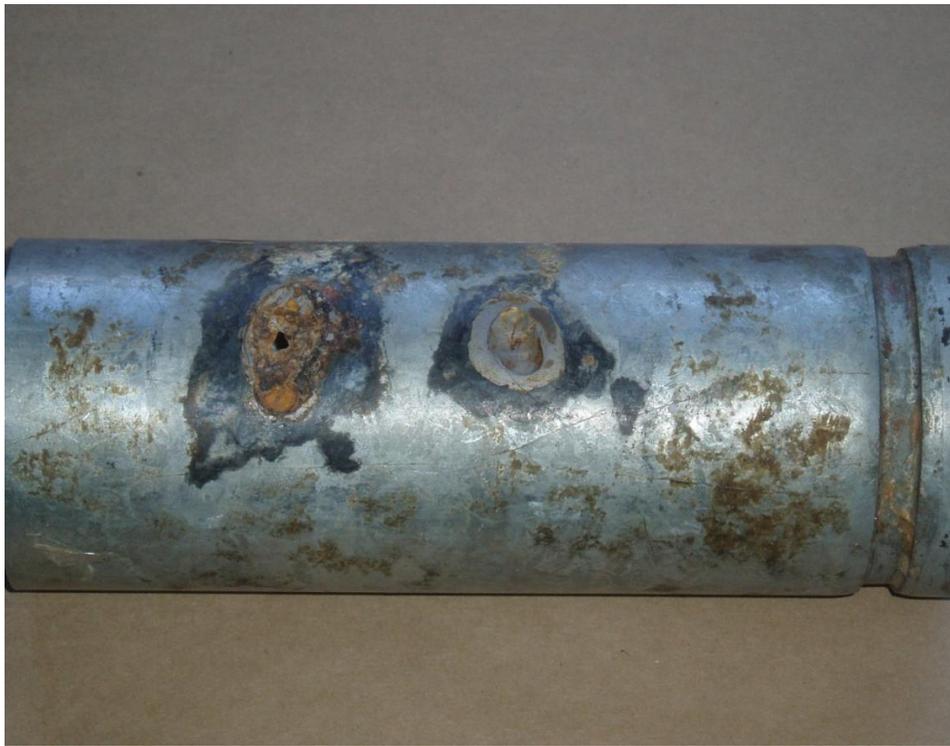
Figure 9: DN63 galvanized steel water pipe with deep perforations. Structural capability was unaffected despite the relatively large size of the holes.

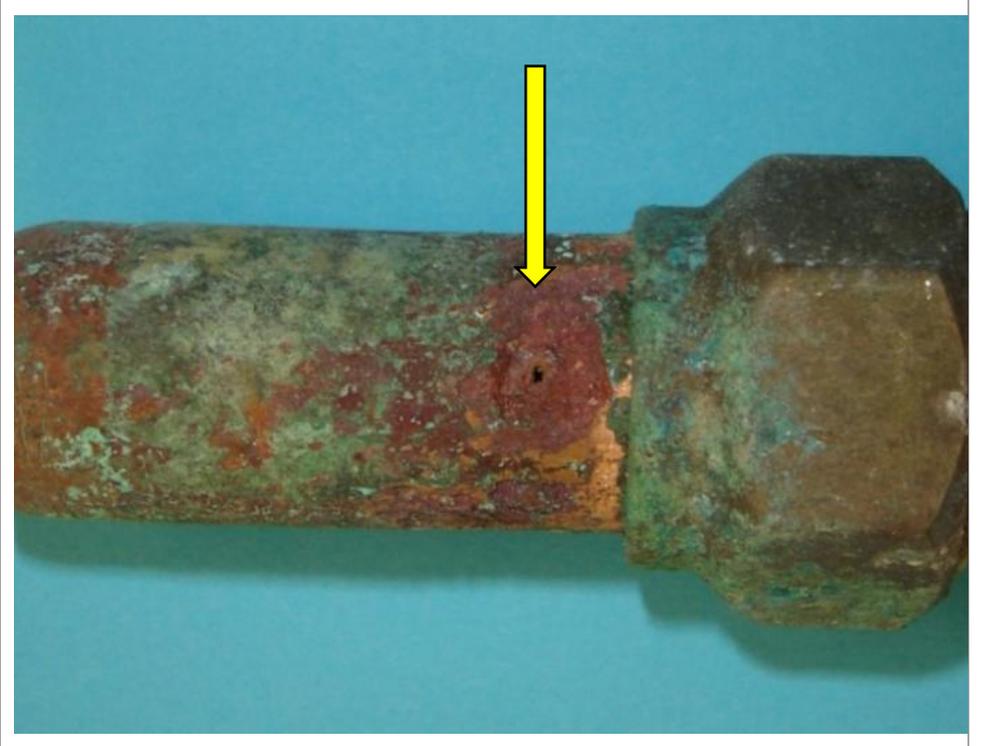
Figure 10: Copper pipe recovered from normal service. Perforation has occurred without structural failure, but the thinned area around the leak indicates that structural failure was a possibility

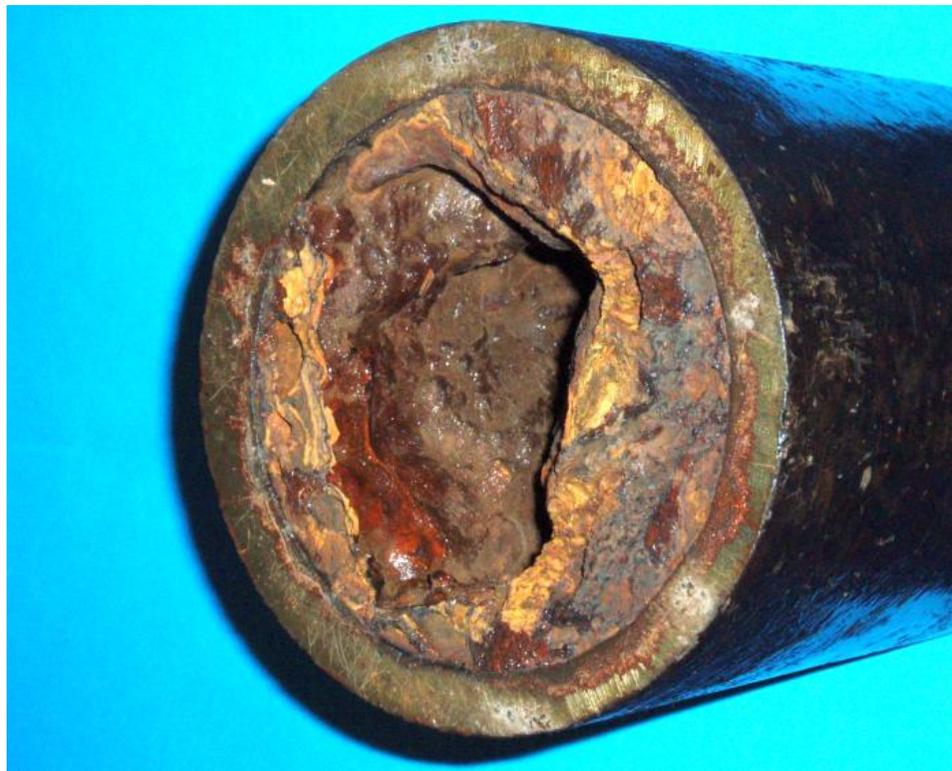
Figure 11: 4" (DN100) cast iron pipe partly blocked by corrosion products. Even if perforated, no or minimal leakage would be expected.

While pitting removes metal from the wall of metal pipes, the corrosion product formed occupies a greater volume than that of the metal consumed. This is readily apparent in smaller bore steel and iron pipelines where internal corrosion products expand into the pipe, blocking the bore (Figure 11). The corrosion product can also block individual perforations, which will either prevent leakage entirely or restrict the leak to a minor weep. In normal service, continued corrosion of the surrounding metal eventually exceeds the bridging ability of the plug of corrosion products causing the leak to become apparent (Figure 12). Where a seismic load dislodges a plug of corrosion product, it has brought forwards the failure rather than caused it.

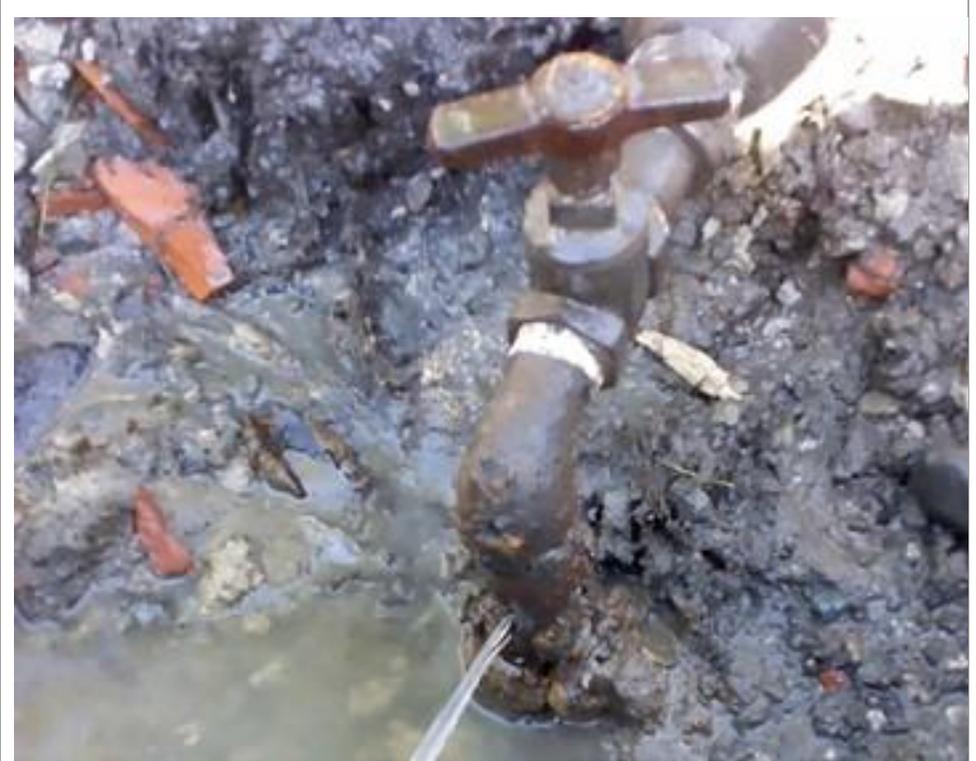
Figure 12: Copper service pipe located after one of the Canterbury earthquakes. The pipe is leaking from a perforation. It is likely that a plug of corrosion product that had been partially or wholly blocking the leak was dislodged by one of the seismic shocks.

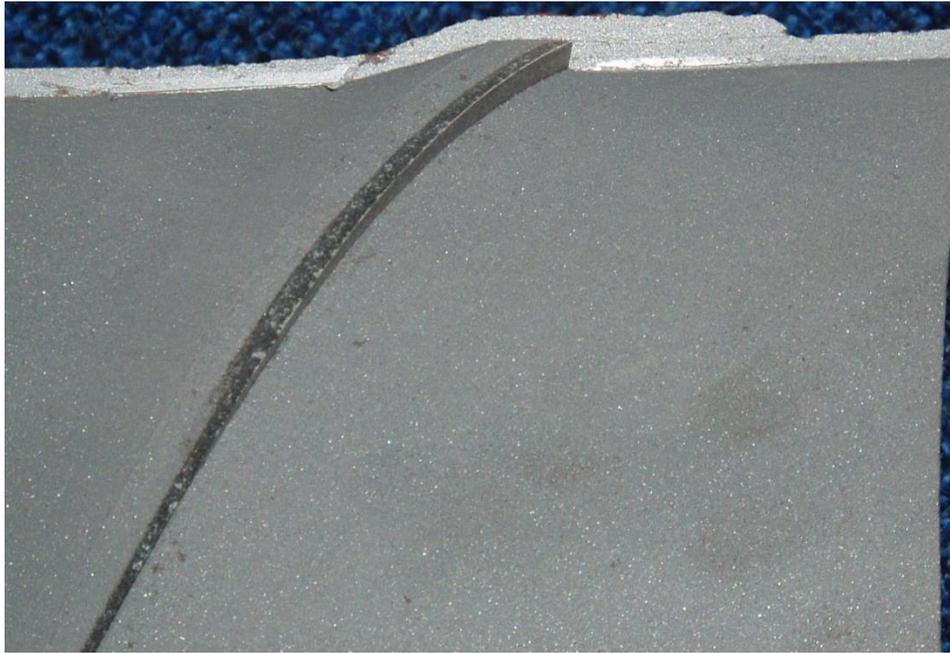
Figure 13: Lap welded steel pipe recovered from normal service for condition assessment, illustrating the form of the welded seam.

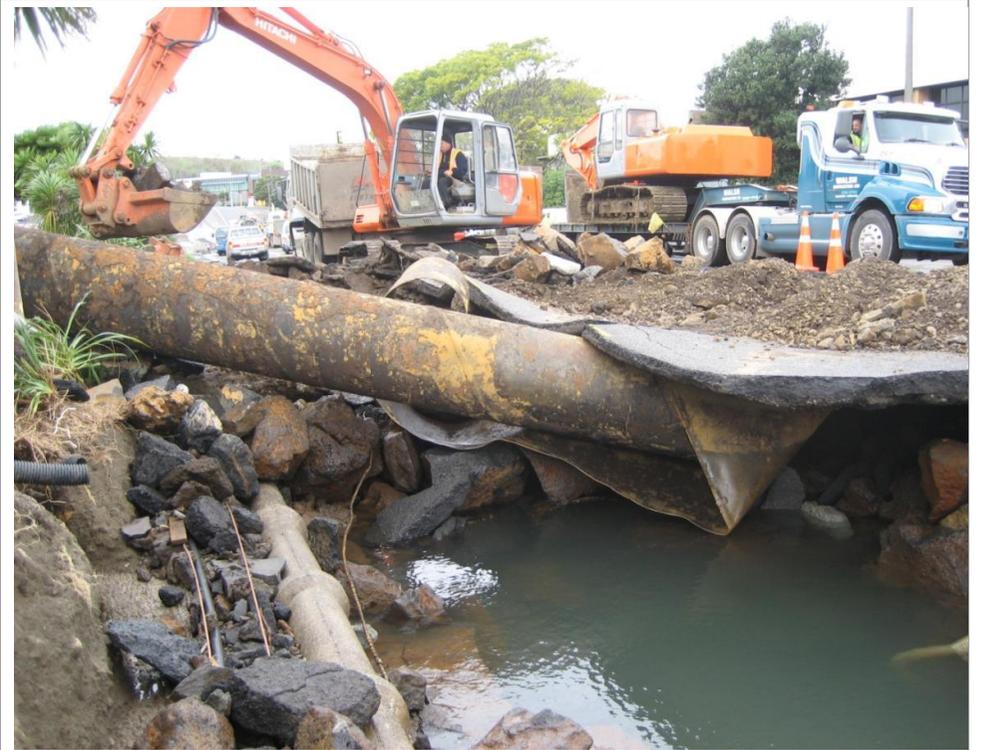
Figure 14: Large diameter lap welded steel pipe that has failed along the weld in normal service

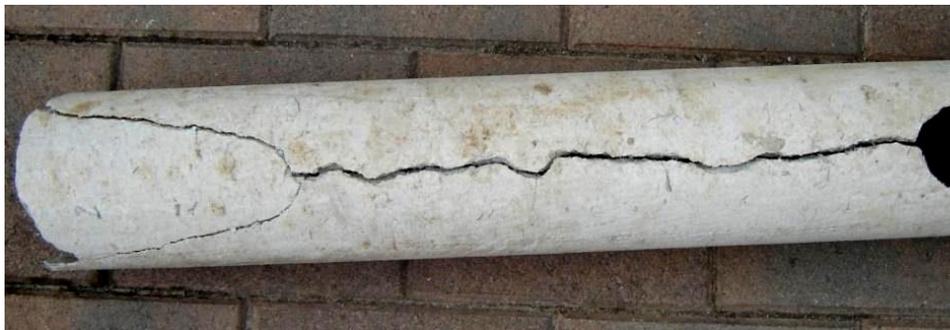
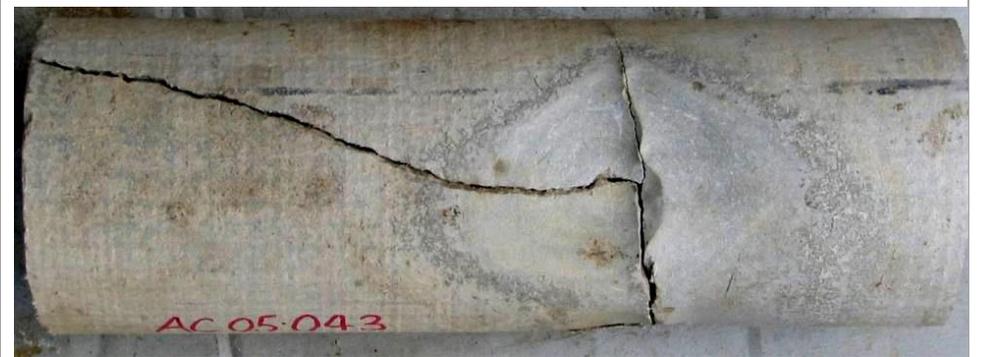
Figure 15: DN100 AC pipe with typical axial split seen in normal service

Figure 16: DN150 AC pipe with wet sandblasting effect. Recovered from normal service.

Figures 15 to 18 show seismic failures that are indistinguishable from in-service failures. All of the pipes shown were heavily degraded, and a small additional load (whether from operational loads or seismic load) triggered the same form of failure.

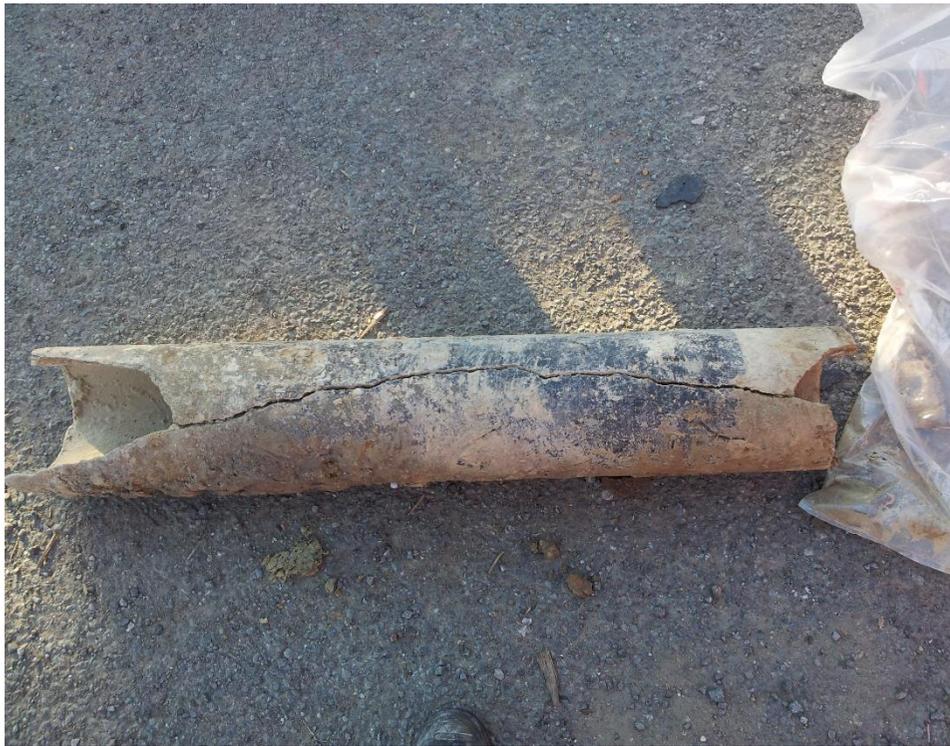
Figure 17: AC pipe with axial split recovered following Canterbury events

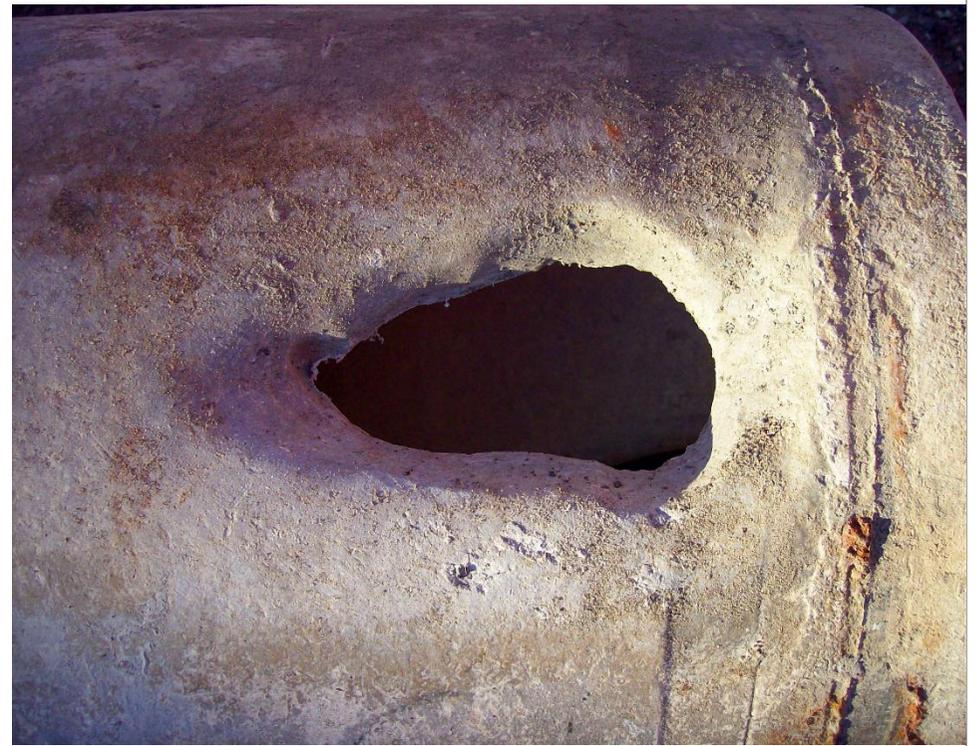
Figure 18: AC pipe with wet sandblasting damage recovered following Canterbury events

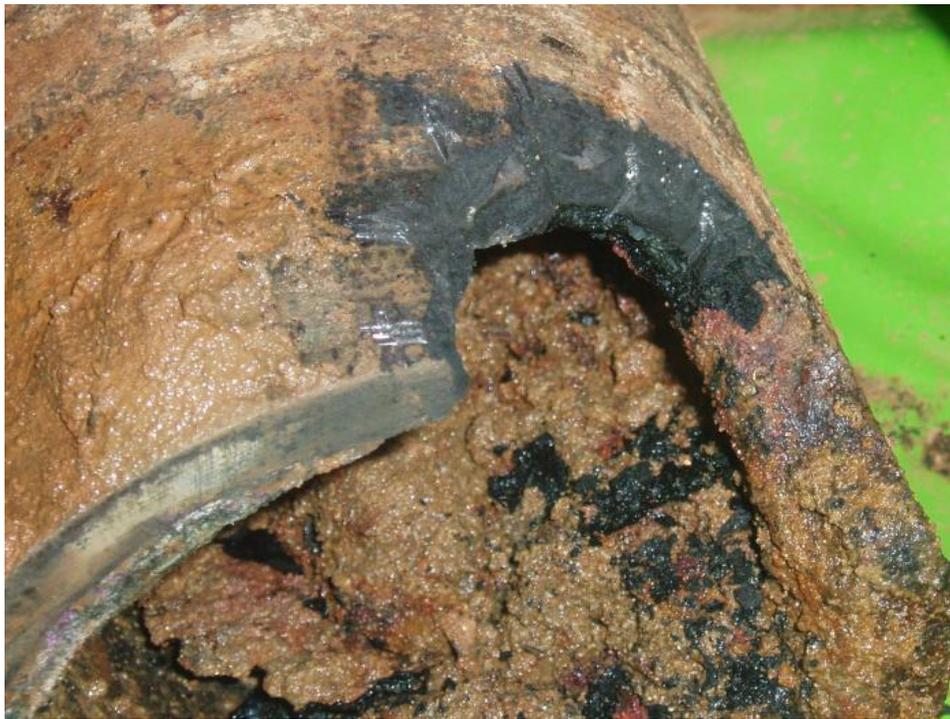
Figure 19: Fully graphitised cast iron wastewater pipe recovered from normal service. Although the blackened material in the wall is fully graphitised, the pipe remained in service for many years before it was recovered.

A similar situation will occur in cast iron pipelines, except that because even a fully degraded pipe they can withstand normal service pressure (Figure 19), there is a possibility that seismic events can cause failures that would not occur in normal service.

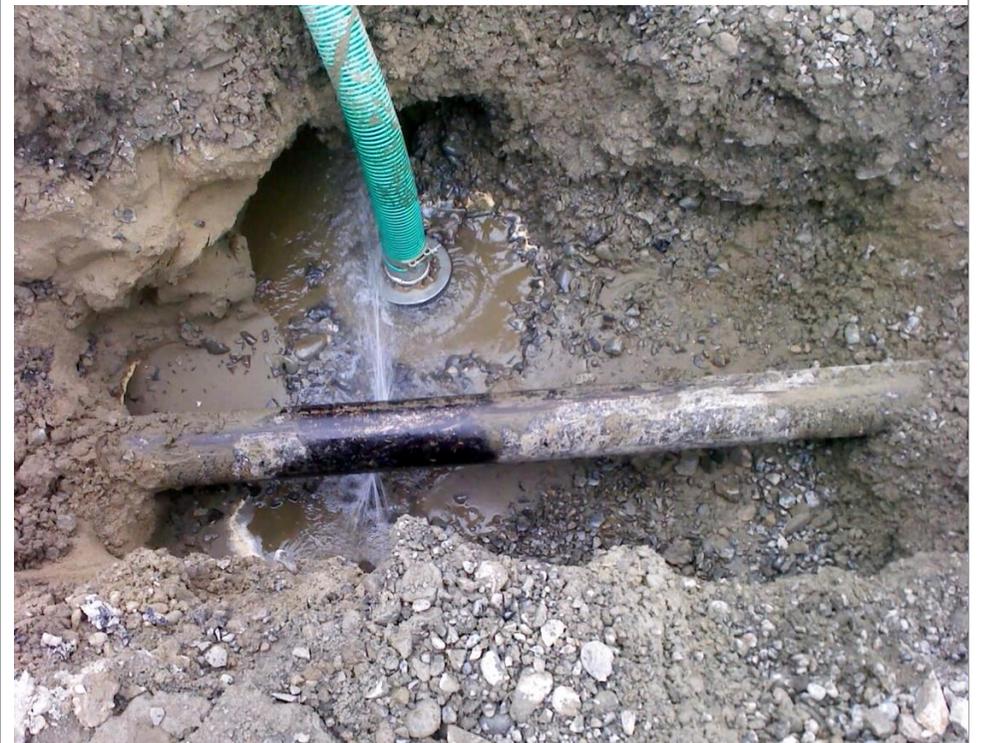
Figure 20: AC pipe beam bending failure. This type of failure can occur in pipes that are essentially uncorroded.

Beam bending failures can occur in smaller diameter pipelines with a high length to diameter ratio even when new. This means that the pipe does not need to be corroded to fail in bending (Figure 20). Failures of joints due to lateral displacement or bending are also largely unaffected by deterioration as they can occur whether the collar is corroded or not (Figure 21). As noted above, the form of deterioration usually means that by the time a pipe is structurally weakened, it will usually have been at risk of failure for some time. However, it is also possible for fittings with severely corroded bolts to remain serviceable for some time, even when exposed to earthquakes, (Figure 22).

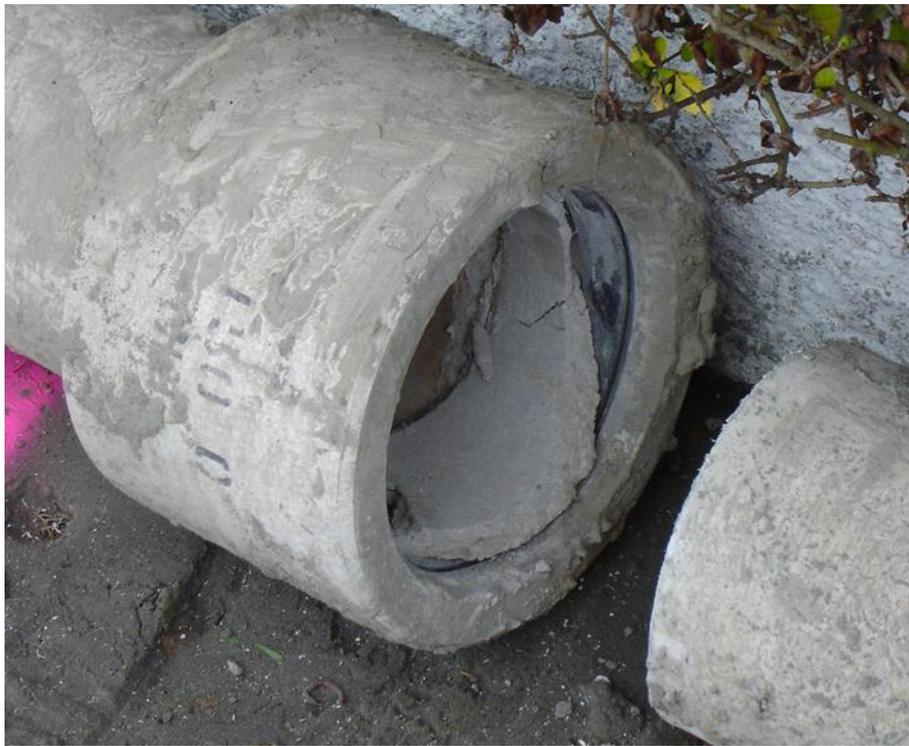
Figure 21: Fractured joints in AC pipe from Kaiapoi following one of the Canterbury earthquakes. The relatively short sockets and rigid material are bigger influences than corrosion. Image provided by Iplex Pipelines

Observed failures from Christchurch show failures in AC pipelines that involve fracture of joint sockets, tensile failure of joints through separation, compressive failure of joints. While deterioration will reduce the resistance of sockets to fracture, it has no bearing on tensile resistance of joints and is not required for beam bending to occur. Evidence from tests on concrete pipes indicates that joint installation practices can have a greater impact on compressive joint resistance than corrosion could. So while deterioration does increase the risk of pressure related failure during a seismic event, failure is inevitable anyway, and the earthquake has merely brought forwards the time of failure.

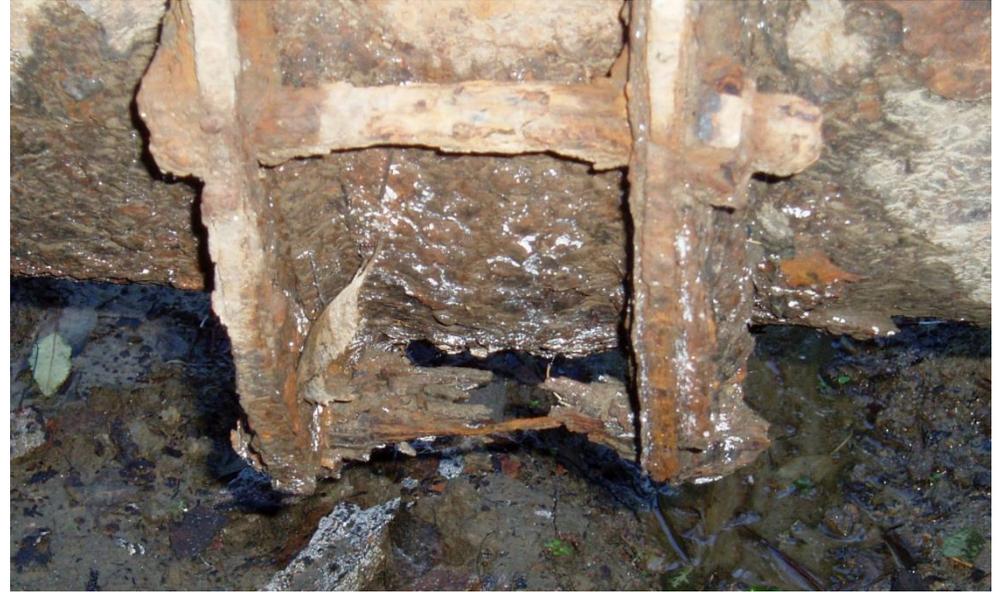
Figure 22: Heavily corroded bolt on a gibault fitting. In places the bolts had corroded through completely, but the pipe had remained serviceable, despite experiencing a substantial earthquake approximately 7 years before this image was taken.

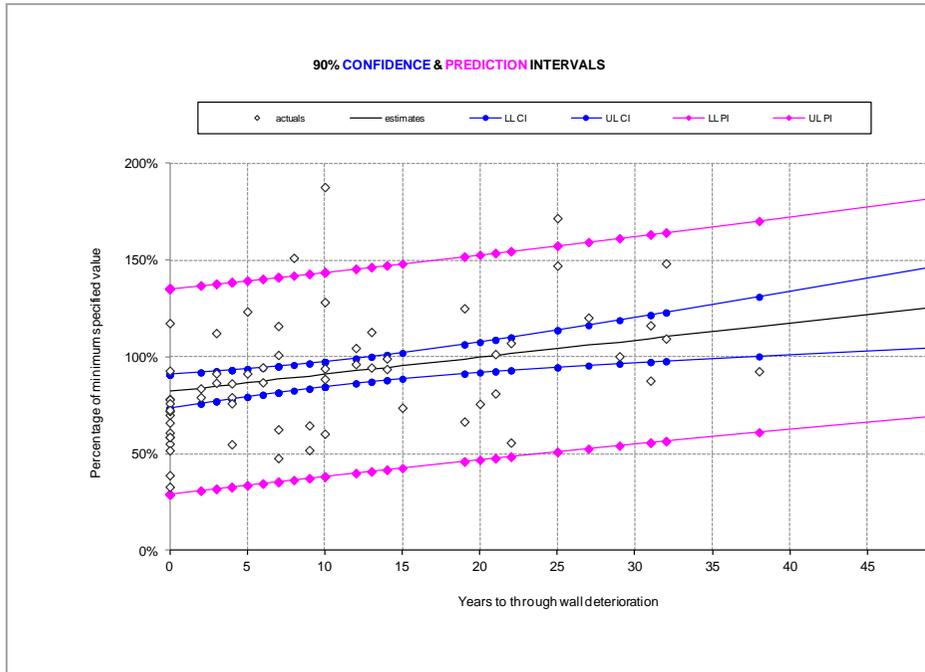
CI = confidence interval - used when estimating mean Y for a given X  
 PI = prediction interval - used when estimating a particular value of Y for a given X

Figure 23: Relationship between observed and predicted time to through-wall deterioration and measured crushing strength as a proportion of the minimum specified strength.

Crushing failures are rare in service, and analysis of crushing test records from the Opus pipeline database indicates that failure will not normally occur until the crushing strength is less than 35% of the contemporary specification value (Figure 23, Figure 24). A pressure pipe in this condition will have lost its ability to withstand normal service pressures many years previously and will have been replaced, although in principle a gravity systems could remain serviceable.

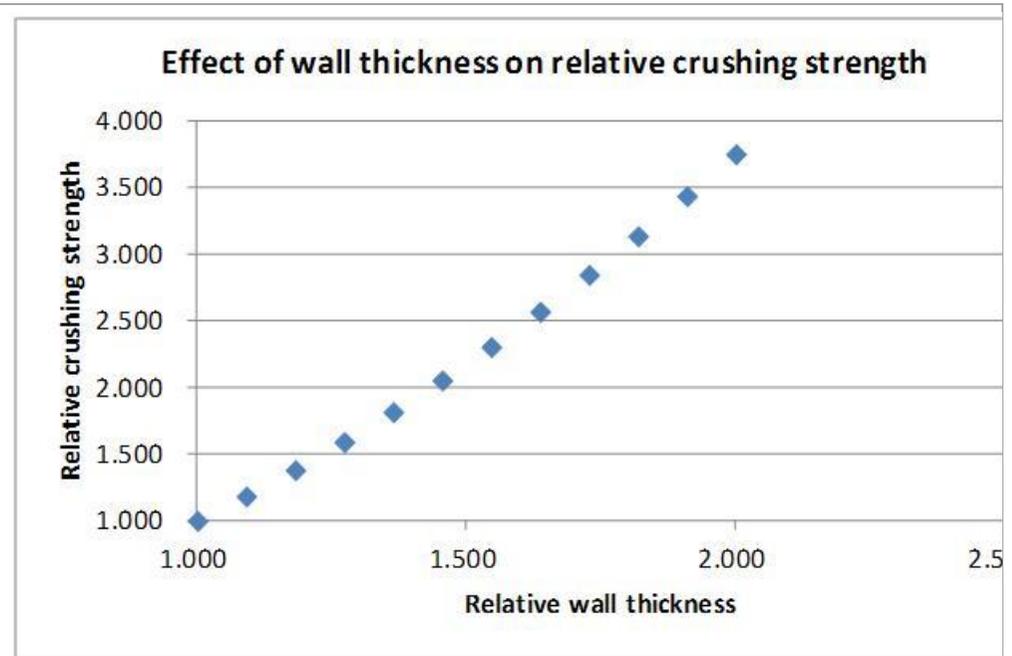
Figure 24: The effect of wall thickness on the crushing strength of an unreinforced pipe sample. Halving the effective wall thickness by corrosion can reduce the crushing strength by almost a factor of 4.

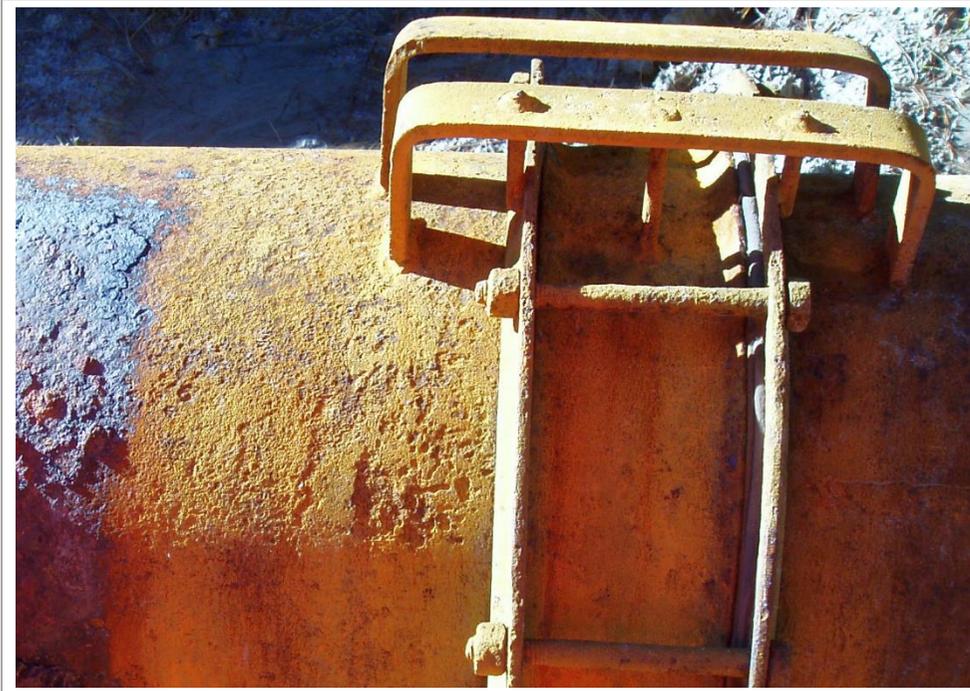
Figure 25: Increased corrosion near the gibault fitting where the coating was damaged while the gibault was installed. The modified fitting is part of the cathodic protection system for the pipeline, which has suppressed subsequent corrosion.

Where a pipeline is cathodically protected (Figure 25) further corrosion is stifled for as long as the system can provide sufficient protective current. The pipeline shown in Figure 25 was found to be corroding following partial exposure of the pipeline in a major storm in the 1980s, and the corrosion state has remained unchanged since a cathodic protection was installed soon after. Despite moderate corrosion, no failures occurred when the system was affected by a substantial earthquake in 2007.
