RIVER MAINTENANCE ACTIVITIES TO ADDRESS EARTHQUAKE DAMAGE ON THE STYX RIVER

Robert Le, GHD Limited
Matt van der Peet, GHD Limited

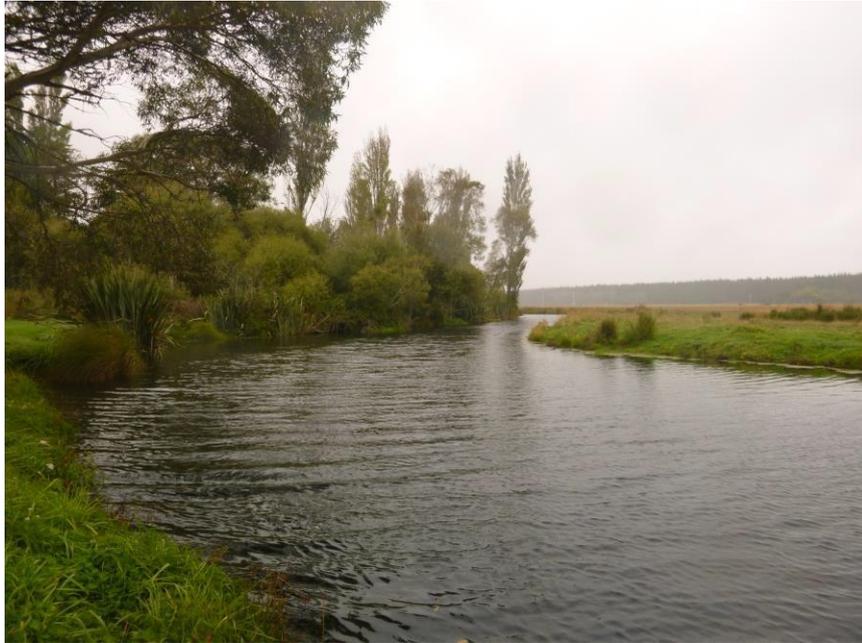
Figure 1: The Styx River within the lower reach

The study also included Kaputone Creek from its confluence with the Styx River to Factory Road. A photograph of the Styx River is shown on Figure 1. The river project extents are shown on Figure 2.

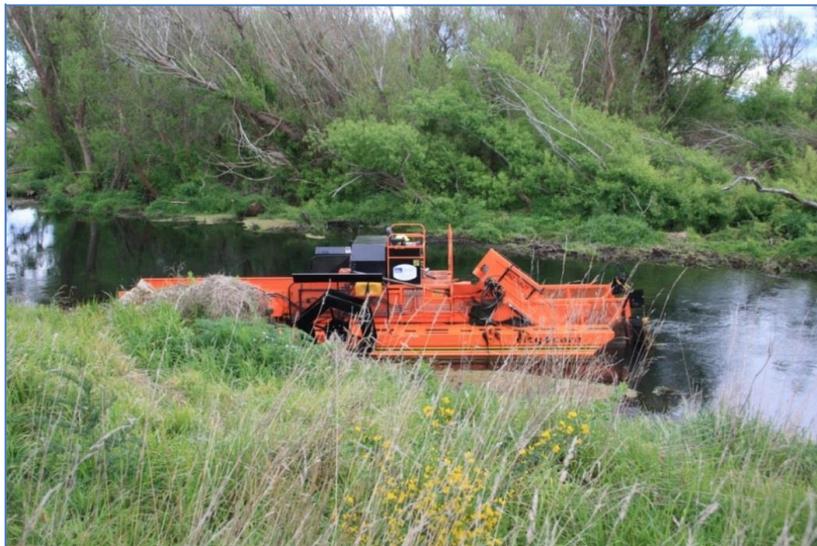
Figure 7: Weed Harvesting Machine

According to Council, there has also been significant clearance of trees along the banks over the years and a shift to more riparian plantings. In the 1990s, river maintenance moved to a programme of weed harvesting which has been refined in operation over the years to the current maintenance programme. A weed harvesting machine is shown in the following Figure.
