INNOVATIVE TREATMENT SYSTEM TRIAL ON INDUSTRIAL SITE

Dr Sean Finnigan (Fraser Thomas Ltd, 21 El Kobar Drive, East Tamaki, Auckland 2013)

ABSTRACT

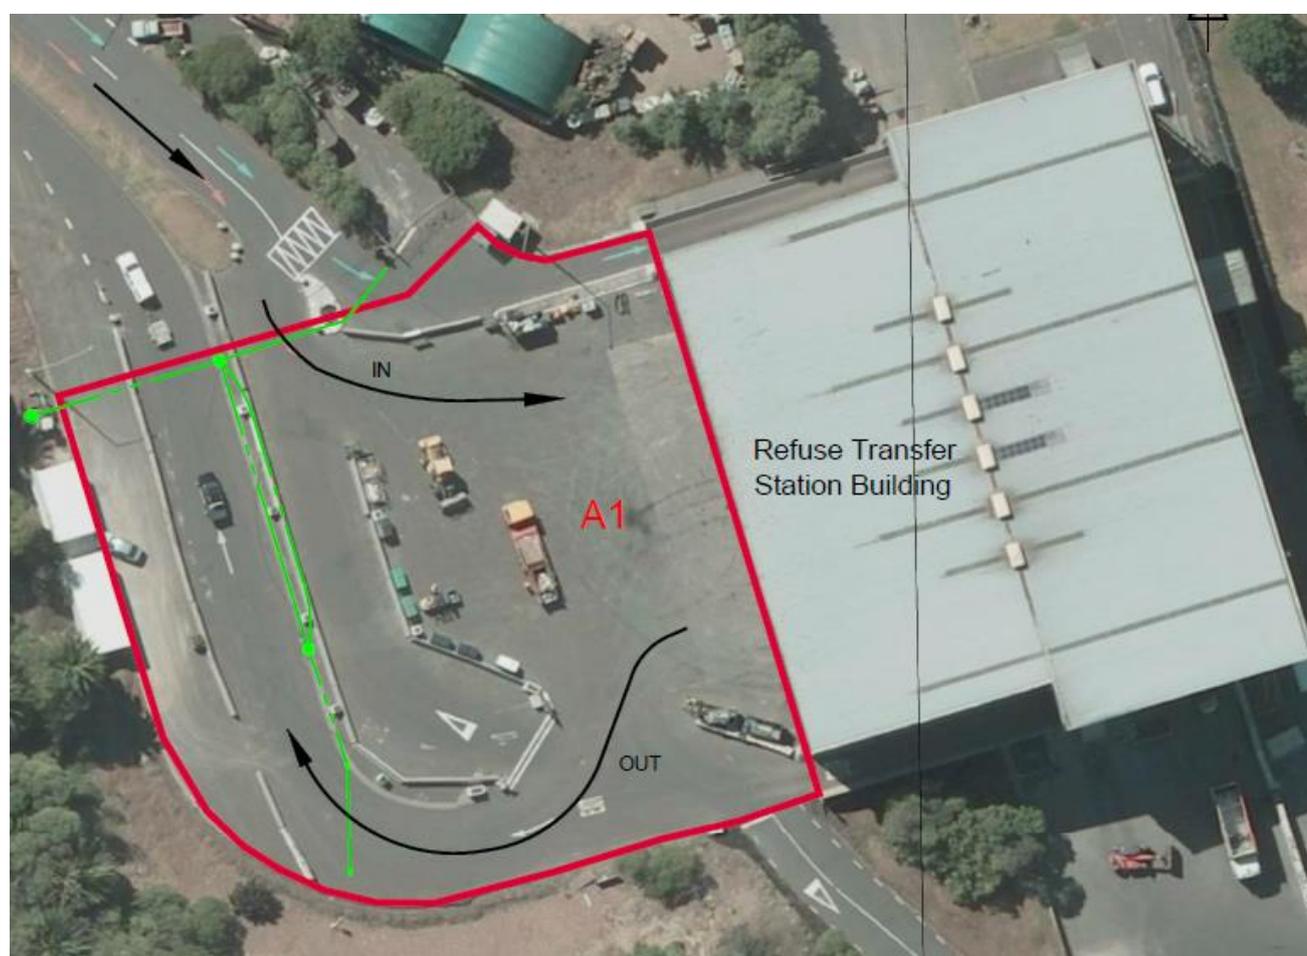
Figure 1: Transfer station showing waste processing building, vehicle circulation pattern and highest priority activity area, A1.

The Transfer Station is located at 81 Captain Springs Rd, Onehunga. The transfer station was operated under RMA existing use rights until 2007, when PPTL obtained a Resource Consent (32925) to authorize the discharge of contaminants onto or into land from an industrial and trade process (Refuse Transfer Station) (ITP consent) under rules contained within the then Proposed Auckland Regional Plan: Air, Land and Water (ALWP, June 2005). This consent is valid until 31 December 2027. The ITP consent required a rain garden treatment device to be installed to treat stormwater from the highest priority activity area, A1, which is subject to the most vehicle movements and closest to the transfer station building waste unloading area. The transfer station building, vehicle movement patterns and activity area, A1, are shown on Figure 1.

Overall, the potential effects related to short term, localised construction activities which were assessed to have less than minor effects, while there will be some long term environmental benefits resulting from the project as a result of providing treatment of stormwater runoff from activity area, A1, shown on Figure 1 to a high standard.

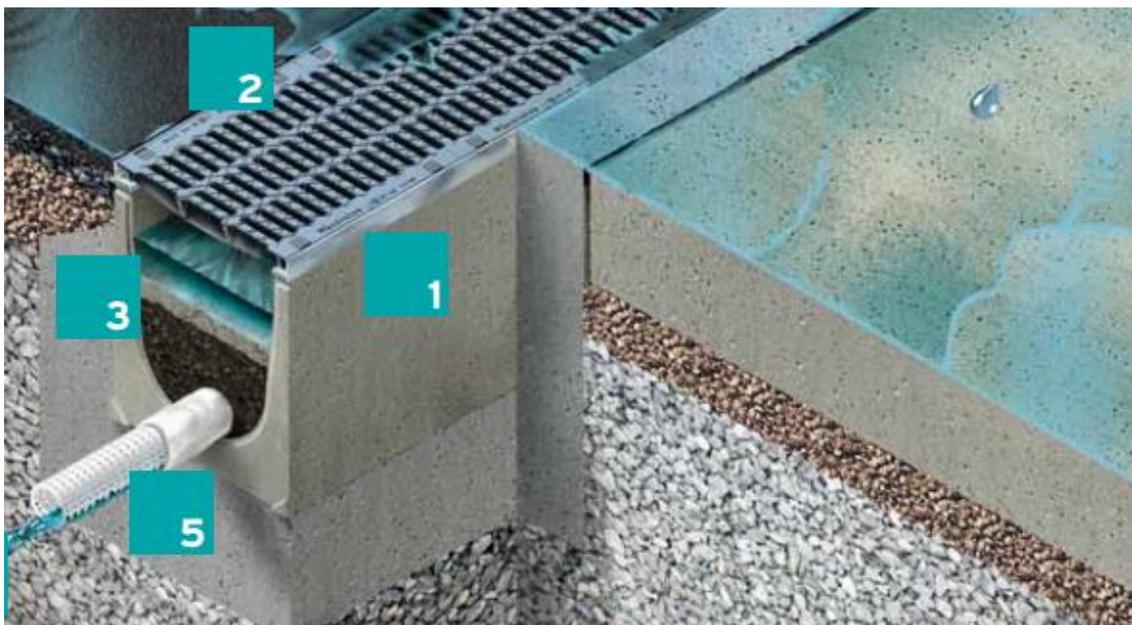
Figure 2: Drainfix Clean device. Key: 1 = drainage channel; 2 = channel grating; 3 = filter media; 5 = treated runoff drainage collection pipe (image courtesy of Hauraton)

The Drainfix Clean system performs a combination of collection and treatment of stormwater runoff. It comprises heavy duty "Faserfix Super" channels complete with ductile iron grates¹. Each channel contains a carbonate rich substrate filter for runoff treatment in its lower half, the carbonate having both a low pH buffering capacity and the ability to form insoluble metal compounds with dissolved heavy metals. Pollutants such as copper, zinc, lead and hydrocarbons are trapped within this material. At the same time the upper section of the channel provides large retention capacities to deal with high water volumes. It is available in various load classes to cater for different traffic loadings.

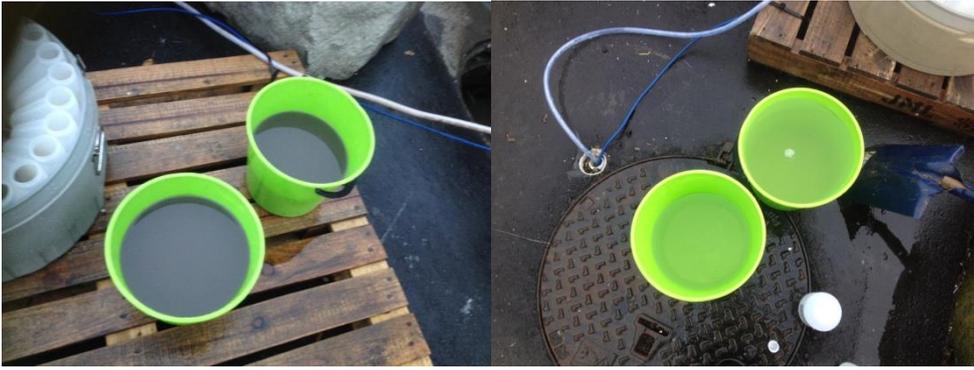
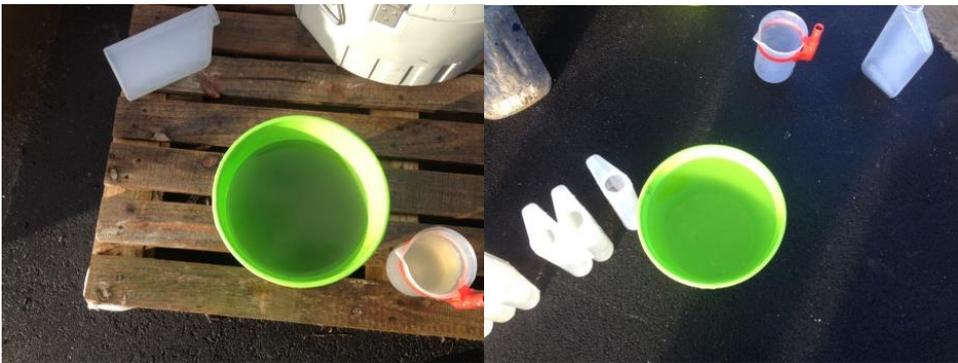
Photograph 2: Visual Differences between Control and Trial Samples

Visual observations of individual and composite samples from the trial (with treatment) and control (no treatment) setups showed clear differences in colour, with the control sample being significantly darker than the trial sample. This is shown for two storm events in Photograph 2.

8/07/16: Control

Trial

14/07/16: Control

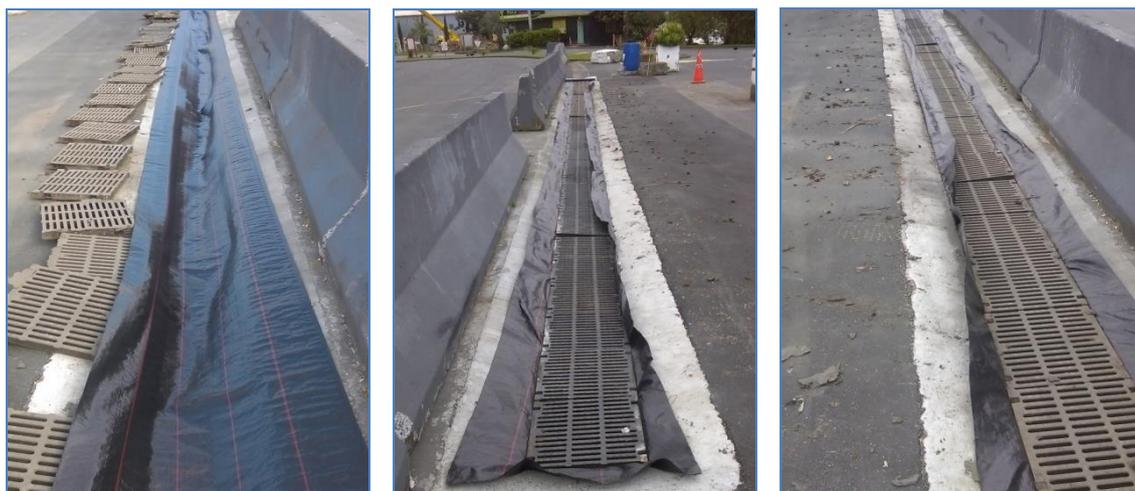
Photograph 3: Addition of filter fabric to treatment drain

These issues, particularly the contaminant loading, were addressed by further trialing the installation of a filter fabric (300 micron rating with tolerance of ± 90 micron) secured under the treatment drain grating and above the media as a temporary measure on 14 September to try and reduce the loading on the treatment device. The three sets of results collected since then show improved metals removal results (90-99% for total metals and 66-98% for dissolved metals).
