# NEW ZEALAND ASBESTOS CEMENT WATERMAIN MANUAL

**August 2001**

NEW ZEALAND WATER AND WASTES ASSOCIATION  
WATER SUPPLY MANAGERS GROUP

OPUS INTERNATIONAL CONSULTANTS  
CHRISTCHURCH, NEW ZEALAND

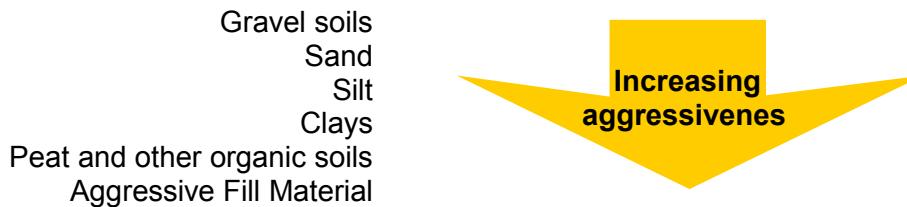
The relative aggressiveness of soils has been generalised as follows: (CIRIA Report 98)

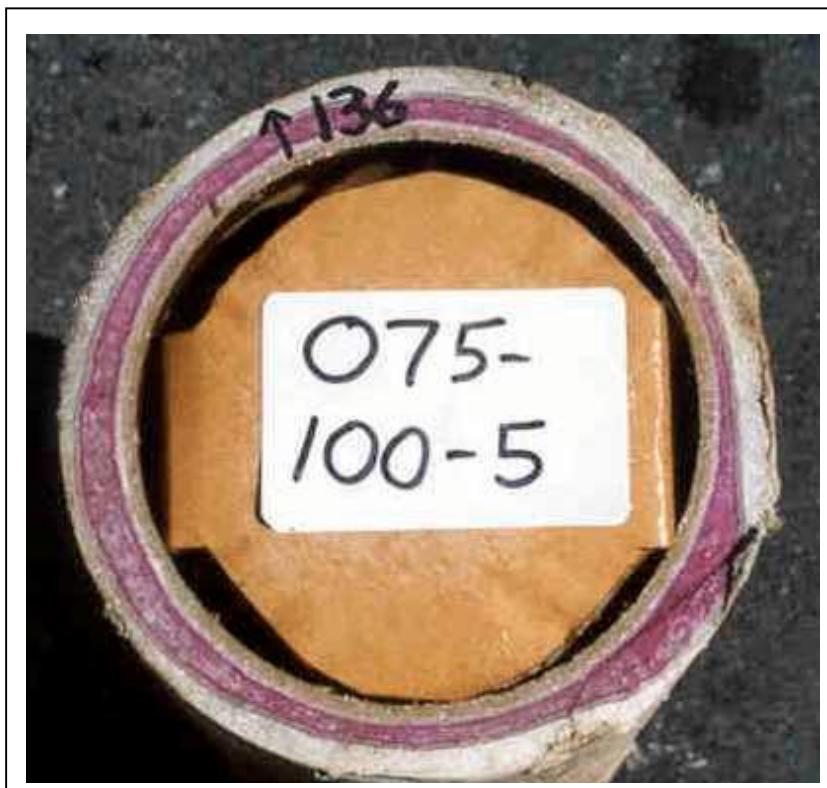
### Example of 100 dia AC pipe with phenolphthalein indicator

The magenta sections of the wall are sound AC, the light coloured areas have deteriorated. This sample shows rather extreme variability in deterioration externally, and fairly uniform deterioration internally.

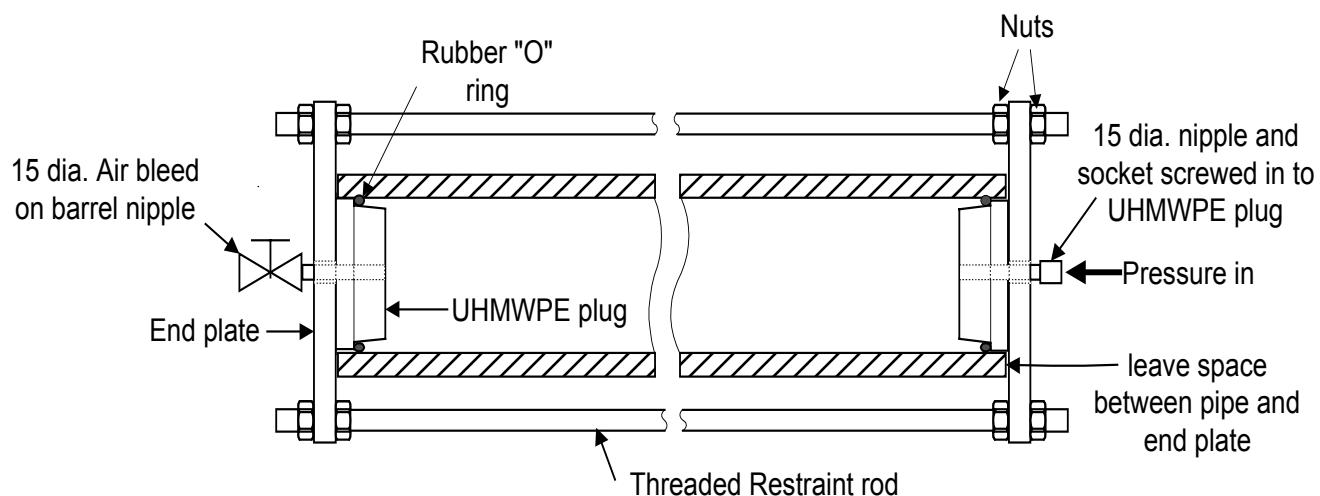
FIGURE 1: (Internal sealing method)

After bursting, the relevant data shall be recorded in the appropriate section of the AC pipe condition report. The burst pipe specimen shall also be tested in accordance with Appendices C, D & E to determine its condition and the extent of deterioration.

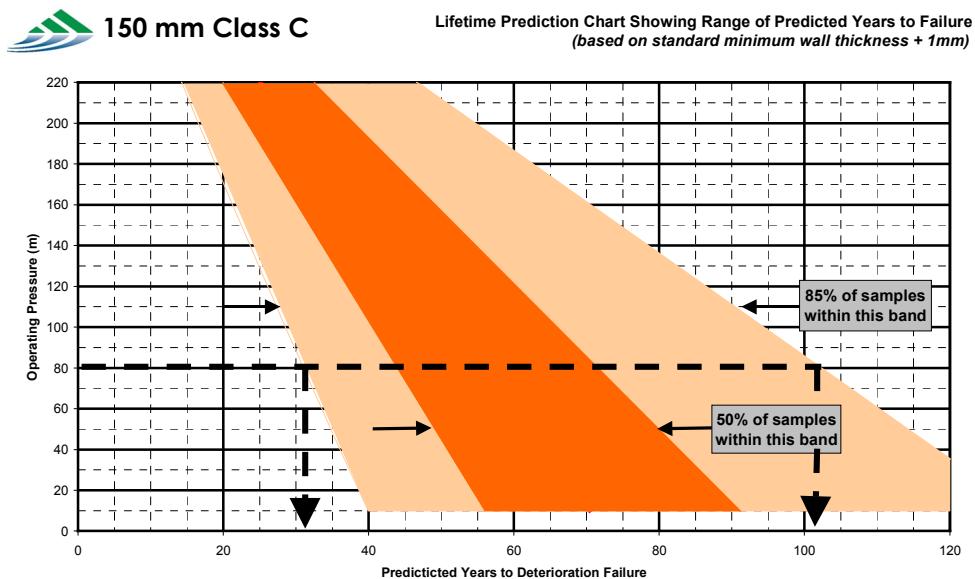
Figure 7: Annotated chart showing the range of lifetime predictions possible

*Example: For the previous example, the “Years to Deterioration Failure” could vary from 31 years to 103 years (see annotated Figure 7).*

*Note: it is not recommended to predict a pipe lifetime greater than 100 years when using the Lifetime Prediction Charts. This is because the mechanisms of AC deterioration beyond this age are unknown and possibly quite variable.*
