# RISK vs COST – PROTECTING HUTT CITY COUNCIL'S VITAL WASTEWATER RIVER CROSSING

*G. Shearer, MWH now part of Stantec, Wellington, New Zealand*

## ABSTRACT

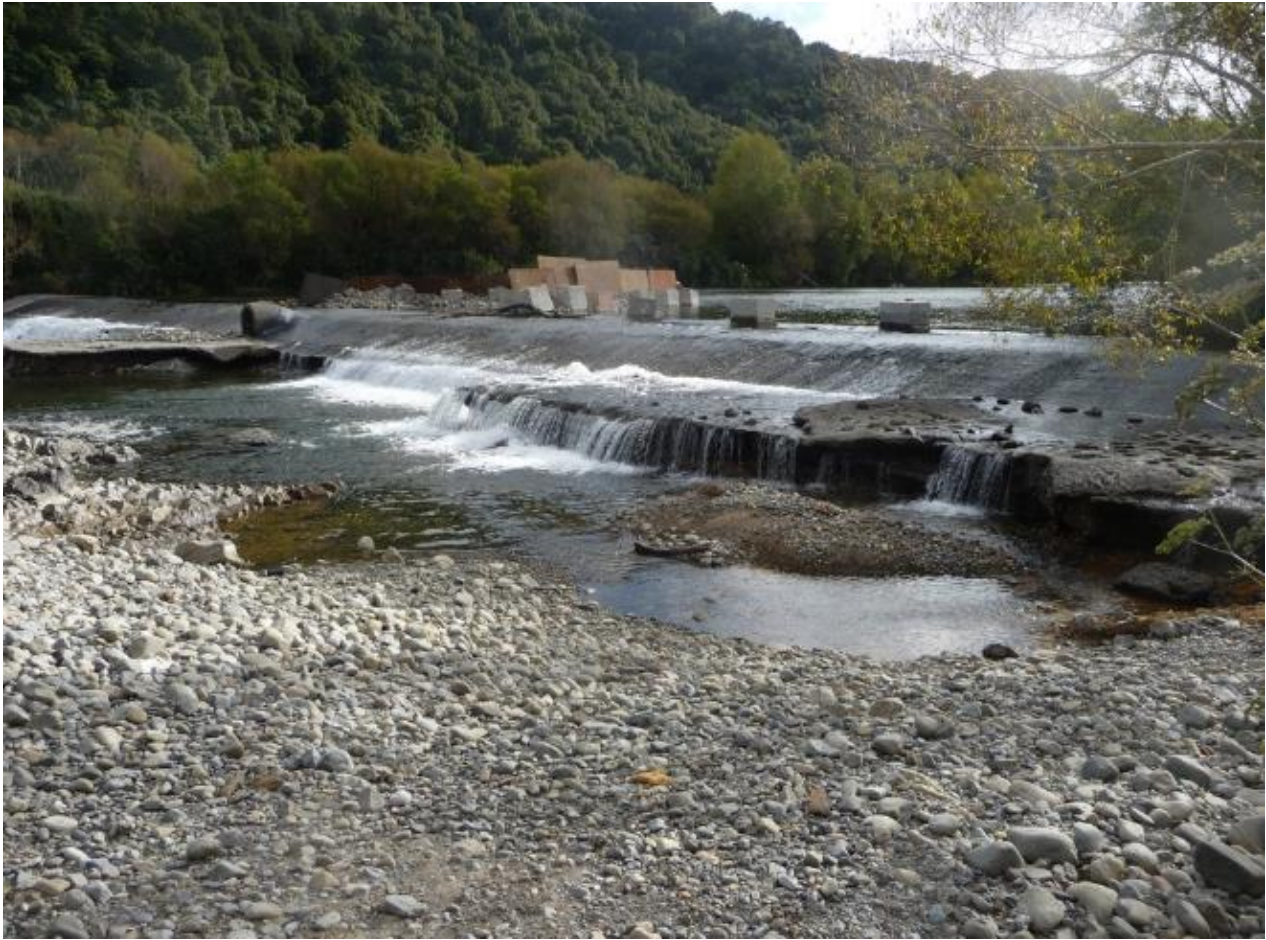
*Photograph 2-3: Photo of the RCPS showing undermining and scour*

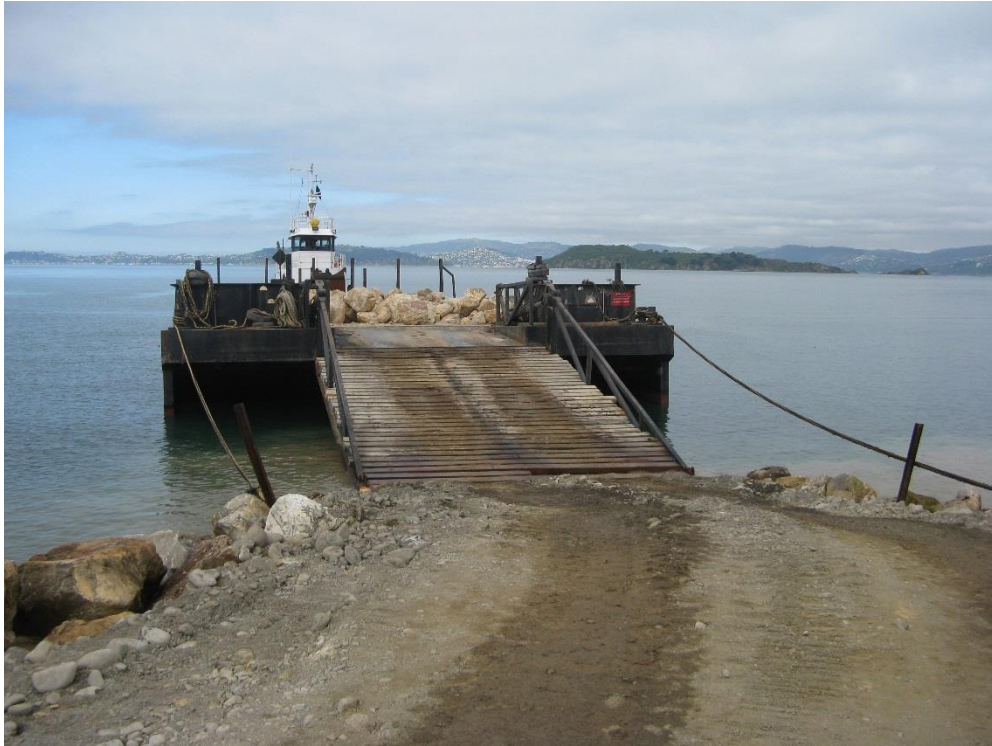
*Photograph 2-4: Rocks arriving at Seaview by barge from Takaka*

Solly Contractors Ltd was chosen by the Contractor as the rock supplier. Rock was Limestone Rock with a density of  $2640\text{kg/m}^3$ . The rock was shipped to the Seaview Marina by barge over the Cook Strait. A graded stockpile was then produced by the Engineer at the Marina to allow the Contractor to transport graded stockpiles to site ready for placement.

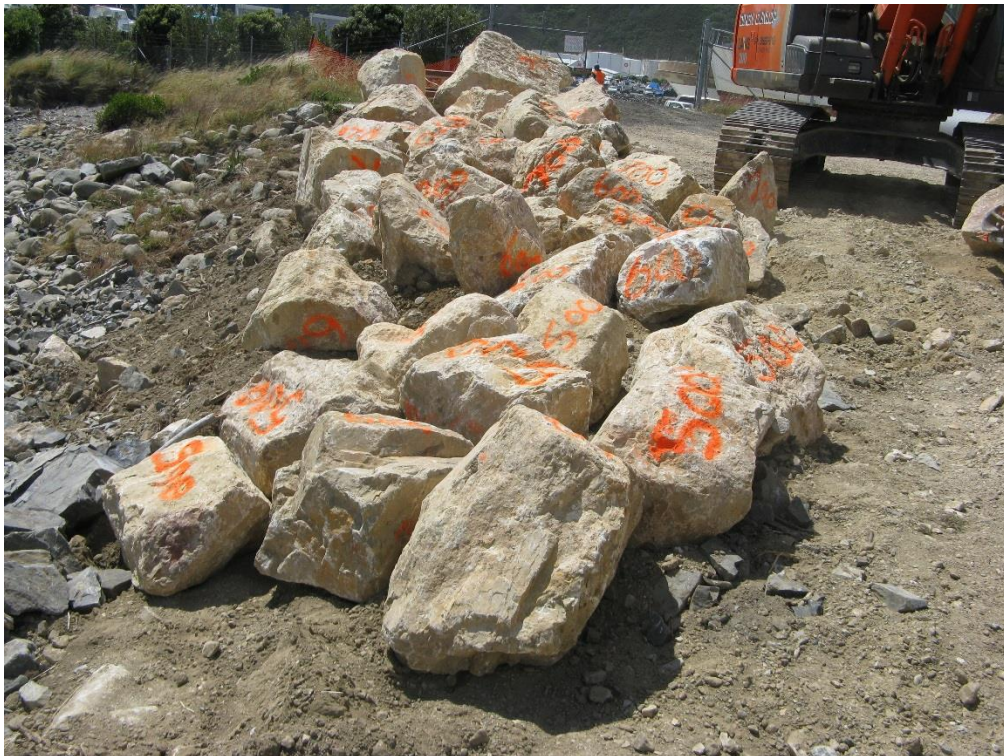
*Photograph 2-5: Sample graded stockpile at Seaview Marina with D50 sizes marked*

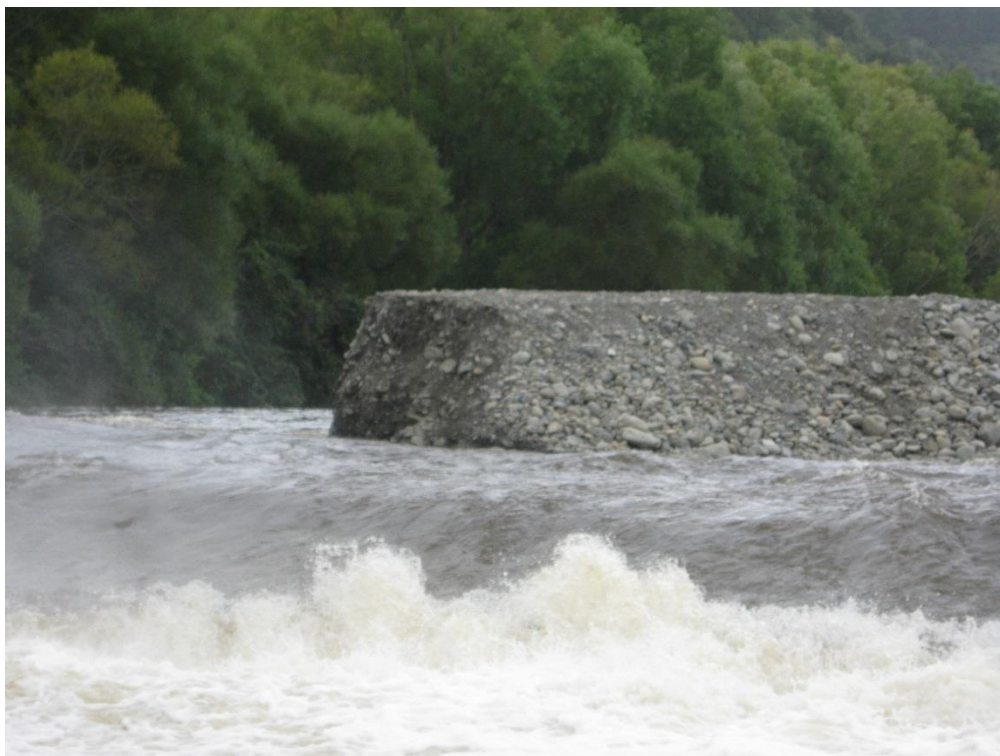
*Photograph 2-6: View upstream looking at partially washed out diversion bund after heavy rain event*

Working with large heavy rock within a substantial river presents significant hazards in terms of managing temporary diversions, coping with flash floods, moving very large rocks, working with major plant and working in difficult terrain. The tender process focussed on obtaining a Contractor who understood the hazards around rock placement within major rivers, and had appropriate experience in working with Regional Councils with regard to reporting and awareness of river and climate behaviour. Within the contract document procedures there were specified protocols that required the Contractor to liaise daily with the GWRC flood protection team as well as maintain regular contact with staff off site. Having the right Contractor for this type of work was vital to the project's success. As it turned out the project experienced some major flood events through the contract period which if not managed correctly could have resulted in harm. Photograph 2-6 shows the power of the river washing out a section of the diversion bund built to temporarily divert the river.

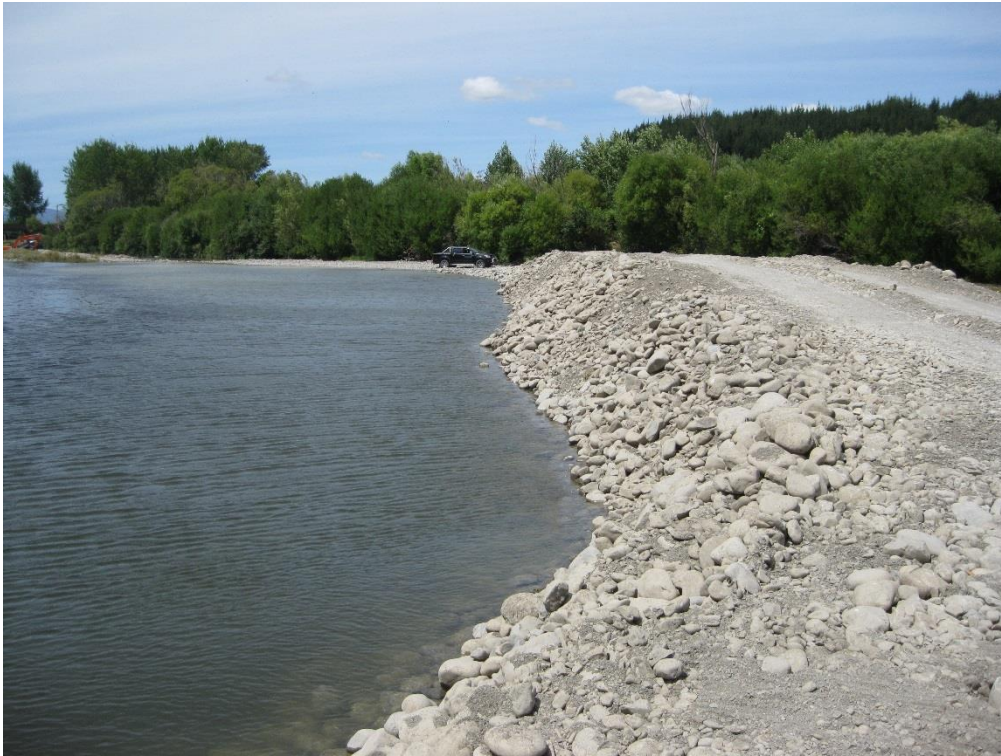
*Photograph 2-7: On top of the temporary river diversion bund looking upstream*

To construct Stage 1 of the rock riprap structure a temporary diversion of the Hutt River was built to facilitate construction. The construction of the temporary diversion was carried out by moving beached gravels from just upstream of the site as shown in Photograph 2-7.

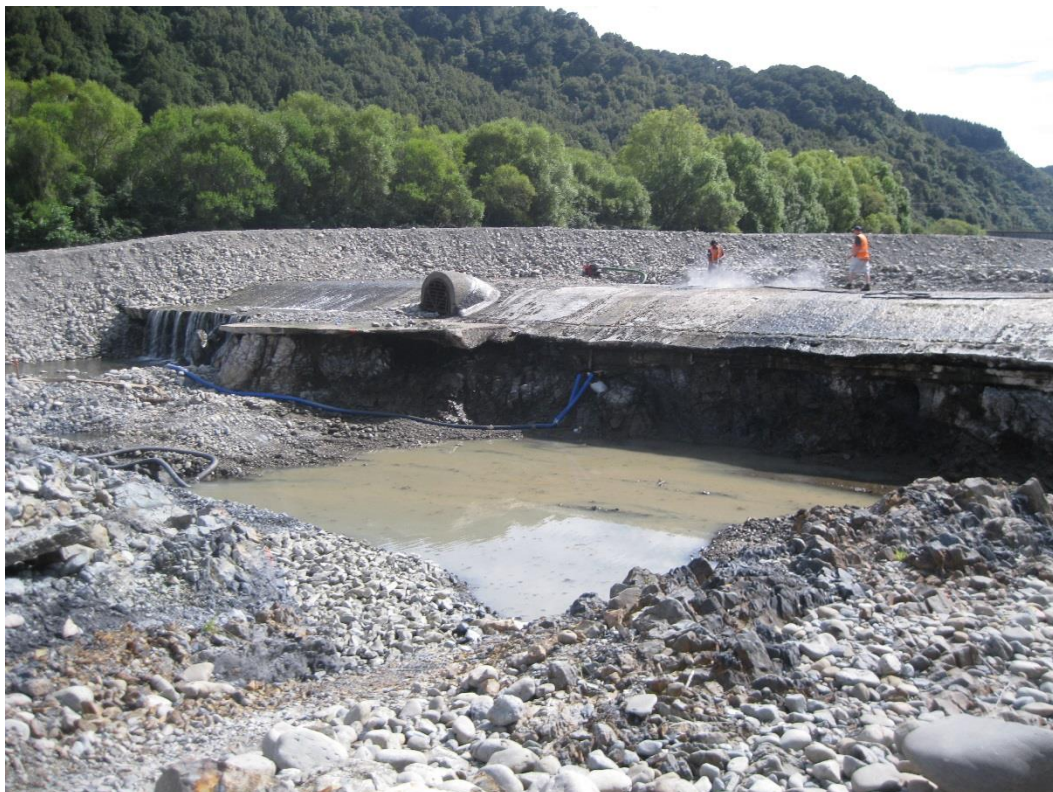
*Photograph 2-8: Diverted River looking at scour under RCPS*

The result of the temporary diversion bund was that it pushed river flow to the true right allowing excavation and rock rip rap placement at the true left as shown in Photograph 2-8.

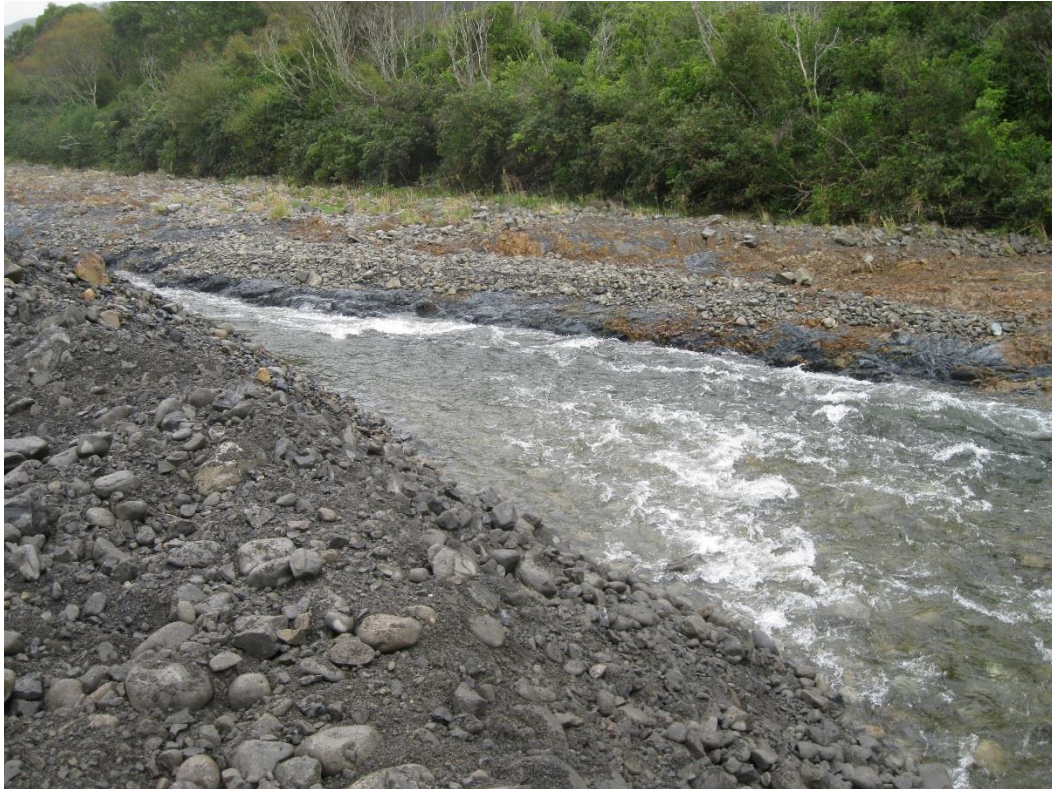
*Photograph 2-9: New ‘incised’ channel formed on true right*

An unexpected result of the diversion bund was the forming of a new ‘incised’ channel on the true right as a result of some of the large events (i.e. greater than a Q2 ARI) during construction of Stage 1. The surprise was the speed at which erosion of the bed took place, i.e. over a 2 month period, showing how weak the bed material is in this area.

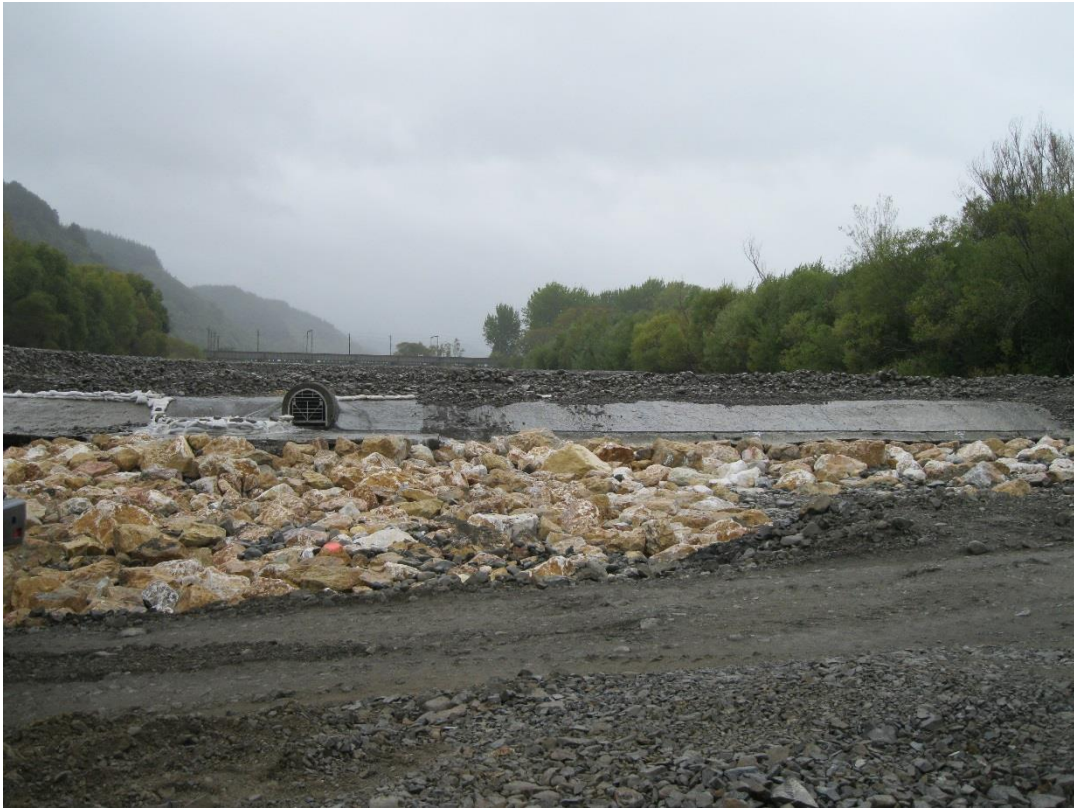
*Photograph 2-10: Final rock placement in scour hole by RCPS complete*

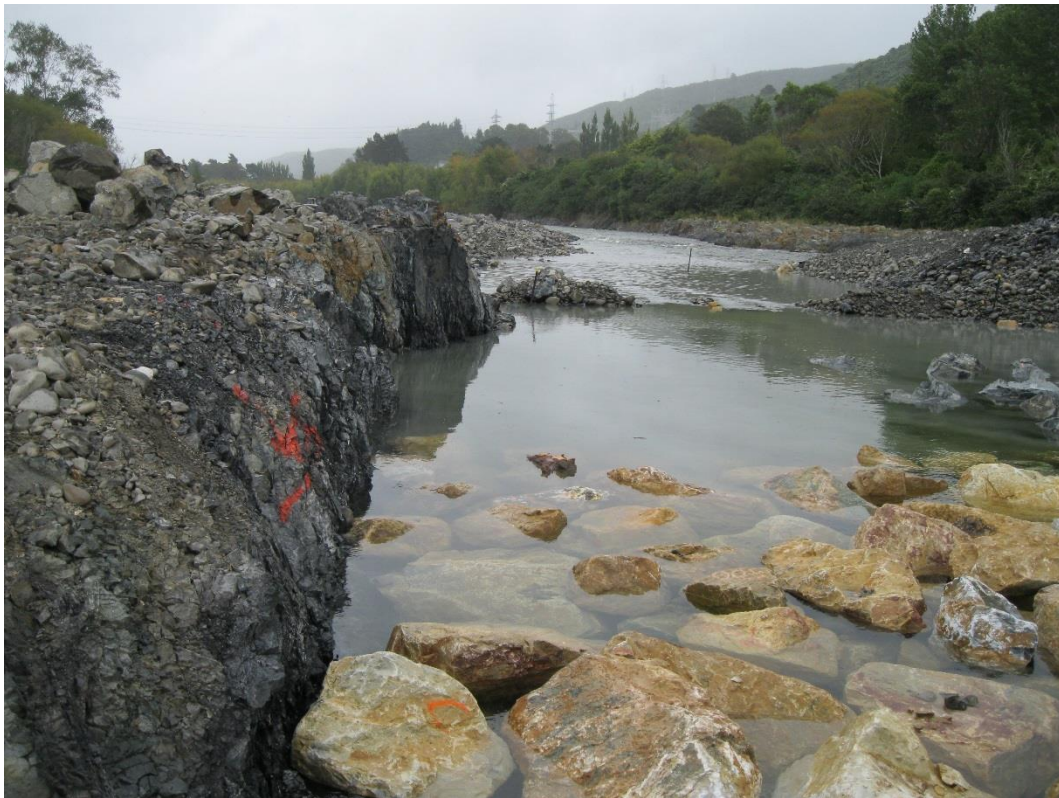
*Photograph 2-11: Rock placement within incised channel looking downstream towards end of rock ramp*

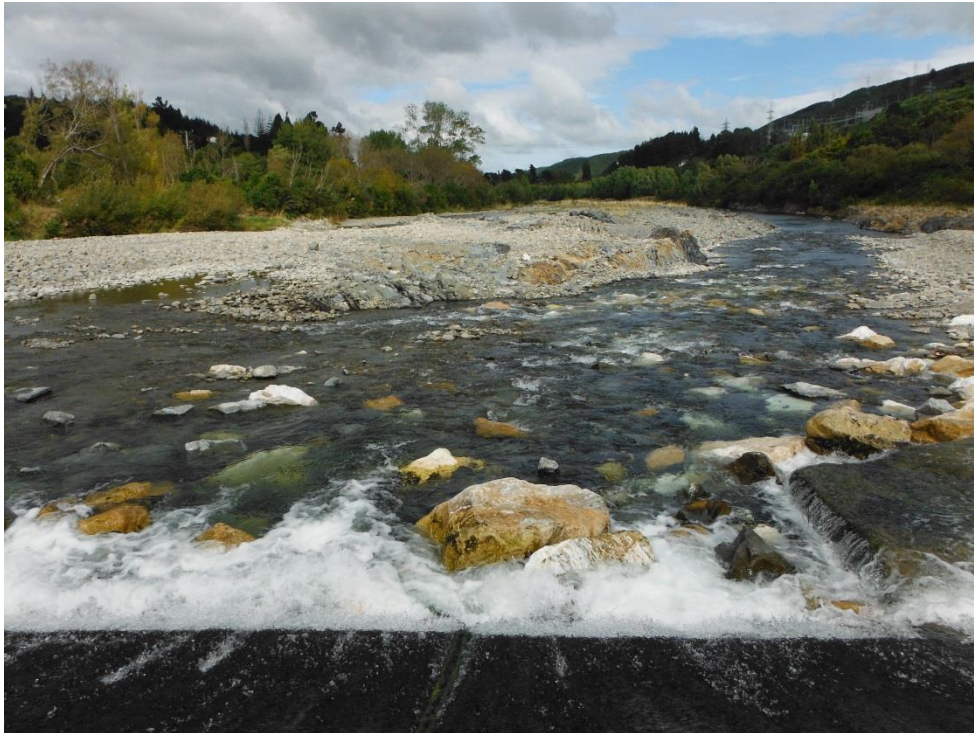
*Photograph 2-12: Looking from the RCPS on true left toward ‘incised’ channel*

The cost of Stage 1 of the works was just over \$500,000. As with all rock structures maintenance and ongoing monitoring is required as well as annual ‘topping up’. For HCC yearly inspections have been carried out since placement at the start of 2012. Inspections are carried out at a time when river levels are low, this is typically during January-March. The following photographs were taken around mid-March 2013 and show that rock is generally in place with a little top up required around the lip of the RCPS.

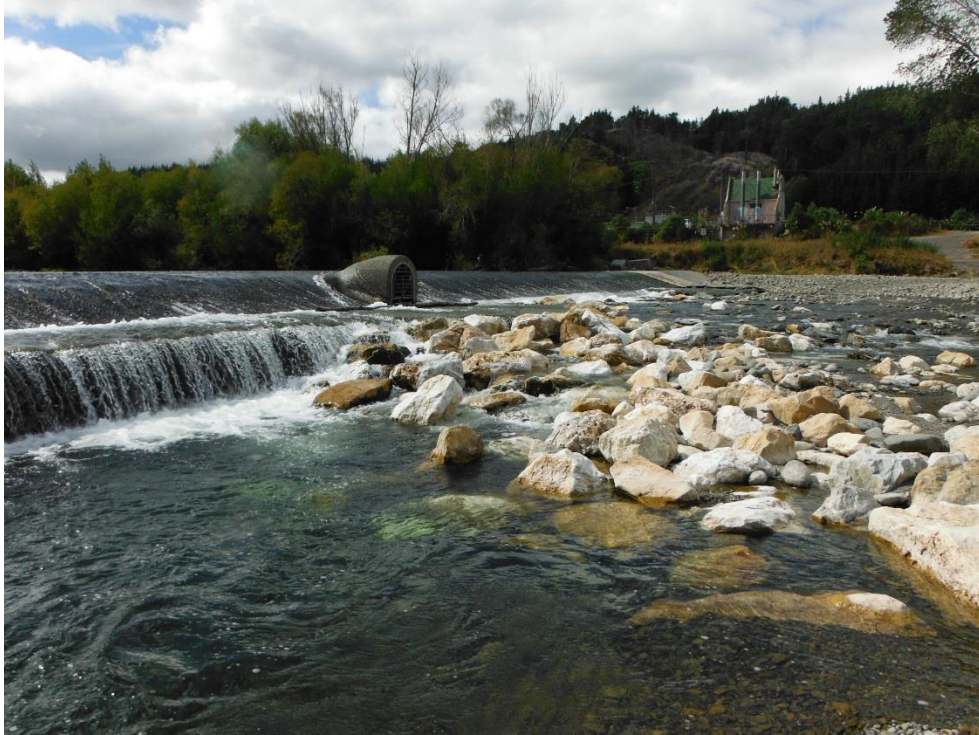
*Photograph 2-13: Looking from the true right embankment toward the area where rock was placed*

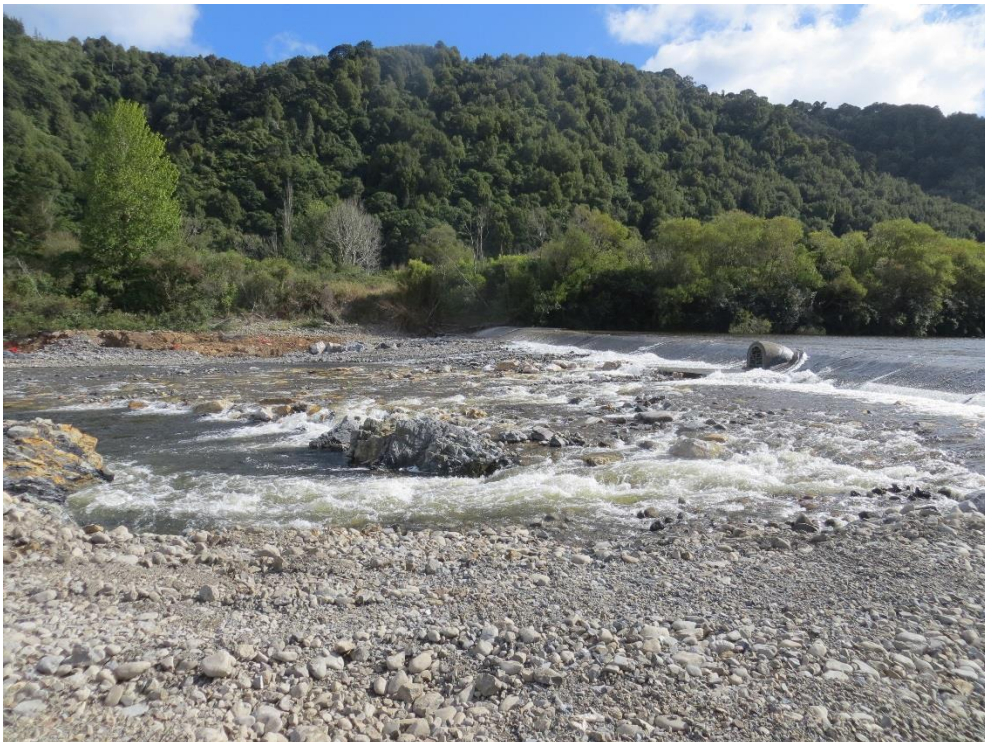
The following photograph was taken mid-March 2015 with no top up. However it can be seen that the rock protection structure has resulted in the river eroding the weaker argillite material next to the rock protection structure which has begun wearing another channel.

*Photograph 2-14: Looking from the true left embankment at intact rock structure showing new channel forming just downstream*
