Design and Rehabilitation of a 1200 mm, 98 Year old brick sewer at depths of over 21m with CIPP (to protect it from a 6 m tunnel being constructed right under it)

Chris Macey Americas Technical Practice Leader Condition Assessment and Rehabilitation AECOM

Water New Zealand Conference & Expo 2018 Hamilton, NZ

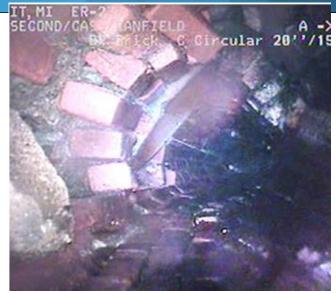
While not removing all of the risk, CIPP had some attractive advantages

- If the settlement trough were allowed to occur without lining the host brick pipe, there was a very high probability that the brick sewer would catastrophically collapse.
- While relining the host pipe wouldn't eliminate all possibility of a failure, it would radically change the mode of failure
- CIPP's ability to yield and stabilize the overall pipe-soil system would greatly minimize the possibility of loss of the overall structure
 - A more localized failure in the lining itself was still possible
 - Worst case considered a localized shear failure
 - Could be repaired internally in a trenchless point repair

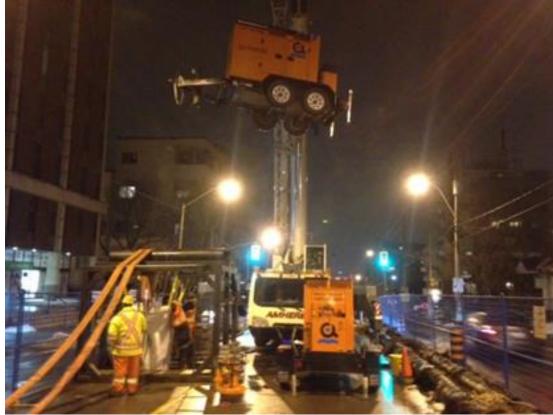
- Site setup for the installation was very tight due to the high traffic volumes on Eglington
- Construction footprint was limited to the two middle lanes
- Liner was cured using conventional hot water cure methods
- Inversion set up was at MH 006, where the depth of the MH (16m/52 feet)
- Hydraulic submersible pumps were used to circulate water within the liner.
- Twin submersibles were originally contemplated for use, each capable of 56 l/s (900 gallons per minute)

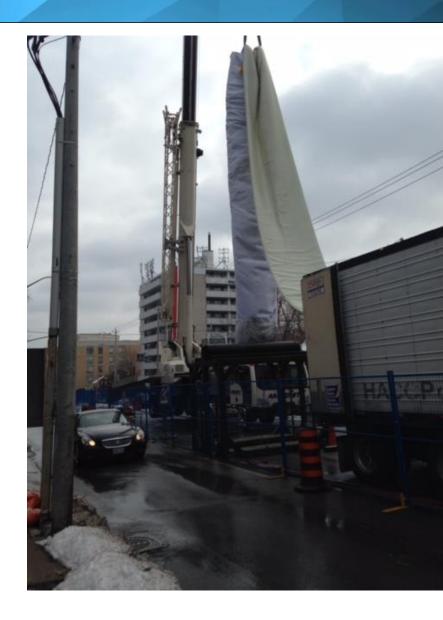
- Wet outs were carried off site in a controlled wet out facility in late December 2015 and early January 2016
- Multiple inversion approach made the liners light enough to be wet out in a controlled environment
 - Over-the-hole wet out wouldn't work given the available construction footprint
- Inversions were all carried out from MH006 in 4 separate installations
- Suitably, given the nature of the challenging installation to be undertaken, the first inversion was successfully executed on New Year's Eve 2015.
- Subsequent inversions were successfully carried out on January 6th, 11th, and 14th; 2016.

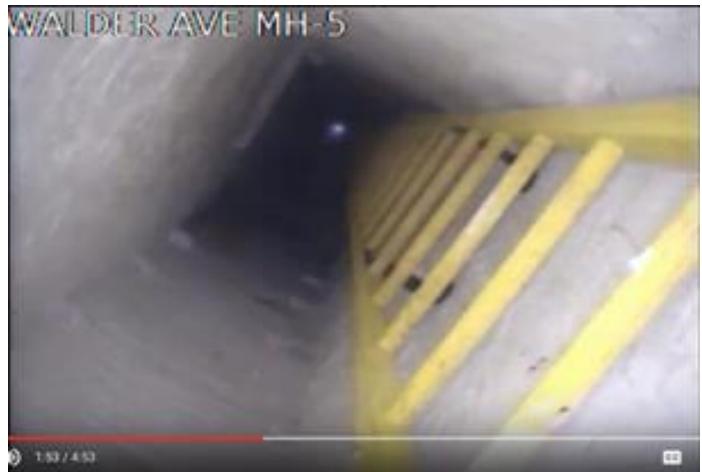
Manhole Restoration

–Subsequent to relining, all brick MH's were rehabilitated with a VOC free spray-on epoxy system to provide a new design life for the MH's

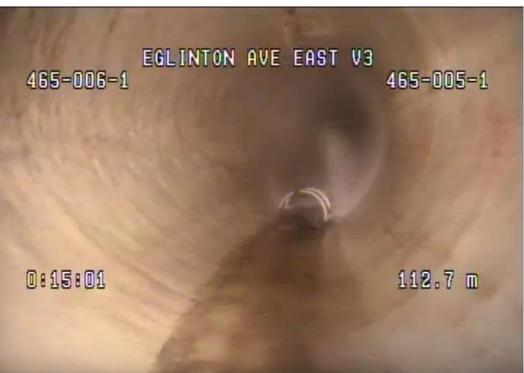
- Visual classification at install
- -No lifts, delamination
- Good evidence of close-fit (to host pipe and between lifts)
- –Minor wrinkling; even around the 90° curve
- Visual classification after tunnel crossing
- -Same as at completion; no defects, no loss of ground response

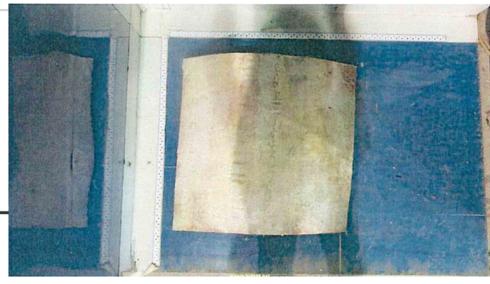
- Sampling and testing was carried out on in-place samples
- -Axial direction was tested
 - Bi-directional fabric, tested in weaker of two directions
- Installed thicknesses were all in excess of minimum
- Flexural strength values were all in excess (ASTM min used for design not based on anticipated values)
- Flexural modulus values were lower than design objective
- -Design reconciliation required
