GRAHAMS CREEK – FLOOD MITIGATION – WHEN ENGINEERING AND ENVIRONMENT COMBINE

Ghassan Basheer and Emily O'Donnell, Waikato Regional Council

ABSTRACT

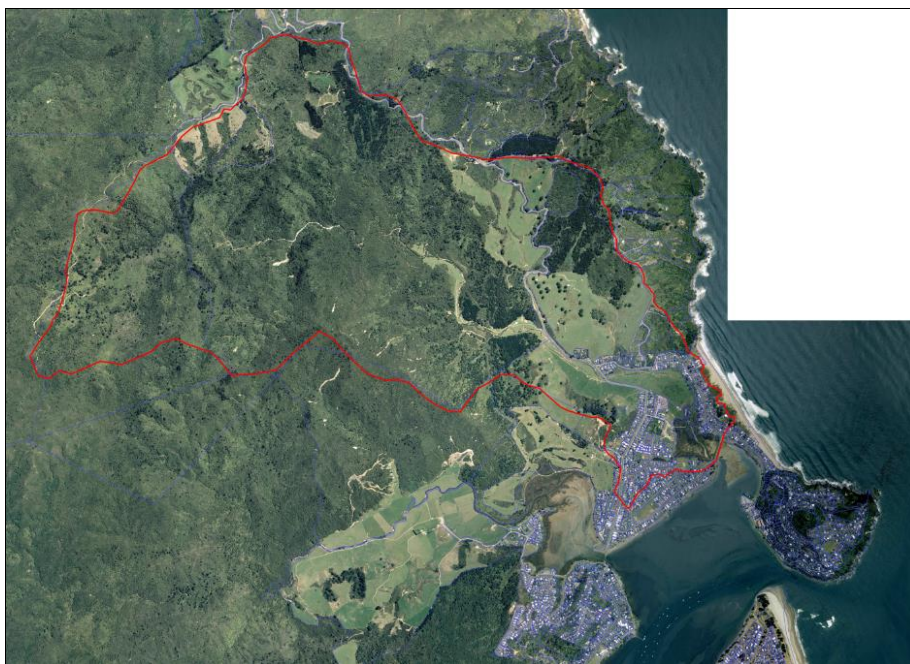
The location and extent of the Grahams Creek catchment and stream channel alignment is outlined in Figure 1 below.

Figure 1: Graham Stream catchment

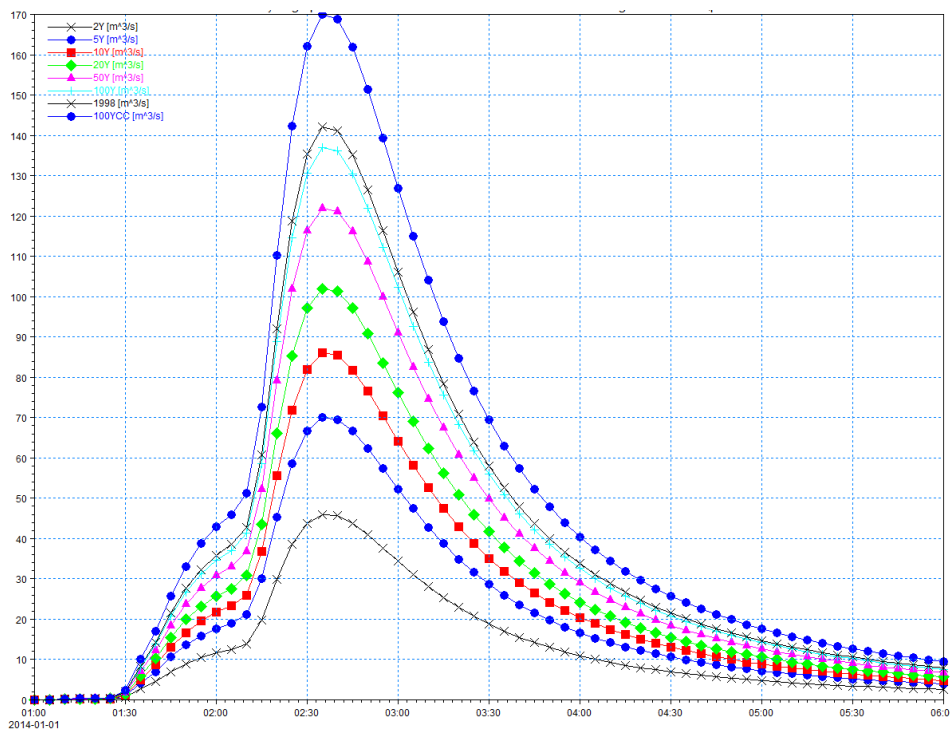
Application of steady high intensity rainfall HIRDS (version 3) for different durations over the whole catchment showed that the time to peak downstream of SH25 Bridge was around 90 minutes. The following Figure 2 provides the hydrographs for different rainfall events established for the stream and applied in hydraulic modelling.

Figure 2: hydrographs for the various events applied to the hydraulic model

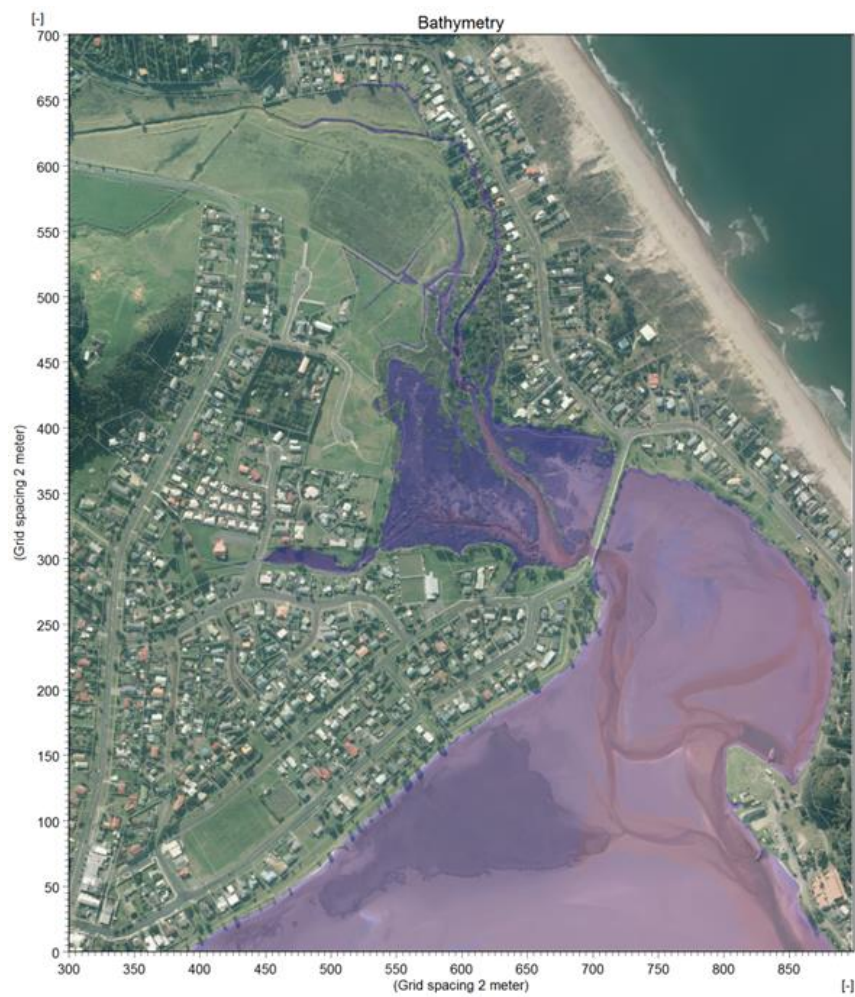
It was necessary to show the community what tidal flooding could mean with no stream flooding. This was important for the community to make an informed decisions on the level of protection they ask us to design the works for. The following two figures were results of modelling the tidal extent of current design high tide as opposed to future design high tide with sea level rise of 0.8 m. The community decision was to have the flood mitigation scheme designed for current flooding, however versatile to allow for future extensions and upgrades as a future stage to prevent future flooding of properties.

Figure 4: Tidal inundation during design high tide

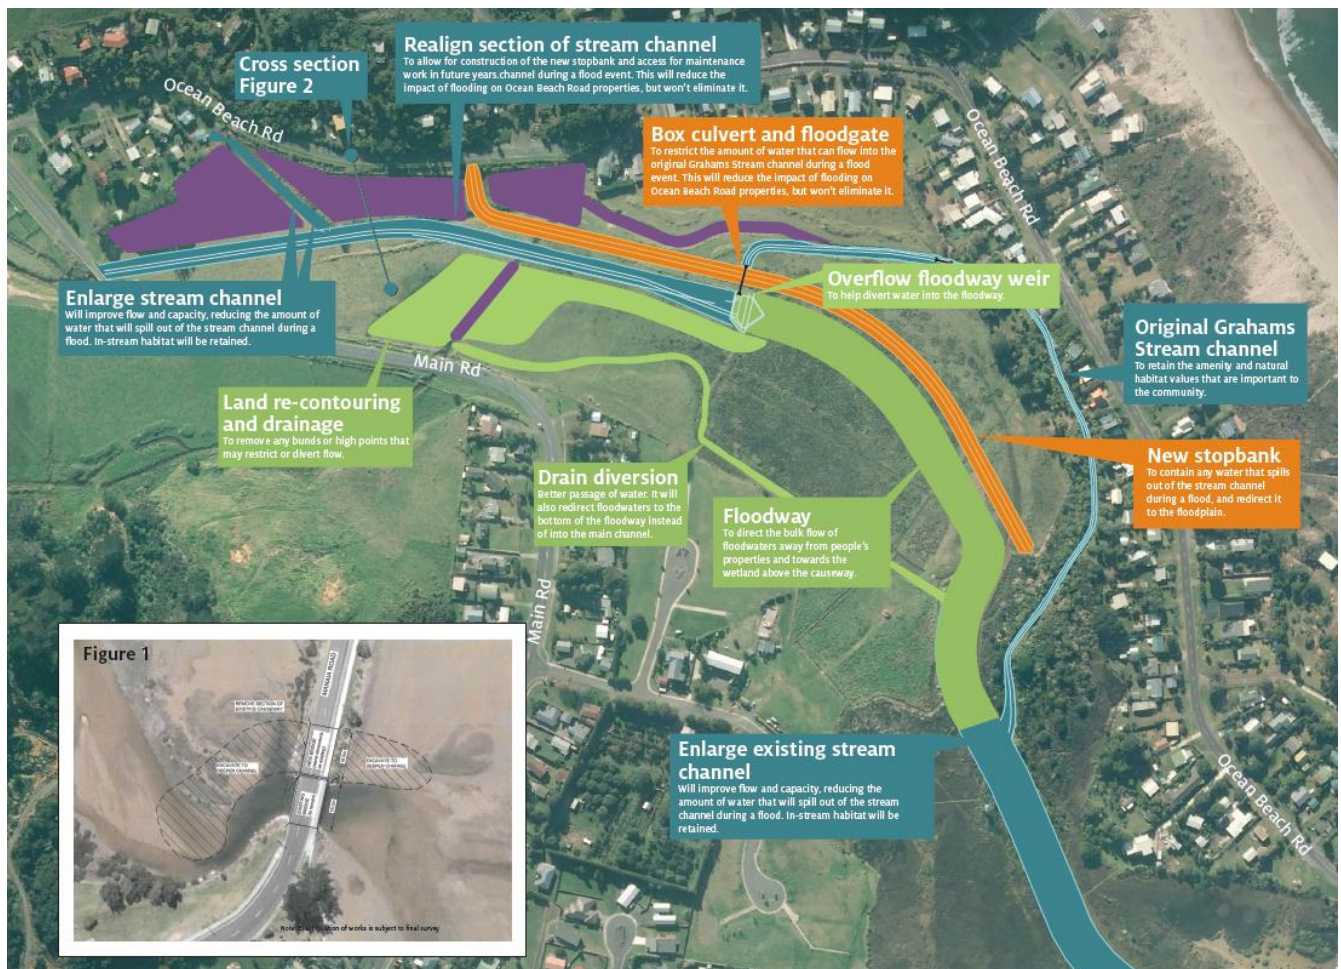
Figure 8: Schematic of flood alleviation components including stopbanks, increased channel capacity, floodway, floodgate, and redirected drain

The above points explaining the design concept, were modelled for a range of events to finally confirm the design concept shown in Figure 7 above.

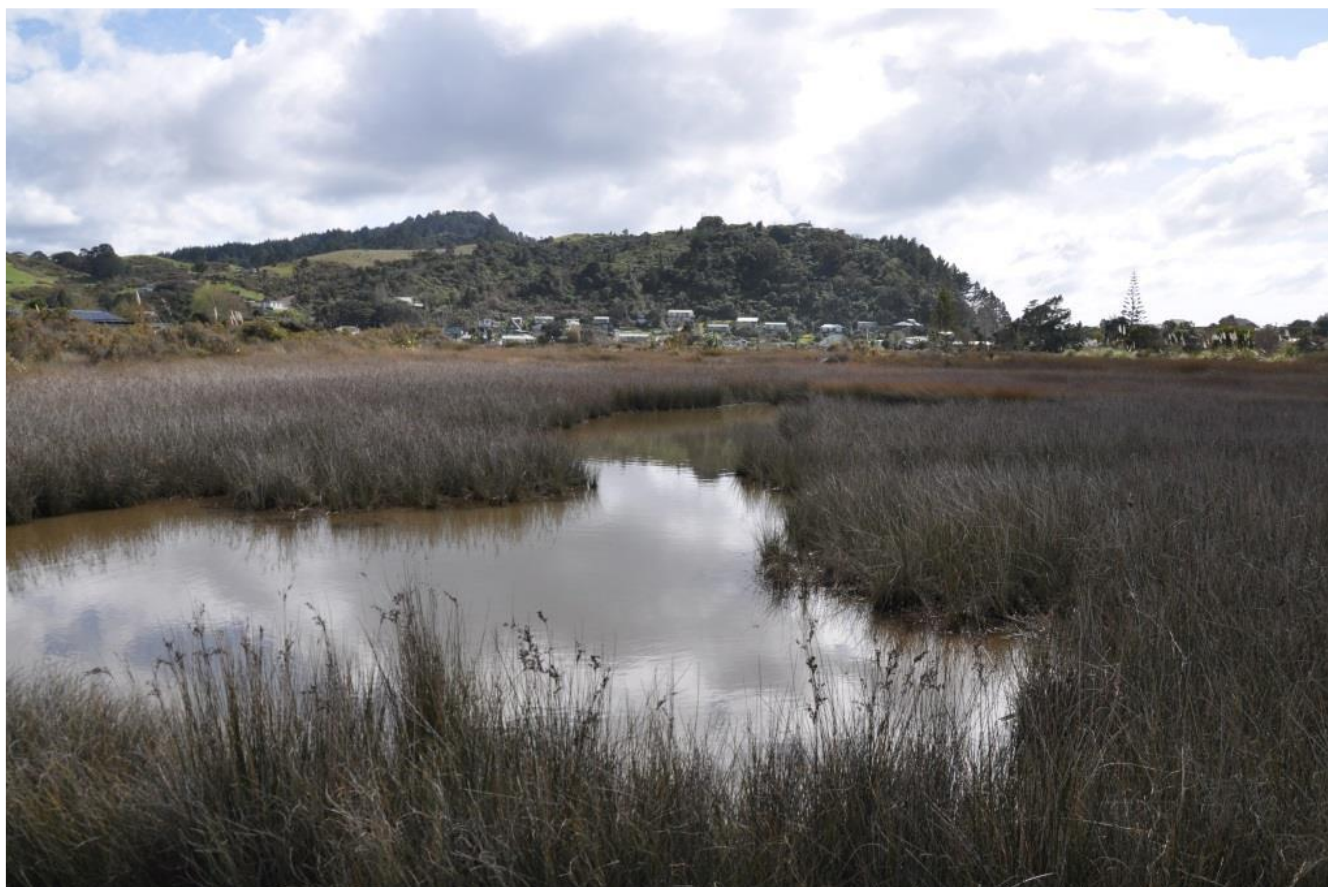
Figure 10: Shallow intertidal pools occur within the saltmarsh. 9 September 2014.

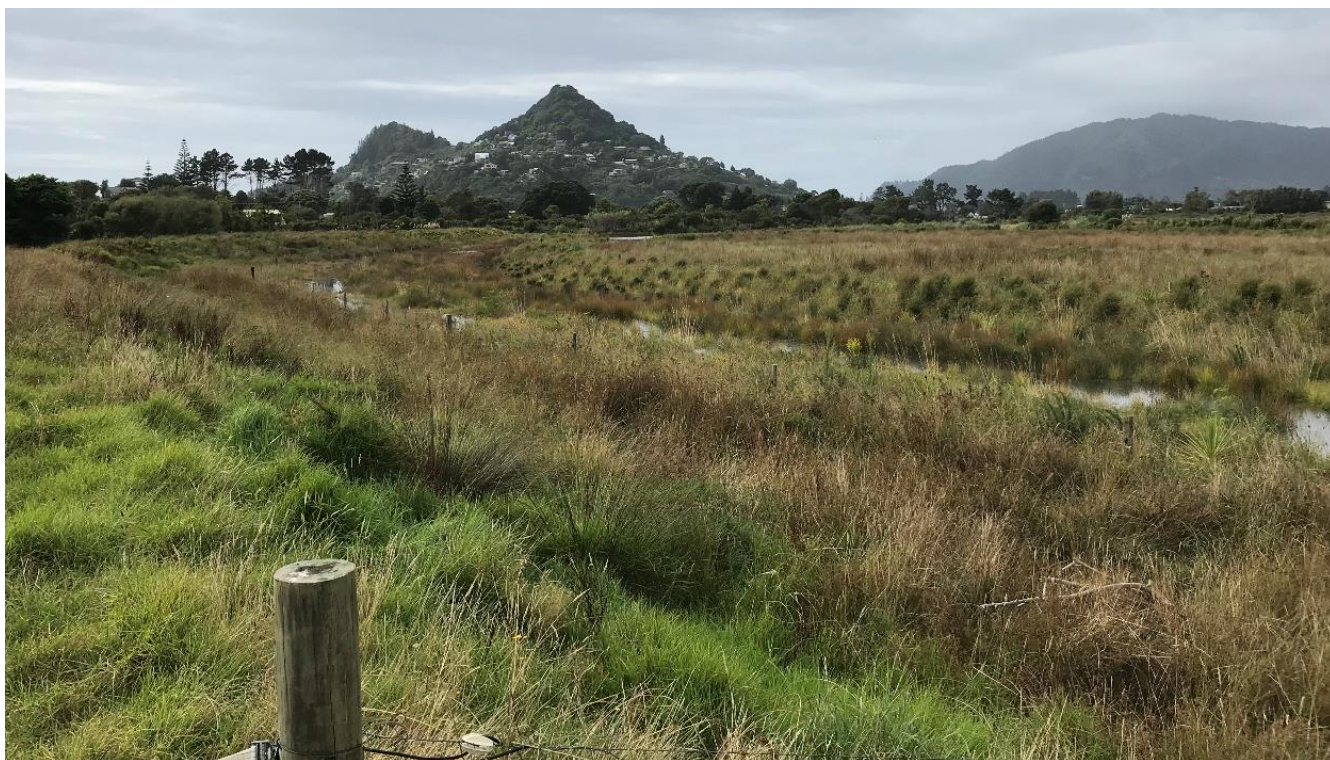
"A site visit was undertaken by T+T staff on 10 July 2018. Site observations from the site visit suggested that restoration plantings and the salt marsh translocation area are continuing to establish well. These observations are similar to previous site visits detailed in Kessels(2017)."

Figure 12: Saltmarsh plants regeration within the floodway 2019
