# WASTEWATER TREATMENT PLANTS - YOU CAN'T SWITCH THEM OFF FOR REPAIRS

*RJ Macdonald , M Christison, CH2M Beca, Christchurch, New Zealand  
G Hovens, Christchurch City Council, Christchurch New Zealand*

This paper uses a case study from the CWTP, the trickling filters.

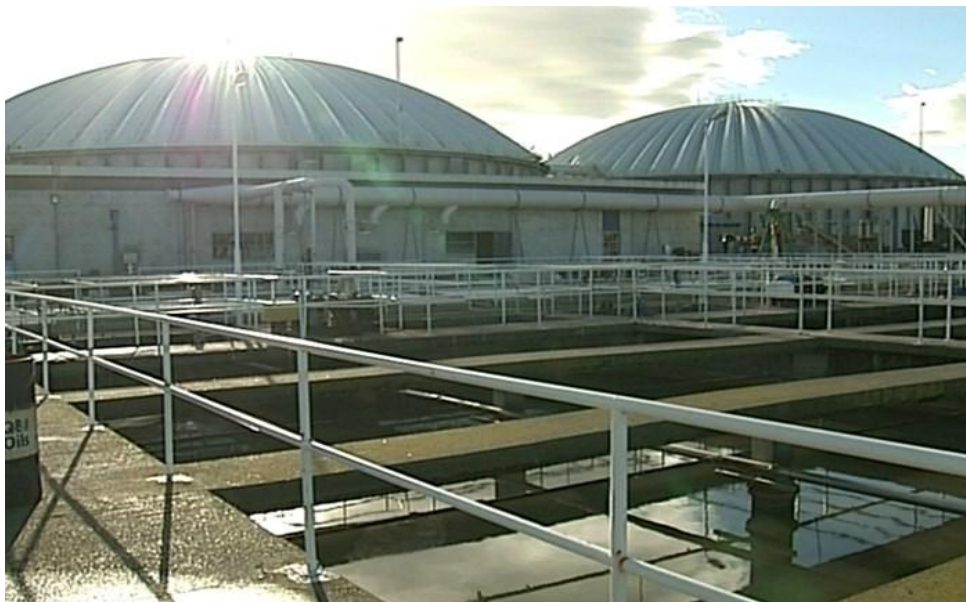
*Figure 1 showing the CWTP Trickling Filters*

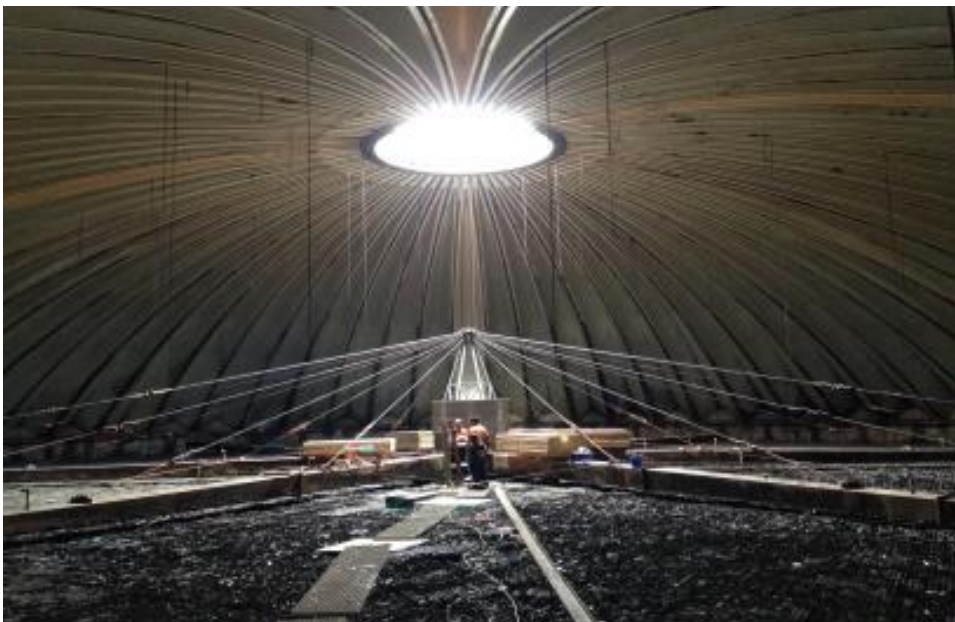
Once off line Trickling Filter 1 was isolated by closing valves, and installing slide gates to block off pipes and ducts. When maintenance staff entered the trickling filter the first action was to install safety equipment, to protect people from harm and equipment from damage. This included installing temporary steps and walkways as shown in Figure 2.

Figure 2 showing the inside of Trickling Filter 1, during R&M

The main R&M task was to dismantle the large rotary distributor and replace the bottom bearing. The distributor comprises a large central column that rotates on a bearing. Attached to this central column are six distributor arms that carry the wastewater and discharge it evenly along their length so that it rains down on to the media

The R&M included checking and repairing tie rods that hold the distributor arms onto the central column. The central column on the distribution tower was dismantled and R&M carried out as required. Finally the large bearing was removed and replaced. On completion of the R&M, the large rotary distributor column and distribution arms were reinstated.

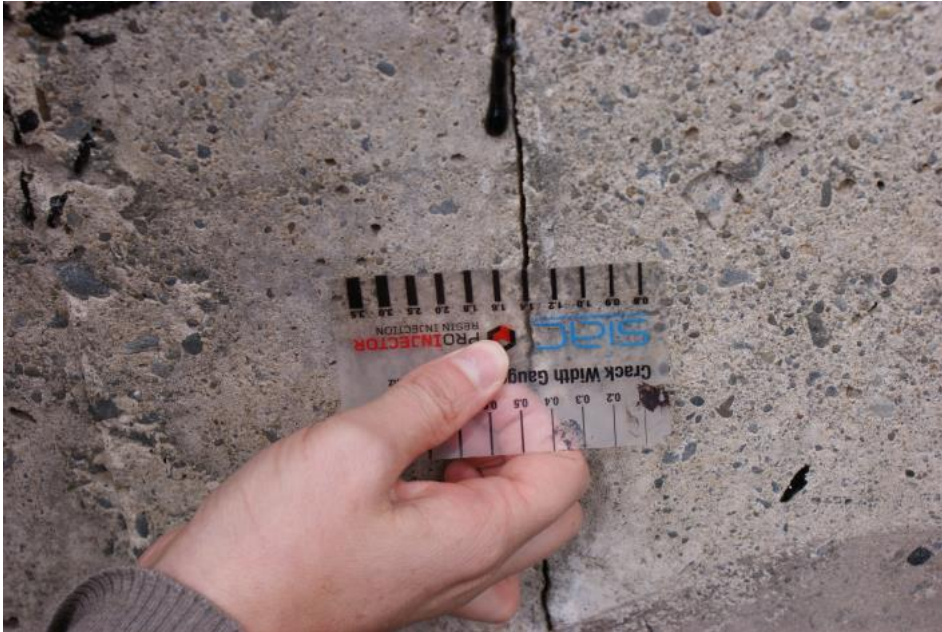
Damaged concrete plenums were demolished and replaced with new precast concrete plenums. Damaged air ducting was removed and replaced with new ducting. There was significant cracking to the concrete (see Figure 3), in particular the lower section of the trickling filter, beneath the trickling filter media. All of these cracks were repaired in situ, using epoxy resin.

*Figure 3 showing typical cracks in CWTP Trickling Filter 1*

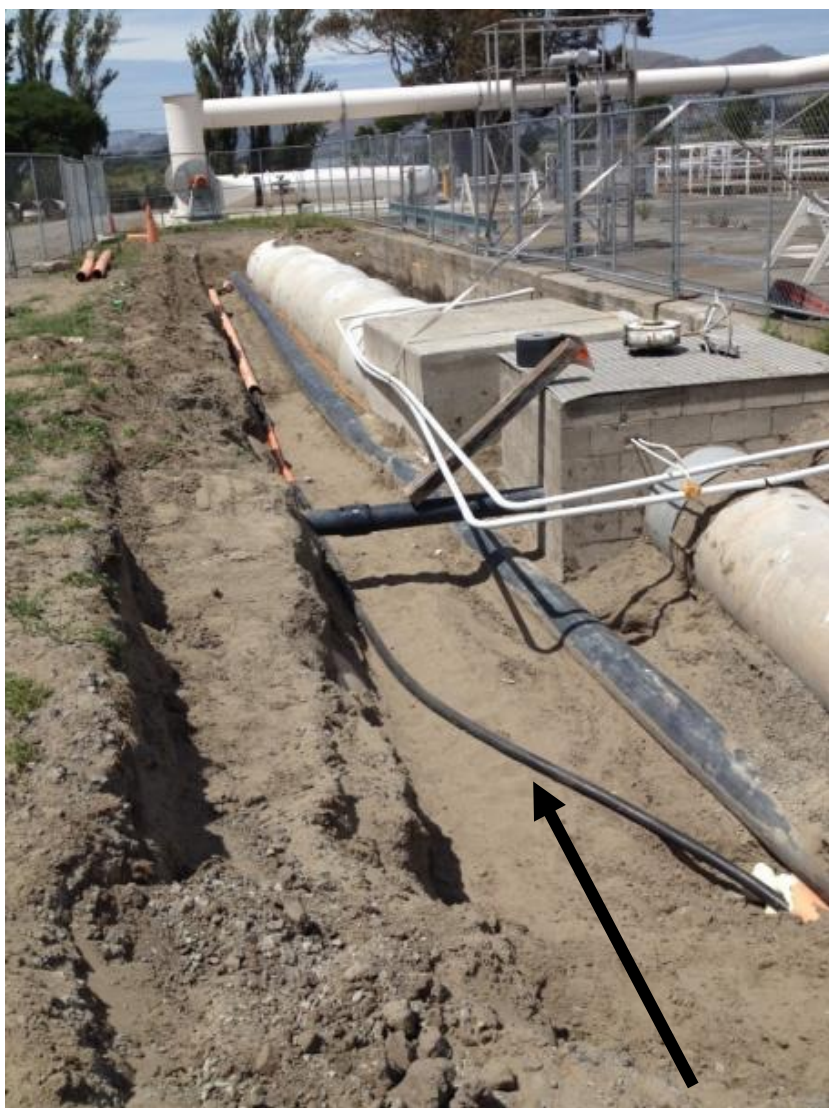
R&M was also undertaken on pipework and ducting associated with the trickling filter. Much of the pipework is buried and needed to be excavated for the R&M to be carried out. Like many WWTP's the CWTP has significant amount of underground services including wastewater pipes, water pipes, air ducts, and electrical cable ducts. This means that any excavations must be carefully planned with existing underground services accurately located prior to commencing. For the trickling filter project the key underground service to locate was an 11kV power cable, located very close to some of the damaged underground pipework.

This 11kV power cable is part of a ring main and presented a significant safety risk. The 11kV ring main had been completed just prior to the Canterbury Earthquakes and was installed as part of a programme to provide the plant with an N-1 power supply. This improvement initiative has provided many benefits since installation. The relevant section of the ring main was shut down for these works. Hydroexcavation using high pressure water was used, rather than a digger, to minimise the risk of damaging this cable. Hydro excavation is now used extensively in Christchurch for service location due to the greatly reduced risk of damage to underground services. The 11kV power cable was rerouted during the project to enable sufficient space for the pipework repairs to be carried out safely. Figure 4 shows the location of the 11kV power cable.

*Figure 4 showing the location of the 11kV power cable.*
