DESIGN OF LINERS FOR DETERIORATED SEWERS – LATEST RESEARCH TO MAKE IT MORE EFFICIENT

John Monro, Interflow Pty Limited

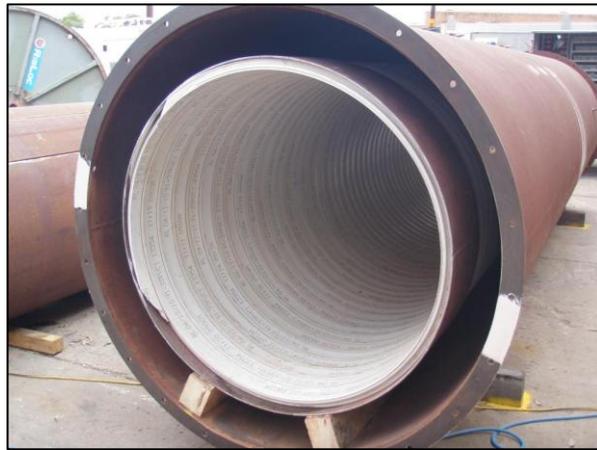
Picture 1: Assembly for the unsupported liner test, prior to placing the end sealing bungs. The Rotaloc liner is located centrally in the cylindrical pressure vessel

1. A cylindrical “pressure vessel” was fabricated with:
 - Internal diameter = 1,500mm
 - Length = 6,000mm
 - Wall thickness = 12mm
2. A Rotaloc liner with an external diameter of 1,200mm was wound into the pressure vessel. The liner was centred in the pressure vessel, supported by 2 wooden rails running along its length.
3. Steel end rings were placed around the ends of the Rotaloc liner to allow assembling of the sealing bungs. (See Pictures below)

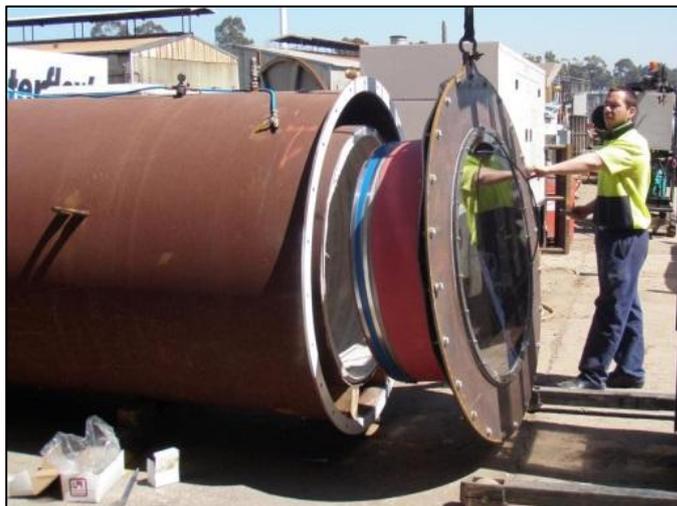
Picture 2: Installing the sealing bungs at the end of the liner

4. The sealing bungs were placed around the ends of the liner, bolted to the flanges on the pressure vessel. This provided a water-tight space between the outside of the liner and the inside of the pressure vessel.
5. Indicator bars were hung inside the liner in 3 positions and in 4 planes at each position. The bars were hung so that the liner would contact the end of one of these bars when its deflection reaches 3%. See Picture 3. This 3% deflection was taken as “buckling failure” to provide a consistent point for comparison in each of the test scenarios.
6. The space between the outside of the liner and inside of the pressure vessel was hydrostatically pressurised.

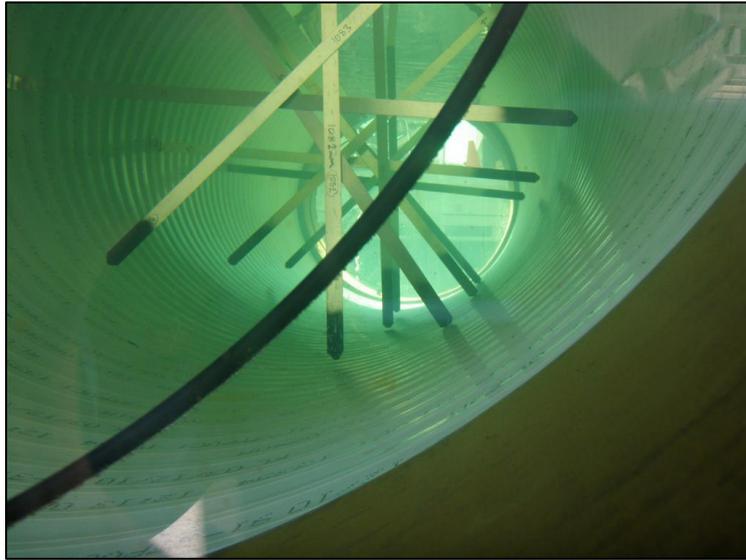
Picture 3: The inside surface of the liner is just touching the indicator bars, showing that the liner has deflected by 3%. For the purposes of the test, this was taken to indicate that the liner had buckled.

Pressure was increased until deformation in the liner reached a stage where the inner surface just touched an indicator bar. This occurred at a pressure of 30 kPa.

By back-calculating, applying 30 kPa as the value for “q” in Equation 2 (above), with $N = 1$ and $K = 1$ (as it was unsupported), it can be determined that the appropriate value of “C” was 0.69. This equated to an ovality of 4.2%.

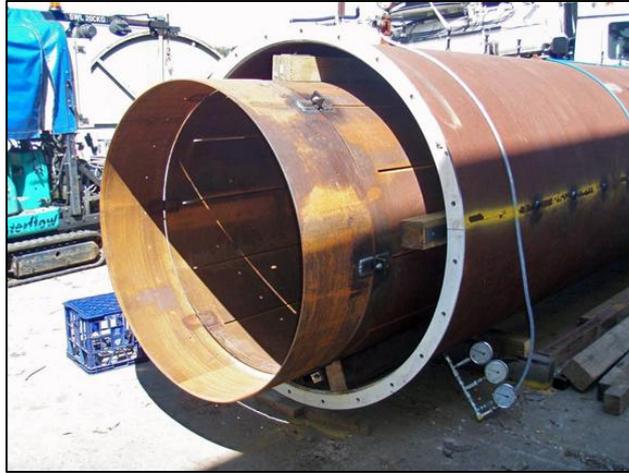
Picture 4: Steel tube fabricated to support the Rotaloc liner to be wound inside it. Slots were cut in the tube to allow hydrostatic pressure to be applied to the liner.

A steel tube with an internal diameter of 1,200mm, composed of 6mm steel plate was fabricated in a length of 6 metres. Slots were cut into the tube running longitudinally and spaced around its circumference. (See Picture 4)

The tube was required for use in both the ungrouted and grouted liner testing, with the slots allowing hydrostatic pressure to be applied to the liner.

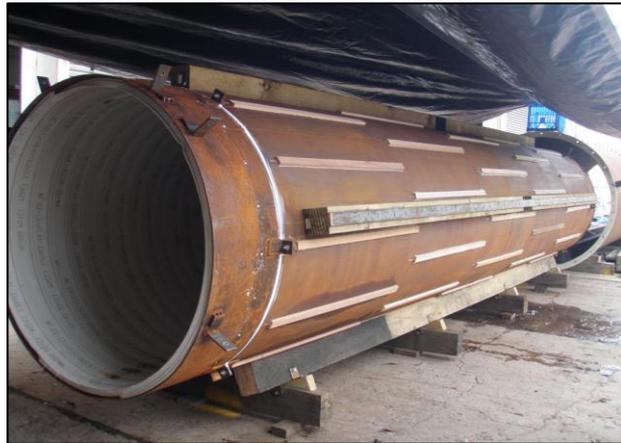
Picture 6: Slots in the steel tube covered while the liner is grouted. The covers were removed prior to it all being inserted into the pressure vessel for testing.

Following the testing of the ungrouted liner, the steel tube was removed and the slots covered.

Following curing of the grout, the covers over the slots were removed and the liner and its steel tube were re-inserted and re-centred in the pressure vessel. Removing the covers from the slots was necessary to allow the hydrostatic pressure to be applied to the grouted liner.
