Modelling in Stream Bank Erosion Management

Presented by Jackie Zhou, Healthy Waters

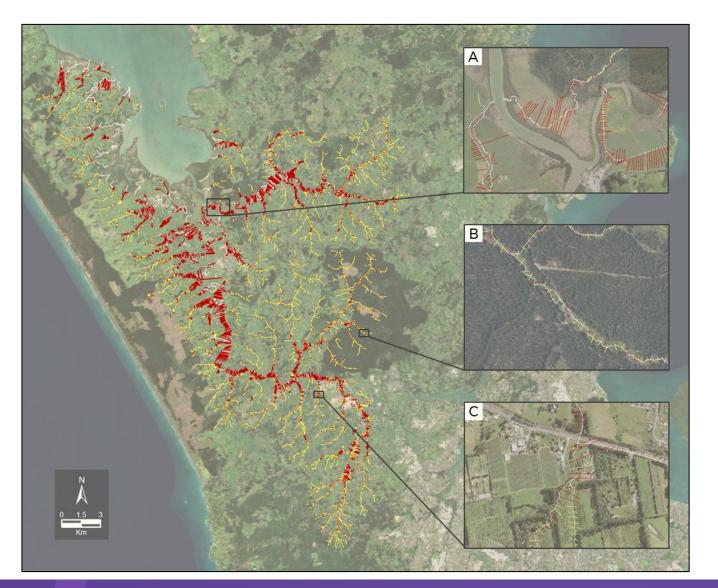
Input Data

Regional flood model (2D model using Tuflow engine)

- Over 100,000 cross sections
- 2 year ARI peak flows with climate change
 2.1 degree (to calculate hydraulic radius)
- Water level of each cross sections (to estimate energy slope)

Critical shear stress data (20 and 40 pa)

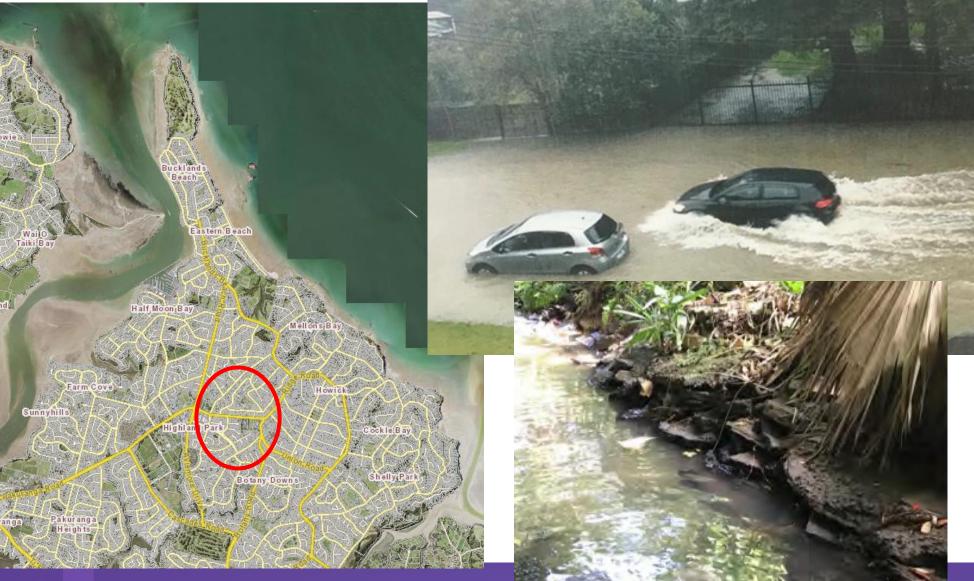
Case Study – Angelo Stream, Howick

- Well known area in South Auckland for flooding to roads and properties
- Stream bank erosion in 800m length of stream
- Poor structures built within the streams by different parties
