INTERNATIONAL FISH PASSAGE LEARNINGS AND RETROFIT LESSONS FROM CHRISTCHURCH

Mullaney M (Christchurch City Council (CCC)), Groves M (WSP), Margetts B (CCC)

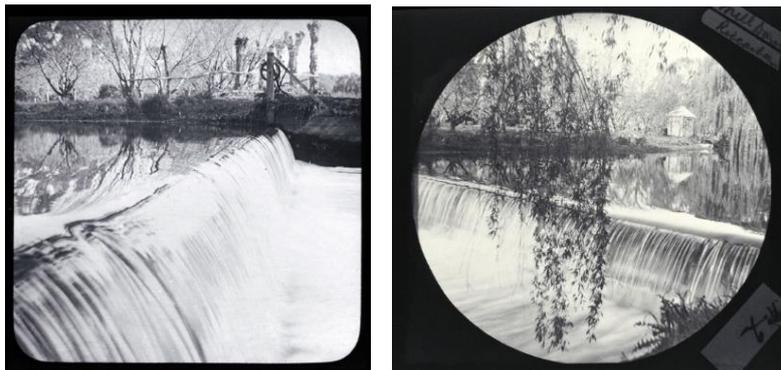
*Figure 1 and 2: From left to right, Weir 1880 and Weir between 1860 and 1890.
Images Christchurch City Libraries*

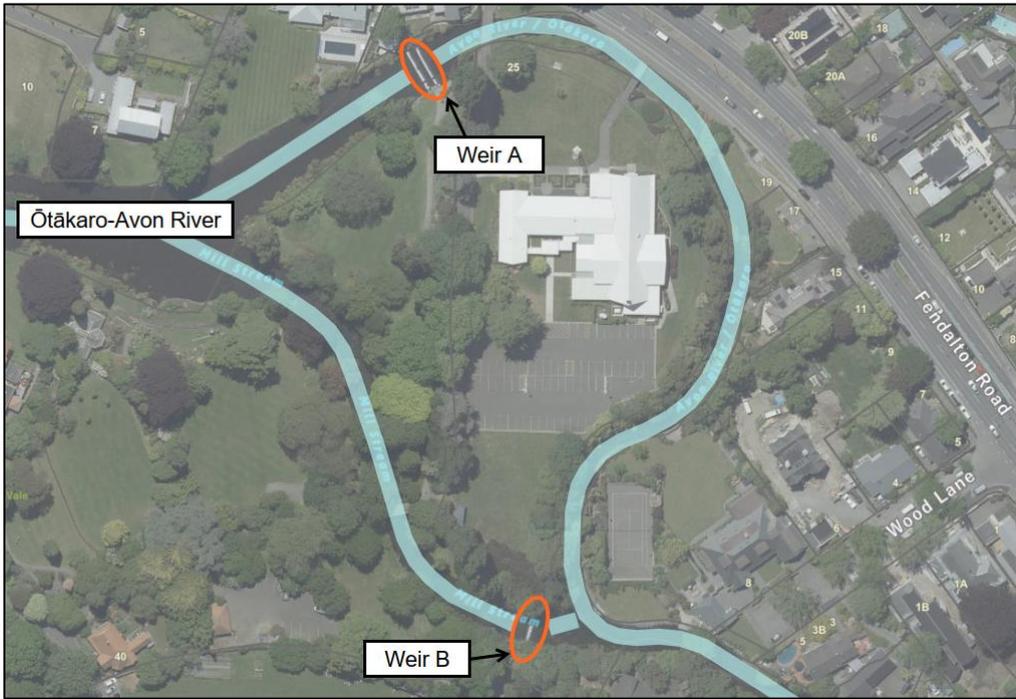
In Christchurch, at the historic Mona Vale setting, there are two historic weir structures each on separate branches of the Ōtākaro-Avon River (Figure 1 - 3) (Mona Vale Park is highly valued in the community and a tourist attraction in Christchurch).

Figure 3: Aerial View of Ōtākaro-Avon River and Weirs

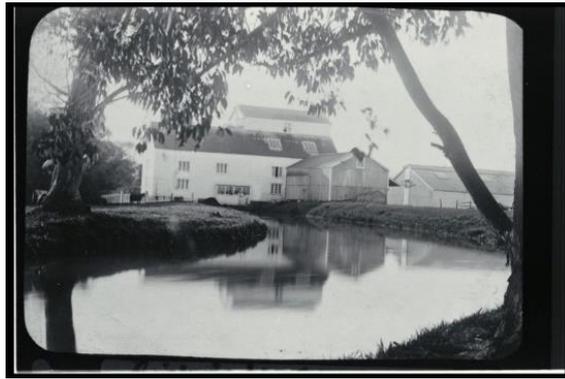
Figure 4: Mill 1895. Image Christchurch City Libraries

The weirs were originally used to divert wai from the Ōtākaro-Avon River to a nearby mill (Figure 4). The mill has since gone, but the weirs remain, as is likely the case in many other townships and cities across New Zealand.

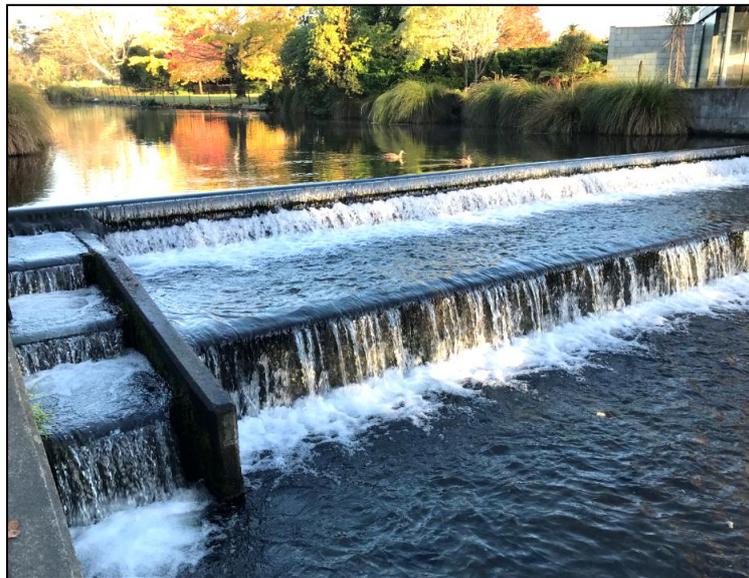
The current iteration of the weirs are concrete structures, with the northern weir having North American style salmon ladders (Figure 5). Limited passage of brown trout does occur at this weir (with individuals anecdotally preferring to jump over the weir rather than use the ladders) but likely not full passage, and the weir is a complete barrier to many of our native ika (fish) who are poor swimmers. Because of this, the weir was assessed as one of the greatest priorities for fish passage remediation within the Ōtākaro-Avon River (Instream Consulting Limited, 2020)¹.

Figure 5: Current concrete weir structure with salmon style ladders

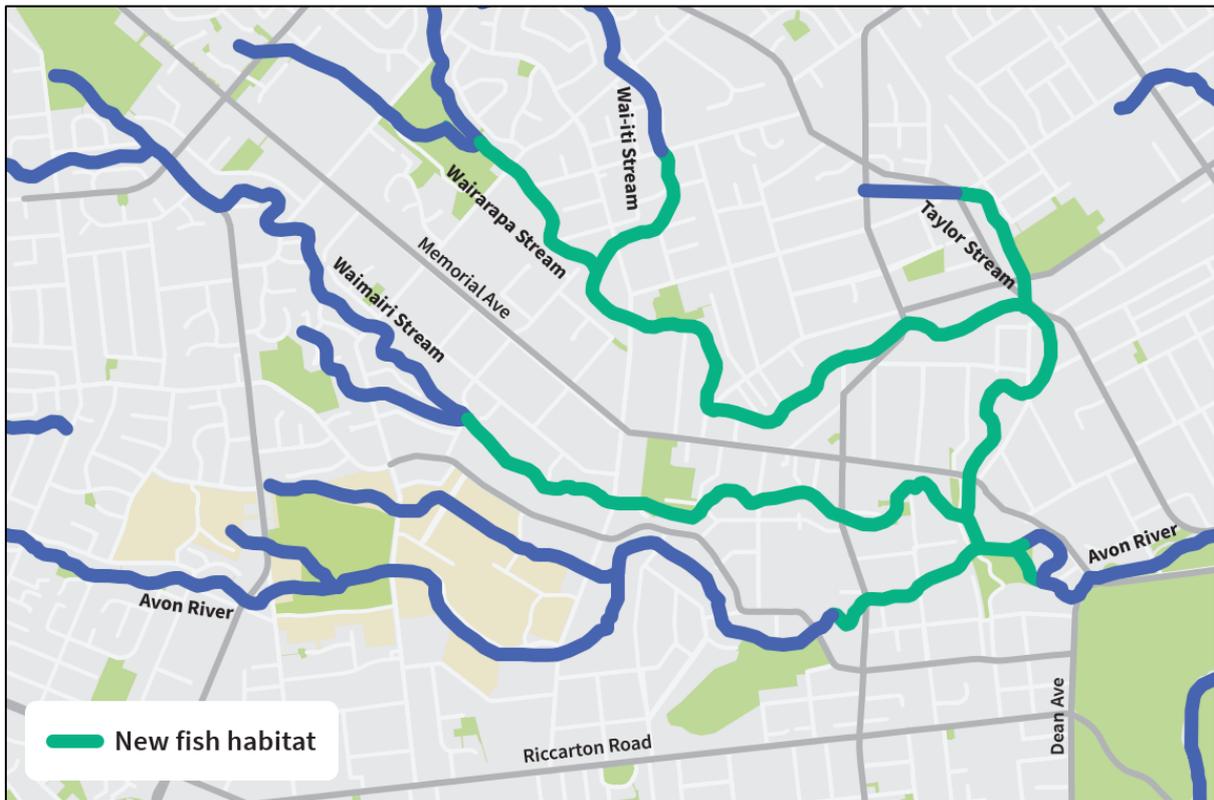
Removing this barrier will open approximately nine kilometers of habitat to these poorer climbing ika (Figure 6).

Figure 6: Approximately nine km of habitat opened upstream if weir is remediated

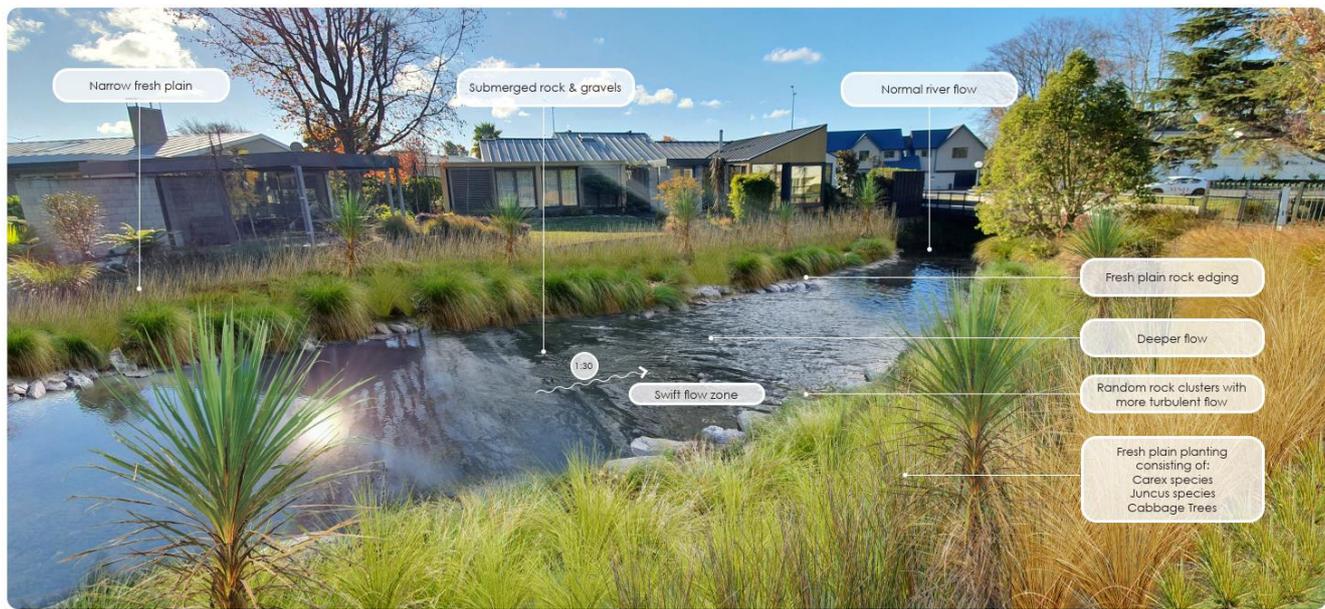
Figure 9 – Visualisation of the finished riffle used to assist with consultation in the early stages of the project

Council had WSP create visuals for the proposed riffle which helped to discuss the project with community boards and adjacent property owners (Figure 9 and 10).

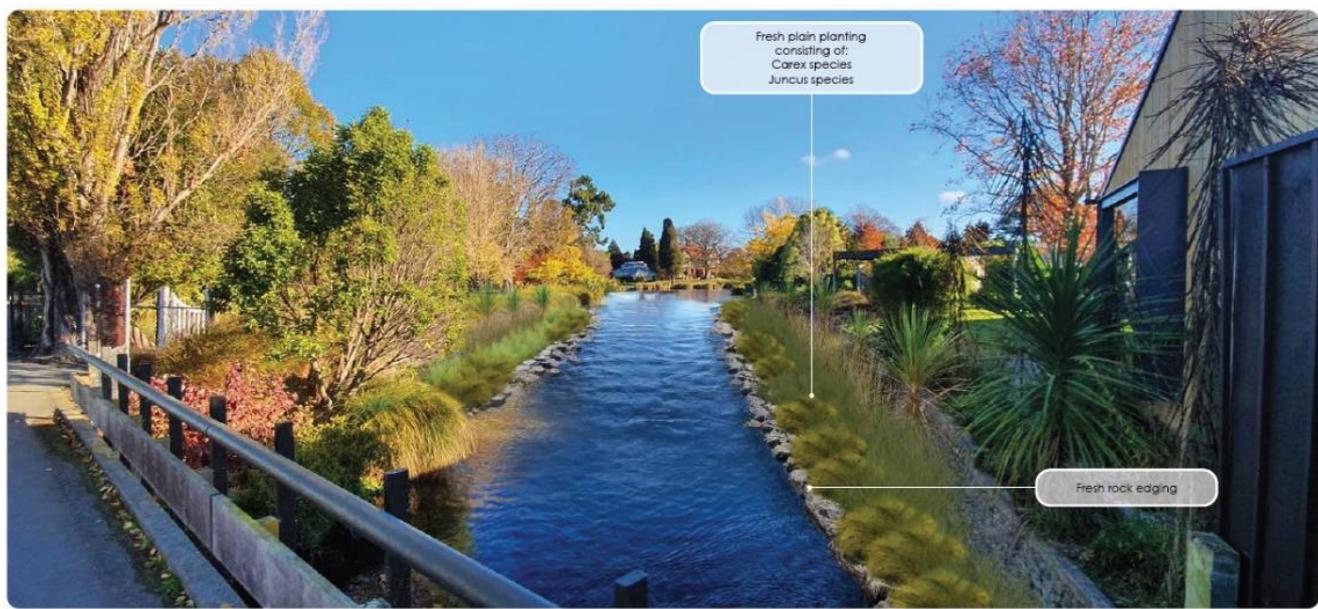
Figure 10 – Visualisation of the finished riffle used to assist with consultation in the early stages of the project

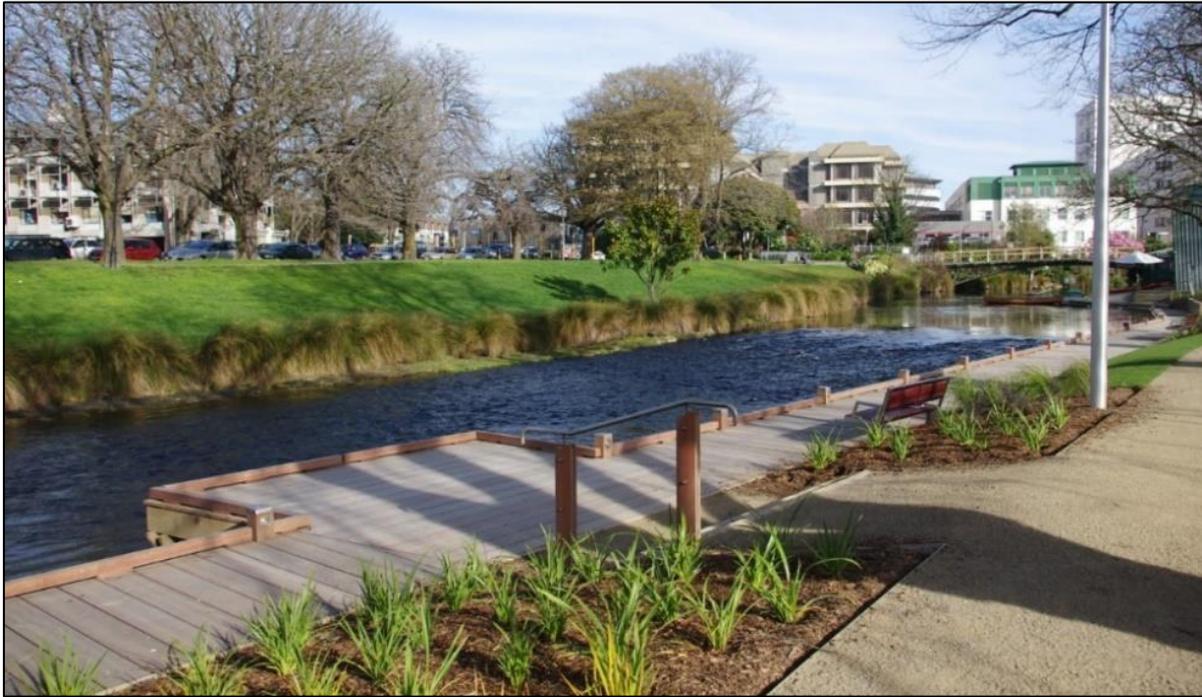
A riffle had previously been constructed downstream to replace an old rock weir located at the historic Antigua Boatsheds (Figure 11) and was used as a basis for design. Ecological monitoring of this weir has shown not only fish passage, but the return of the fast-water specialist bluegill bully.

Figure 11 – Previously Constructed Antigua Riffle Downstream

The flow gauging at Antigua Boatsheds indicated flow depths varied from 120 mm to 310 mm with a mean depth and velocity of 220 mm and 0.75 m/s and higher hydraulic roughness than would typically be assumed for design.

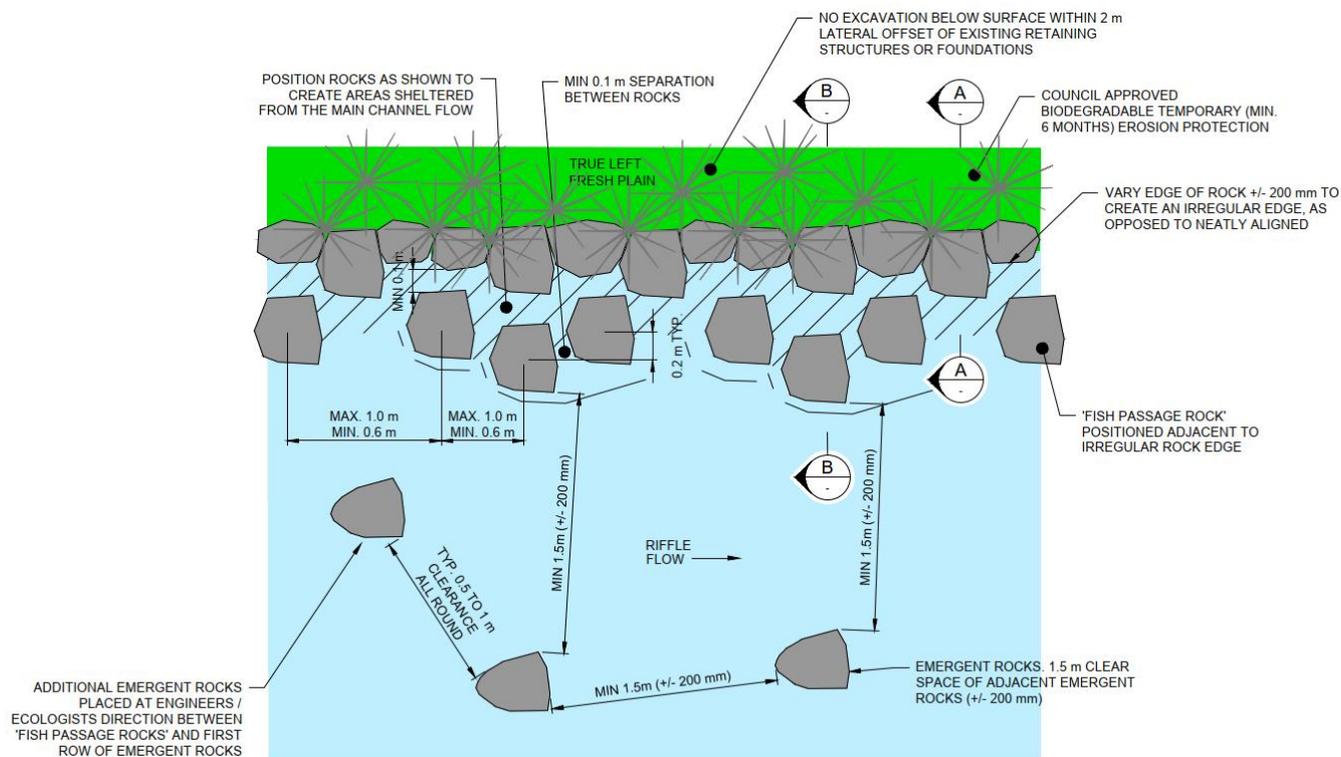
To enhance the proposed riffle, an irregular rock edge is also included. The irregular edge creates pockets of stilled water where ika can rest. This is complimented by a buffer of closely spaced emergent rocks along the edge of the riffle to dissipate energy and direct momentum away from the river's edge.

Figure 15 – Irregular Rock Edge, 'Fish Passage Rocks' and Emergent Rocks
