# MORE THAN A DRAIN; THE ECOLOGICAL SURPRISE OF HARRISONS CUT DRAIN

***Gareth John, Project Manager, Tauranga City Council***

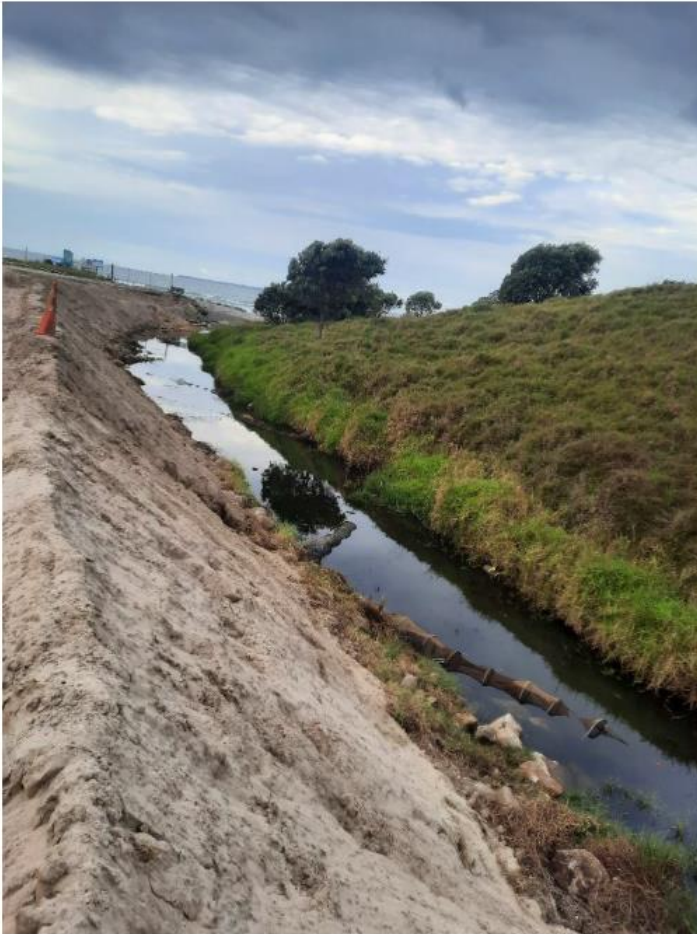
Boffa Miskell fyke nets set throughout the middle portion of Harrison's Cut drain below.

During fish salvage of this small section (approx. 175m) of drain the ecologists captured and relocated a whopping 2,132 fish (including some 'At Risk' species). The fish salvage was undertaken by both Boffa Miskell and Bioresarches between April through to June 2022.
