20 YEARS OF WATERCOURSE ASSESSMENTS - RESURVEY IMPLICATIONS FOR FRESHWATER MANAGEMENT

AMQ Nguyen , S Speed, C Brent (Auckland Council), A Rossaak, DF Brockerhoff (Morphum Environmental), E Morrison, C Davis (4Sight - Part of SLR)

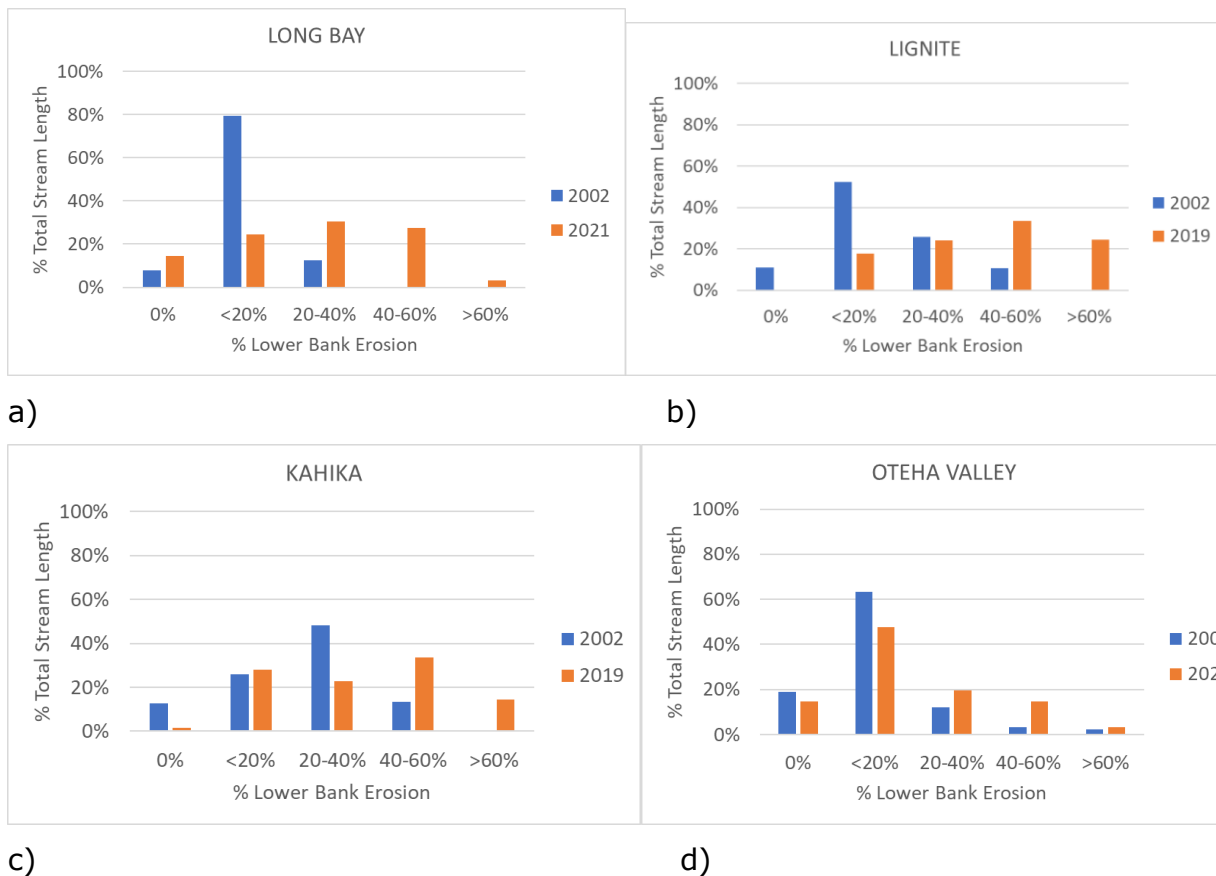
Figure 9: Changes in Lower Bank Erosion percentage since the original stream survey for a) Long Bay, b) Lignite, c) Kahika and d) Oteha Valley.

Overall, the WA resurveys indicate a deteriorating trend in lower bank erosion across all four catchments (Figures 9a, b, c and d).

There was a higher prevalence of lower bank erosion in 2022 compared to the 2002 survey (Figure 9a) for Long Bay. In 2002, bank erosion was low with most reaches characterised as “less than 20%” erosion. In 2022, scour, fluvial undercutting, and mass wasting were all common throughout the survey area (Davis et al., 2022). In urbanised rural areas where riparian planting has been installed this may be attributable to the natural process of eroding previously slumped soils as they stabilise to a more natural stream profile (Davies-Colley, 1997). Lower bank erosion was most prevalent in the upper catchment even in dry reaches, with 8% of reaches having more than 60% erosion (Davis et al., 2022). The presence of erosion in dry reaches suggests poor stormwater runoff management and it is likely that this erosion is occurring within the winter months when baseflow is higher and/or during and after rainfall (Figure 10) (Davis et al., 2022).

Unlike the other 3 catchments, Oteha Valley lower bank erosion was present across all of the % Bank erosion categories in the original survey (Figure 9d). However, the resurvey still shows a general worsening of lower bank erosion between the two surveys. Lower bank erosion of lesser severity in Oteha Valley has dropped by 4% for “little to no sign” of bank erosion and by 15% for “less than 20%” (Figure 9d) since 2003. Although the percentages of more severe lower bank erosion were relatively low compared to other resurveyed catchments, they have all increased since 2003. The “40%-60%” lower bank erosion increased sharply from 3% in 2003 to 15% in 2021. Simultaneously, “20%-40%” lower bank erosion increased by 7% to 20% and “more than 60%” increased slightly to 3% in 2021 (Figure 9d). This means that this will likely be an ongoing issue for Oteha Valley (Brockerhoff et al, 2022). The lower bank erosion is also illustrated in the stream cross sections in Oteha Valley (Figure 12) where cross sections taken in 2001 were repeated in 2019. It is worth noting that despite the improvement and construction of the Unsworth Reserve stormwater detention pond and Barbados stormwater wetland, an increase in lower bank erosion of the reaches has been observed in these areas, indicating the potential insufficiency of these devices to reduce stormwater peak flows (Brockerhoff et al, 2022).

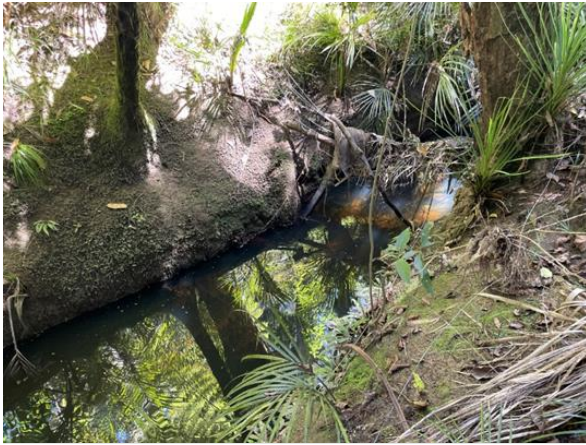
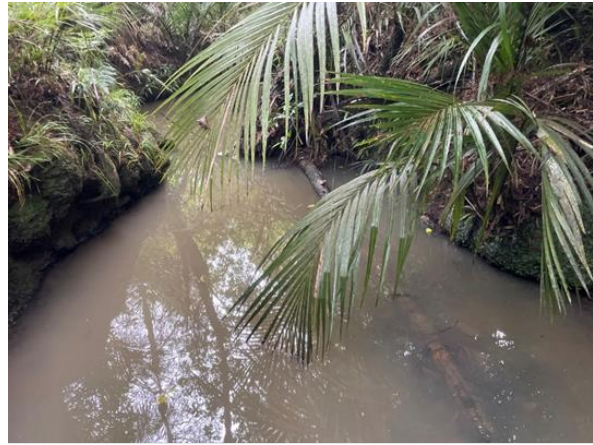
Figure 10: Observed changes in water clarity on the Vaughan Stream (VAUG_MAIN_8) during dry weather in summer (25/01/2022, left) and after 12 mm of rain in 24 hours (right, 31/05/2022, Awanohi Rainfall at Okura rain gauge).

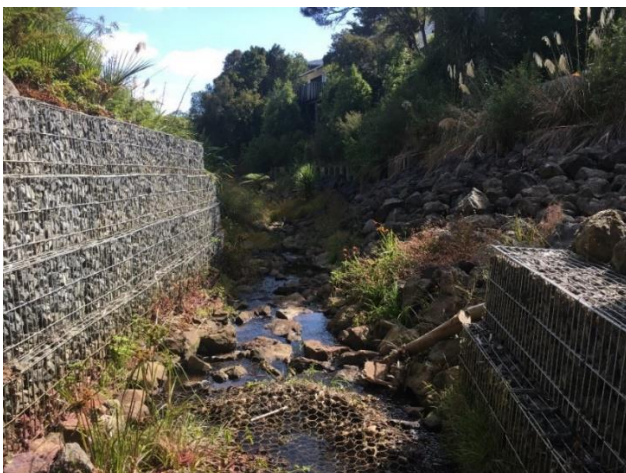
Figure 11: Kahika channel hard engineering approaches

The percentage of Kahika lower bank with "little to no sign" of erosion decreased to about 1% in 2019, while "20%-40%" lower bank erosion has halved from 48% to 23% since the original survey (Figure 9c). At the same time, "40%-60%" lower bank erosion has more than doubled from 13% to 34% compared to data collected in 2002. Similar to Long Bay and Lignite, 14% of Kahika's lower bank was noted with "more than 60%" bank erosion 2019, while there were no records of this lower bank erosion severity in the original survey (Figure 9c). The resurvey indicates that densification and intensification of residential developments resulting in increase of impervious surfaces could have contributed to the deterioration of lower bank erosion in the catchment (Brockhoff et al., 2020). At one site on the main Kahika Stream channel hard engineering approaches (Figure 11) led to improved lower bank erosion since the original survey (Brockhoff et al., 2020), however this is not the preferred approach to achieve sustainable stream management.

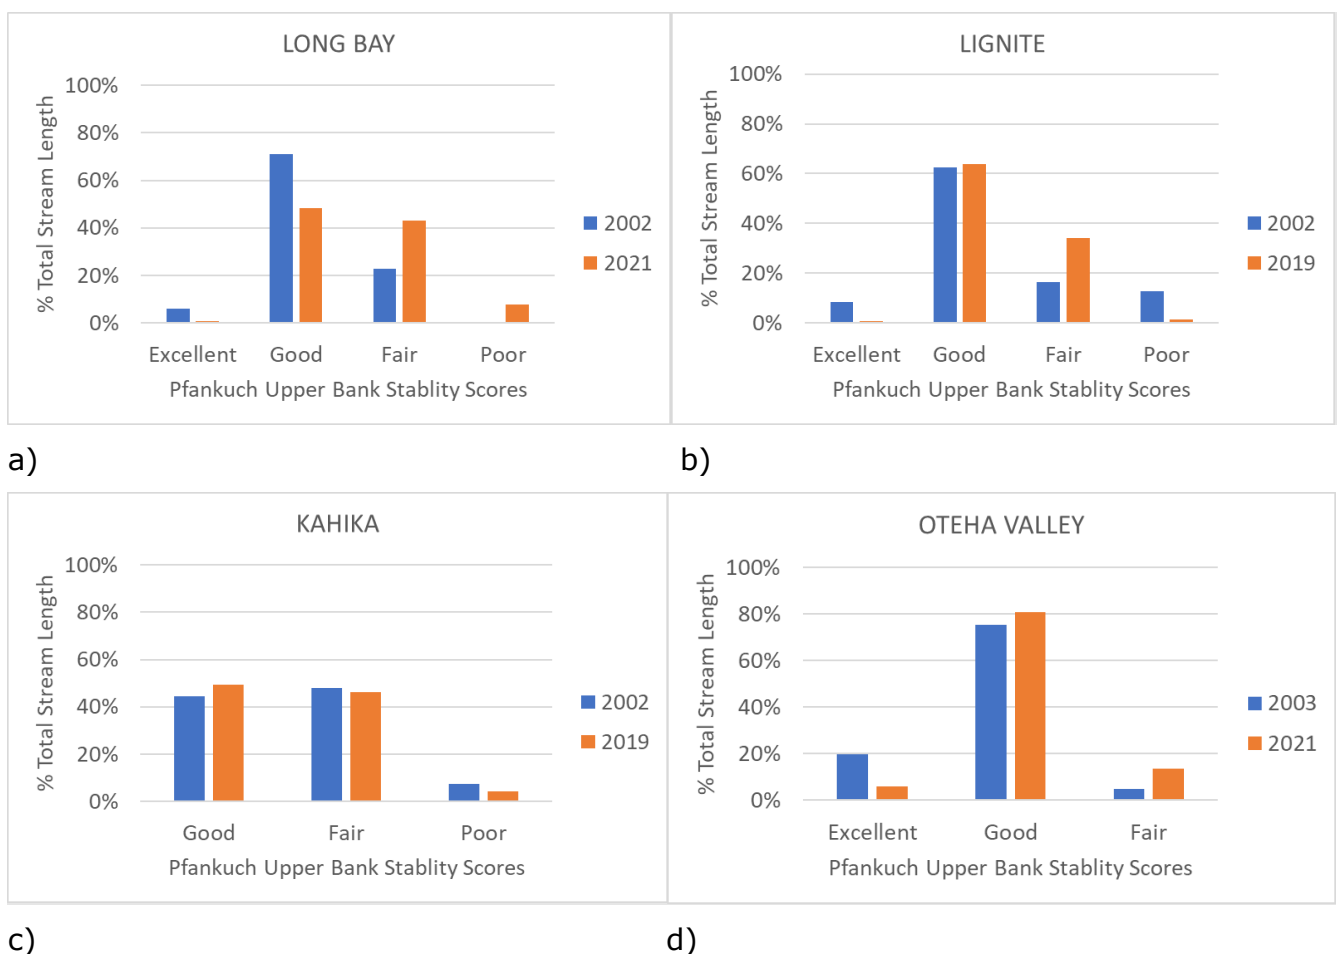
Figure 13: Pfankuch upper bank stability percentage changes since the original stream survey for a) Long Bay, b) Lignite, c) Kahika and d) Oteha Valley

The WA utilises the Pfankuch stability index to assess the upper stream bank stability. The Pfankuch stability indices are a function of upper bank slope, mass wasting, debris jam and bank vegetation. This section compares upper bank stability indices changes over time for each catchment (Figures 13a, b, c and d).

The Pfankuch stability indices show a decrease in upper bank stability over time at Long Bay, changing from 71% to 48% good upper bank stability. There is also an emergence of 8% poor upper bank stability over the original study (Figure 13a). The resurvey found that despite the improvement in riparian vegetation since 2002, the overall lower upper bank stability scoring is largely due to the increases in land slope, mass wasting, and debris jams (Davis et al., 2022). It is likely that the young age of the newly planted riparian vegetation in this catchment has not established enough yet to provide the improved bank stability we would expect to see over time. Land slope has steepened over time, with 45%

A similar trend can also be seen for Lignite (Figure 13b), with the exception that good upper bank stability remained relatively the same with a slight increase, while poor upper bank stability decreased significantly. In contrast to Long Bay, the Lignite resurvey found that excellent bank vegetation provides good stability in many of the reaches within the catchment (Brockerhoff et al., 2021). Several factors responsible for the fair to poor upper bank stability have also been identified, such as the landslide-prone underlying geology, along with increased impervious surfaces and stormwater runoff from urban intensification. Mass wasting was also commonly observed in the resurvey (Brockerhoff et al., 2021). The decline in poor upper bank stability also indicates some reaches have eroded to a stable underlying rock layer (Brockerhoff et al., 2021).

In the Oteha Valley, a decrease in excellent and an increase in fair upper bank stability could be observed in Oteha Valley (Figure 13d). This may be due to the increase in mass wasting and debris jam, as no change in land slope and minimal change in riparian vegetation were observed since the original study (Brockerhoff et al., 2022). Interestingly, the resurvey also found that mass wasting is closely related to lower bank erosion, which showed a similar increase (Brockerhoff et al., 2022).

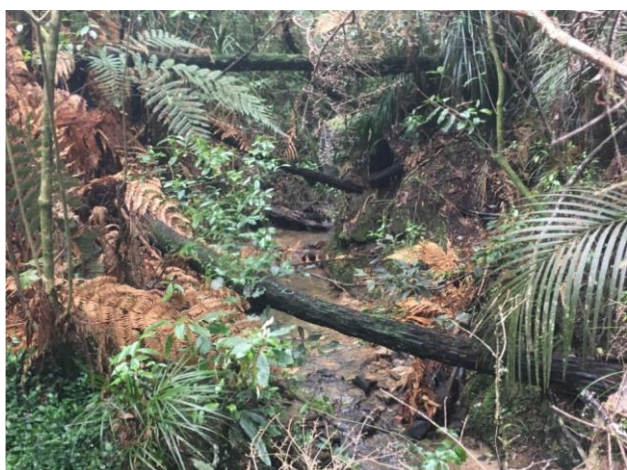
Figure 14: Debris jams observed in Kahika

Although changes in upper bank stability are similar to the lower bank erosion described above for Kahika and Oteha Valley, upper bank stability shows much less dramatic changes than lower bank erosion (Figures 13c and 13d). In fact, very slight changes in Kahika's upper bank stability have been observed. As with Lignite, extensive riparian vegetation has been found to provide good stability in the catchment (Brockerhoff et al., 2020). Mass wasting and debris jam were found to contribute to the lower upper bank stability scores. In particular, debris jams from improper vegetation clearance could possibly contribute to the emergence of 200 m of poor stability reaches (KAH_MAIN_7, KAH_TRIB4_1) (Figure 14) (Brockerhoff et al., 2020).
