# More than a drain; the ecological surprise of Harrisons Cut drain

Prepared – Gareth John, Project Manager

Stormwater Conference

May 2023

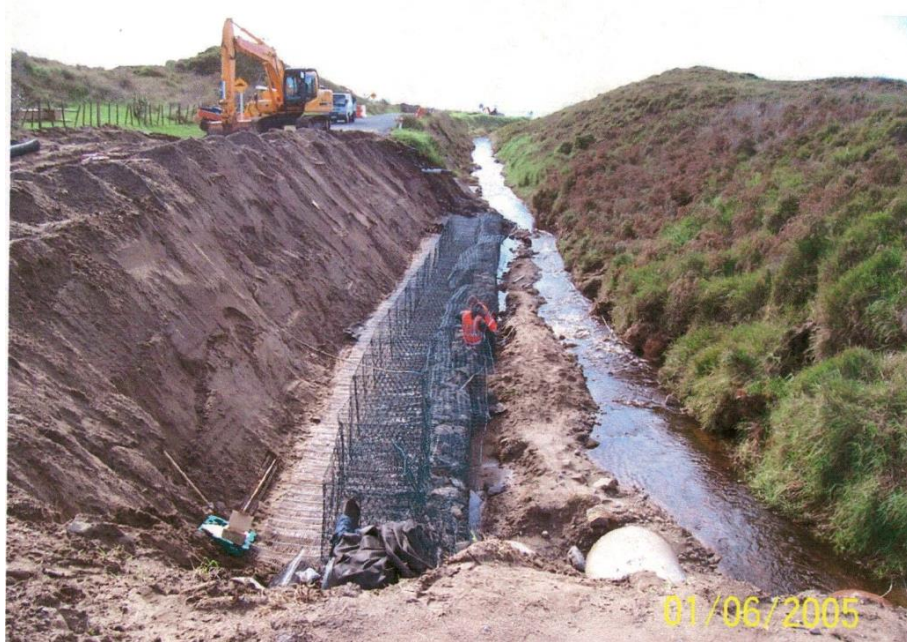
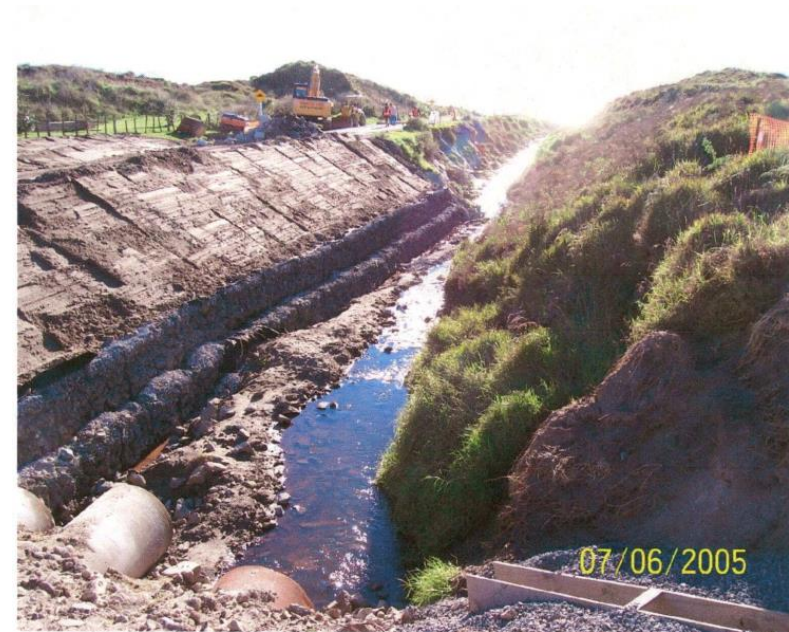
# 2005 works

- Works to keep up with development (residential subdivision, CMP)
- Papamoa Beach Road Culvert and 50m of gabions installed in 2005 (previous storm damage)

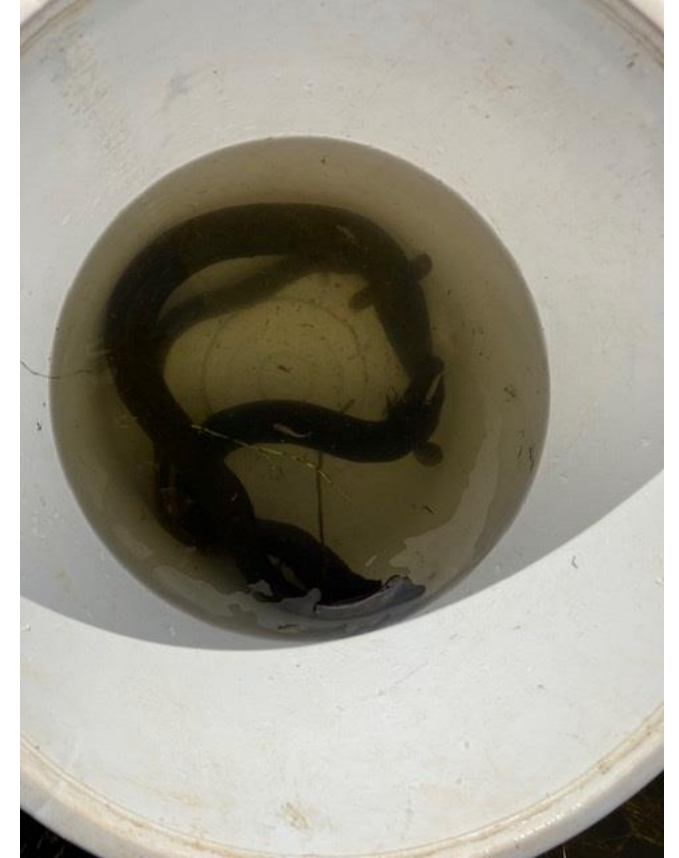
- Fish salvage was required as we needed to divert the drain, dewater, and install boxing for our retaining wall footing within the live drain.
- Gee Minnow traps and Fyke Nets overnight within the drain
  - Checked in AM and relocating any fish caught after data was collected including species, length etc.
- Fish salvage continued until the fish numbers were reduced by 80% for common species and >90% for At Risk species relative to the first days catch.

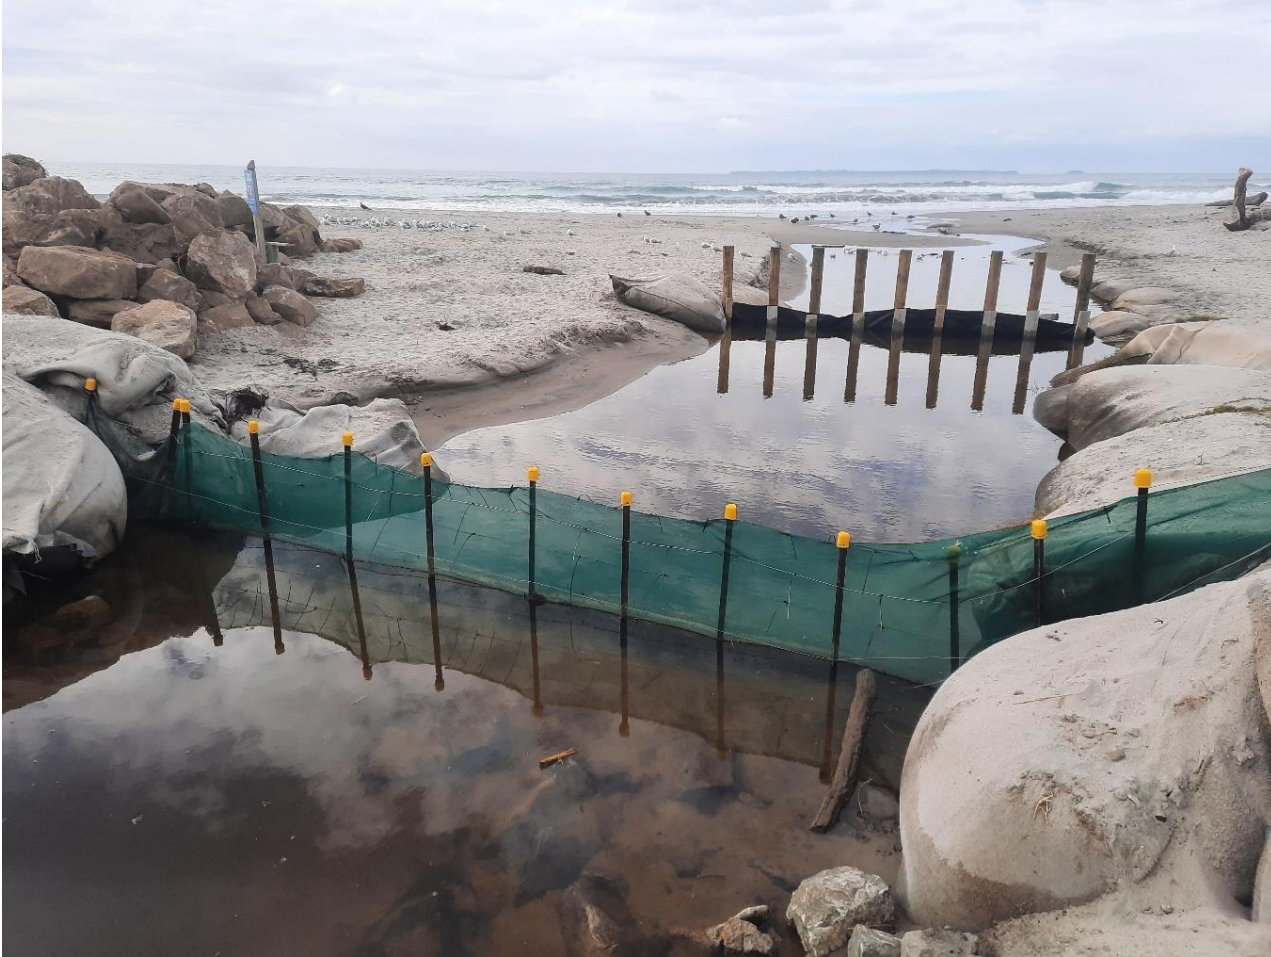
# Fish Barriers

*Yes – these were audited/regularly inspected*

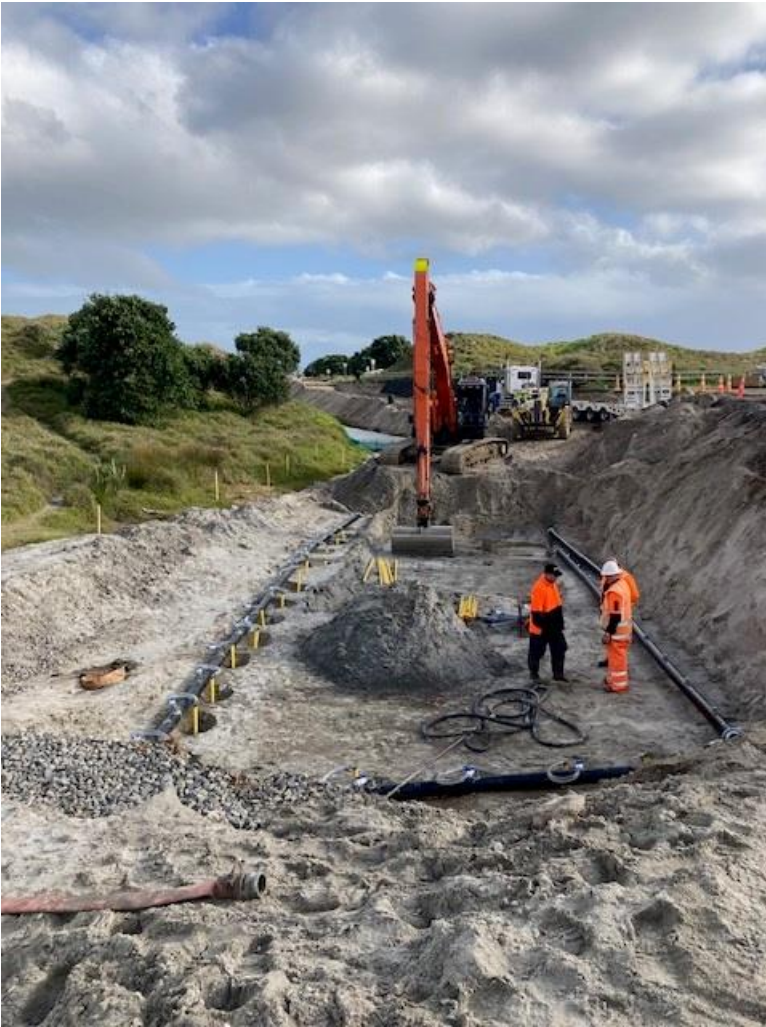
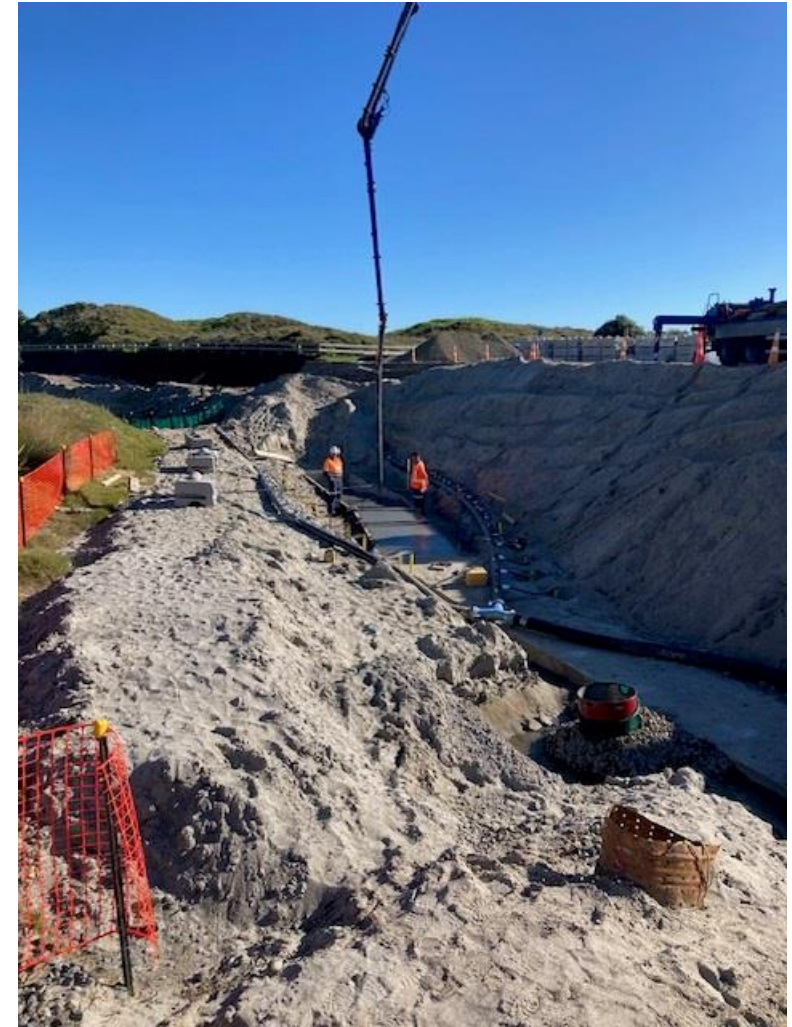
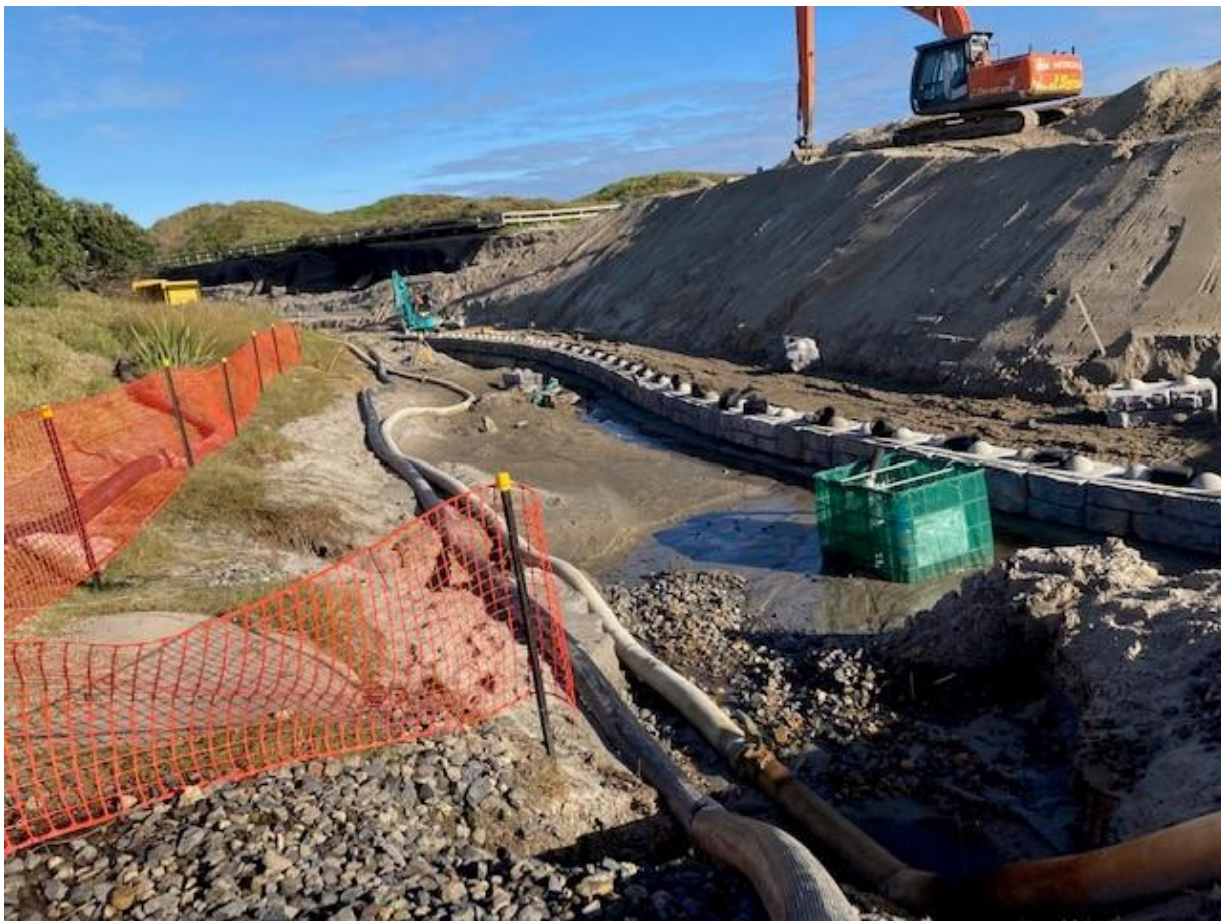
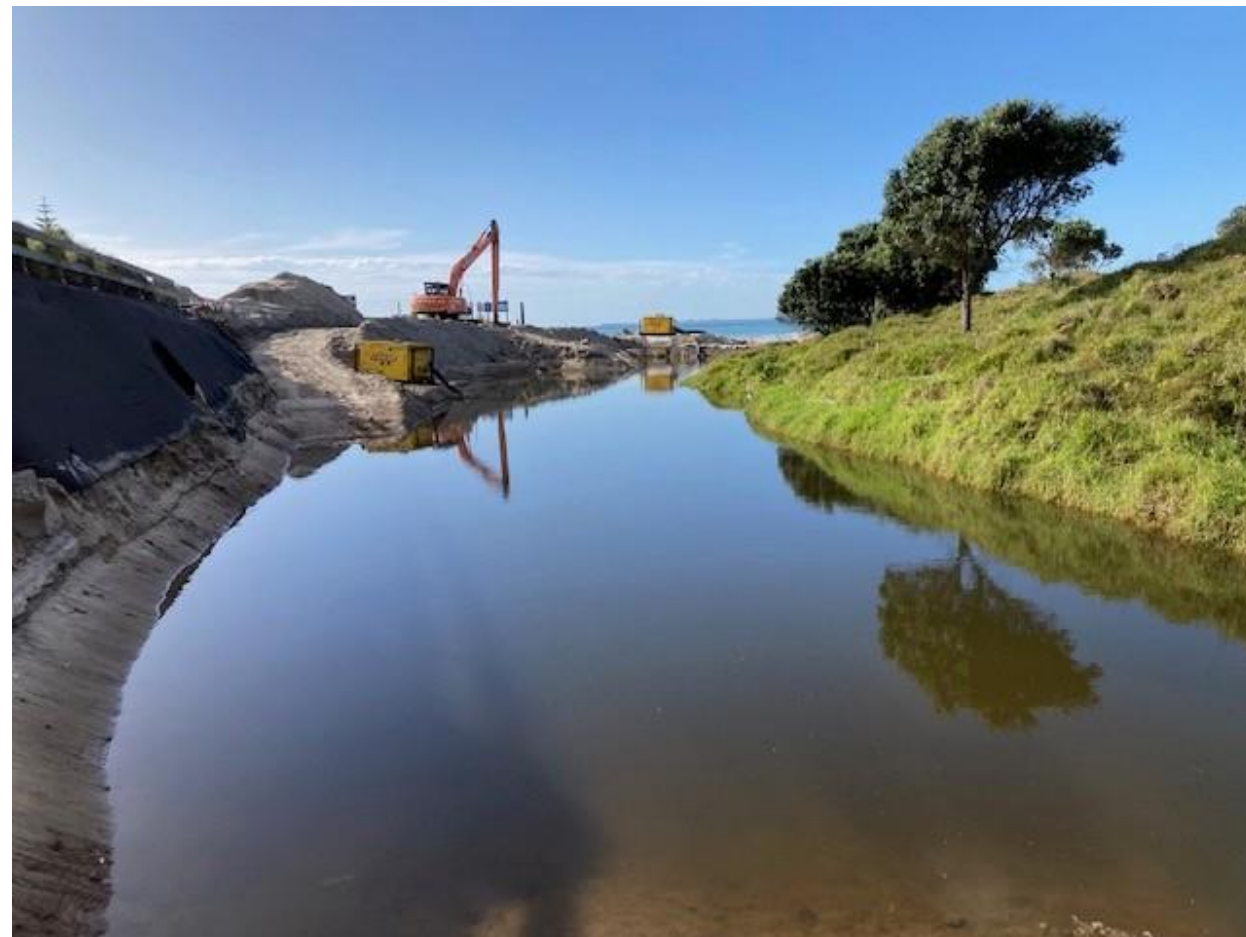
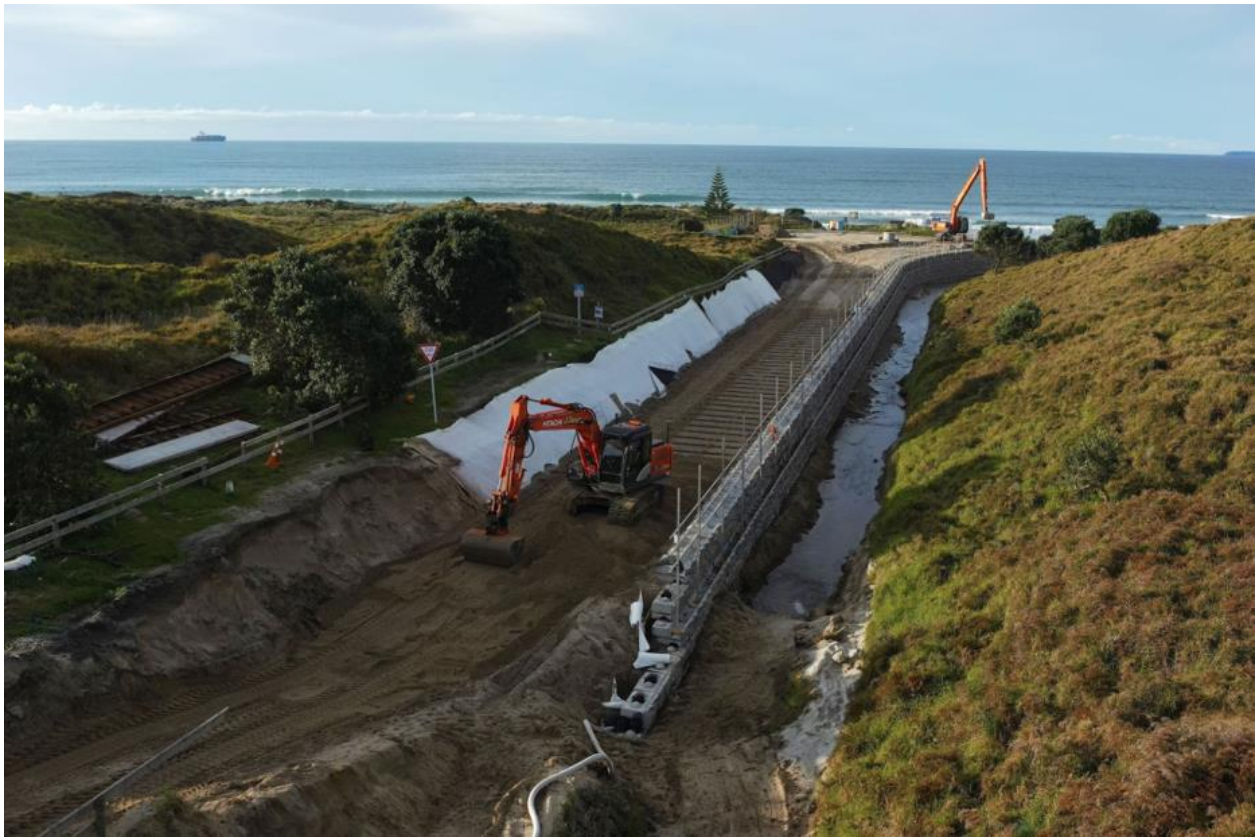
# Construction – Main Works (MSE Wall)

- Scope of Works
  - Earthworks;
  - Construction of **Redi-Rock** retaining wall to support the road/accessway (approx. 175m of total wall + 30m);
  - Minor drainage and road reconstruction (new pavement/surfacing, kerb/channel, footpath line marking and signage); and
  - Landscaping.
- Area is well used – coastal boat ramp/launch. Popular spot for locals.
