TREATING LANDFILL LEACHATE-IMPACTED STORMWATER WITH A NITRIFYING TRICKLING FILTER -NOT A LOAD OF RUBBISH

Liam Allan (Pattle Delamore Partners Ltd), Dr Mark Ellis (Pattle Delamore Partners Ltd), and Dr Sachin Narkhede (Timaru District Council)

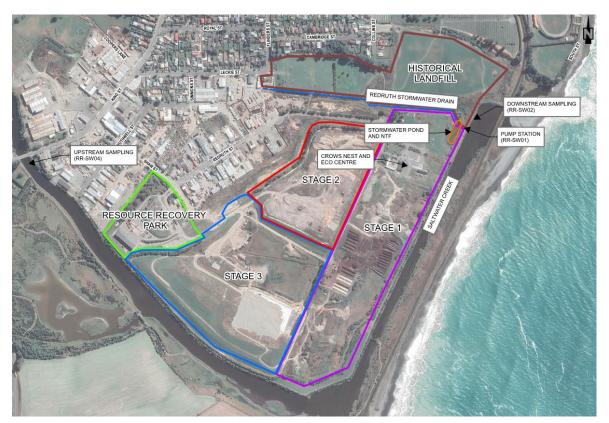
Figure 1: Overview of the Redruth Landfill site showing landfill stages, compliance monitoring locations referred to in this paper, and the location of the NTF.

As shown in Figure 1, Redruth Landfill is bordered on two sides by Ōtipua-Saltwater Creek and features a public walkway between the landfill boundary fence and the waterway. The remaining two boundaries consist of an industrial area and the Redruth Stormwater Drain, which receives runoff from a significant catchment of southern Timaru including parts of the Redruth Landfill.

The "Historical Landfill" site north of the Redruth Landfill shown in Figure 1 was landfilled in the early 1900s, whilst landfilling has been occurring at the present Redruth Landfill site since the 1940s. The oldest landfill cells at the site, which were mostly unlined and uncapped, are referred to as Stage 1, which is adjacent to Ōtipua-Saltwater Creek and closed in 1996. Stages 2 and 3 began in 1996 and 2005 respectively, and both consisted of a base liner and a leachate collection system and will be capped upon completion.

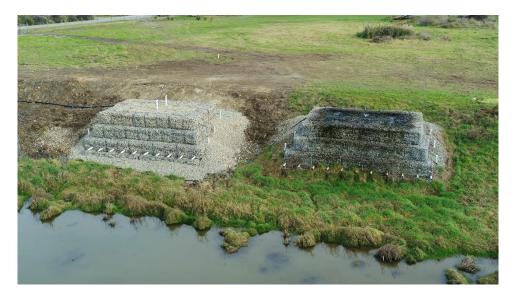
Photograph 1: Drone photo of the trickling filters following the recent completion of NTF number 2 (on left).
