INTERNATIONAL FISH PASSAGE LEARNINGS AND RETROFIT LESSONS FROM CHRISTCHURCH

Mullaney M (Christchurch City Council (CCC)), Groves M (WSP), Margetts B (CCC)

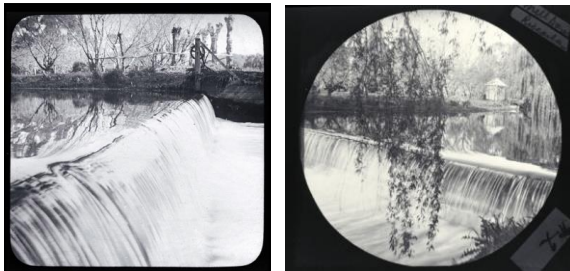
Figure 1 and 2: From left to right, Weir 1880 and Weir between 1860 and 1890.
Images Christchurch City Libraries

In Christchurch, at the historic Mona Vale setting, there are two historic weir structures each on separate branches of the Ōtākaro-Avon River (Figure 1 - 3) (Mona Vale Park is highly valued in the community and a tourist attraction in Christchurch).

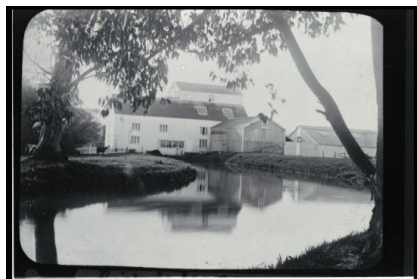
Figure 4: Mill 1895. Image Christchurch City Libraries

The weirs were originally used to divert wai from the Ōtākaro-Avon River to a nearby mill (Figure 4). The mill has since gone, but the weirs remain, as is likely the case in many other townships and cities across New Zealand.

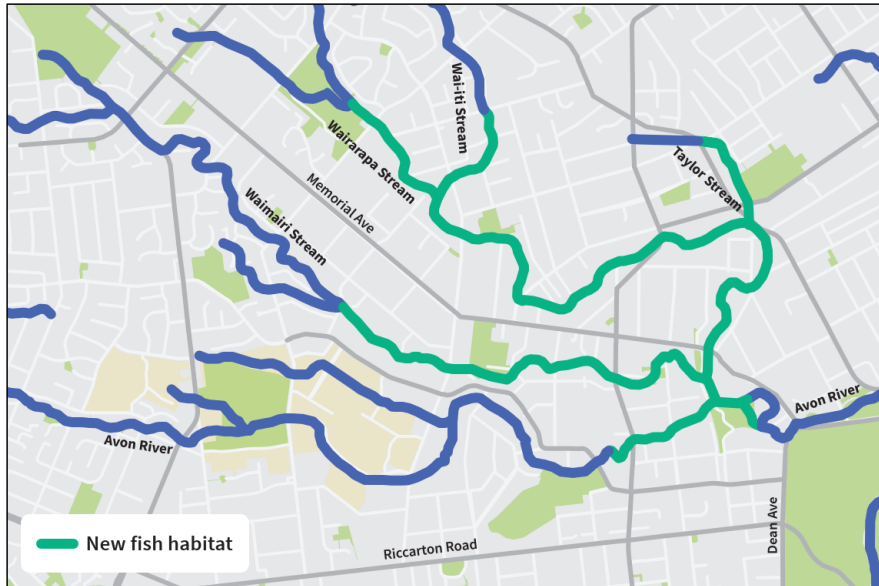
Figure 6: Approximately nine km of habitat opened upstream if weir is remediated

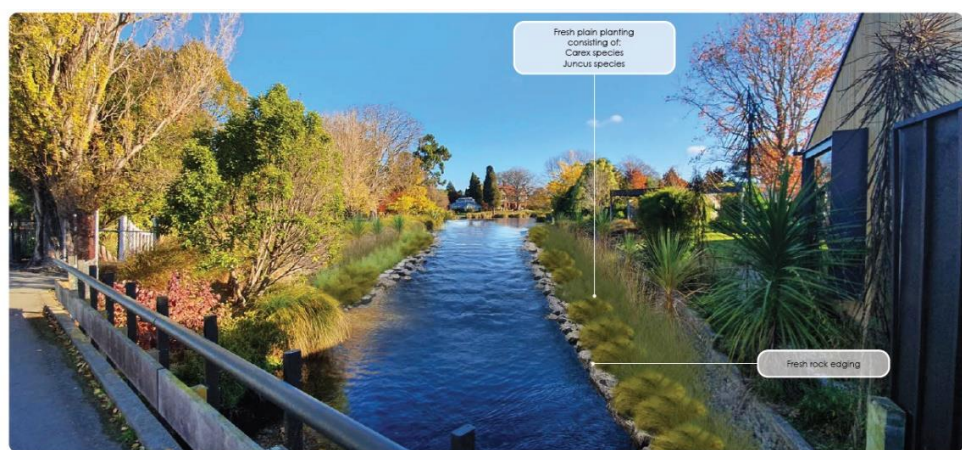
Figure 10 – Visualisation of the finished riffle used to assist with consultation in the early stages of the project

Council had WSP create visuals for the proposed riffle which helped to discuss the project with community boards and adjacent property owners (Figure 9 and 10).

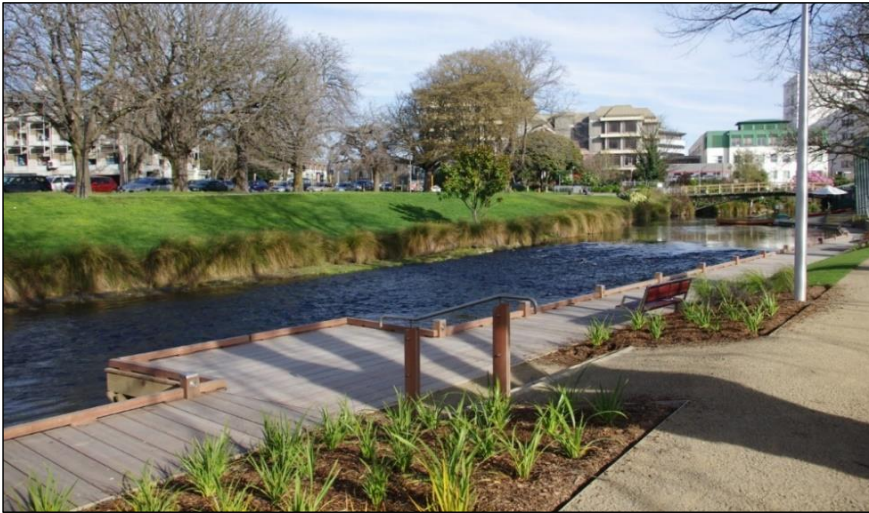
A riffle had previously been constructed downstream to replace an old rock weir located at the historic Antigua Boatsheds (Figure 11) and was used as a basis for design. Ecological monitoring of this weir has shown not only fish passage, but the return of the fast-water specialist bluegill bully.

Figure 11 – Previously Constructed Antigua Riffle Downstream
