# BARBADOS WETLAND HYDRO-ECOLOGICAL DESIGN

This paper documents the biophysical process assessed in the Barbados Wetland and the ecological, morphological and hydraulic design components used to develop detailed design. This includes discussion of the design process, key elements and research outcomes that informed the final detailed design.

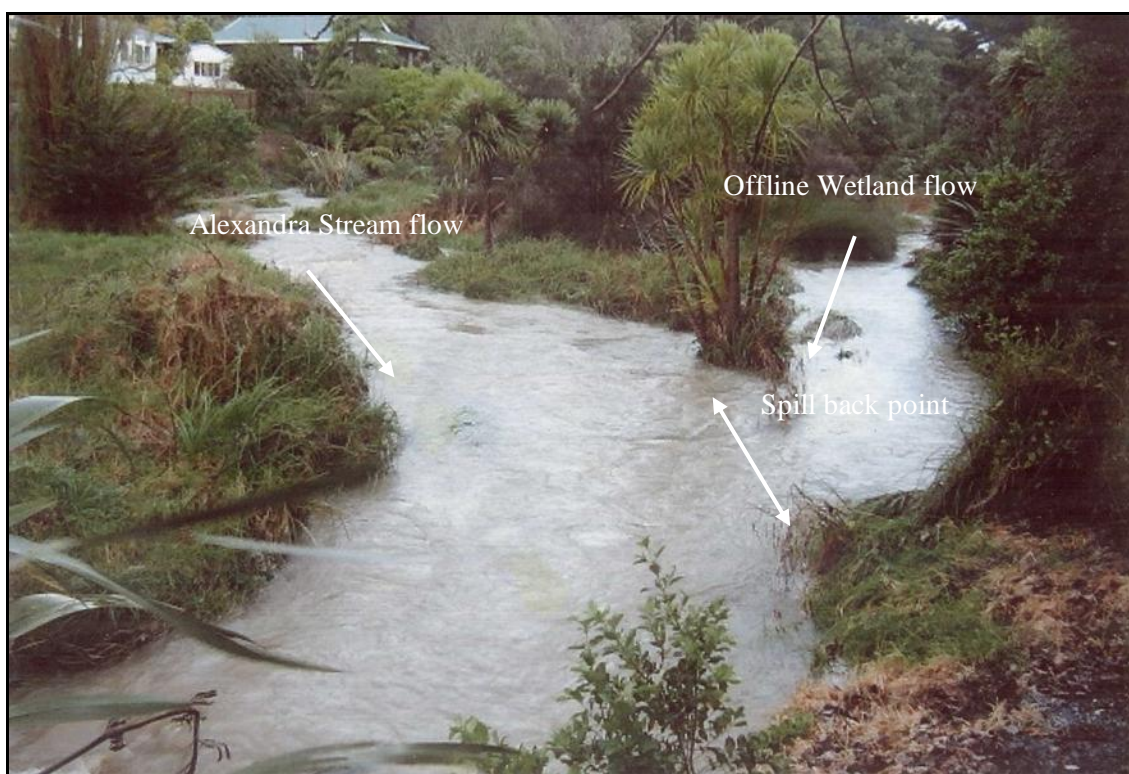
*Figure 2: Confluence of Alexandra Stream main channel and current natural wetland area during storm event (photo taken by local resident Nicholas Mayne)*

At the point of confluence both channels are open and unmodified. During low flow conditions all flows are conveyed via the main channel along the northern side of the wetland and then discharge via the Barbados Ave culvert into open channel downstream in Rook Reserve. During bankfull flows water enters the southern end of the wetland via two main paths. Firstly, the Westminister sub-catchment flows overtop its true left bank just upstream of its confluence with Alexandra Stream. Secondly, the Alexandra Stream overtops its true left bank just downstream of the confluence point with the Westminister Stream. The consequence of this is that the untreated flows from the Westminister sub-catchment have the potential to be treated before being reintroduced into the main channel in the south western end of the wetland. Figure 2 shows the confluence of the Alexandra Stream main channel and current natural wetland area during storm event, this photograph represents the pre-construction situation in bankfull flow.

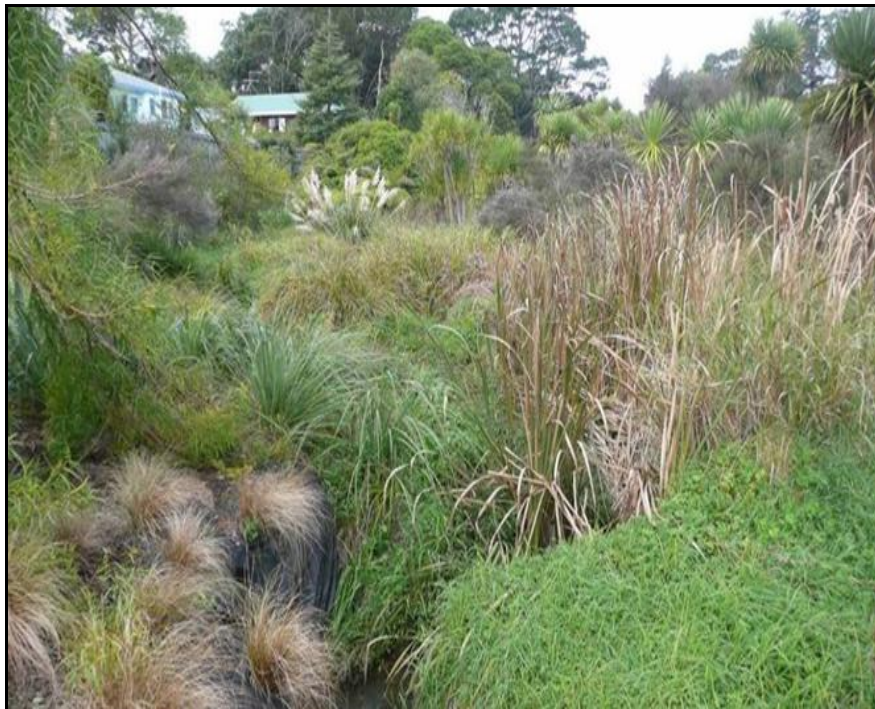
*Figure 4: Main stream channel and SEV site location (Barbados Wetland)*

A Stream Ecological Valuation (SEV) assessment was carried out on 29th May 2009 (see Rook Reserve & Barbados Wetland SEV Report, Morphum Environmental Ltd, 2009). Macroinvertebrate samples were collected following Protocol C2 (Stark et al., 2001) and processed in the laboratory. Fish data was collated from previous studies, the NIWA Freshwater Fish Database (NZFFD) and through net-fishing carried out during the assessment (Refer Figure 4).

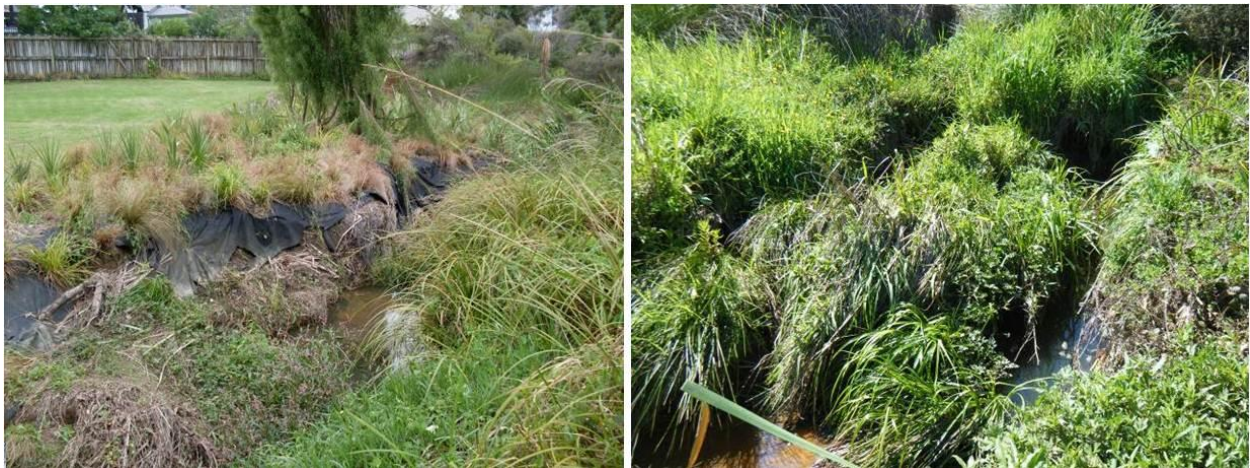
*Figure 5: Showing previous attempts to arrest bank slumping and the reduction in channel cross-sectional area*

An attempt has been made in recent years to stabilise the banks using a geotextile layer and planted grasses (through council supported local community action). However, this has proved unsuccessful with slumping and benching into the main channel being observed ongoing. This has been reducing the cross section of the channel and the flow area, resulting in reduced instream habitat quality and amenity value, as well as presenting a health and safety risk for the public using the reserve for recreation.

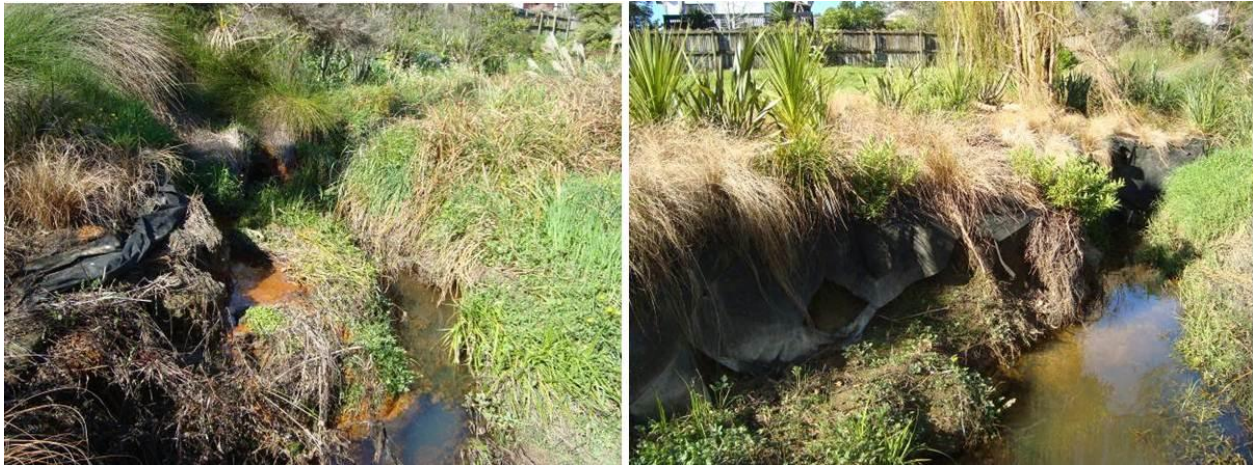
*Figure 6: Showing previous attempts to arrest bank slumping*

The continual and ongoing slumping had resulted in a shifting and unstable substrate with lowered water depths. The effects of this being reduced macroinvertebrate habitat quality and the movement of mobile sediments to reaches downstream.

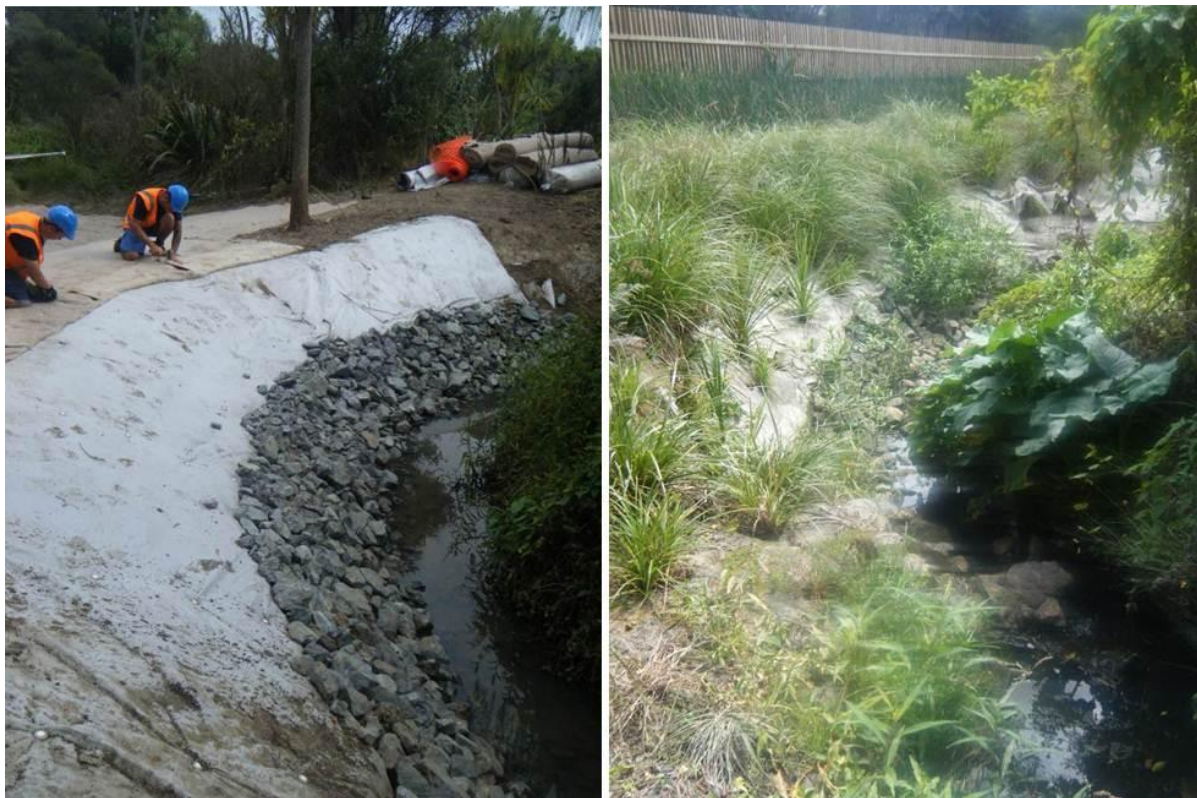
*Figure 8: Showing toe armoring and planting after 6 months*

Bank and toe protection measures included rock lining of the toe, geotechnical fabric pinned and closely spaced planting for future biological stability enhancement. This has resulted in increased habitat value of the stream through improving habitat complexity and heterogeneity. This is particularly relevant when point bars are used in conjunction with designed riffle features to create a varying depth profile of pools and the aerating effects of the rock riffles which increased the function of the stream to support fish and other aquatic organisms. Revegetation of the stream banks has improved overhead cover and now provides overhanging vegetation which provides a stable substrate for macroinvertebrates.

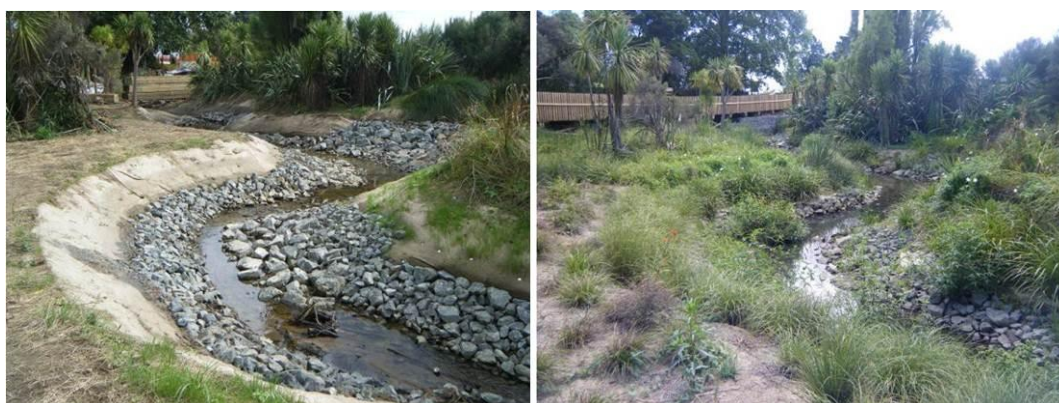
*Figure 9: Showing bank and bed modifications through pool and run sequences*

Pool, riffle run sequences are important geomorphic and ecology features of a habitat diverse natural stream system. In this instance the design has had to mimic nature through channel design and substrate placement. Figure 9 shows this partially through the works and six months after. The design was based on the existing pool run sequence and directly reflects the pre works hydraulics in this regards. The maximum pool depths targeted to 500mm and small point bars used to create riffles and increase substrate heterogeneity. The minimum run depths being 50mm but this understandably depends on baseflow regime.

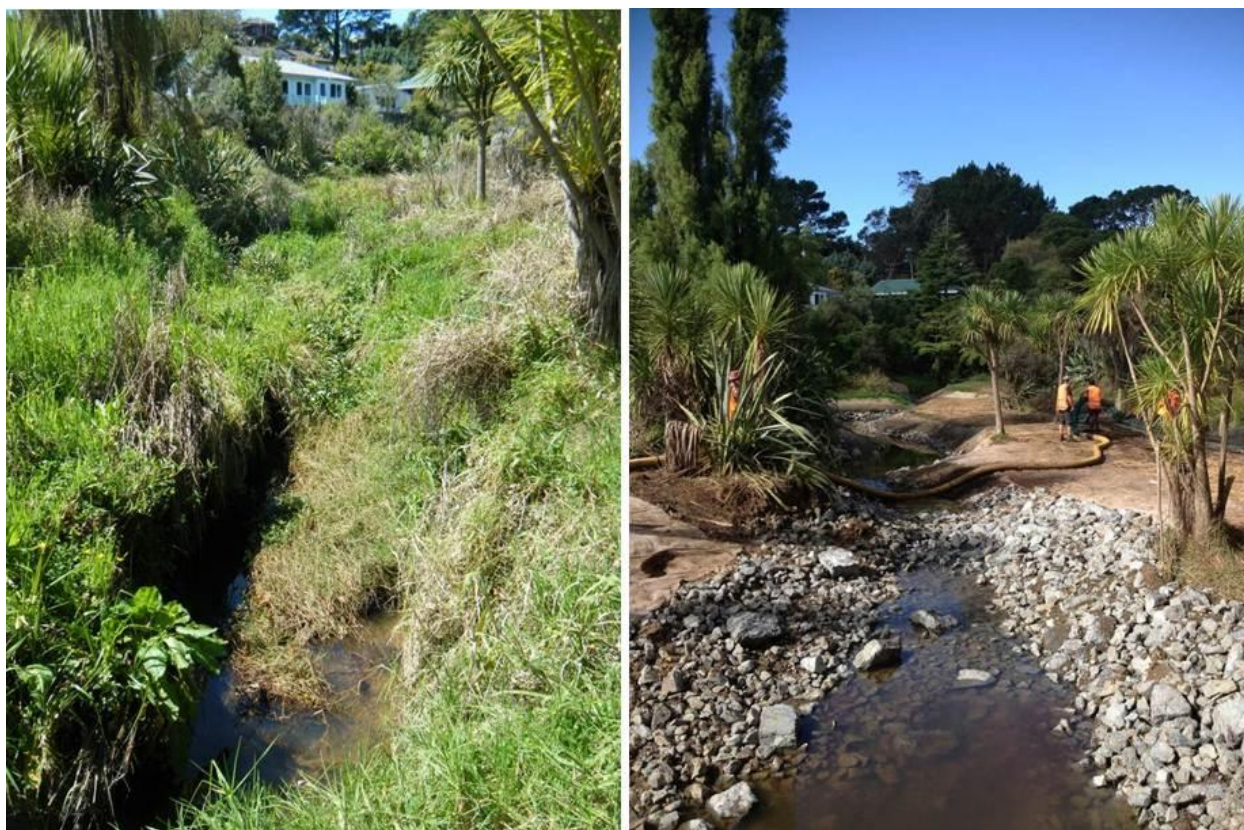
*Figure 11: Rock riffle pre and immediately after works*

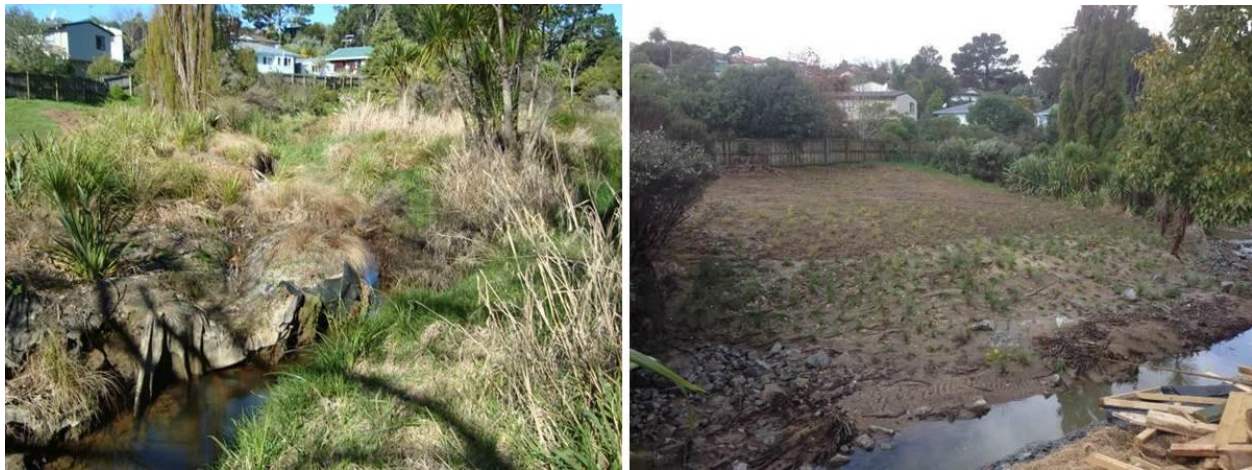
*Figure 13: Shows before and after point bar construction*

The works resulted in a dramatic transformation of banks that had been slumping and unstable with high flows rushing toward the culvert entrance, to a stable widened section creating an eddy, capturing sediment and reducing peak flow velocities (refer Figure 13).

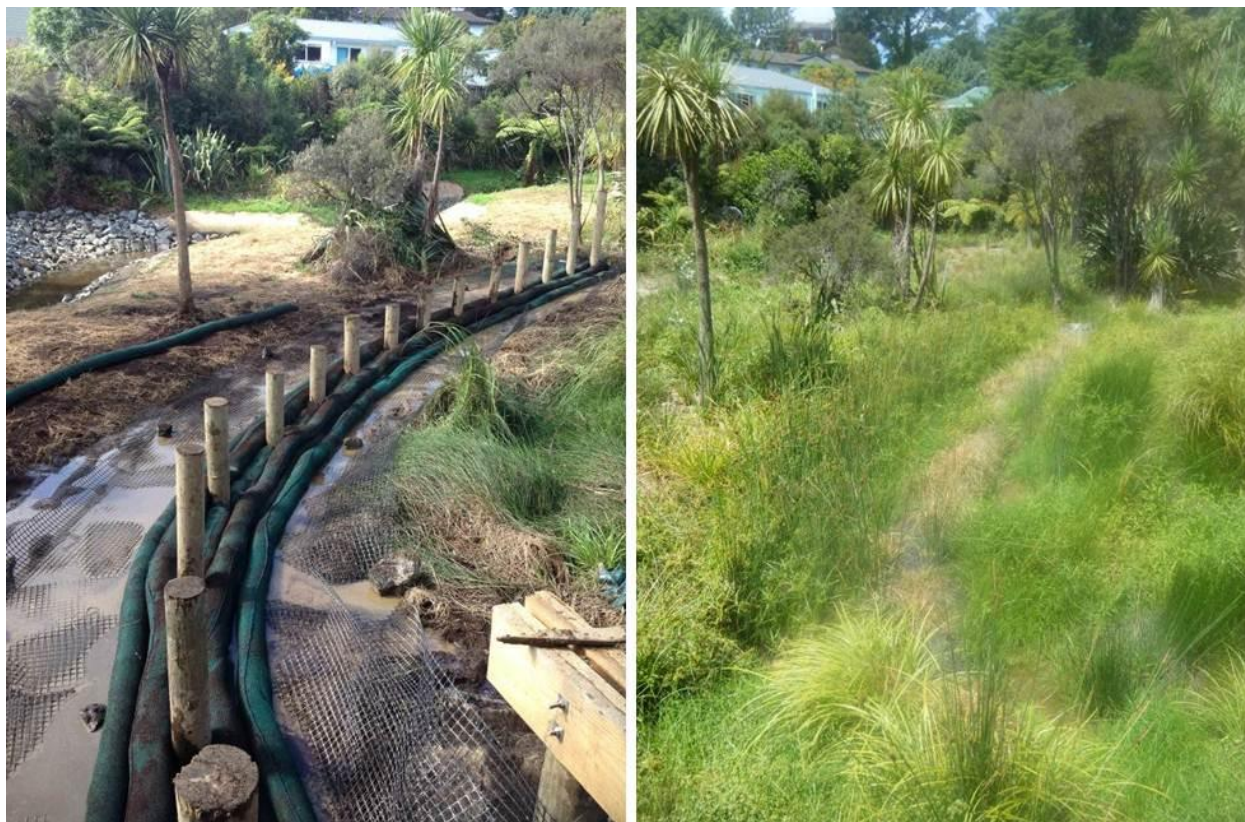
*Figure 15: Weeping Wall Bund During and 6 Months After Construction*

One of the main aims in the design and construction of this element was for it to blend into the environment. Even after six months this has begun to occur with seed stock from the remnant wetland plant assemblages beginning to take hold and sprout through the geotextile (refer Figure 15).

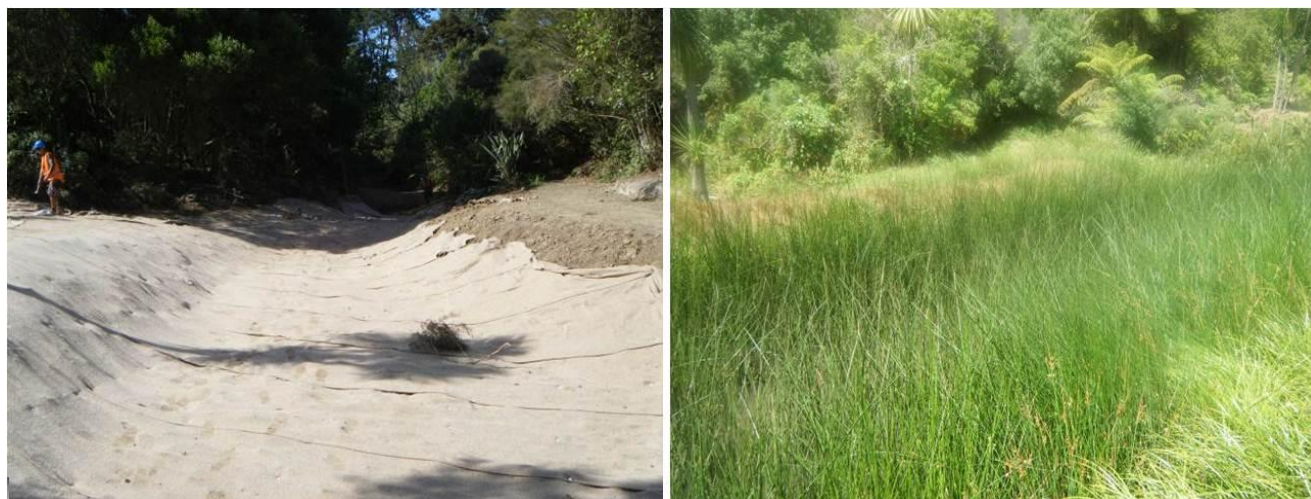
*Figure 16: Improved conveyance channel and constructed depression wetland*

The final design included two depression areas separated by a low earth bund which were lined with geotextile and planted with wetland species. This has acted to increase the conveyance capacity which provides flows to the ephemeral wetland and has provided deep water wetland habitat with associated storage that recharges the downstream reach with treated waters that augment low summer base flows (refer Figure 16).

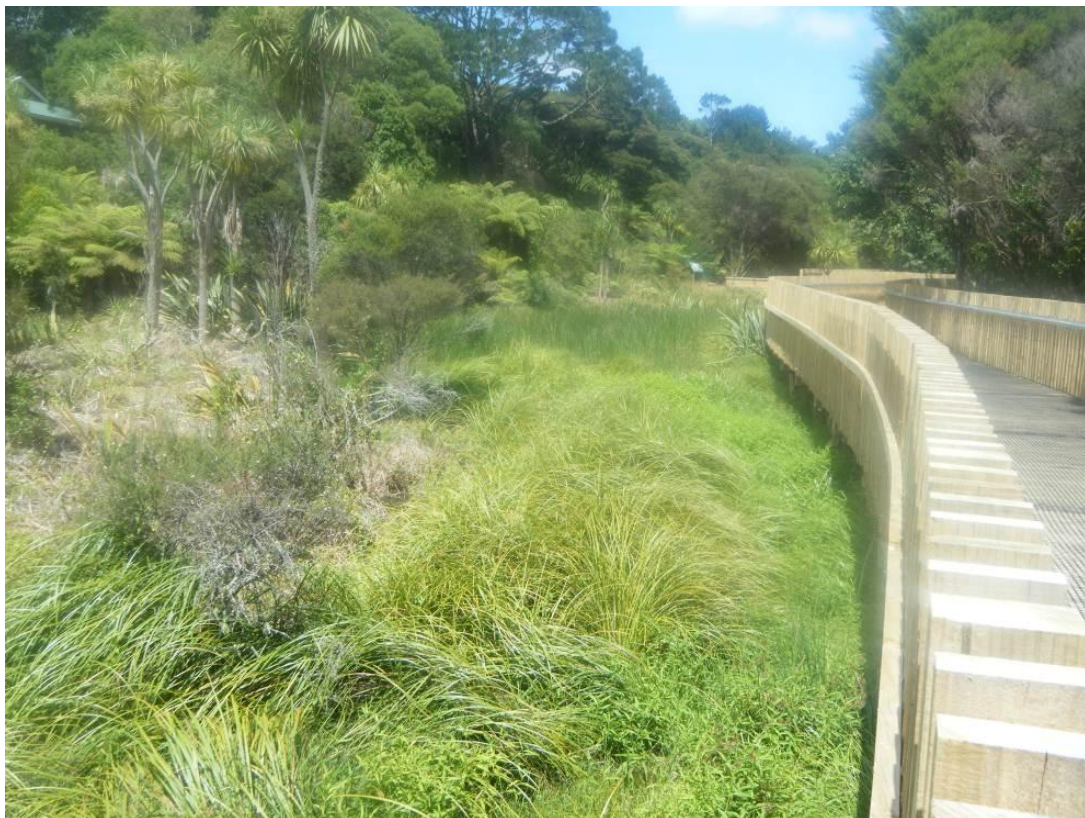
*Figure 17: The finished works looking along the new Cycleway*

The replacement of a weed infested wetland with eroded and unstable banks, with a system now enhanced in habitat value and structural resilience, is a positive outcome from the project. The design integrated a cycleway and created a high value amenity feature (refer Figure 17).

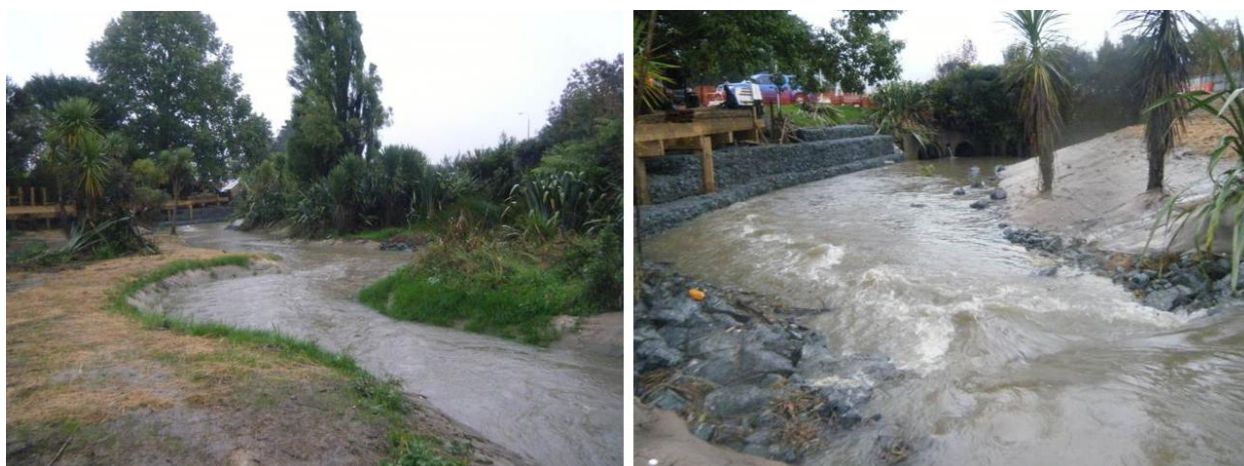
*Figure 18: Showing flood flows during final stages of site works*

Critical to the success of channel modification and erosion protection works is how they are able to stand the force of erosive flows. During final construction phases the site experienced approximately annual peak flows and responded well (Figure 18).
