Sourcing pollution at Paekakariki Wainui Stream Study

Stan Abbott, School of Public Health and Barry R Palmer with Margaret McNeill, School of Food and Nutrition, Massey University, Wellington.

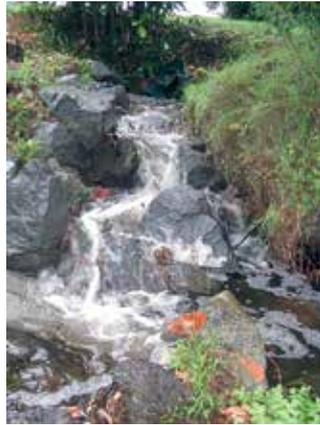
Figure 3

Horomona Road, run under the Caravan Holiday Park. These drain urban rainfall runoff from impervious road surfaces into the Wainui Stream in the caravan park (Figure 3). There are also two 100mm PVC pipes that drain stormwater from the roads, car parks, and roofs of buildings in the caravan park into the stream. Kerb-side stormwater drains on the road at the entrance to the caravan park drain storm water to the stream via soak pits.

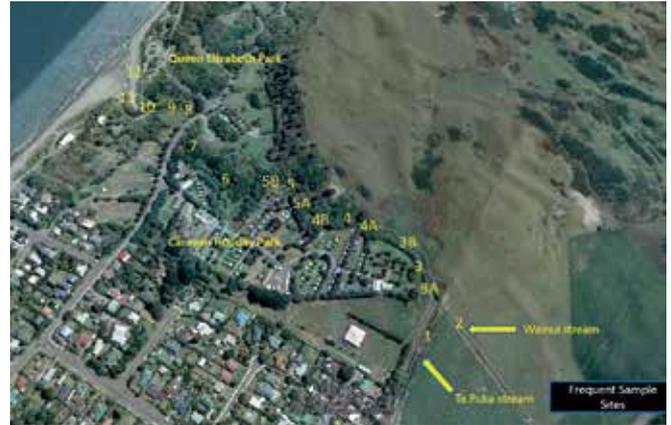
Figure 4: Most frequently sampled stream sites.

From February 2013 to January 2015, we collected and tested 317 water samples from 51 different sites along the entire length of the Wainui and Te Puka streams including stream samples taken in farm land above and below SH1. Upstream and downstream stormwater samples of the four outlets discharging into the Wainui Stream at the Caravan Holiday Park were also collected and rainfall depth (mm), 24 hours prior to and at the time of each sampling event was recorded (<http://www.weatheronline.co.nz>). Some of the most frequently sampled stream sites are shown in figure 4.

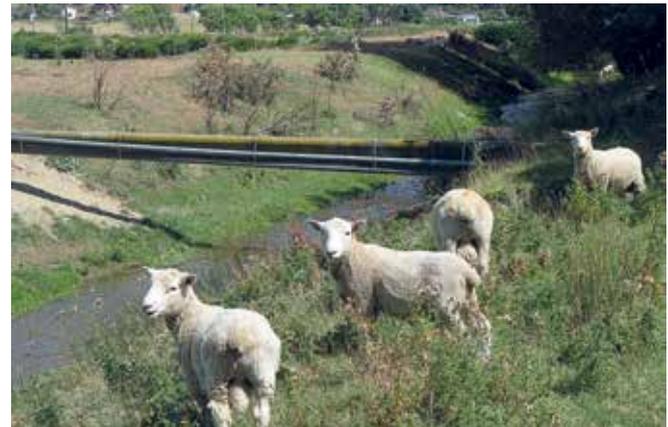
Figure 6: Stock near the unfenced stream.

cent yielded counts of greater than 2419.6 *E.coli* per 100 ml and 38 per cent of samples results were above 1553.1 *E.coli* per 100 ml. These *E.coli* counts ranged from 689.3 to > 2419.6 with a median of 1732.9. The results of the most frequently taken samples in 2013 are shown in figure 5. Significantly, all the very high *E.coli* bacterial levels were found at same time that cattle, sheep and horses grazing in the two paddocks had access to unfenced Wainui and Te Puka streams in the farm land (Figure 6).
