Legionellosis & building water services
An environmentally engineered disease

Service design & installation considerations

Legionella
Management
Advisory Group

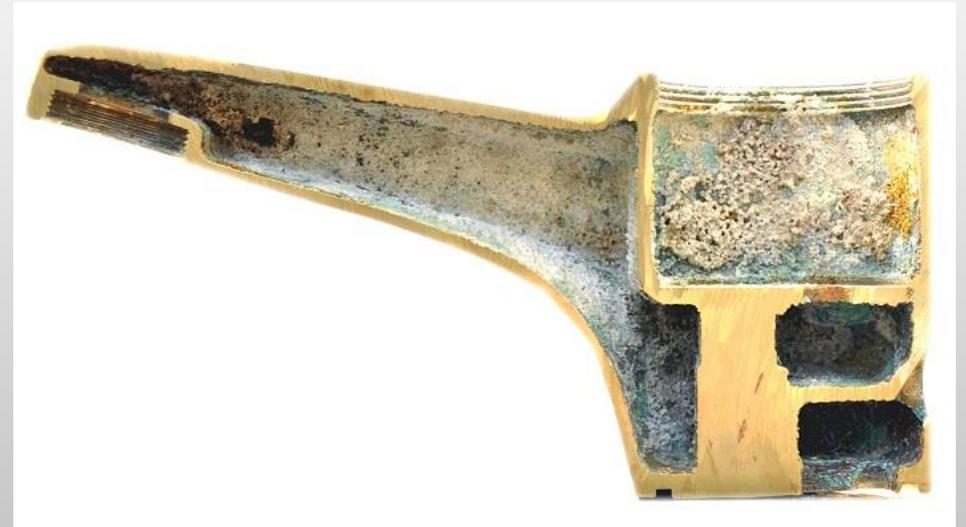
- *Pipework that allows heat transfer :-*
proximity and/or poor insulation
- *Pipework that allows stagnation :-*
capped ends, branches installed for future use,
bypass valves, dead legs such as infrequently
used fixtures or taps
- *Age and condition of pipes :-*
biofilm or scale buildup, use of flexible hoses / connectors
