Technical Note 7 – Kaiapoi Wastewater Damage

In September 2010 the Darfield earthquake caused extensive damage to wastewater reticulation system in parts of Kaiapoi and ProjectMax Ltd completed damage assessments in 2010. This report discusses the evaluation of these to determine damage trends and the frequency of damage.

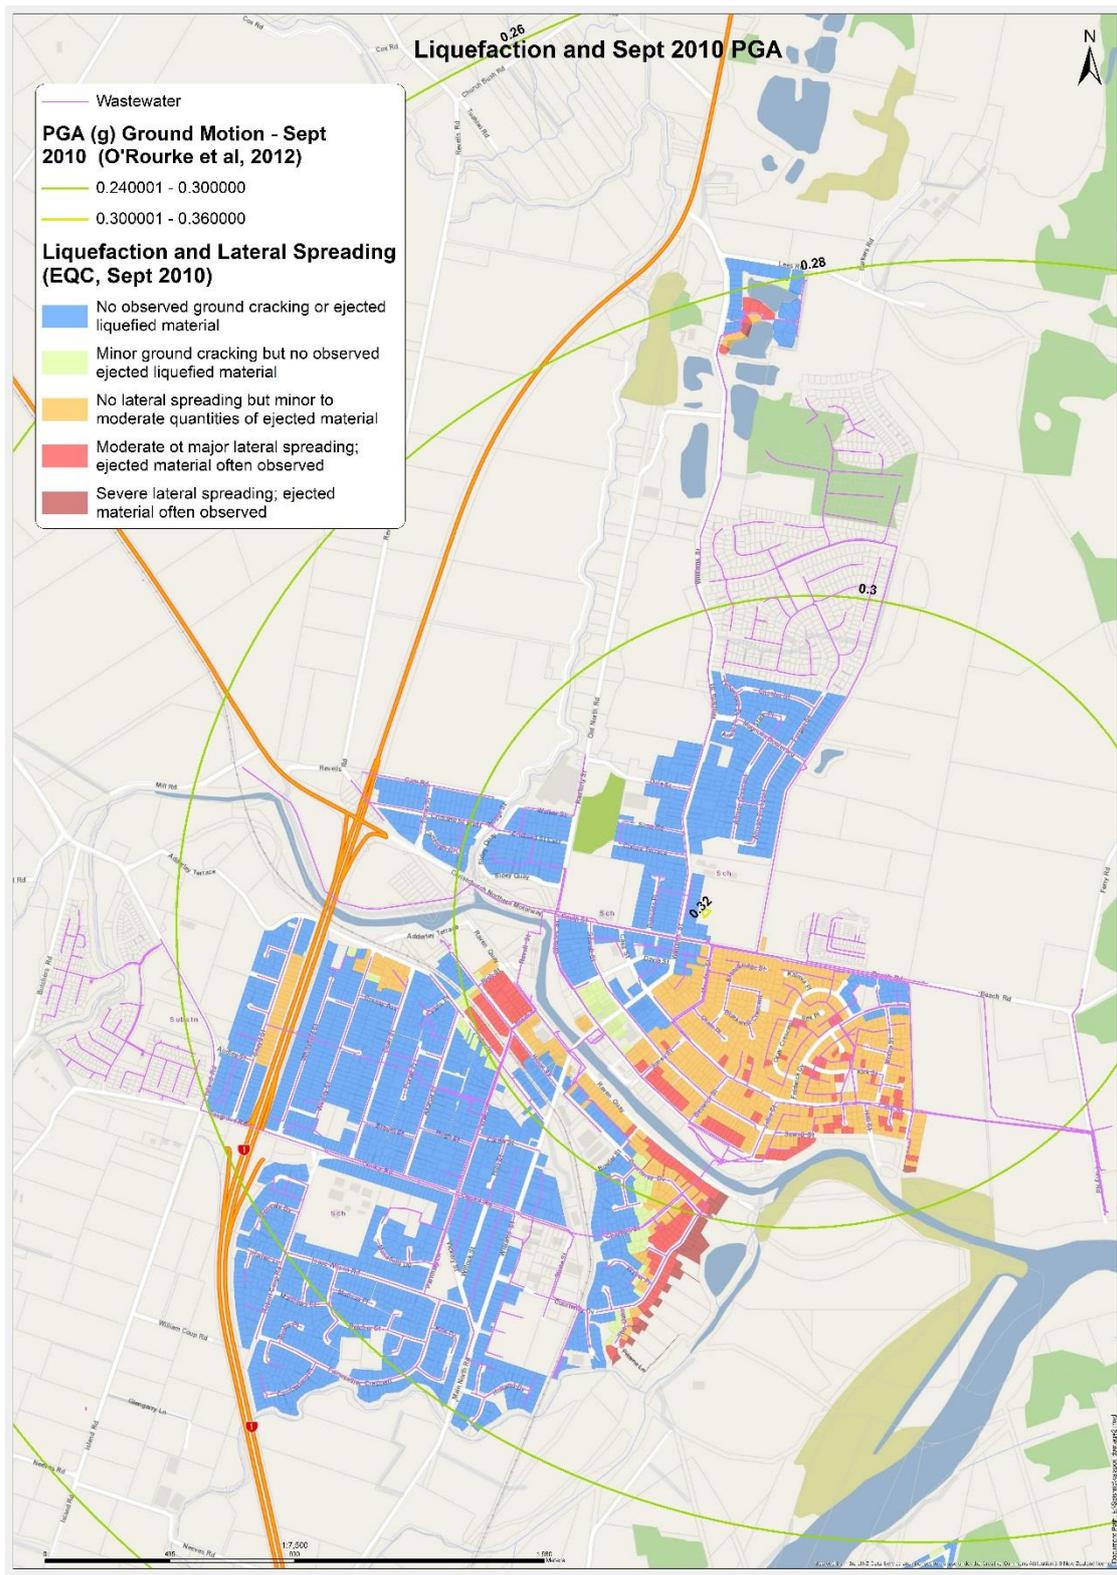
Figure 2-2: Kaiapoi Wastewater Network and Peak Ground Accelerations and Liquefaction and Lateral Spread Resulting from the Darfield Earthquake

Figure 2-2 shows the Kaiapoi wastewater network with overlays of the estimated peak ground accelerations (O'Rourke, Toprak, Cubrinovski, Jung, & Jeon, 2012) and areas where liquefaction and lateral spread (Tonkin & Taylor Ltd, 2013) were recorded.

Peak ground accelerations in Kaiapoi ranged from 0.2 to 0.3g.

The earthquake caused sections of land to liquefy and in some cases for lateral spread to occur. Areas of liquefaction and lateral spread noted by (Tonkin & Taylor Ltd, 2013) are indicated in orange & red areas in Figure 2-2.

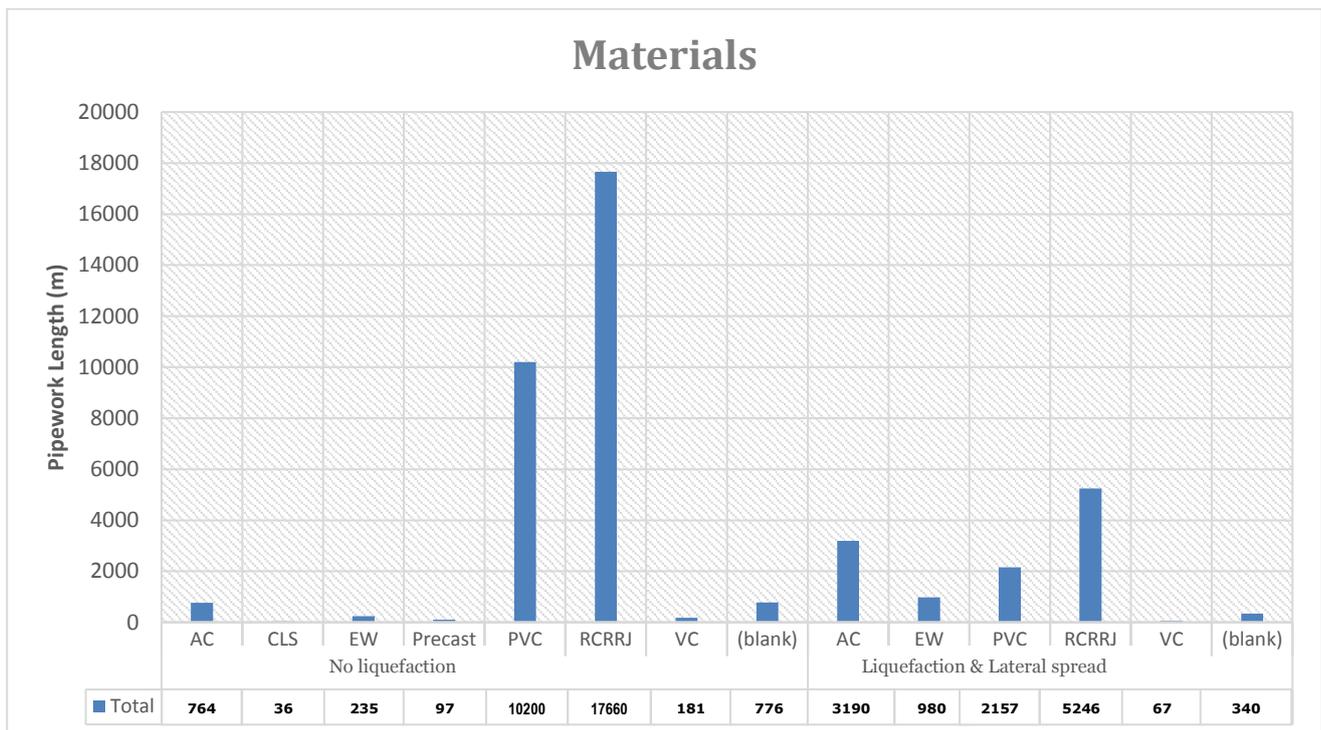
Figure 2-3: Overview of Pipe Materials

Figure 2-3 provides an overview of the pipe materials in the network and the proportion of the network that was subjected to liquefaction or lateral spread. The majority of pipes are reinforced concrete pipes (55%) followed by PVC (30%). There are also earthenware and asbestos cement pipes.

Only 12km of pipework (28%) is located in areas where either liquefaction or lateral spread occurred.

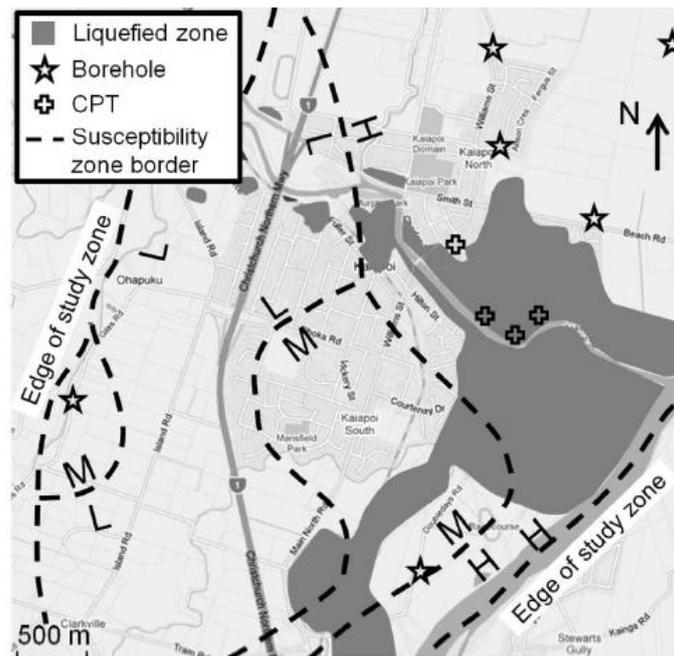
Figure 2-4: Map of Kaiapoi indicating high (H), medium (M) and low (L) liquefaction susceptibility zones defined by Christensen (2001) and areas that liquefied during 2010 Darfield event (Liam M. Wotherspoon, 2012)

Wotherspoon compared the extent of liquefaction predicted by analysis undertaken prior to the Darfield Earthquake with what actually occurred, as shown in Figure 2-4 (Liam M. Wotherspoon, 2012). Whilst there are differences between the extent of liquefaction recorded by Wotherspoon (Figure 2-4) and that noted by Tonkin & Taylor (Figure 2-2) these differences are not significant.

The predicted extent of liquefaction corresponds reasonably well with what actually occurred. The locations where the ground liquefied, but this had not been predicted, were located in reclaimed land which had been built over historic streams.
