Technical Note 09 – Photobook of Damaged Underground Utilities

1. Introduction

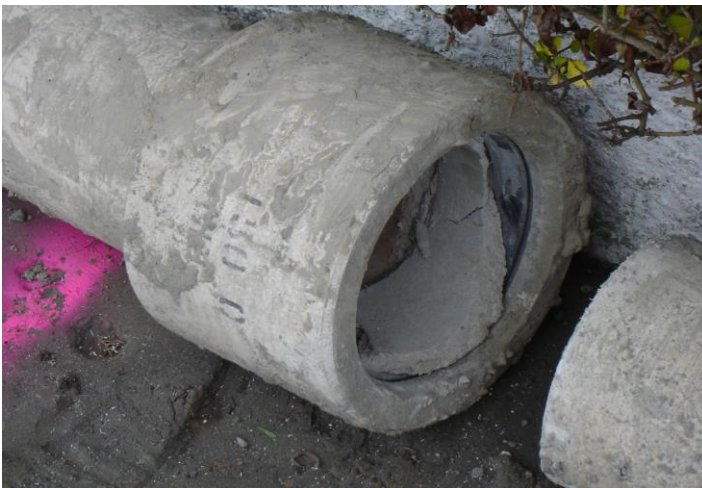
Reference: PI002

Cause: Lateral shear or bending.

Comment: Fracture pattern indicates failure could be due to bending, compression or lateral shear. Modern materials have more tolerance to this kind of loading.

Repair: Replace collar and damaged pipe.

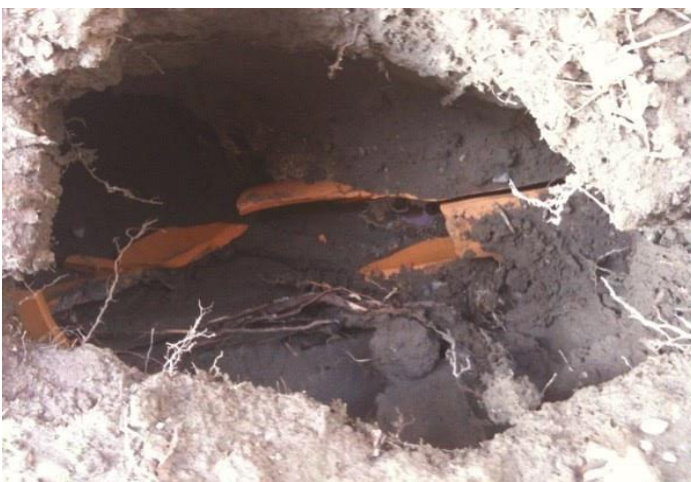
Reference: PI006

Cause: Compression, shaking or bending.

Comment: Earthenware pipes have poor tolerance to most seismic loads loading. Modern systems have better resistance to shaking and bending.

Repair: Replace damaged pipes.

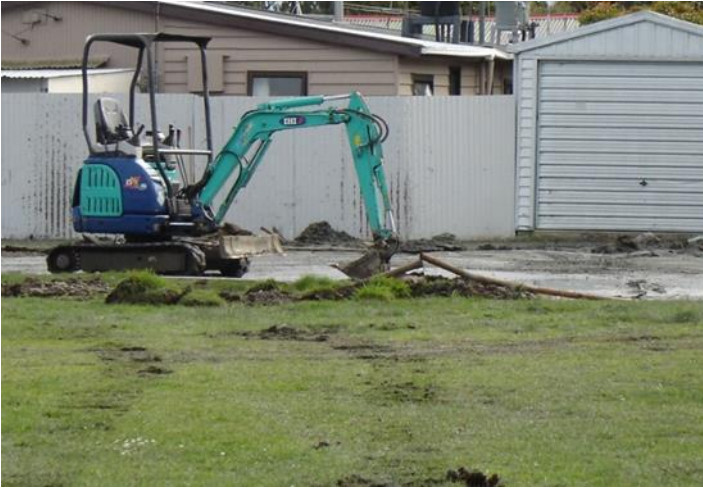
Reference: PI007

Cause: Compression of shallow buried pipe.

Comment: Deeper burial will result in buckling rather than bending but failure will occur in both cases. Most alternative materials would also bend but modern plastics are more likely to provide some (limited) service when damaged.

Repair: Replacement

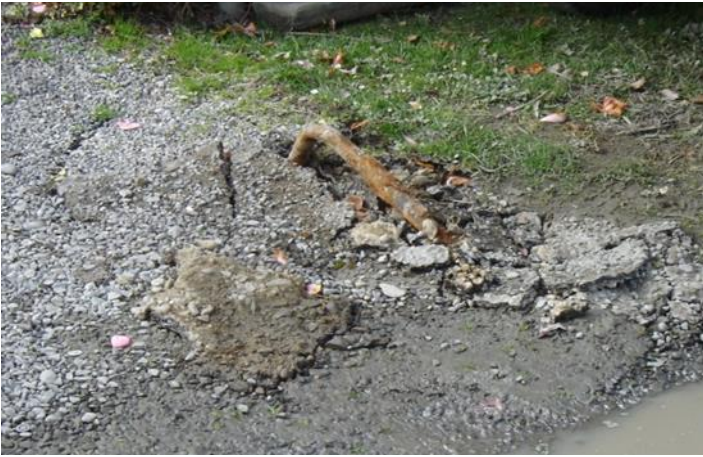
Reference: PI008

Cause: Compression of shallow buried pipe.

Comment: Deeper burial will result in buckling rather than bending but failure will occur in both cases. Most alternative materials would also bend but modern plastics are more likely to provide some (limited) service when damaged.

Repair: Replacement

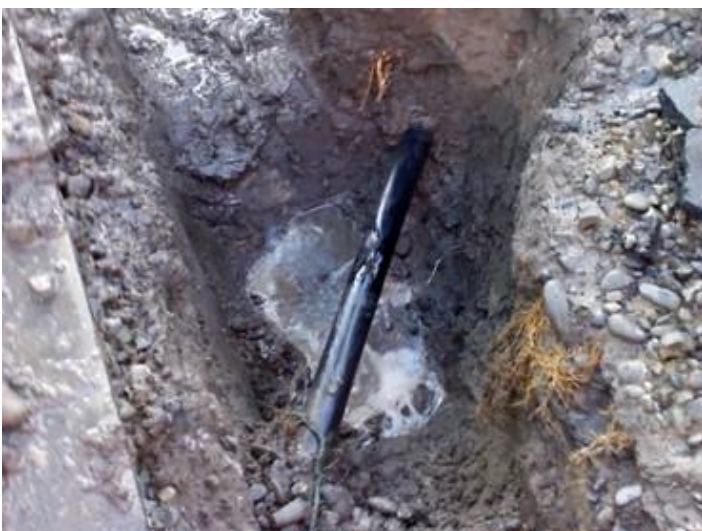
Reference: PI015

Cause: Compression

Comment: Most alternative materials would also buckle and fail but modern plastics are more likely to provide some limited service when damaged.

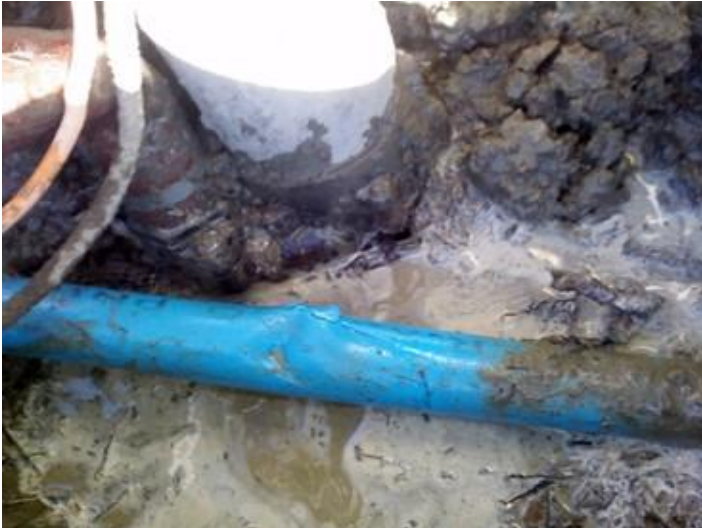
Reference: PI016

Cause: Compression

Comment: Most alternative materials would also buckle and fail but modern plastics are more likely to provide some limited service when damaged.

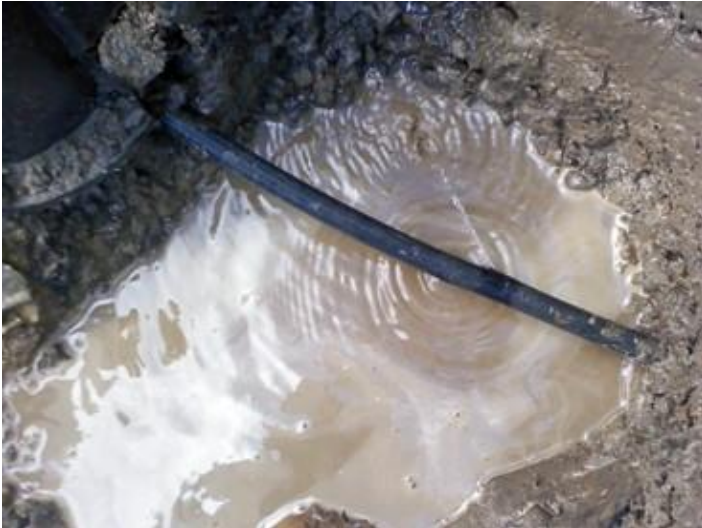
Reference: PI019

Cause: Compression

Comment: The pipe has buckled and torn. Most alternative materials would also buckle and fail but modern plastics are more likely to provide some limited service when damaged.

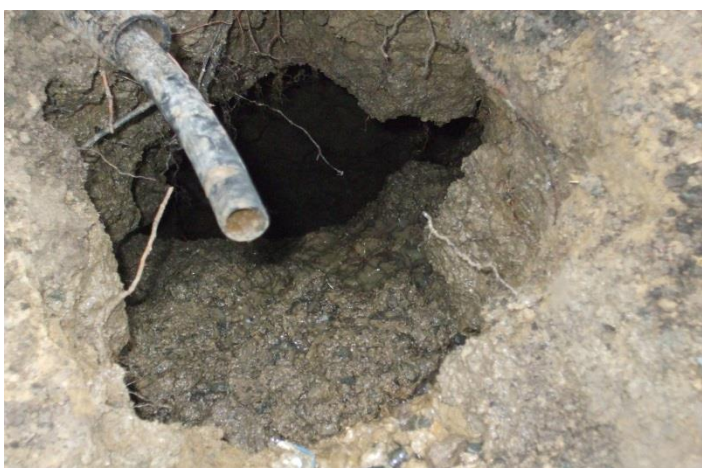
Reference: PI024

Description: Pipe failed.

Cause: Tension

Comment: Older PE has limited ductility and is less tolerant of tensile displacement than modern PE. There appears to be a smaller pipe inserted inside a larger pipe. Snaking the pipe in the trench and using modern ductile pipeline systems will reduce the risk. While risks can be reduced by construction practices, it is not practical to eliminate all risks in service connections.

Repair: Replace damaged pipe.

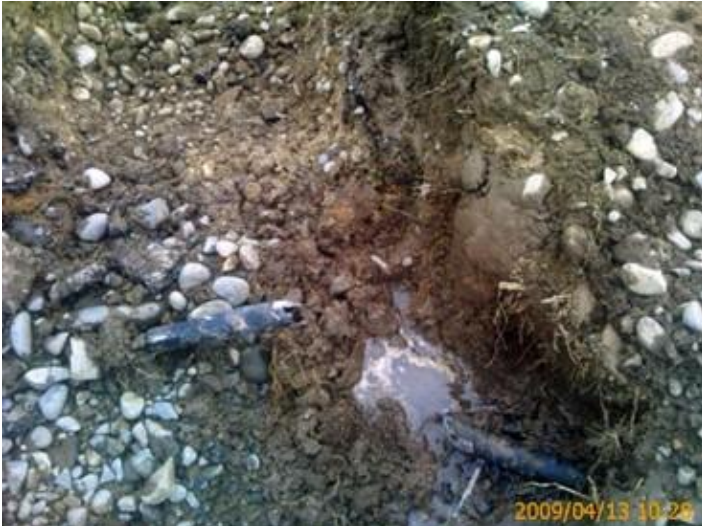
Reference: PI025

Description: Pipe failed.

Cause: Tension and lateral displacement.

Comment: The pipe appears to have failed due to lateral spreading of several hundred millimetres. While risks can be reduced by construction practices and use of modern materials, it is not practical to eliminate all risks in service connections.

Repair: Replace damaged pipe.

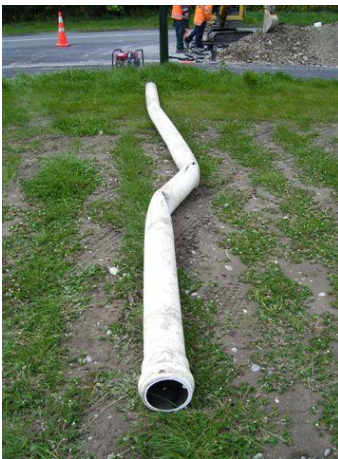
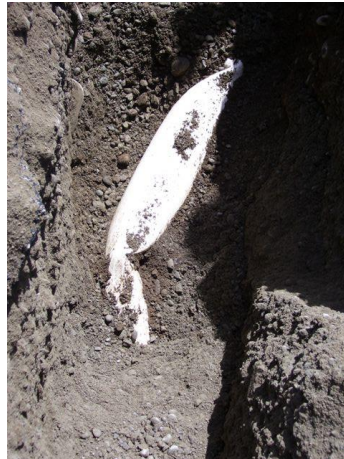
Reference: PI029

Cause: Permanent Ground Displacement. Pipe is driven into a fixed structure (most likely) or rigid structure is driven into pipe (less likely).

Comment: Where possible locate pipelines away from similar structures where risk of lateral spreading is present and direction of movement likely to cause damage. Despite the damage, some limited service may be retained if the buckled pipe wall does not tear.

Repair: Replace damaged pipe length. May need to replace adjoining pipes if damaged.

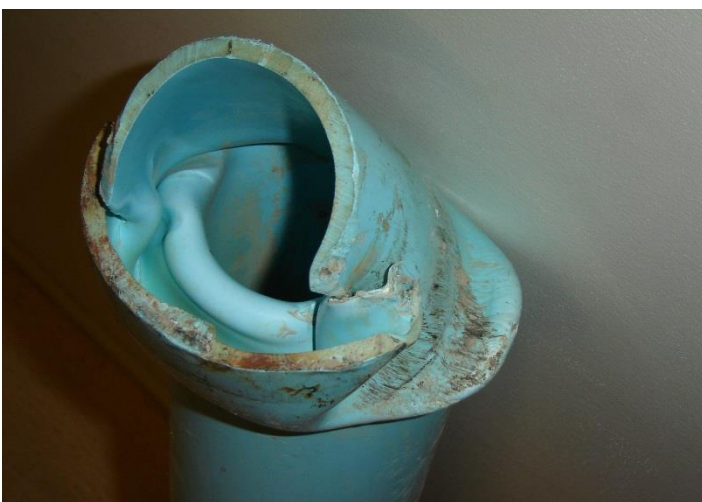
Reference: PI030

Cause: Compression

Comment: No practical solution. Some service may have been retained if compression had been slightly less as this may have avoided tearing.

Repair: Cut out damaged pipe and repair.

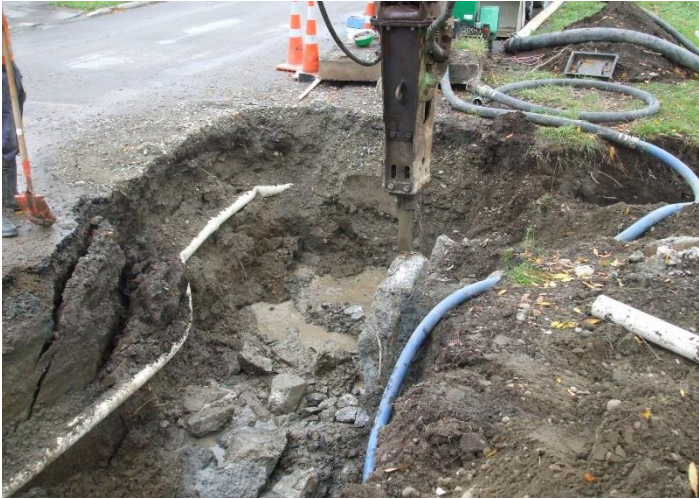
Reference: PI031

Cause: PGD. Pipe is driven into a fixed structure (most likely) or rigid structure is driven into pipe (less likely).

Comment: Where possible, locate pipelines away from similar structures where risk of lateral spreading is present and direction of movement likely to cause damage. Despite the damage, some service may be possible if the buckled pipe wall does not tear.

Repair: Replace damaged pipe length. May need to replace adjoining pipes if damaged.

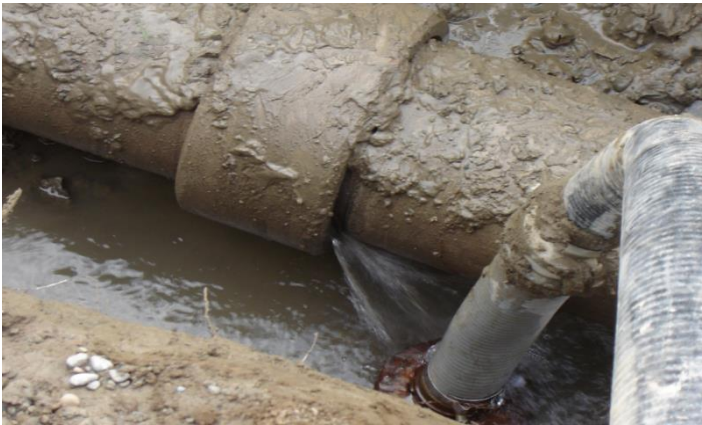
Reference: J001

Description: Leaking joint.

Cause: Bending or tension .

Repair: Replace the collar with a repair coupling if necessary or replace the affected pipes.

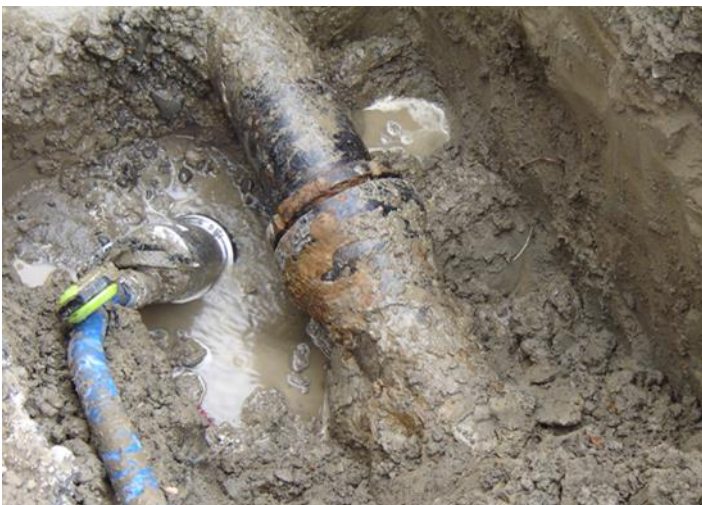
Reference: J003

Description: Leaking joint.

Cause: Bending or compression.

Repair: Cut out and replace, or attempt reassembling if not misaligned.

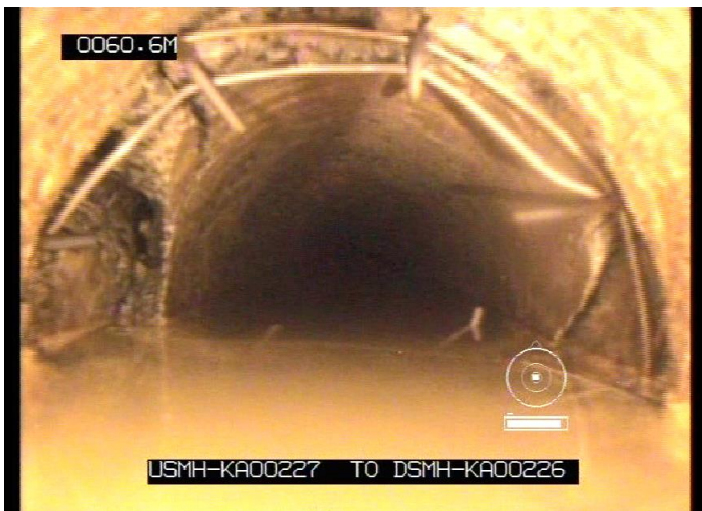
Reference: J005

Description: Joint failure.

Cause: Compression

Comment: Some other materials can survive limited compression. Otherwise accept risk and plan for repair.

Repair: If localised damage, may be able to use repair patch or line affected section. Otherwise, cut out and repair.

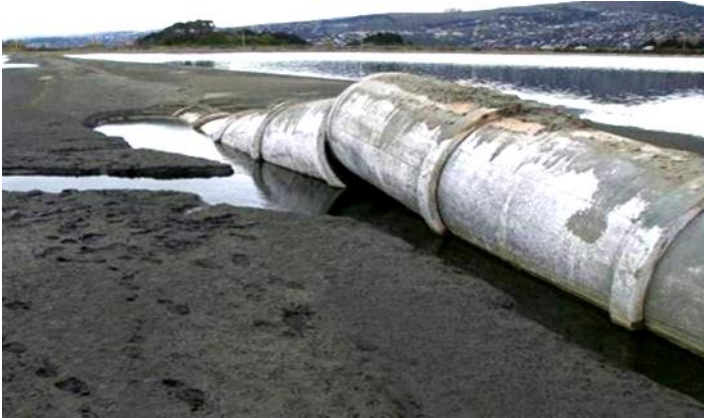
Reference: J007

Description: Joint failure.

Cause: Flotation

Repair: May be possible to reinstall undamaged pipes.

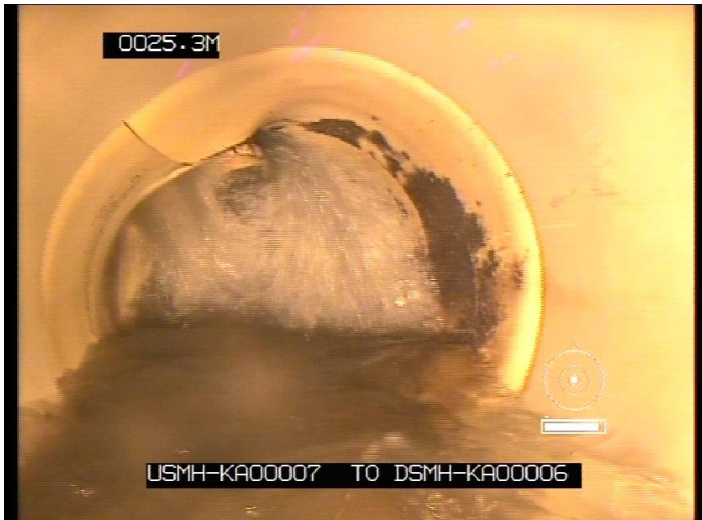
Reference: FT013

Comments: No practical avoidance in reticulation systems. Accept risk and make plans for repair.

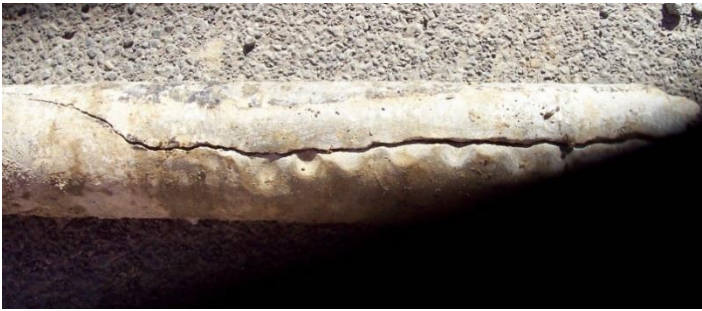
Reference: EX001

Comment: Requires degraded pipe wall, but triggered by ground movement or pressure surge.

Scalloped edges show continued flow of water after crack formed and show that the material was degraded at the time of failure.

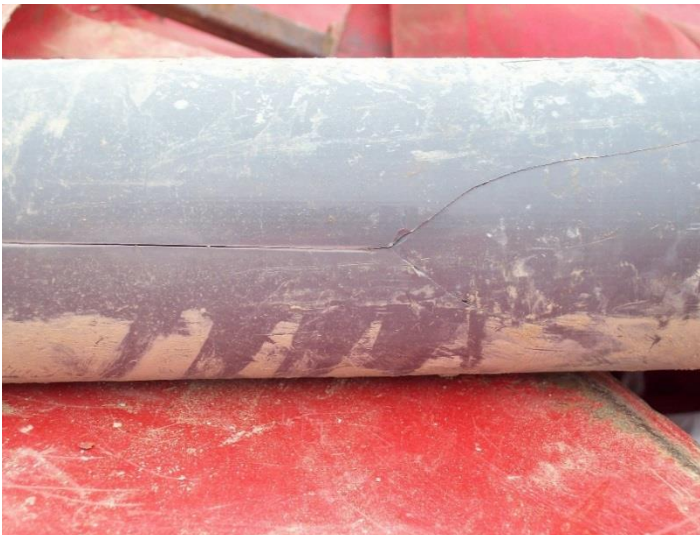
Reference: EX008

Comment: Split due to slow crack caused by uneven bedding or point load (eg rock impingement). While the earthquake may have triggered failure continued crack growth would have caused failure in the future. The bifurcation to the right is a common feature in PVC pipe failures.

Repair: Replace affected pipe.

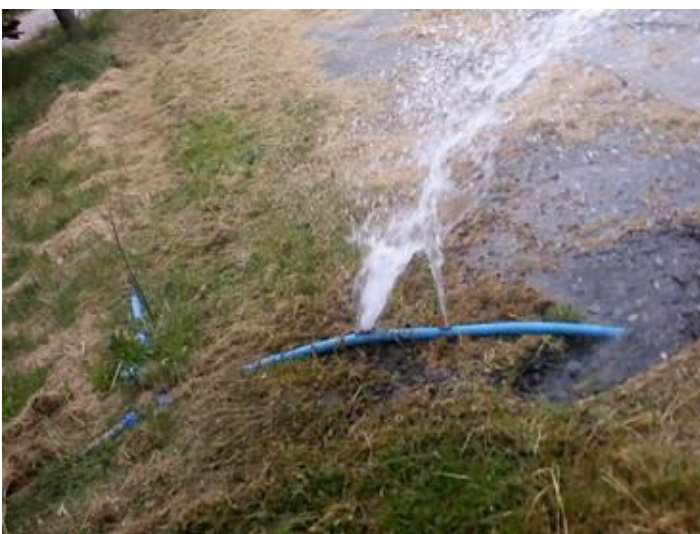
Reference: OT013

Comment: Difficult to avoid where above ground pipes cross access routes. Risk may be reduced for smaller lines by installing a duct protector.

Repair: Replace damaged pipe

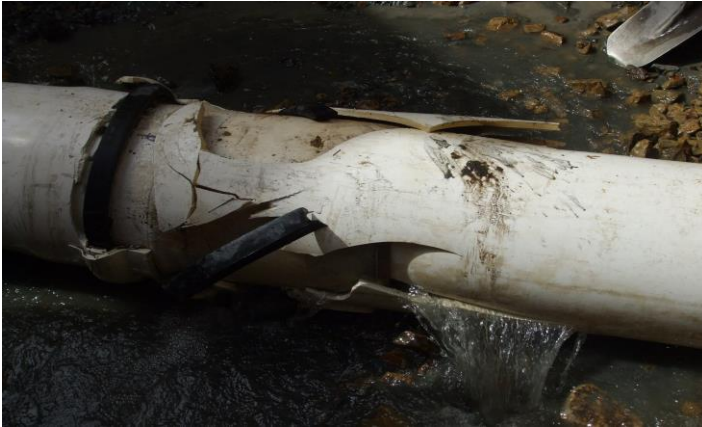
Reference: OT014

Comment: Smaller PVC pipes may have sufficient ductility to accommodate compressive buckling, but larger and thicker walled pipes do not. There is no practical solution to minimising risk. This large pipe is too rigid to cope with buckling deformation. Butt welded steel may have remained partly serviceable under these loads, but unlikely.

Repair: Cut out damaged section and repair.

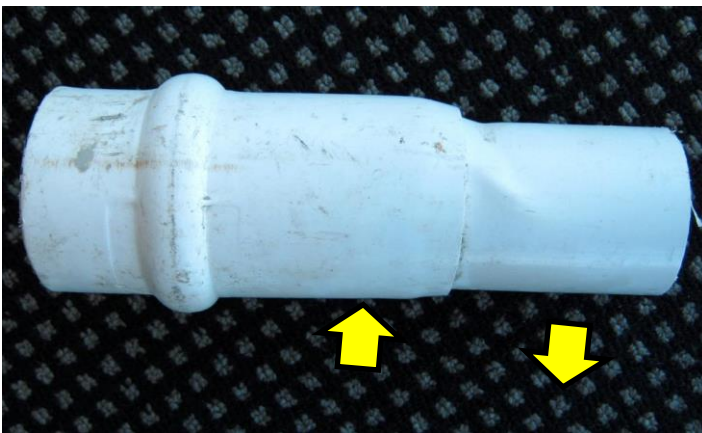
Reference: OT015

Comment: This is a form of subcritical damage. It is probably caused by a shearing movement as marked but could result from compressive buckling that has started to cause bending of the wall.

No practical method of avoiding. Minimise occurrence and impact by using modern materials.

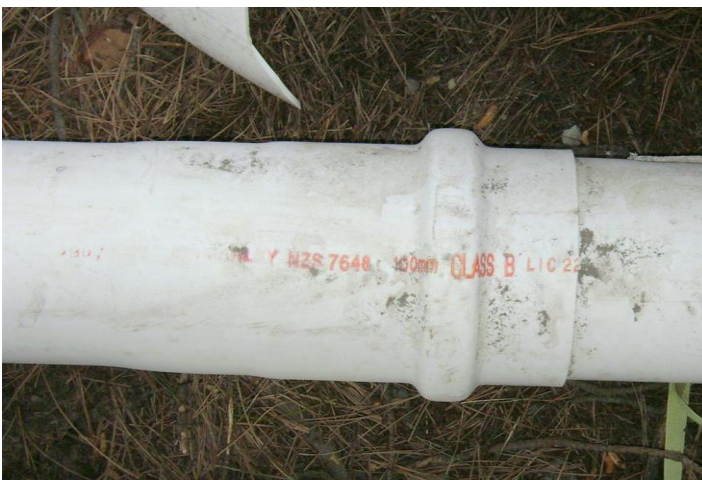
Reference: OT016

Comment: Where the socket does not fracture, this may result in sub-critical damage or delayed failure. Effectively limited to thinner walled high-toughness PVC. With thicker walled pipes or older less, ductile materials the socket will shatter.

Repair: Cut out defective area and repair.

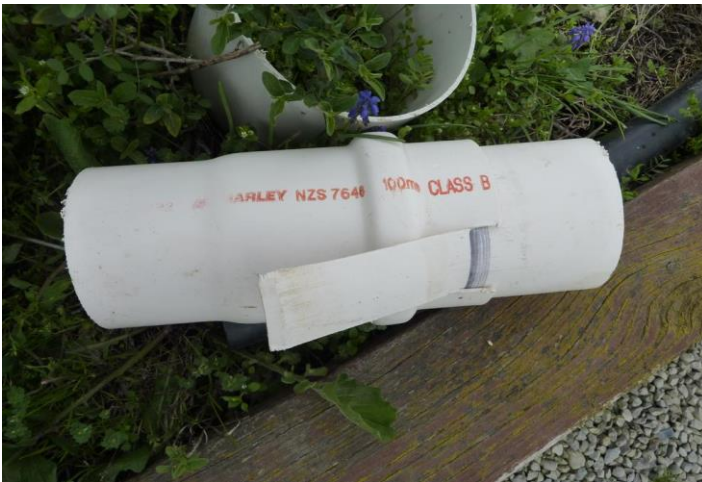
Reference: OT017

Comment: A relatively rare phenomenon requiring ductile socketed materials and high amplitude shaking with magnitude greater than socket insertion depth. Where high amplitude shaking is expected, longer-socketed pipes or (more reliably) alternative materials such as fused PE could be used. Otherwise accept risk and prepare for repairs.

Repair: Cut out and repair

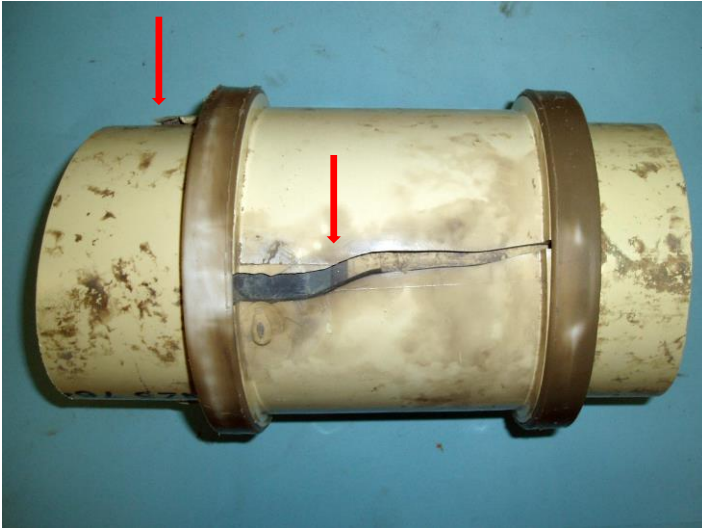
Reference: OT020

Comment: The red arrows mark the position of the pipe ends. The pipe walls have cut through each other, and the increased diameter has cracked the surrounding socket. This type of failure can only occur in a collar or sleeve joint.

Repair: Cut out damage and repair.

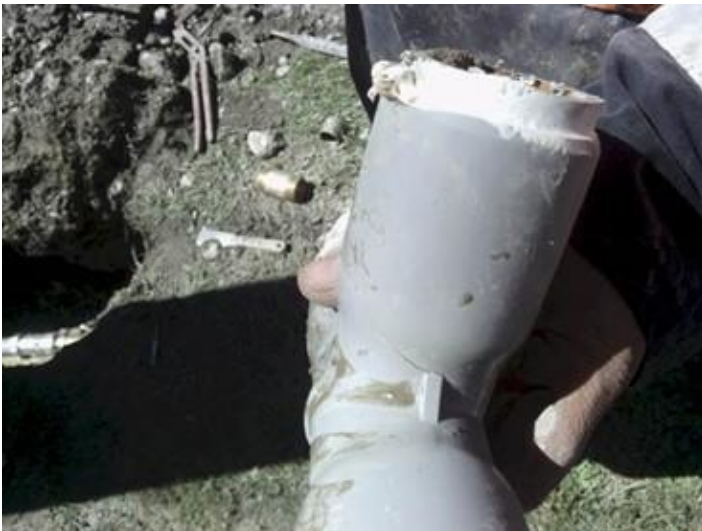
Reference: OT021

Comment: Solvent cemented PVC is not widely used as service pipes. Although cracking may have initiated in service with final failure being triggered by shaking, other fittings failed in the same event. Replacement with PE service lines may be advisable.

Repair: Replace failed elbow.

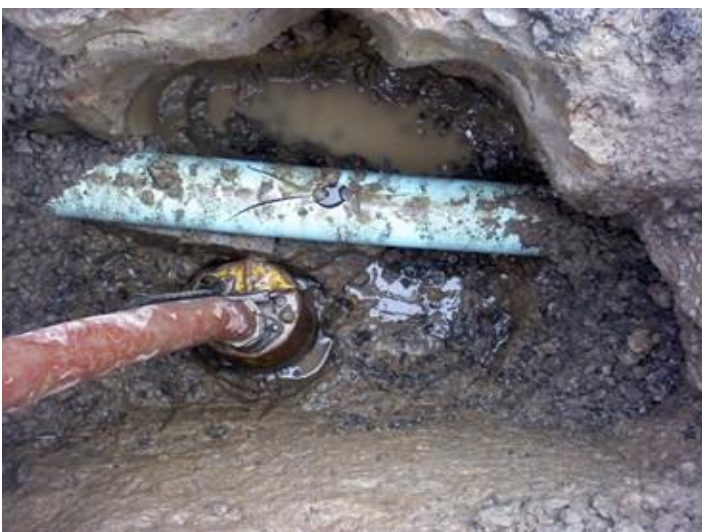
Reference: OT022

Comment: It is possible that there was a crack present which failed through shaking. Fused PE has better tolerance.

Repair: Replace damaged pipe and re-make connection.

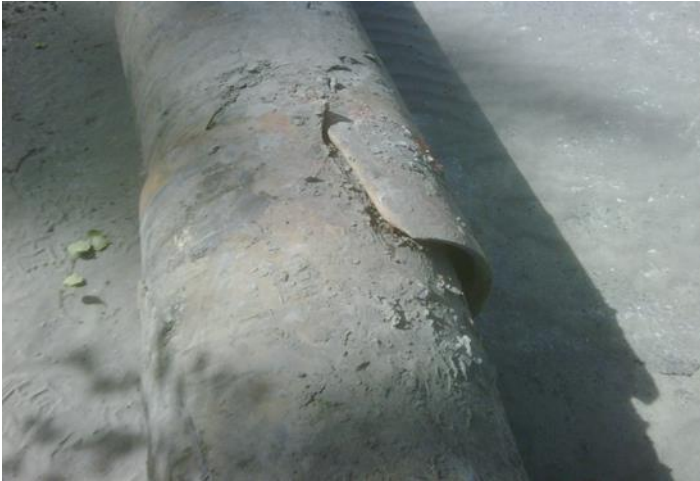
Reference: OT023

Comment: This type of failure can only occur in a collar or sleeve joint. Modern welded steel pipelines are likely to buckle in compression but may retain some functionality.

Repair: Cut out damage and repair.

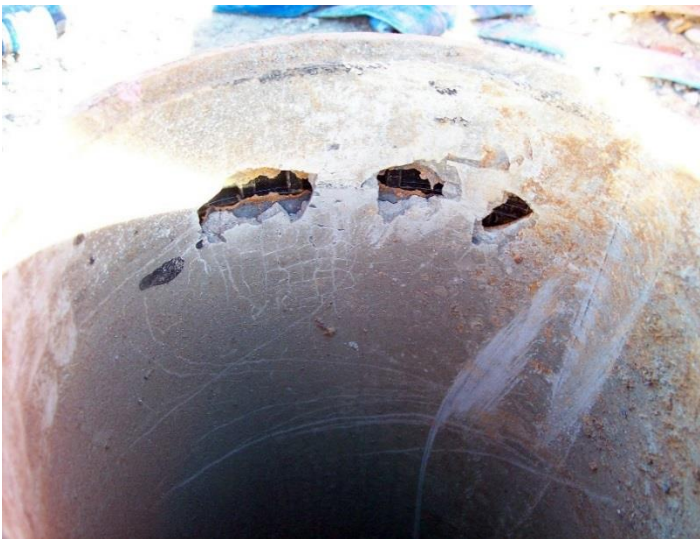
Reference: OT024

Comment: Not expected to cause problems in the short term, so will only be detected after an event if the joint or the pipe is damaged. Because of this, the scale of the problem is unknown and likely to remain until perforations start to cause detectable leakage issues. More flexible polymer linings would probably avoid this problem, there is no evidence that damage to concrete linings is a major issue.

Repair: This is a sub critical failure that increases the risk of future leakage from corrosion of the unprotected steel. Replace damaged pipe sections as and when detected.

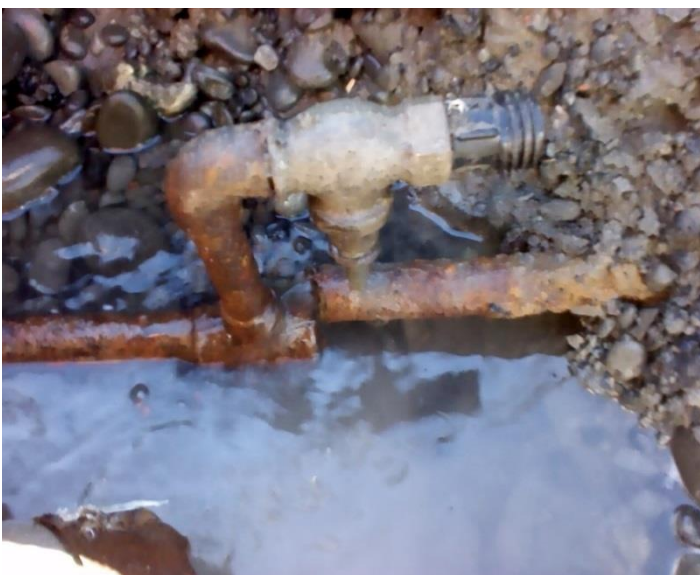
Reference: OT025

Comment: Modern service pipe systems with inserts at mechanical joints are more robust.

Repair: Replace damaged tee.
