A consistent approach across the 3 waters sector

NEW ZEALAND GRAVITY PIPE INSPECTION MANUAL

4TH EDITION

Prepared for Water New Zealand by
ProjectMax Ltd and Citycare Water 2019

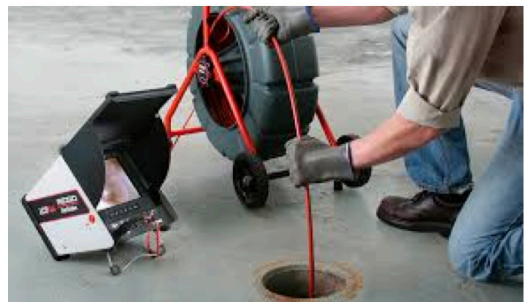
Figure A2.3 – Semi-rigid cable is used to push and pull the camera through the pipe

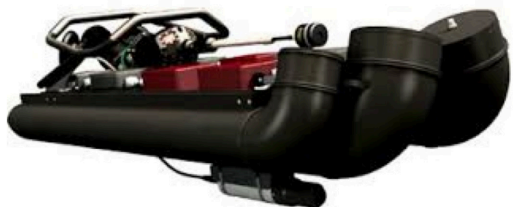
Figure A2.4 – Pipe Inspection float system, transporting in this example rear facing VPTZ camera, laser profiling and Sonar equipment below (MSI HD System, Photo Credit Red Zone Robotics)

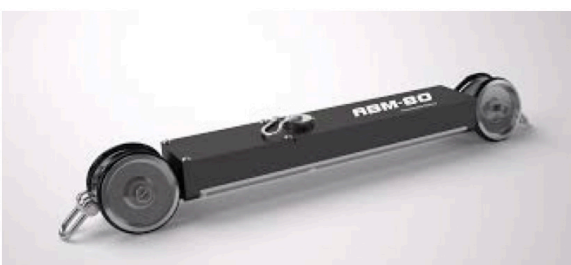
Figure A2.5 – Gyroscope based mapping tool developed for gravity pipelines (Reduct ABM-80)

A mapping probe equipped with inertial sensors (gyroscopes, accelerometer, magnetometer, etc) that can position the X, Y and Z coordinate location of the pipe over its entire length at 100 samples per second. The probe is pulled through the pipeline on wheels at ± 2 m/second and provide an accuracy of 0.03% XY and 0.01% Z as a percentage of pipeline length surveyed. (e.g. a 100m long pipe the accuracy would be 3mm XY and 1mm Z). Prior to undertaking gyroscopic profiling, the pipeline must be clean with no debris or attached deposits in the pipe invert that may affect the pitch of the profiler

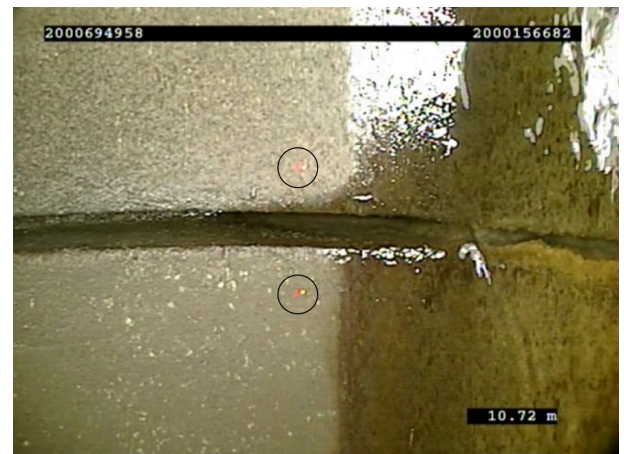
Figure A2.6 – Laser dots projected from the camera head panned towards to pipe wall either side of a joint

- Laser calliper measurement (Laser dots) – the most commonly available measurement enabling tool for Pan-Tilt-Zoom cameras. Laser dots are projected on to the pipe surface which have a known fixed measurement that can then be used to calibrate and measure the width of joints or other smaller features (that can be viewed within the monitor). To use these laser measuring dots, the camera must be panned directly towards the pipe wall (90° to the pipe axis).
- Gyroscopes – enabling the tracking and plotting of the camera to map the position of pipelines.
- Laser profiling – this is limited to some digital scanning cameras

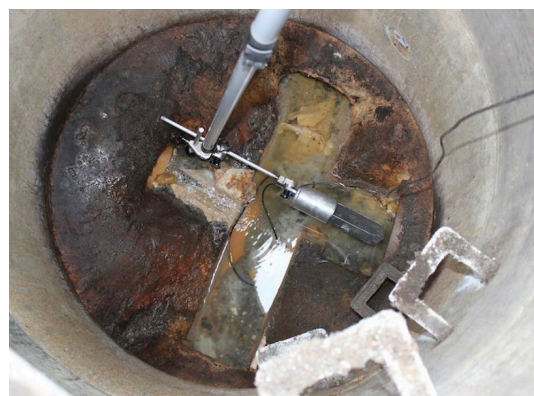
Figure A2.9 – SewerBatt inserted into the pipe for rapid inspection (photo credit Lanes Group plc)

SewerBatt is a portable acoustic sewer inspection tool that consists of an acoustic sensor head that is mounted on a pole (similar to a pole camera) which is lowered into the manhole and inserted into the pipe to be tested. The sensor head contains a sound source (speaker) that transmits an acoustic excitation signal into the pipe. Simultaneously, the acoustic signal response from the pipe is captured by an array of microphones that are also contained in the sensor head. The captured signal responses are used to assess the pipe service condition. An automated condition assessment module that reviews the acoustic signal response, makes allowance for the energy loss from the pipe-ends and lateral connections, and then grades the pipe. The final pipe service condition is simply in the form of a coloured traffic light indicator providing a red, amber (yellow), or green (RAG) grade. A red grade assessment indicates the need for further inspection or cleaning. An amber grade assessment is cautionary, indicating that there may be some blockage issues, but not enough to block the flow. A green assessment indicates the pipe is free of any significant blockages and no further evaluations are necessary.

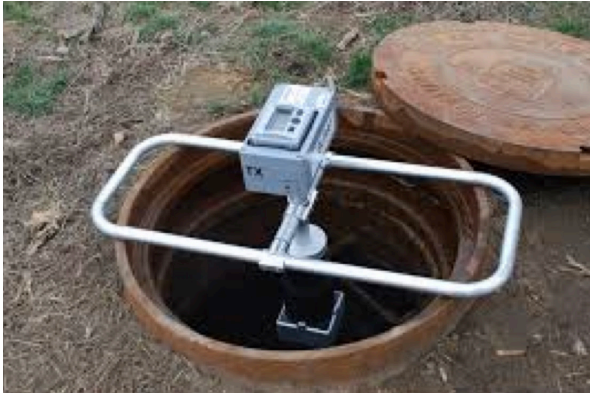
Figure A2.10 – SL-RAT device is positioned at each end of a pipe section to be tested (photo credit www.kci.com)

SL-RAT measures the dissipation of sound energy between a transmission speaker and a separate receiver, device. The transmission and receiver devices are set up in the upstream and downstream manholes at either end of the pipe to be tested. Any single service defect that completely obstructs the pipe will not allow the transmission of sound energy between the two devices. Additionally, defects such as roots, fat etc., increase the sound dissipation. The overall blockage assessment by SL-RAT is provided in the form of a numeric output value on a scale of 0 (completely obstructed) to 10 (completely unobstructed).

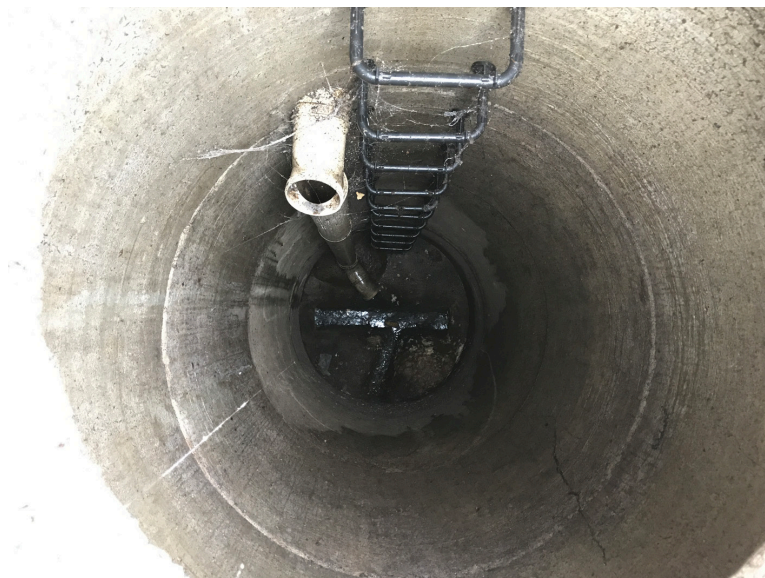
Figure B1.2.4 – Example of view looking down a manhole when the camera (pan and tilt or fixed head) cannot start in the manhole

1. Prior to lowering the camera into the manhole, a view looking down into the manhole from the ground surface shall be recorded, such that the manhole wall, benching and all the incoming and outgoing pipes can be seen on the video.
2. The distance counter is set to zero metres (0.0m). Note later requirement to reset the distance counter when the camera is in the pipe.
3. A screen header is displayed for 5 to 10 seconds notifying the start of the inspection (refer B1.2.2.8 Screen Displays).
4. The recording shall then continue as the camera is lowered into the entrance of the pipeline to be inspected, ensuring that the entire interface between the manhole wall and the pipe can be clearly seen as this is undertaken.

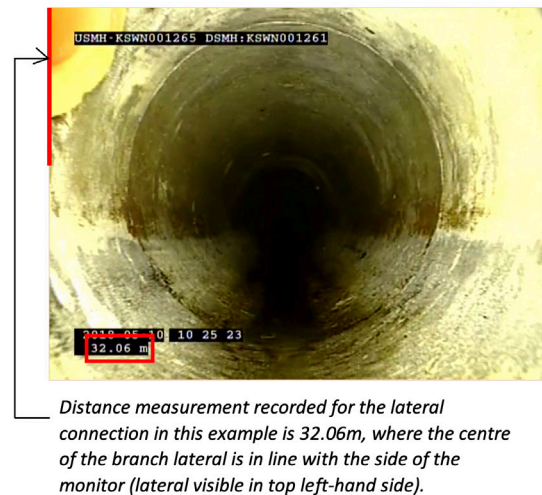
Figure B1.2.13 – Example of measurement to a lateral connection

The distance measurement to features such as lateral connections are recorded when the centre of the lateral connection is in line with the edge of the monitor.

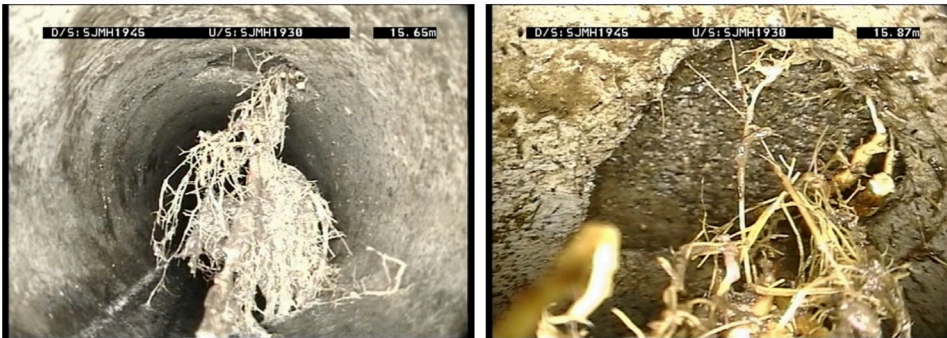
Figure B1.14 – Example of first photograph and second/subsequent photograph showing defect detail without over zooming

The second, and any subsequent, photographs can be in a tilted position or zoomed to show detail or view of the defect or feature that cannot be seen in the first photograph. The second and subsequent photographs shall be added to the log sheet report using the General Photograph code (GP). Remarks shall be provided to describe the view perspective if the image has been zoomed.

First photograph taken looking 'straight ahead' down the pipe axis, with the camera stopping position as described in clause B1.2.3.3, where the defects (pipe hole and root intrusion) can be clearly seen within the pipe circumference.

Second photograph taken with the camera tilted and panned towards the defect showing more information that cannot be clearly seen in the first photograph

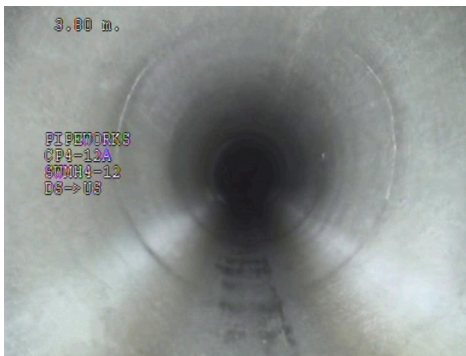
PW1.1 – Cracking Circumferential

Remarks: Autogenous (self-healed) crack

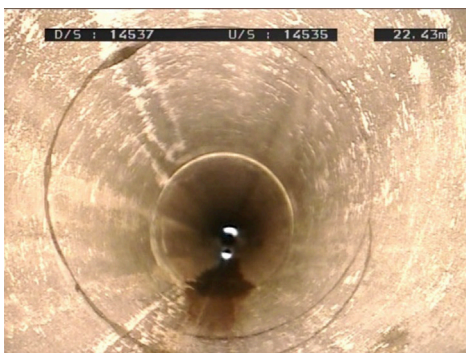
PW1.1.1 – Branch Cracking

Dist.	Cont.	Code	Char.	Quant.	From	To
22.6		CC		M	12	12

Remarks: Small branching crack extending < 100mm between 3 and 9 o'clock

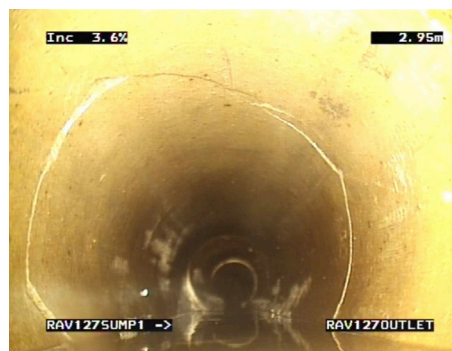
PW1.1.2 – Chipping of Crack Edges (C)

Dist.	Cont.	Code	Char.	Quant.	From	To
3		CC	C		7	5

Remarks: Chipped edges along the crack circumference, particularly obvious from 7 to 11 o'clock

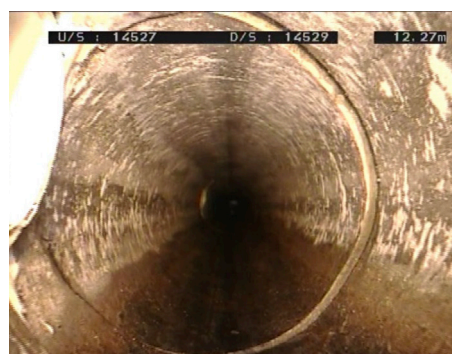
PW1.1.3 – Vertical Displacement of the crack (D)

Dist.	Cont.	Code	Char.	Quant.	From	To
12.5		CC	D		12	12

Remarks: Crack is open and has a slight displacement (left)

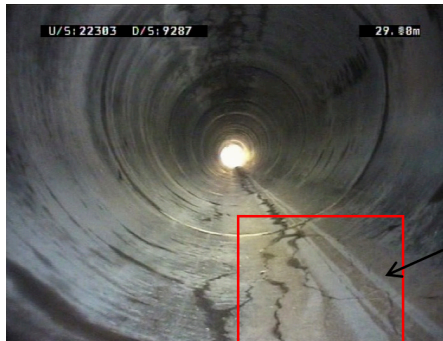
PW1.2.4 – Slabbing (B)

Dist.	Cont.	Code	Char.	Quant.	From	To
29.8		CL	B		6

Remarks: Slabbing in the pipe invert

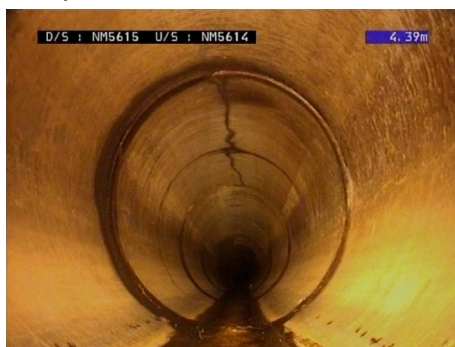
Dist.	Cont.	Code	Char.	Quant.	From	To
5	S1	CM		M	7	3

Remarks: Simple CM with CL & CC intersecting. Crack appears to be damp (would need to confirm if Infiltration was present)

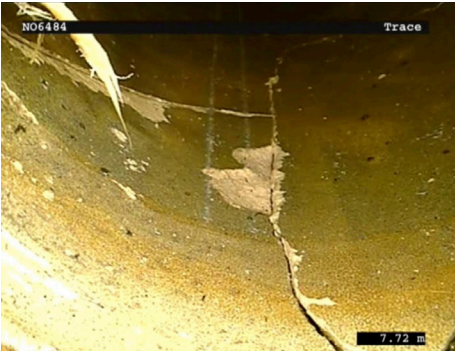
PW1.3.1 – Chipping/Splintering (C)

Dist.	Cont.	Code	Char.	Quant.	From	To
7.7		CM	C		6	9

Remarks: Edges of crack chipped.

This example shows a portion of the multiple crack. The cracking extends beyond the joint zone (edge of joint visible in immediate foreground) and the branching(circumferential) cracks do not connect back with the joint to form a ‘block(s)’. If they do this defect would be coded PB.

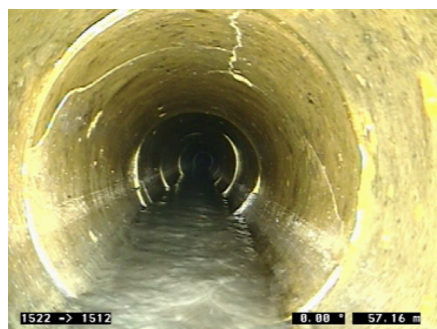
Dist.	Cont.	Code	Char.	Quant.	From	To
57.4		PB		L	9	4

Remarks: Cracks extending beyond the joint zone have formed 'blocks' (> 25% of the pipe circumference) with the joint

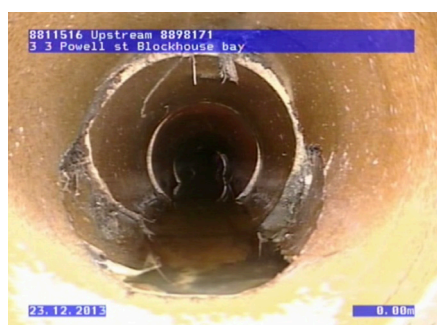
Dist.	Cont.	Code	Char.	Quant.	From	To
0.5		PB		L	3	9

Remarks: Broken pipe pieces have displaced more than half the pipe wall thickness and some have fallen out

Remarks: Flow exfiltrating from the pipe through the broken pipe

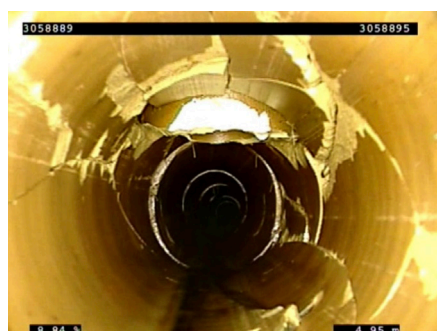
Dist.	Cont.	Code	Char.	Quant.	From	To
8.8		PB		L	9	6

Remarks: Broken pipe pieces >25% of circumference and have displaced more than half the pipe wall thickness

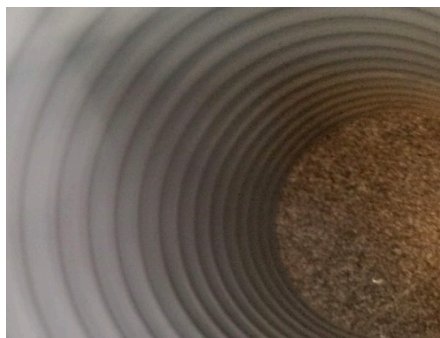
BossPipe Twin wall drainage pipe

Regarding characterisation code G, corrugation growth, it should be noted that some types of profile walled pipes are manufactured with corrugated internal pipe walls, e.g. BossPipe twin wall drainage pipe, and the corrugations in these pipes should not be recorded as a defect.

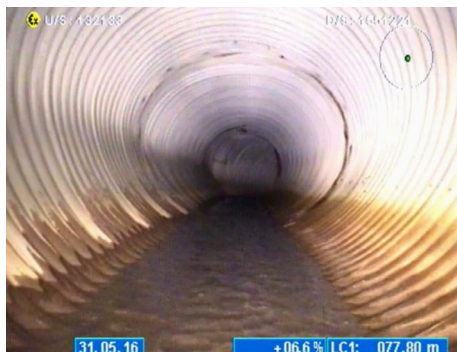
Dist.	Cont.	Code	Char.	Quant.	From	To
77.8	S1	PF	V	M

Remarks: Corrugated steel pipe with vertical deformation resulting in > 10% reduction in pipe diameter

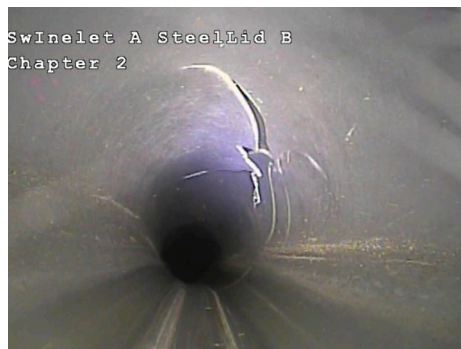
PW1.5.2 – Cracking (C)

Remarks: Rupture of the PVC pipe wall

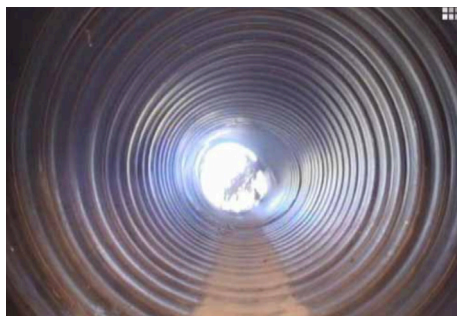
PW1.5.3 – Corrugation Growth (G)

Remarks: Profile section HDPE pipe with corrugation growth failure

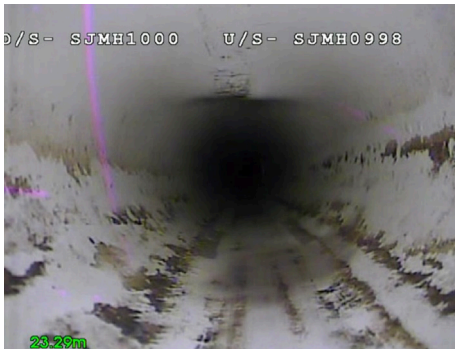
PW1.5.5 – Inverse Curvature (IC)

Dist.	Cont.	Code	Char.	Quant.	From	To
23.4		PF	IC	M	10	2

Remarks: Bulge in the soffit of the PVC pipe

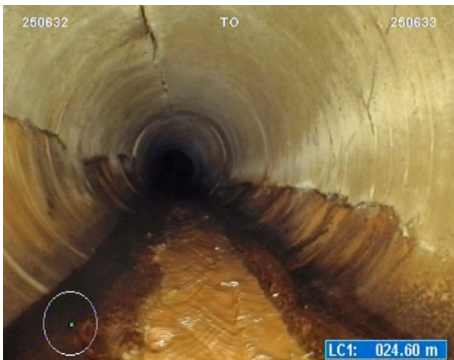
Dist.	Cont.	Code	Char.	Quant.	From	To
24.6	S1	DF	V	M		
Remarks: 3 longitudinal cracks are visible at 12, 3 and 9 o'clock. Expect 4th crack is hidden beneath the deposits in the invert. Reduction in diameter (due to deformation) <10%						
24.6	S2	GC			3	9
Remarks: Pipe wall below the longitudinal cracks is stained from leakage						
24.6	S3	DE		S		
Remarks: Silty deposits

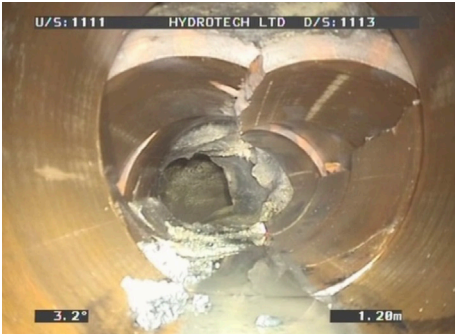
Dist.	Cont.	Code	Char.	Quant.	From	To
1.3		DF	V	L

Remarks: EW pipe has deformed to an extent that the pipe has moved out of place >25% (but <50%)

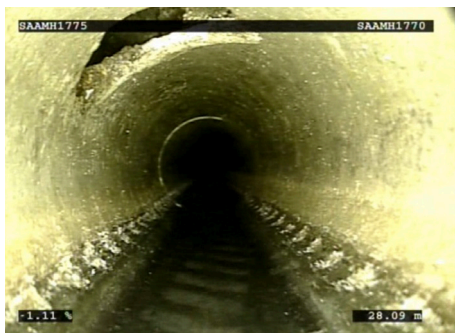
Dist.	Cont.	Code	Char.	Quant.	From	To
28.2		PH		M	10	1

Remarks: Pipe hole up to 25% of the pipe circumference, the cause of the hole is not known

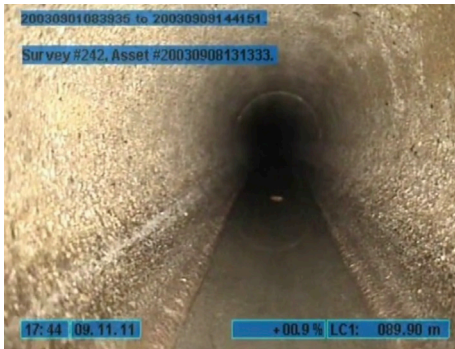
PW1.8.1 – Wall Roughened (W)

Dist.	Cont.	Code	Char.	Quant.	From	To
89.9	S1	S	W		12	12

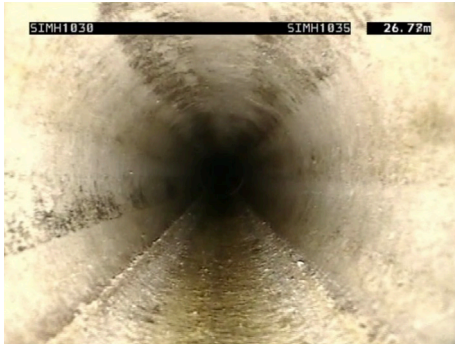
Dist.	Cont.	Code	Char.	Quant.	From	To
26.7	S1	S	W		5	7

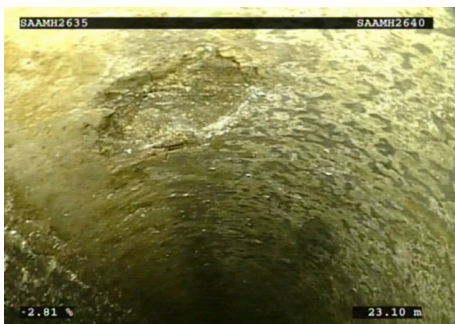
PW1.8.2 – Spalling (S)

Dist.	Cont.	Code	Char.	Quant.	From	To
23.2		S	S		8	10

Remarks: No reinforcement visible

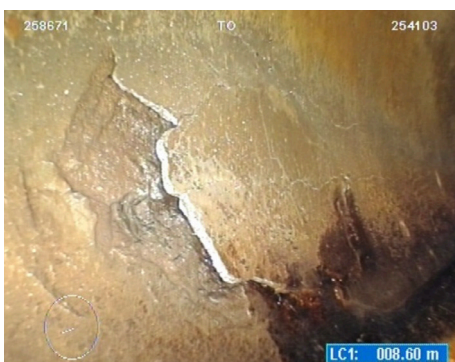
Dist.	Cont.	Code	Char.	Quant.	From	To
8.6		S	S		7	9

Remarks: Cement surface spalling. Reinforcement corrosion staining at the base of spalling area

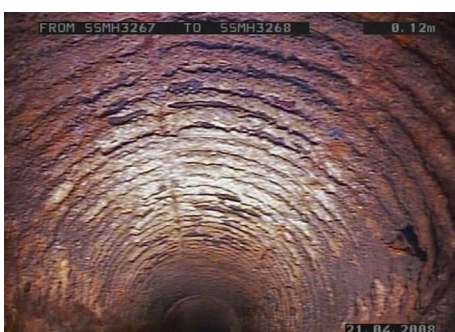
PW1.8.3 – Pipe Missing (PM)

Dist.	Cont.	Code	Char.	Quant.	From	To
0.12	S1	S	PM		8	4

Remarks: Corrosion beyond the reinforcement with only a paper-thin veneer of pipe wall remaining

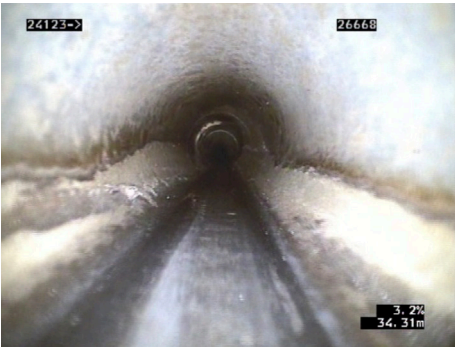
Dist.	Cont.	Code	Char.	Quant.	From	To
1.6	S1	S	DL	S	3	9

Remarks: Thin layers of AC pipe wall delamination

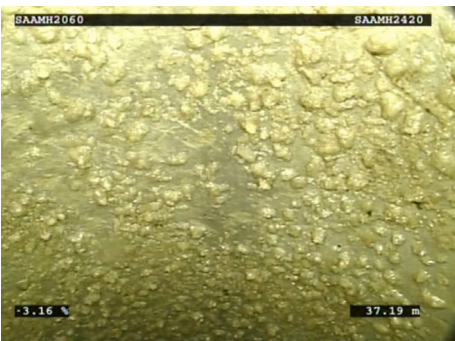
Dist.	Cont.	Code	Char.	Quant.	From	To
37.2	S1	S	DL	S	9	3

Remarks: Cement deposits on the pipe surface that have leached from the AC pipe wall

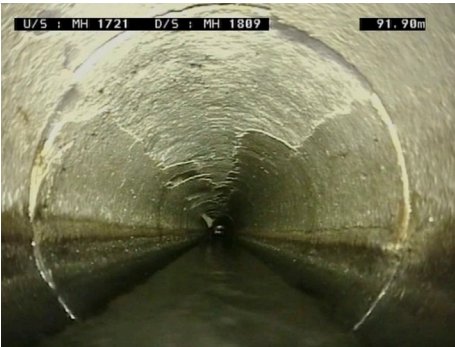
Dist.	Cont.	Code	Char.	Quant.	From	To
91.9	S1	S	DL	M	9	2

Remarks: Thick layers of AC pipe wall are delaminating but the pipe still retained it circular shape

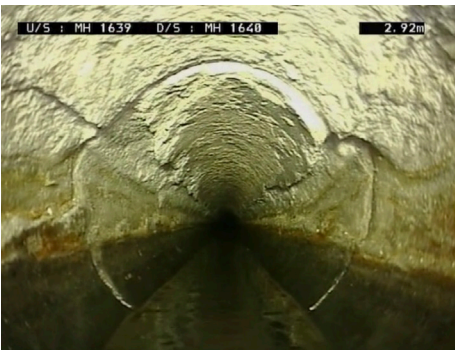
Dist.	Cont.	Code	Char.	Quant.	From	To
2.9	S1	S	DL	L	9	3

Remarks: Thick layers of AC pipe wall are delaminating and the pipe is losing its circular shape

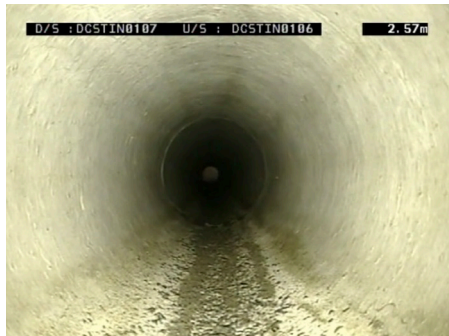
PW1.8.5 – Aggregate Exposed (AE)

Dist.	Cont.	Code	Char.	Quant.	From	To
2.6	S1	S	AE	M	5	7

Remarks: Aggregate exposed in the invert (up to 25% of pipe circumference) because of erosion from the flow in the pipe.

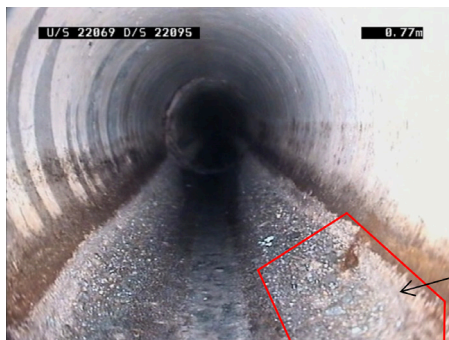
PW1.8.7 – Aggregate Missing (AM)

Dist.	Cont.	Code	Char.	Quant.	From	To
0.77	S1	S	AM	L	4	7

Remarks: Coarse aggregate protruding with evidence that some aggregate has been lost (>25% of the pipe circumference)

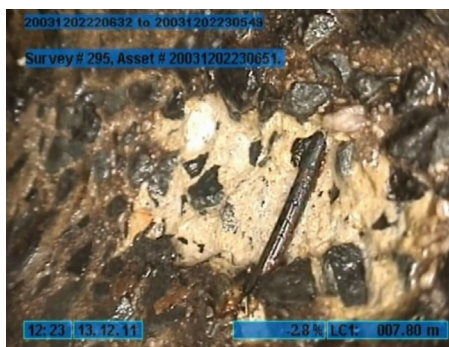
PW1.8.8 – Reinforcement Visible (RV)

Dist.	Cont.	Code	Char.	Quant.	From	To
7.8		S	RV	S	3	5

Remarks: Circumferential reinforcement exposed

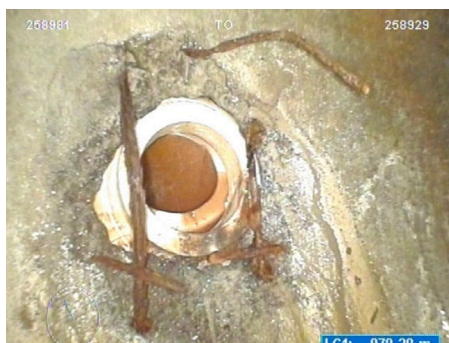
Dist.	Cont.	Code	Char.	Quant.	From	To
70.2		S	RV	S	9	10

Remarks: Circumferential reinforcement exposed where saddle connection has been installed

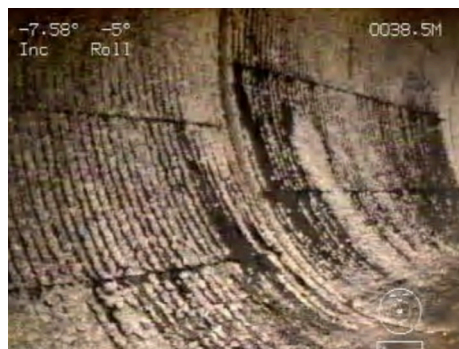
PW1.8.9 – Reinforcement Corrosion (RC)

Dist.	Cont.	Code	Char.	Quant.	From	To
38.5	S1	S	RC		6	12

Remarks: Wall loss due to corrosion exposing reinforcement steel (which is corroded)

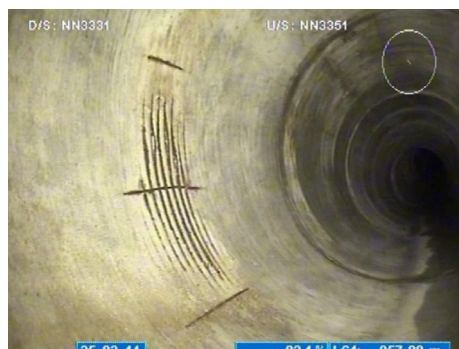
PW1.8.10 – Steel Reinforcement is Visible and Projecting into the Pipe (RVP)

Dist.	Cont.	Code	Char.	Quant.	From	To
58.4		S	RVP	M	9	11

Remarks: Reinforcement projecting above the pipe surface due to manufacturing defect (up to 25% of the pipe circumference)

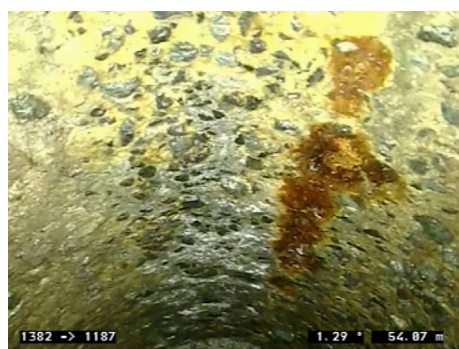
PW1.8.11 – Wall Staining (WS)

Dist.	Cont.	Code	Char.	Quant.	From	To
54.7		S	WS	S	9	11

Remarks: Staining on the pipe wall from steel reinforcement corrosion

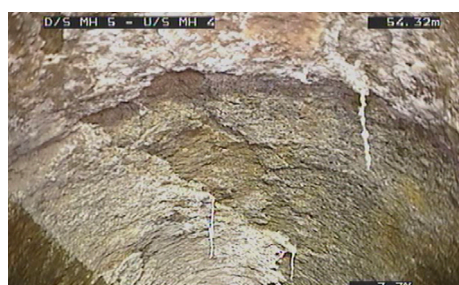
PW1.8.12 – Corrosion Products (CP)

Dist.	Cont.	Code	Char.	Quant.	From	To
54.3	S1	S	CP	L	10	2

Remarks: Calcium Carbonate buildup on the pipe surface (some has been removed) >25% of the pipe circumference

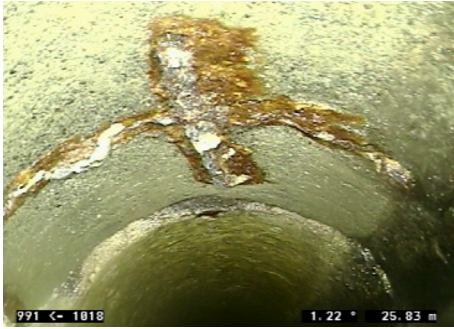
Dist.	Cont.	Code	Char.	Quant.	From	To
25.8		S	CP	L	12	5

Remarks: Steel corrosion products on the pipe wall

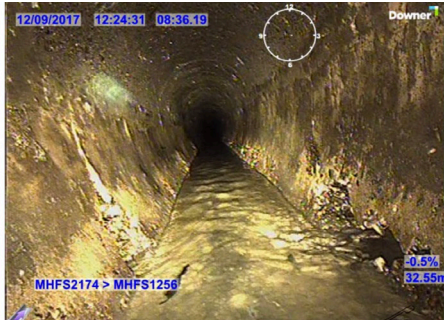
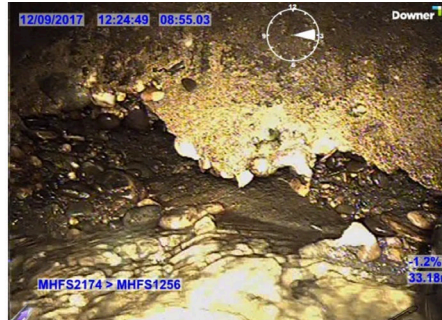
PW1.8.13 – Holed (H)

Dist.	Cont.	Code	Char.	Quant.	From	To	Remarks
33.2		S	H	L	4	8	Hole(s) eroded through cast-insitu pipe wall.
33.2		SV

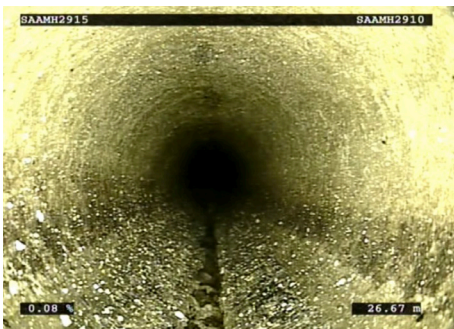
Dist.	Cont.	Code	Char.	Quant.	From	To
26.7	S1	S	H	L	4	8

Remarks: Erosion of the AC pipe wall in the invert causing a 'slot' to open to the outside

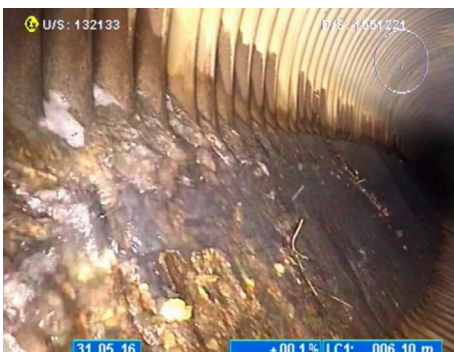
Dist.	Cont.	Code	Char.	Quant.	From	To
6.1		S	H	M	5	7

Remarks: Rusting of the steel in the invert of this corrugated steel pipe causing a hole to open to the outside

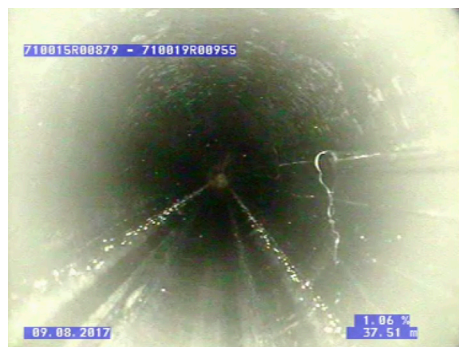
PW1.8.14 – Mechanical Damage (MD)

Dist.	Cont.	Code	Char.	Quant.	From	To
37.6		S	MD	S	2	3

Remarks: Scratch at 3 o'clock peeling a thin layer of PE

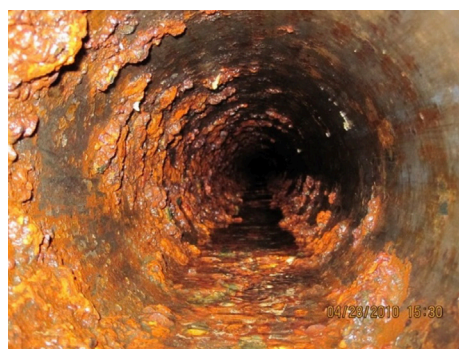
Dist.	Cont.	Code	Char.	Quant.	From	To
X	S1	S	T	M	12	12

Remarks: Steel tubercles buildup on the pipe wall reducing the pipe diameter >10%

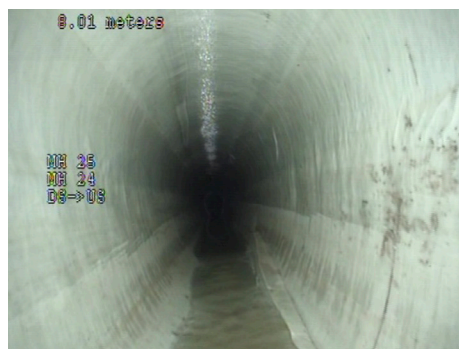
Dist.	Cont.	Code	Char.	Quant.	From	To
8	S1	PL	WL	S	5	6

Remarks: Thin Longitudinal (fin) wrinkle @ 5 o'clock

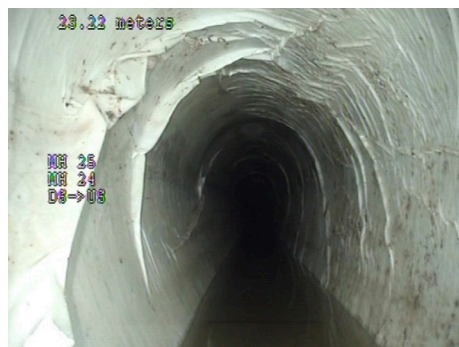
PW1.9.2 – Wrinkling Circumferential (WC)

Dist.	Cont.	Code	Char.	Quant.	From	To
23.2	S1	PL	WC	S	8	4

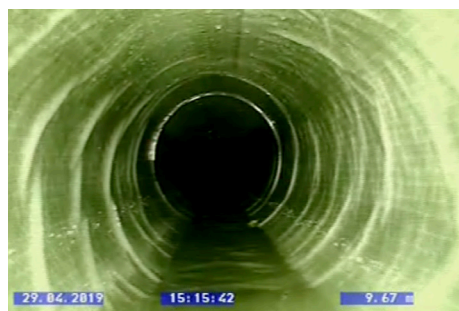
Dist.	Cont.	Code	Char.	Quant.	From	To
9.7	S1	PL	WC	S	1	10

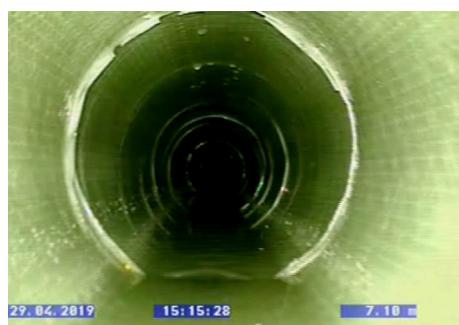
Dist.	Cont.	Code	Char.	Quant.	From	To
7.2		PL	WC	S	12	12

Remarks: Residual Polyester Resing

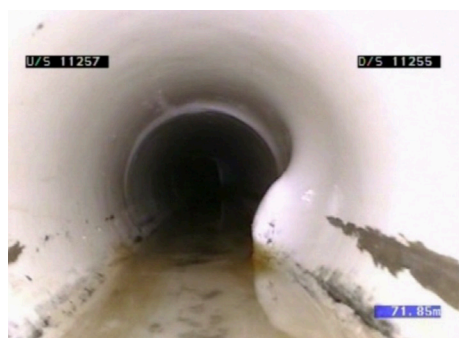
PW1.9.3 – Bulged or Deformed liner (BU)

Dist.	Cont.	Code	Char.	Quant.	From	To
72		PL	B	L	1	6

Remarks: Bulge in fold & form liner

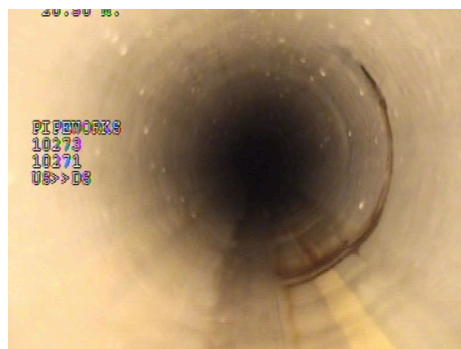
Dist.	Cont.	Code	Char.	Quant.	From	To
20.7		PL	H		2

Remarks: Small hole/perforation in the liner.

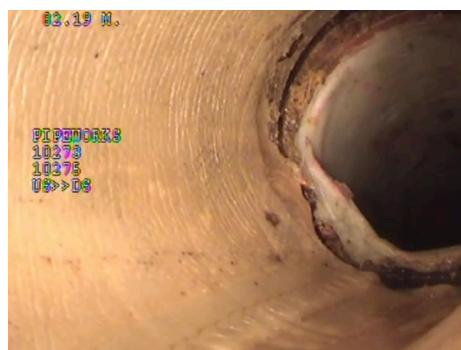
PW1.9.9 – Re-establishment of Connection done improperly (RC)

Dist.	Cont.	Code	Char.	Quant.	From	To
82.2		PL	RC		3

Remarks: LJR leg does not extend to cover the first joint inside the lateral

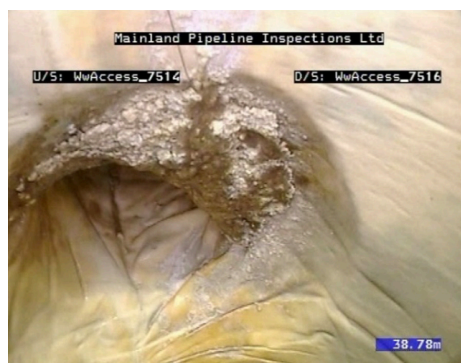
Dist.	Cont.	Code	Char.	Quant.	From	To
38.8		PL	RC		12

Remarks: Only just beyond the point of connection. Appears that an incorrect size LJR/LCR used, with excess resin, obstructing/blocking the lateral

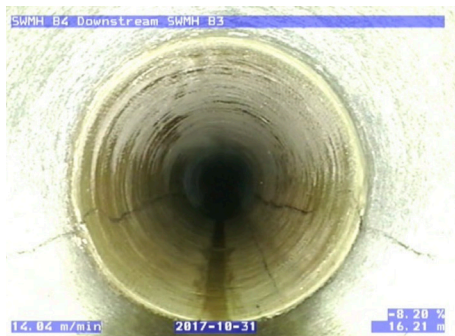
PW1.10.1 – Localised Lining (Patch Repair) (L)

Dist.	Cont.	Code	Char.	Quant.	From	To
16.4		PR	L			
Remarks: CIPP Patch Repair						
16.2		GC			4	8
Remarks: Marks (lines) on the pipe wall

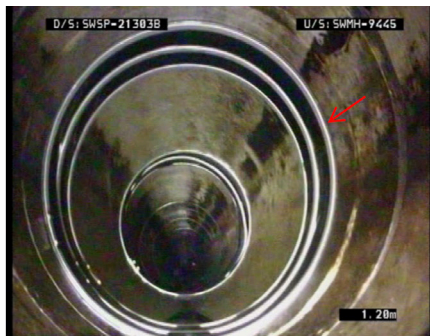
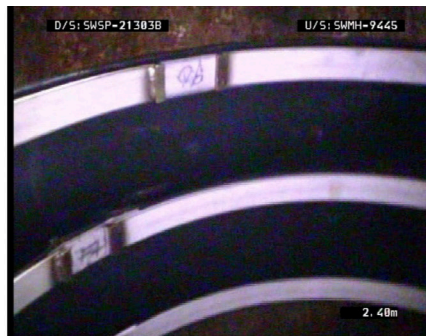
PW1.01.2 – Internal ‘Clip’ Seal (IC)

Dist.	Cont.	Code	Char.	Quant.	From	To	Remarks
2.4		PR	IC				Internal sealing repair band

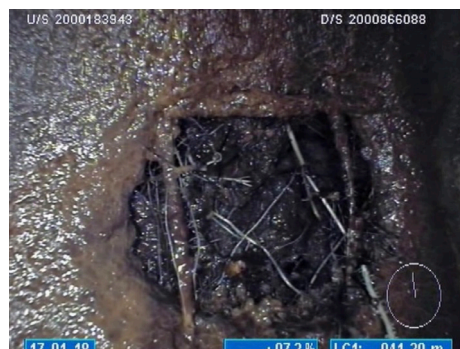
Dist.	Cont.	Code	Char.	Quant.	From	To
11.2		SV				
Remarks: Soil visible through pipe hole						
11.2		PH		M	9	11
11.2		S	RV		9	11

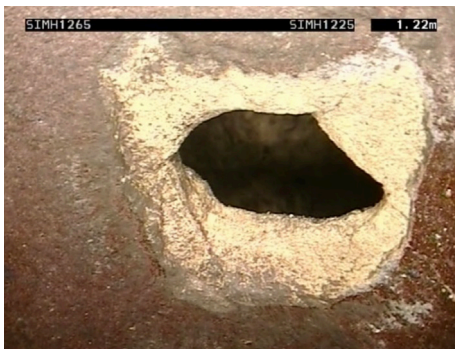
Dist.	Cont.	Code	Char.	Quant.	From	To
1.2		TM				
Remarks: Tomo (Cavity) visible through pipe hole						
1.2		PH		M	12	1

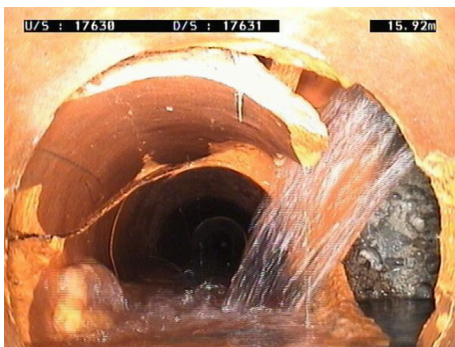
Dist.	Cont.	Code	Char.	Quant.	From	To
16		TM				
Remarks: Tomo (Cavity) visible missing piece of broken pipe						
16		PB		L	12	12
16		GC				
Remarks: Broken section of pipe is a junction and the water entering is flow from the lateral pipe (obscured)

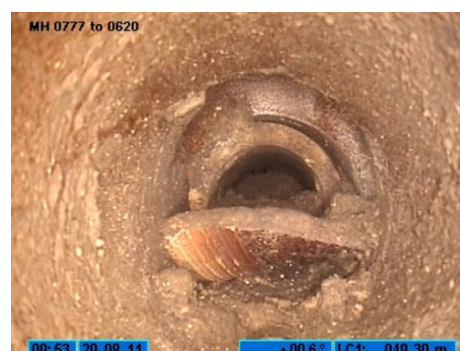
Dist.	Cont.	Code	Char.	Quant.	From	To
49.5		PX

Remarks: Pipe roof collapsed in with broken pipe and debris reducing pipe diameter >50% and pipe no longer functioning as a free flowing conduit.

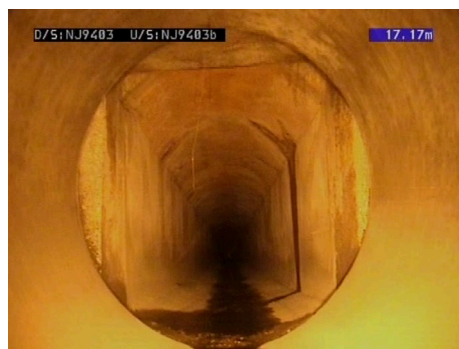
Dist.	Cont.	Code	Char.	Quant.	From	To
18.2		DC

Remarks: Change in pipe shape from Circular to Arch

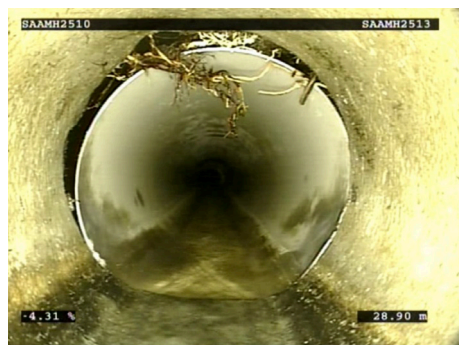
Dist.	Cont.	Code	Char.	Quant.	From	To
29.1		MC

Remarks: Concrete to PVC

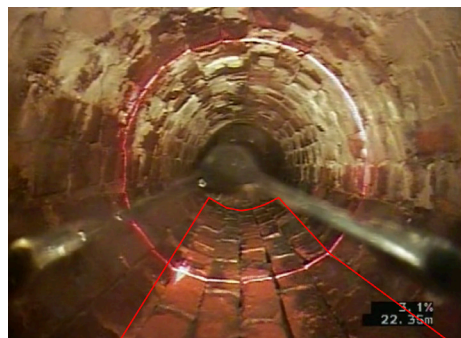
Dist.	Cont.	Code	Char.	Quant.	From	To
22.4	S1	MM		M	4	7

Remarks: Part or all the mortar is missing between bricks in the pipe invert

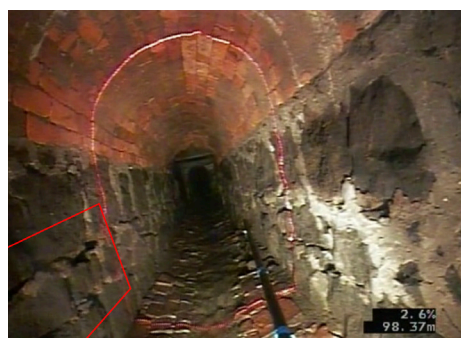
Dist.	Cont.	Code	Char.	Quant.	From	To
98.4		MM		S	7	8

Remarks: Part or all the mortar is missing between basalt block

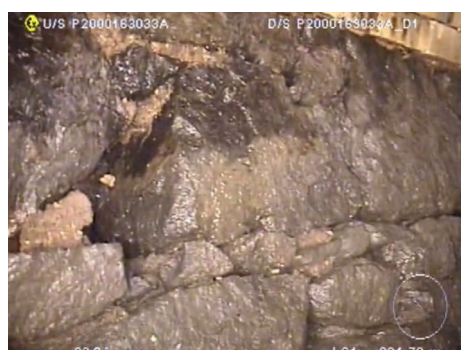
Dist.	Cont.	Code	Char.	Quant.	From	To
21.7		MM		S	7	10

Remarks: Part or all the mortar is missing between basalt block

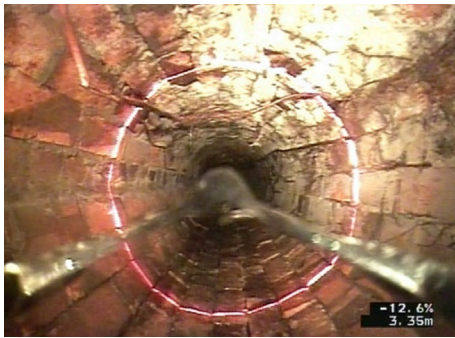
Dist.	Cont.	Code	Char.	Quant.	From	To
3.35	S1	MM		L	10	3

Remarks: Roots growing through the mortar joints indicating that some or all of the mortar is missing where the roots are present.

3.35	S2	RI	F	S	10	3
------	----	----	---	---	----	---

Remarks: Mostly fine Roots entering through mortar joints

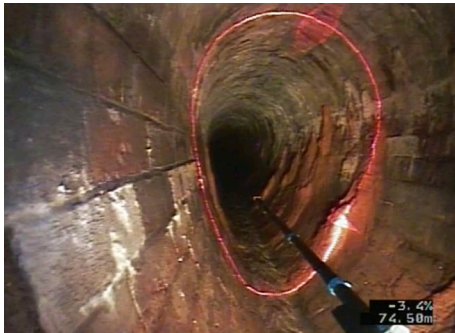
Dist.	Cont.	Code	Char.	Quant.	From	To
74.5	S1	MM		L	2	6

Remarks: Leakage through mortar joints indicating that some or all of the mortar is missing

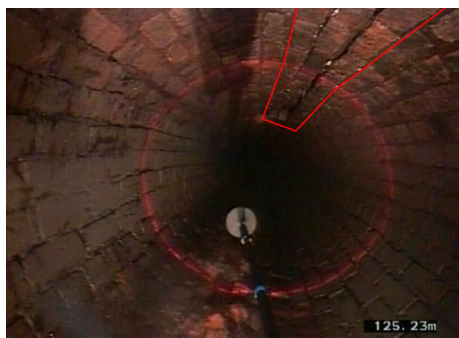
Dist.	Cont.	Code	Char.	Quant.	From	To
125.2	S1	MUS		S	1	2

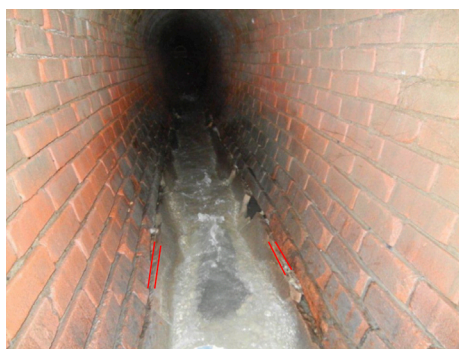
Dist.	Cont.	Code	Char.	Quant.	From	To
X	S1	DI		M	5	7

Remarks: 2 clear gaps between masonry units near the invert indicating a dropped invert

Dist.	Cont.	Code	Char.	Quant.	From	To
X		DE		S

Remarks: Debris in pipe invert

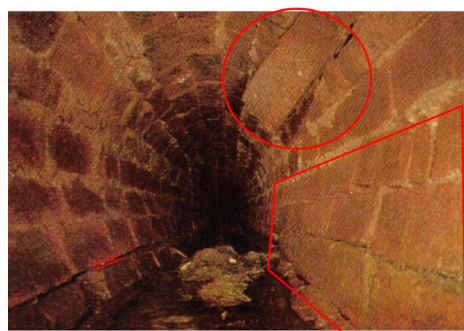
Dist.	Cont.	Code	Char.	Quant.	From	To
X		DMU	I	L	1	7

Remarks: 1 brick has moved out of position (1 o'clock) close to falling out. At least 2 other courses between 3 and 5 o'clock appear to be moving inwards.

X	SI	DI		S	5	7
-----	------	------	--	-----	-----	-----

Remarks: 2 longitudinal gaps near the invert indicating the invert has dropped relative to the grade of the pipe (coded as defect is continuous passing through the location of the displaced bricks)

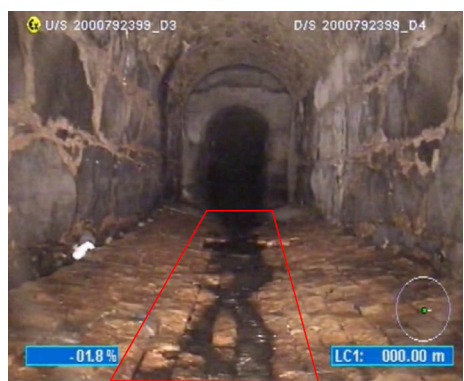
Dist.	Cont.	Code	Char.	Quant.	From	To
0.0	S1	DMU	O	S	5	7

Remarks: Bricks in the invert of the pipe have displaced down (outwards)

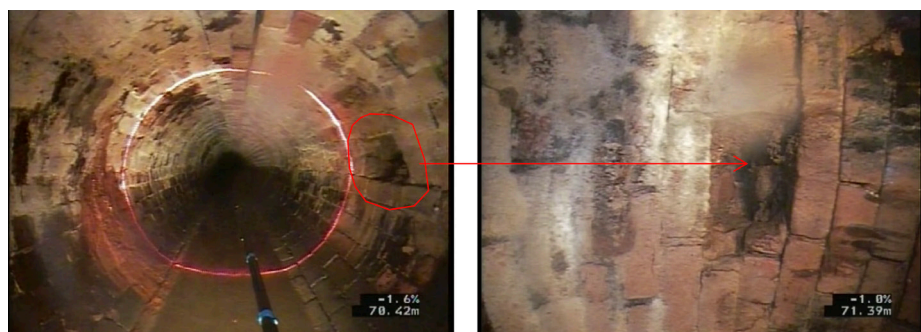
Dist.	Cont.	Code	Char.	Quant.	From	To	Remarks
70.9		MMU	NV	S	2	3	2 brick courses missing. Leakage through mortar joints evident by ED
70.9		ED		S	7	10	
70.4	SI	GC			5	7	Possible that invert is beginning to drop but gap is not wide enough to record as such.

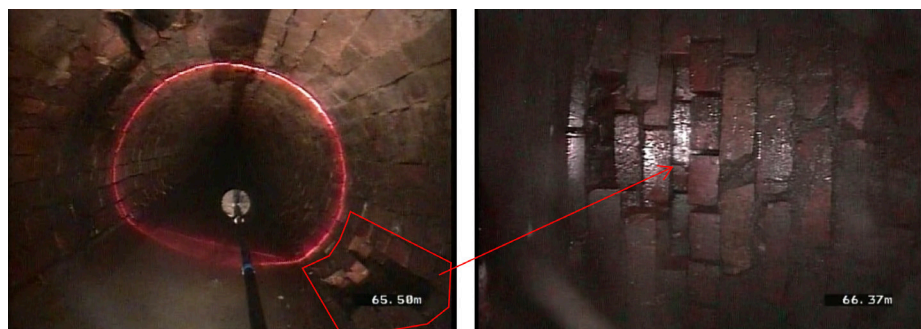
Dist.	Cont.	Code	Char.	Quant.	From	To	Remarks
65.6		MMU	V	S	4	5	At least 3 brick courses missing (more visible behind)

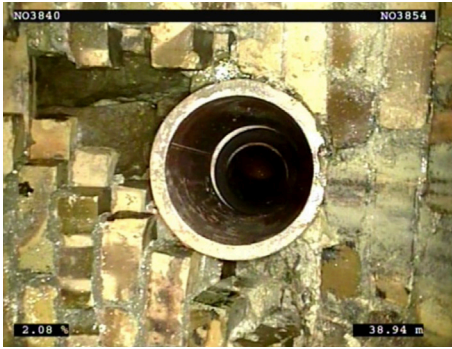
Dist.	Cont.	Code	Char.	Quant.	From	To
38.9		MM	NV	M	3	5

Remarks: Bricks below the lateral are missing (2 courses)

38.9		TM				
------	--	----	--	--	--	--

Remarks: Cavity visible

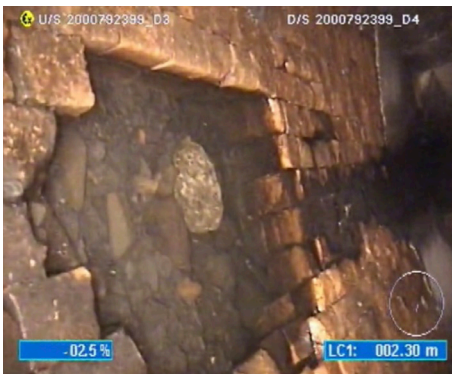
Dist.	Cont.	Code	Char.	Quant.	From	To
38.9		MM	NV	M	5	7

Remarks: Bricks in the invert are missing (camera is tilted)

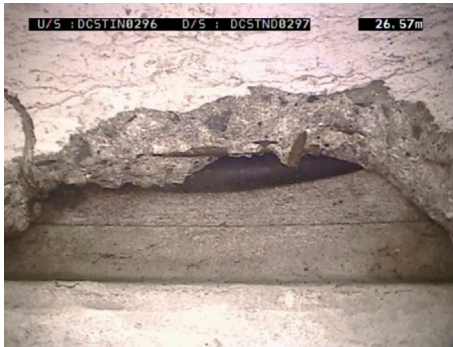
J3.1.3 – Damaged end of pipe (D)

Dist.	Cont.	Code	Char.	Quant.	From	To
26.6		JF	D	L	7	8

Remarks: End of the spigot is chipped exposing edge of displaced rubber ring.

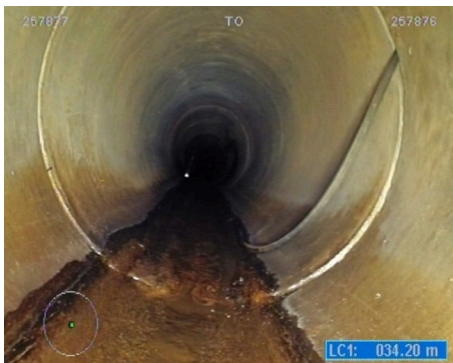
J3.1.4 – Faulty Seal (X)

Dist.	Cont.	Code	Char.	Quant.	From	To
34.5		JF	X	L	12	12

Remarks: Sealing rubber ring is broken and hanging inside the pipe

34.5		O	P	S	2	5
------	--	---	---	---	---	---

Remarks: Rubber ring

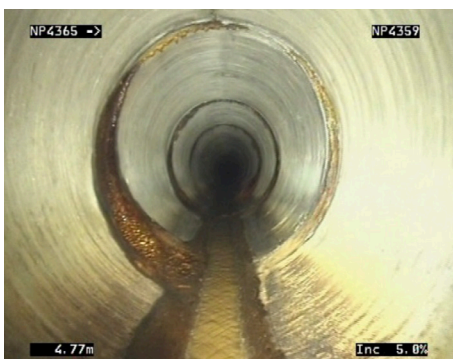
Dist.	Cont.	Code	Char.	Quant.	From	To
6		JF	X	L	12	12

Remarks: Encrustation deposits (left) and staining (right) from leakage through joint

6		ED		S	6	12
---	--	----	--	---	---	----

Remarks: Buildup on joint

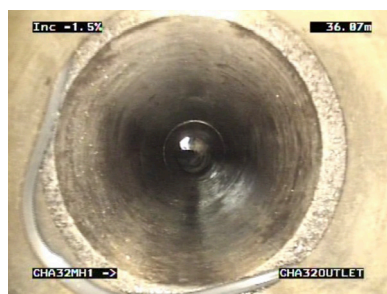
Dist.	Cont.	Code	Char.	Quant.	From	To
3.8		JO		S		
3.8		JF	X	L	4	10

Remarks: Rubber sealing ring displaced

Dist.	Cont.	Code	Char.	Quant.	From	To
3.8		O	P	S	5	9

Remarks: Rubber ring hanging inside the pipe

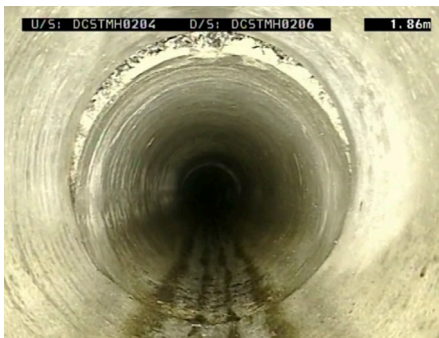
Dist.	Cont.	Code	Char.	Quant.	From	To
2.1		JD	V	S	9	3

Remarks: Vertical displacement up to 10% of the pipe diameter

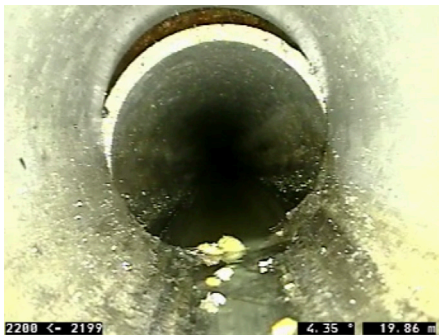
Dist.	Cont.	Code	Char.	Quant.	From	To
20.1		JD	V	M	8	2

Remarks: Vertical displacement down > 10% of the pipe diameter

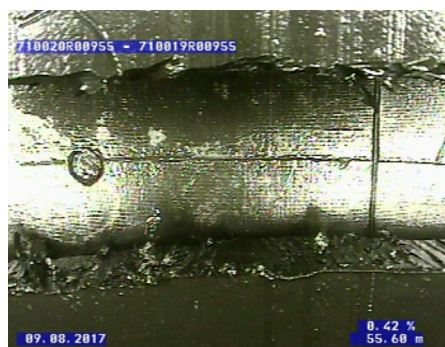
Examples:**J3.4.1 – Incorrect Insertion (I)**

Dist.	Cont.	Code	Char.	Quant.	From	To
55.6		W	I		12	12

Remarks: Poorly prepared pipe ends with internal gap within the electrofusion coupler of >5% of the pipe diameter (more than 10mm)

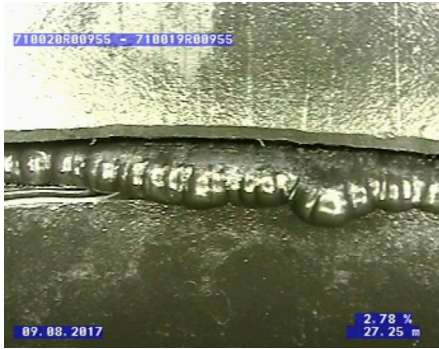
J3.4.2 – Electrofusion coupler (PE welding only) has partially melted (M)

Dist.	Cont.	Code	Char.	Quant.	From	To
2.8		W	M		10	2

Remarks: Melt has flowed out and filled the gap between the two pipe ends and is slightly protruding

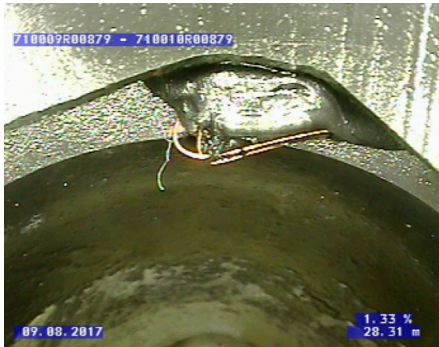
Dist.	Cont.	Code	Char.	Quant.	From	To
28.3		W	M		10

Remarks: Melt has flowed out a small gap between the cut-out pipe and EF saddle with wires exposed

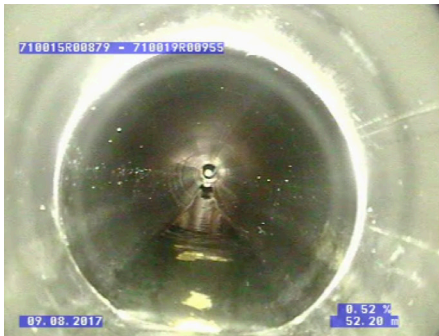
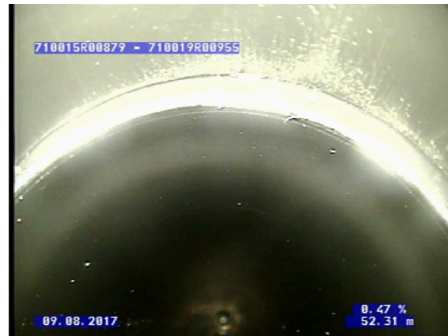
J3.4.3 – Ovality (O)

Dist.	Cont.	Code	Char.	Quant.	From	To	Remarks
52.3		W	O		12	12	2 brick courses missing. Leakage through mortar joints evident by ED
52.3		WL	C				Flow depth increases to approx. 5% due to EF joint ovality

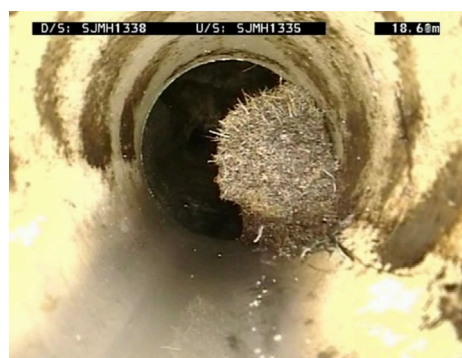
Dist.	Cont.	Code	Char.	Quant.	From	To
20.2		MHJ			12	12
Remarks: Manhole joint seal defective, roots intruding						
20.2		BRI			2	6
Remarks: Roots growing through manhole connection reducing cross-section by >50%

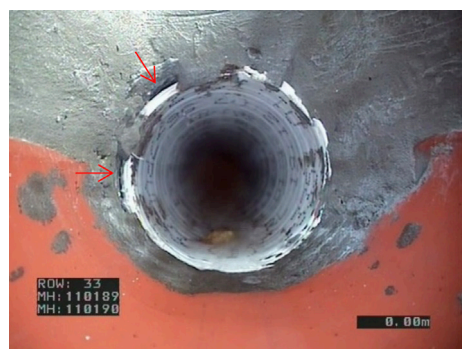
J3.5.1 – Liner Terminations with Manholes/Chambers

Dist.	Cont.	Code	Char.	Quant.	From	To
0.5		MHJ			8	11

Remarks: Gaps/defects in the end seal with the manhole

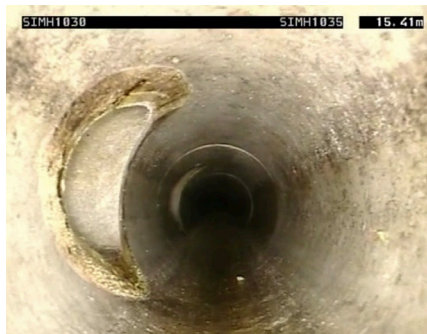
L4.1.1 – Open (O)

Dist.	Cont.	Code	Char.	Quant.	From	To
15.6		L	O		9	
Remarks: AC Junction 100mm						
14.4	S1	S	W	M	4	8
Remarks: Minor abrasion in the invert

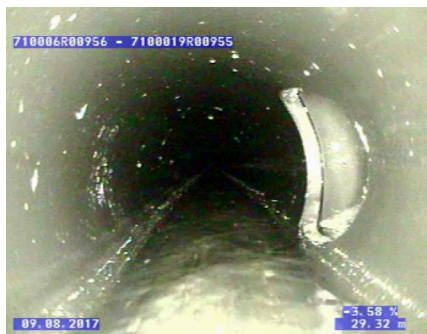
Dist.	Cont.	Code	Char.	Quant.	From	To
29.5		L	O		3	
Remarks: PE Fusion saddle connection, 100mm						
29.3	S1	DG		S	4	8
Remarks: Slight fat buildup above the flow level

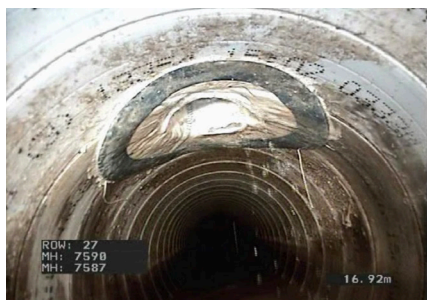
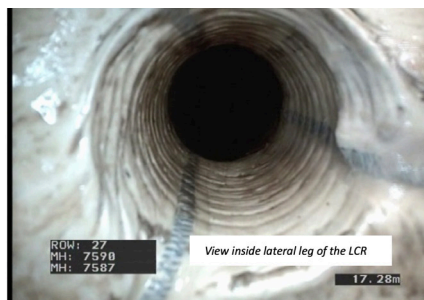
Dist.	Cont.	Code	Char.	Quant.	From	To	Remarks
17.3		L	O		12		Lateral Connection Repair, 100
17.3		PR	L		10	2	CIP Lateral Connection Repair (LCR)

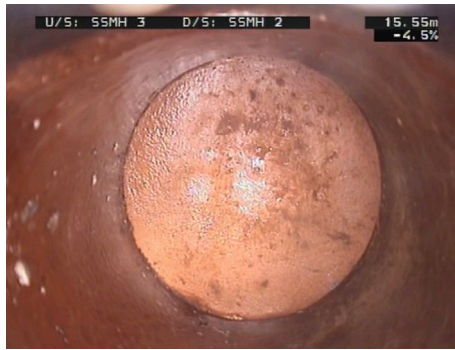
L4.1.2 – Blank (B)

Dist.	Cont.	Code	Char.	Quant.	From	To
15.6		L	B		3

Remarks: Lateral is capped

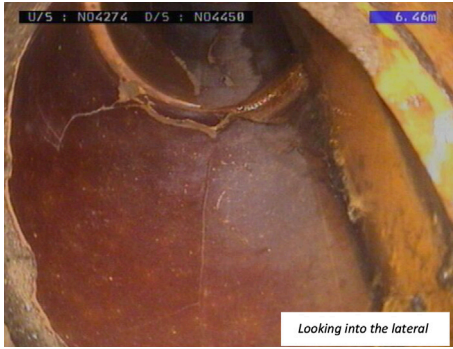
L4.2.1 – Cracks (C)

Dist.	Cont.	Code	Char.	Quant.	From	To
6.5		LF	C	L	3

Remarks: Displaced cracks inside the lateral stub. Poor seal around lateral connection

6.5		GC				
-----	--	----	--	--	--	--

Remarks: Discolored flow in the lateral

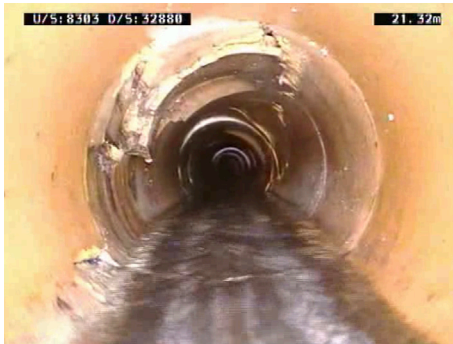
L4.2.2 – Broken Pipe (B)

Dist.	Cont.	Code	Char.	Quant.	From	To
19.7		LF	B	L	11

Remarks: Lateral connection is broken and the lateral partially protruding into the main

19.7		LP		M	11	
------	--	----	--	---	----	--

Remarks: Broken lateral connection protruding >10% in to the main

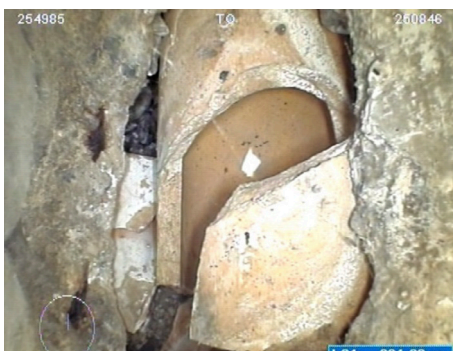
Dist.	Cont.	Code	Char.	Quant.	From	To
4.2		LF	B	L	12

Remarks: Lateral connection is broken with the broken pipe partially blocking the lateral

4.2		SV				
-----	--	----	--	--	--	--

Remarks: Stones/bedding visible through gap around the broken lateral connection
