A consistent approach across the 3 waters sector

NEW ZEALAND GRAVITY PIPE INSPECTION MANUAL

4TH EDITION

Prepared for Water New Zealand by
ProjectMax Ltd and Citycare Water 2019

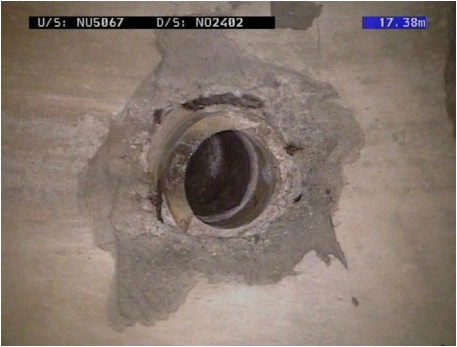
L4.2.3 – Seal (X)

Dist.	Cont.	Code	Char.	Quant.	From	To
17.4		LF	X	M	12

Remarks: Missing internal mortar. Possible pathway around the saddle connection

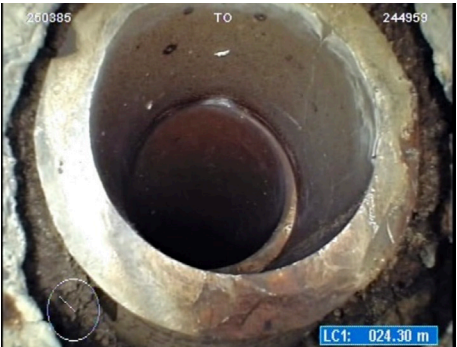
Dist.	Cont.	Code	Char.	Quant.	From	To
24.3		LF	X	L	10

Remarks: Missing mortar and Tomo visible through wall gap at lateral connection

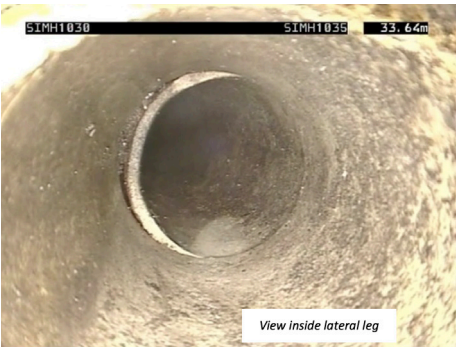
Dist.	Cont.	Code	Char.	Quant.	From	To
33.6		LF	X	M	2

Remarks: First joint is displaced with possible pathway through joint.

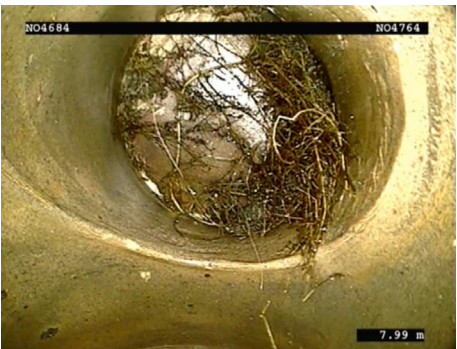
Dist.	Cont.	Code	Char.	Quant.	From	To
8		LF	X	L	3

Remarks: Roots entering through faulty seal of the blank cap

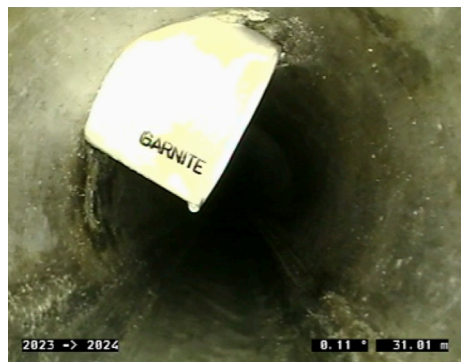
Dist.	Cont.	Code	Char.	Quant.	From	To
31.2		LP		L	10	
Remarks: Lateral protruding >25% (almost 50%)						
31.2		LF	X	M	10	
Remarks: Missing internal mortar, possible staining below lateral connection

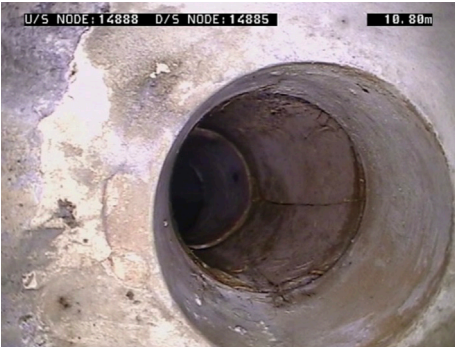
L4.4.1 – Branch Cracked (C)

Dist.	Cont.	Code	Char.	Quant.	From	To
10.8		LX	C		9

Remarks: Longitudinal Crack in the Lateral pipe beyond the first Joint

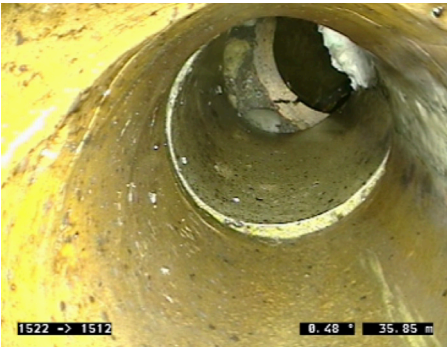
L4.4.2 – Displaced (D)

Dist.	Cont.	Code	Char.	Quant.	From	To
35.9		LX	D		3

Remarks: Significant joint displacement beyond the first joint

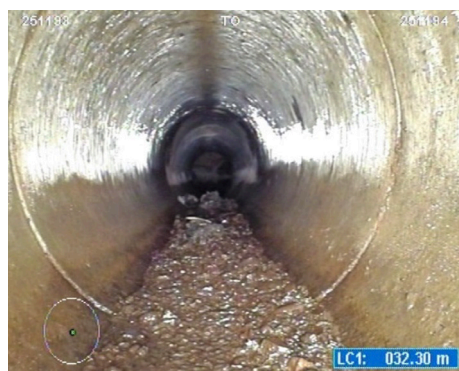
Dist.	Cont.	Code	Char.	Quant.	From	To
32.3	S1	DE		S

Remarks: Silty Gravels up to 10% reduction in diameter

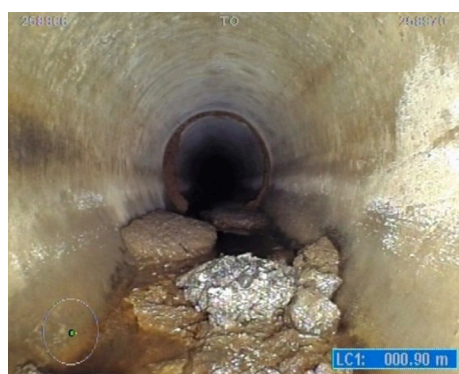
Dist.	Cont.	Code	Char.	Quant.	From	To
0.9		DE		M

Remarks: Rocks and Stones up to 25% reduction in diameter

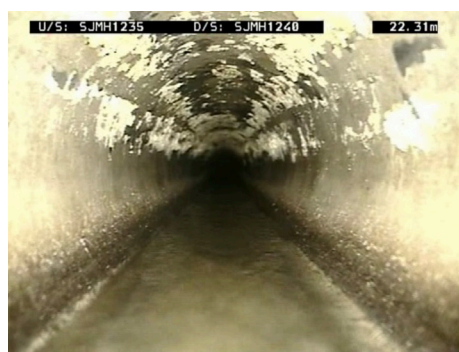
Dist.	Cont.	Code	Char.	Quant.	From	To
22.3	S1	DG		S	9	3

Remarks: Thin layer of fat on the pipe roof

Dist.	Cont.	Code	Char.	Quant.	From	To
22.3	S2	S	W		4	9

Remarks: From flow in the pipe

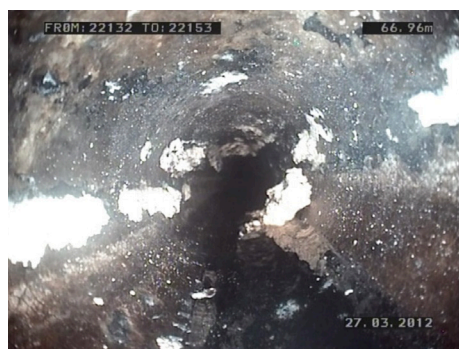
Dist.	Cont.	Code	Char.	Quant.	From	To
67	S1	DG		M	8	6

Remarks: “chunks” of fat remaining attached to the pipe wall post cleaning (pipe was blocked before the cleaning)

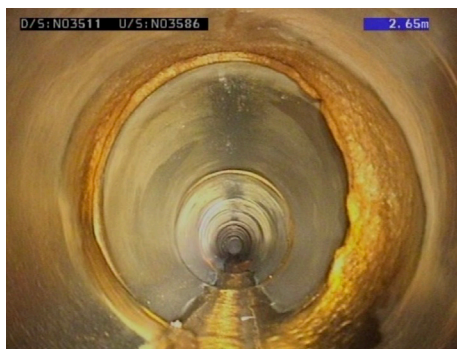
Dist.	Cont.	Code	Char.	Quant.	From	To
2.8		ED		M	7	5
Remarks: Buildup of encrustation deposits on the pipe wall around joint with faulty joint seal						
5		JF	X	L	7	5

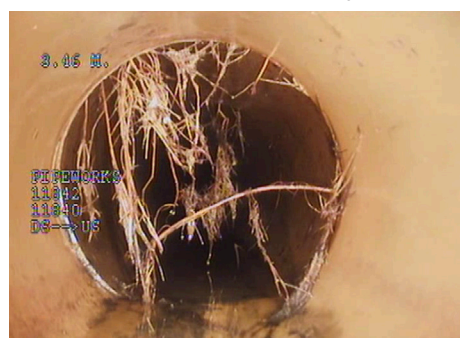
S5.4.1 – Fine Root Intrusion Through Joint

Dist.	Cont.	Code	Char.	Quant.	From	To
3.6		RI	F	S	12	12
Remarks: Fine roots through faulty joint seal. Although the location of the roots almost covers a substantial portion of the pipe diameter, they only effectively reduce the pipe diameter by <10% as flow in the pipe would push the roots up						
3.6		JF	X	L	12	12
Remarks: Faulty joint seal evidenced by the roots growing through the joint

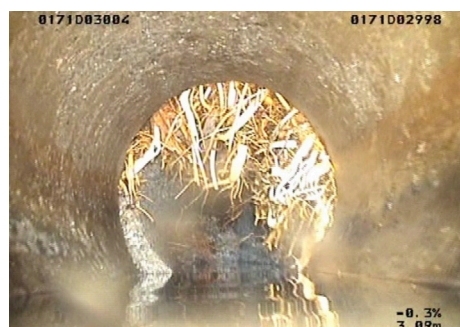
S5.4.2 – Recently Cut Root Beard

Dist.	Cont.	Code	Char.	Quant.	From	To
3.3		RI	RB	L	9	5
Remarks: Root beard post pipe cleaning (fine roots have been removed)						
3.3		JF	X	L	12	12
Remarks: Faulty joint seal evidenced by the roots growing through the joint						
3.3		JD	H	S	10	5

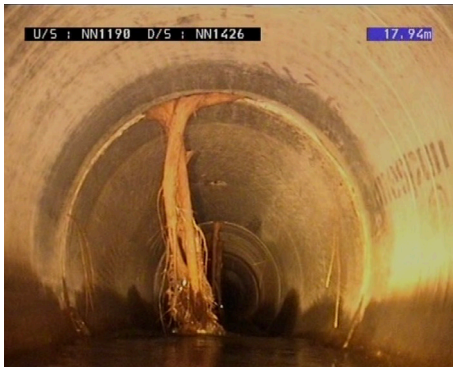
S5.4.3 – Tap Root

Dist.	Cont.	Code	Char.	Quant.	From	To
18.8		RI	T	M	6	12
Remarks: Tap root growing through faulty joint seal						
3.6		JF	X	L	12	12
Remarks: Faulty joint seal evidenced by the root growing through the joint

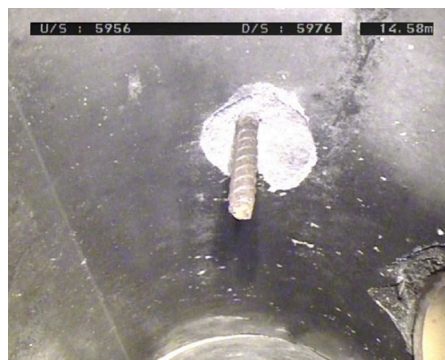
S5.5.2 – Permanent Obstruction (P)

Dist.	Cont.	Code	Char.	Quant.	From	To
14.6		O	P	S	12

Remarks: Steel bar intruding into the pipe

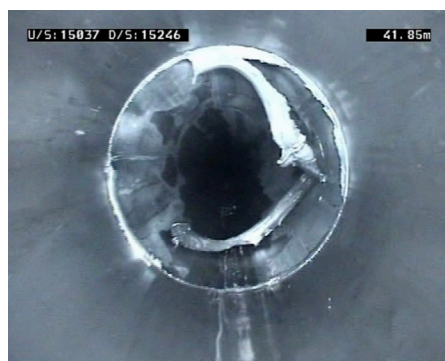
Dist.	Cont.	Code	Char.	Quant.	From	To
42		O	P	M	12	7

Remarks: PE Butt Weld bead partially removed

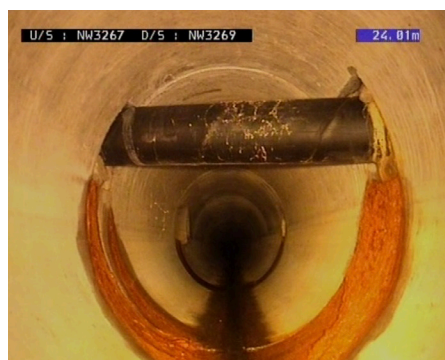
Dist.	Cont.	Code	Char.	Quant.	From	To
24.5		O	S	M	10	2

Remarks: Service strike with steel pipe crossing the pipe

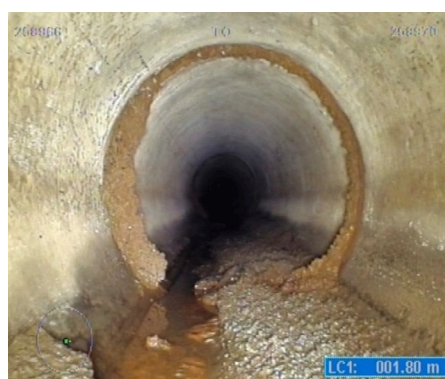
Dist.	Cont.	Code	Char.	Quant.	From	To
1.8	S1	O	P	M	5	7

Remarks: Concrete in the pipe invert

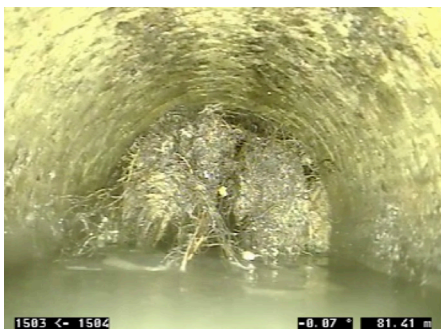
S5.6.1 – Root Blockage (RI)

Dist.	Cont.	Code	Char.	Quant.	From	To
81.6		B	RI			
Remarks: Roots fill the pipe						
81.4		WL	T			
Remarks: Flow depth approx. 40% of pipe diameter – holding due to blockage

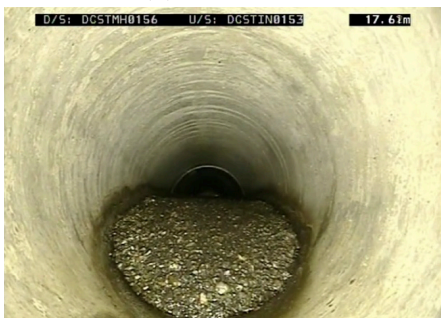
S5.6.3 – Other (Z)

Dist.	Cont.	Code	Char.	Quant.	From	To
17.7		B	Z

Remarks: Blockage – concrete obstruction in pipe >50% of pipe diameter

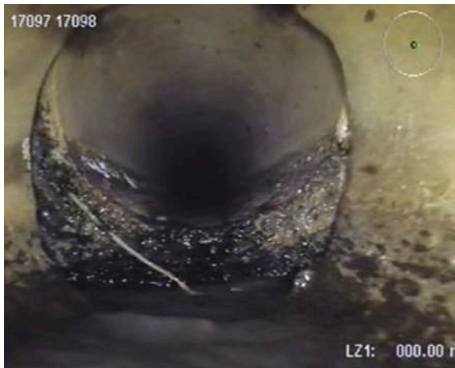
Dist.	Cont.	Code	Char.	Quant.	From	To
0.5		EX			5	7
Remarks: Flowing out of the pipe through displaced joint						
0.5		JD	V	L	3	11
0.5		JF	X	L	12	12

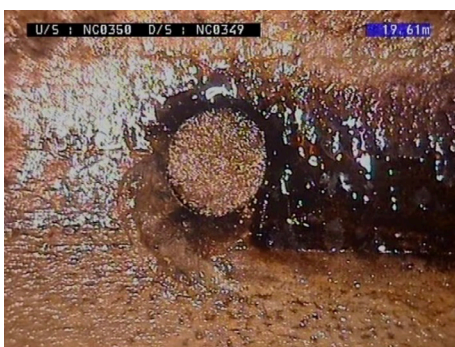
Dist.	Cont.	Code	Char.	Quant.	From	To
19.6		IP		S	12	5
Remarks: Seeping infiltration through lifting eye. Seeping infiltration visible as the wet sheen on the pipe wall						
19.6		CF			12	
Remarks: Lifting eye

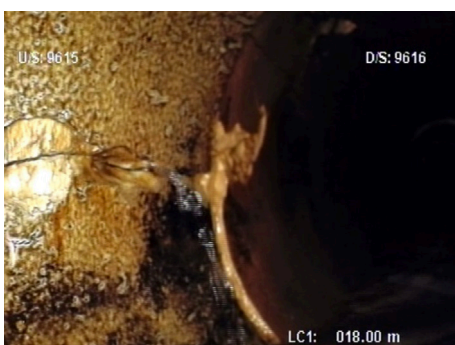
Dist.	Cont.	Code	Char.	Quant.	From	To
18.1		IP		M	7	9
Remarks: Running infiltration from longitudinal crack near joint						
17.6		CL	C		9	
Remarks: Crack edges chipped and IP through crack

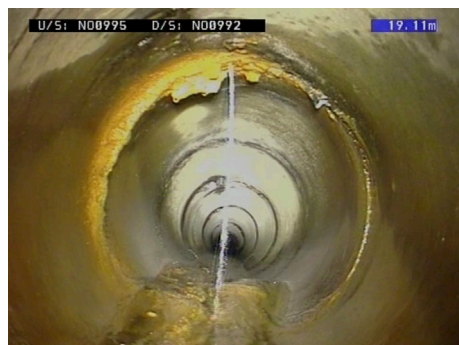
Dist.	Cont.	Code	Char.	Quant.	From	To
19.3		IP		L	6	12
Remarks: Jetting infiltration through faulty joint seal						
19.3		JF	X	L	7	2
Remarks: Infiltration through joint and build-up of ED						
19.3		ED		S	8	2
Remarks: Build-up on pipe wall around joint

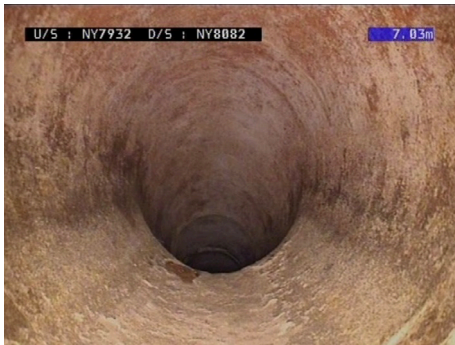
S5.11.1 – Down (D)

Dist.	Cont.	Code	Char.	Quant.	From	To
7.2		LD	D			
Remarks: 45° ramp down						
7.2		CF				
Remarks: Start of Syphon (top of syphon)						
7.0		LC				
Remarks: Cement lining (steel pipe) not present

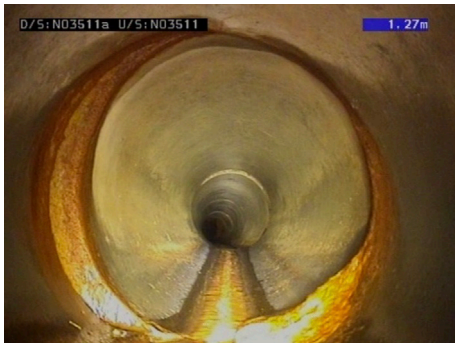
S5.11.2 – Up (U)

Dist.	Cont.	Code	Char.	Quant.	From	To
1.5		LD	U			
Remarks: 15° -20° ramp up						
1.5		JD	H	S	6	12
Remarks: Horizontal displacement (10% of pipe diameter)						
1.5		JO	A	M	2	11
1.5		JF	X	L	12	12
Remarks: Joint seal faulty with staining and ED on pipe wall around the joint						
1.5		ED		S	3	6
Remarks: Buildup on pipe joint

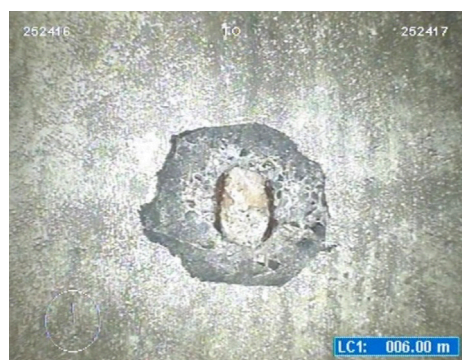
Dist.	Cont.	Code	Char.	Quant.	From	To
6		CF			12

Remarks: Sealed lifting eye with chipping and small amount of reinforcing steel exposed. (Exposed reinforcement is not coded separately)

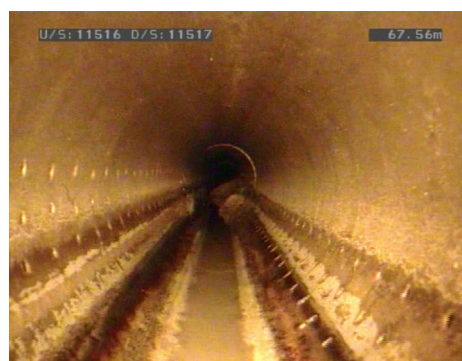
Dist.	Cont.	Code	Char.	Quant.	From	To
67.6	S1	CF			4	9

Remarks: Drainage 'weep' holes in rows

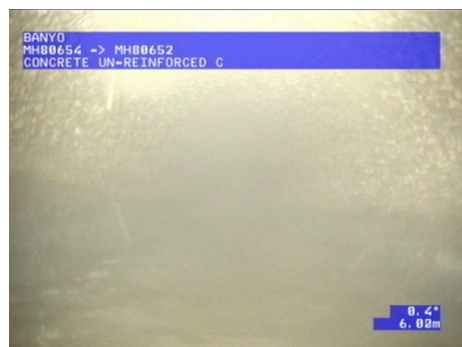
16.4.1 – Steam or Fog (S)

Dist.	Cont.	Code	Char.	Quant.	From	To
6.02		LOV	S			
Remarks: Unable to see the pipe due to Fog						
6.02		IA				
Remarks: Inspection Abandoned due to Loss of Vision

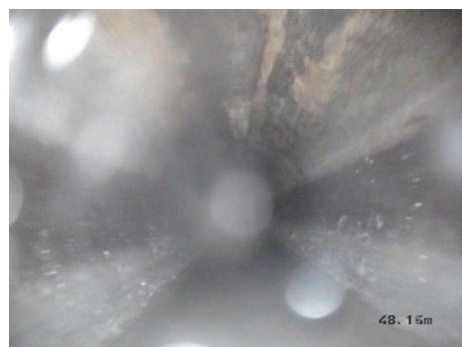
16.4.2 – Grease on Lens (G)

Dist.	Cont.	Code	Char.	Quant.	From	To
48.1		LOV	G

Remarks: Unable to see the pipe due to Waterdrops/grease on the lens

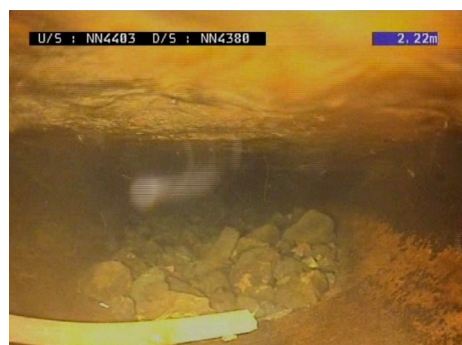
16.4.3 – Underwater (UW)

Dist.	Cont.	Code	Char.	Quant.	From	To
2.22		LOV	UW			
Remarks: Unable to see the pipe due to the camera being under water						
2.3		DE		M		
Remarks: Gravels

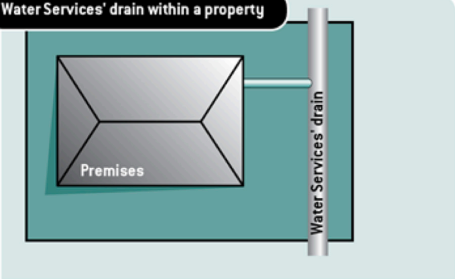
Scenario	Ownership
<p>1</p> <p>Water Services' drain within a property</p>

<p>All Local Authorities consider where a lateral serves one property and the lateral is entirely within that private property it would be a private lateral.</p>
<p>2</p> <p>Water Services' drain within a legal road or reserve</p>

Table C1.1 – Examples of private lateral ownership

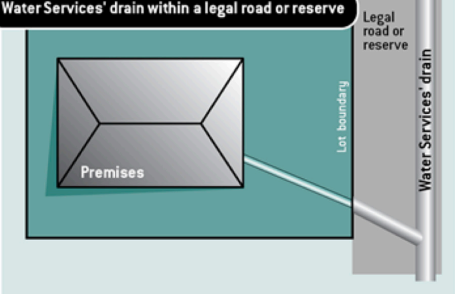
<p>Most Local Authorities consider where a private lateral crosses a property boundary into a legal road or reserve, the lateral ownership will change to public.</p> <p>Some will define the lateral to be private right up to the connection to the council main, even if this is under the public road.</p>
<p>3</p> <p>Water Services' drain outside a property</p>

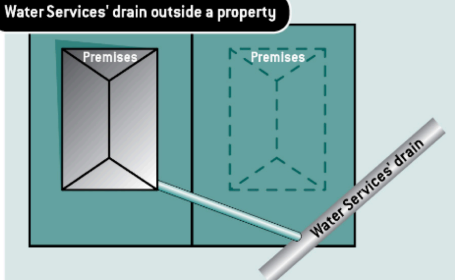
<p>Some Local Authorities consider where a lateral crosses a property (Lot) boundary into a neighbouring private property, the ownership would remain private, (owned by the property it serves) up to the public main.</p> <p>Conversely some Local Authorities, like scenario 2, consider where a private lateral crosses any property (Lot) boundary the ownership changes to public.</p>

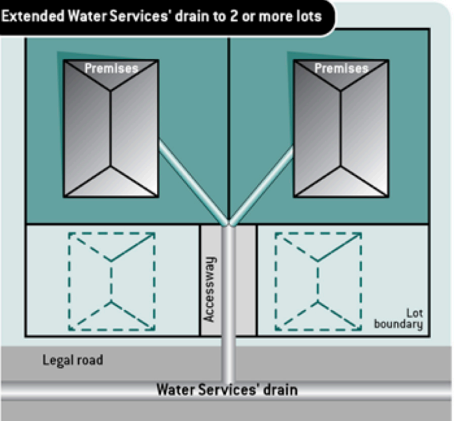
<p>4</p> <p>Extended Water Services' drain to 2 or more lots</p>

<p>Most Local Authorities consider where a lateral serves two or more properties it is public.</p> <p>A shared drain could also have been installed as a 'Drain in Common' and considered to be private.</p>
<p>5</p> <p>Cross-lease or Unit title</p>

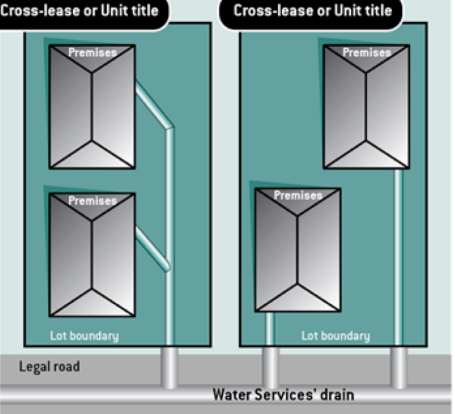
<p>Most Local Authorities consider where a lateral serves two cross leased properties then it is private, and the owners of the cross leased properties jointly own, and are responsible for, its maintenance.</p>

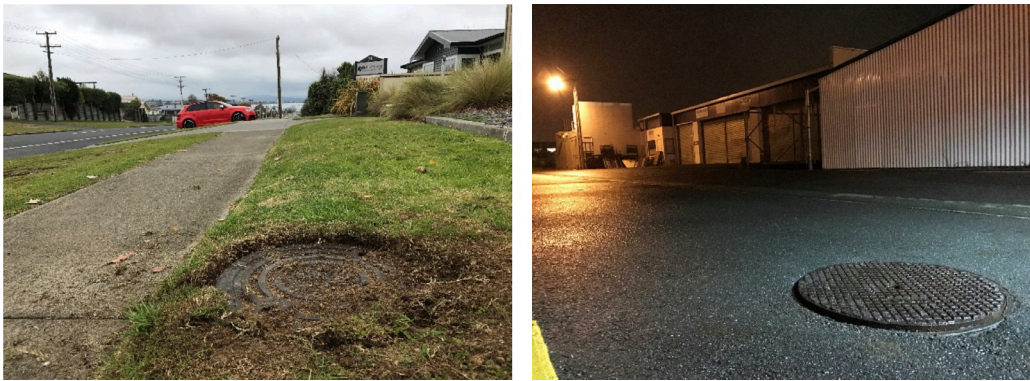
Figure D1.2.2 – Examples of manhole location images

- The location can be seen relative to structures or features nearby the manhole, i.e. fences, roads, buildings etc.
- The position of the manhole cover to the surrounding surfaces and its height. The footage or images shall clearly show whether the manhole cover is sitting higher than, lower than, or flush with the ground surface.
- The condition of the manhole cover and frame and how it is seated can be seen.
- Any settlement issues with the surface around the manhole cover can be observed.

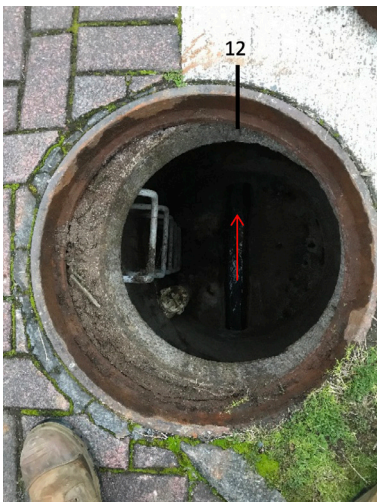
Figure D1.2.3 Initial view at the start of the inspection, outlet at 12 o'clock and the cover frame visible

An initial view of manhole shall be provided looking down the manhole, so all features can be seen in relation to each other with the outlet shown in the 12 o'clock position. The manhole cover frame must be included in the initial inspection footage.

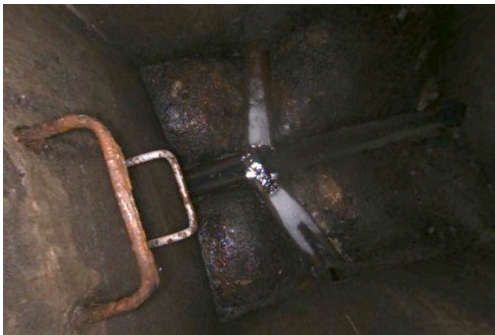
Figure D1.2.5 – Examples of photos

Example 1st photo showing corroded step rung

For all other inspections, Pole Cameras or Action Cameras that are not able to view vertically down the manhole chamber, or the second/subsequent photographs (with CCTV camera) is in a panned position (zoomed if required). The second or subsequent photographs shall be added to the log sheet report using the General Photograph code (GP). Remarks shall be provided to describe the view perspective if the image has been zoomed.

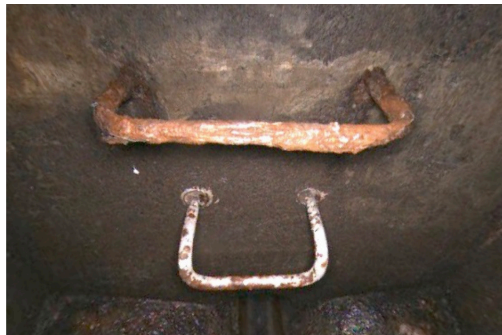
Example 2nd photo providing a panned view of corroded step rung

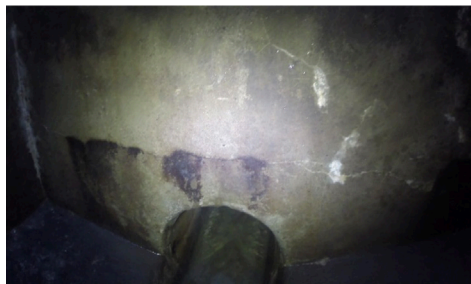
Dist.	Cont.	Code	Char.	Quant.	Location	From	To
X		HCC		L	CH	11	1
Remarks: Vertical crack with chipping of the edges							
Y		HL	CB			12	
Remarks: 225mm Outlet.

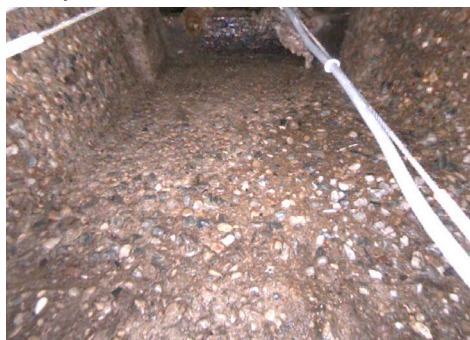
Dist.	Cont.	Code	Char.	Quant.	Location	From	To
18.54	S1	HS	AP		12	12	CH
Remarks: Corrosion of chamber wall – aggregate protruding							
19.29	F1	HS	AP		12	12	CH

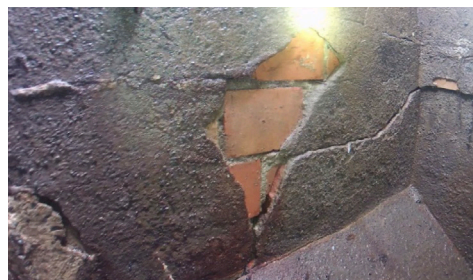
Dist.	Cont.	Code	Char.	Quant.	Location	From	To
X		HPL	RM		CH	7	11

Remarks: Rendered mortar has bulged and some of the mortar is missing.

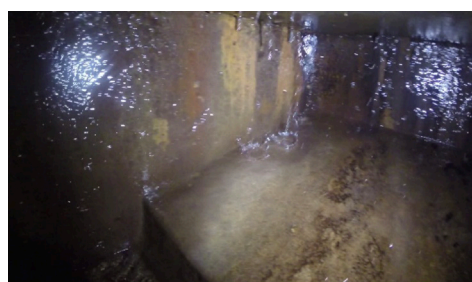
Dist.	Cont.	Code	Char.	Quant.	Location	From	To
X		HJFX		L	CH	6	9
Remarks: Joint seal between Chamber and Lid is faulty with infiltration.							
X		HIP		M	CH	6	9
Remarks: Running infiltration through joint 'splashing' on benching.

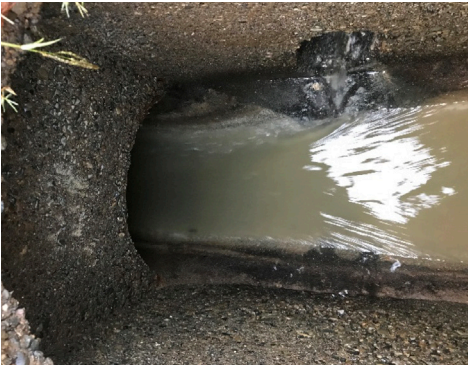
Example:
Lateral connecting pipe – Under Benching

Dist.	Cont.	Code	Char.	Quant.	Location	From	To
1.02		HL	UB		3		
Remarks: 100mm Connecting under benching.							
0.2		HS	AP		12	12	CH
Remarks: Down to channel.							
1.3		HL	CB		12		
Remarks: 300mm Outlet.

Note: appears that HS AP is also present in the throat or lid.

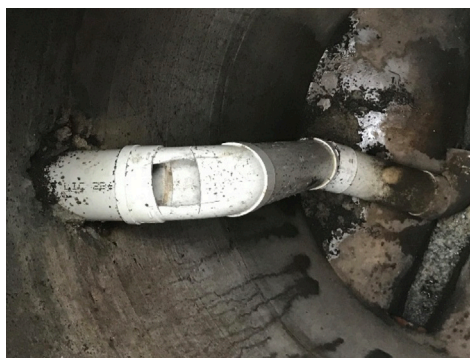
Dist.	Cont.	Code	Char.	Quant.	Location	From	To
1.4		HL	ID		8		
Remarks: 100mm Internal Drop – outlet obstructing channel							
0.88		HLF	X		8		
Remarks: No internal seal around connection No evidence of a pathway							
1.9		HDE		S	7	9	B
Remarks: Soil deposits on benching.							
2.15		HL	CB		6		
Remarks: 100mm							
2.15		HO	P	L			
Remarks: Dropper outlet obstruction the channel.							
2.15		HDE		L			C
Remarks: Paper buildup due to obstructing dropper outlet.

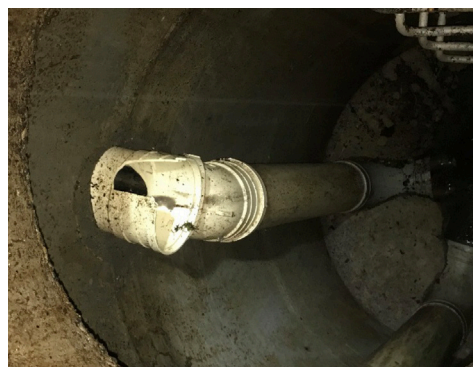
Drop Pipe is Cracked

Dist.	Cont.	Code	Char.	Quant.	Location	From	To
1.02		HL	ID		9		
Remarks: 150mm Internal Drop.							
1.02		HDP	C		9		
Remarks: Top of the Dropper (inspection) is cracked and broken.							
1.1		HL	ID		6		
Remarks: 150mm.

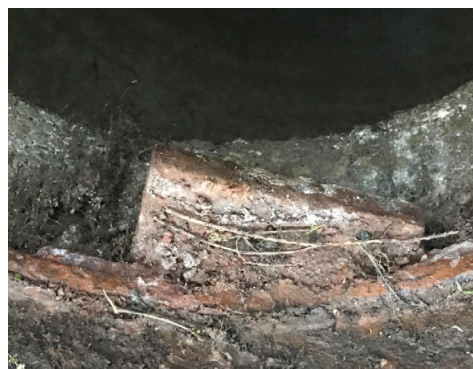
Defective Cover and/or frame – Gap or hole between frame and Lid.

Dist.	Cont.	Code	Char.	Quant.	Location	From	To
0.1		HFR	G

Remarks: Frame sitting upon a brick with a gap between the frame and lid.

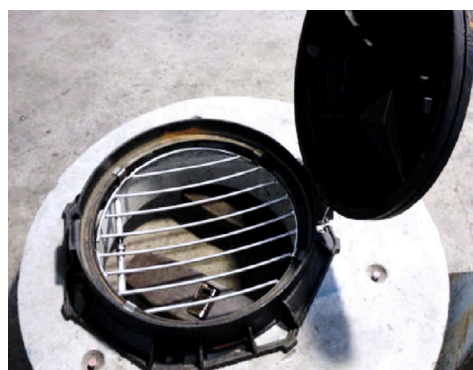
Device Cover and frame – Access Barrier

Dist.	Cont.	Code	Char.	Quant.	Location	From	To
0.1		HUF	AB				
Remarks: Impact Safety Grille.

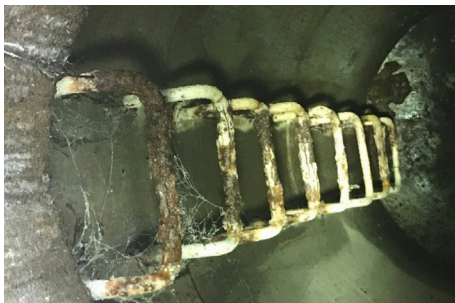
Dist.	Cont.	Code	Char.	Quant.	Location	From	To
0.6	S1	HSL	SC		9

Remarks: Steps Significantly corroded.

2.7	F1	HSL	SC		9		
3.1		HDE		S	9	10	B

Remarks: Soil deposits on the benching.

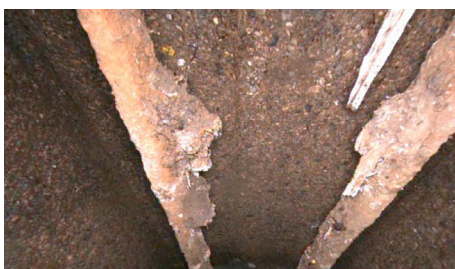
Dist.	Cont.	Code	Char.	Quant.	Location	From	To
15.3	S1	HSL	LRM		12

Remarks: Ladder significantly corroded, and rungs are missing.

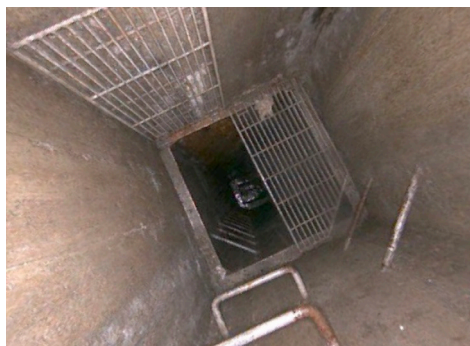
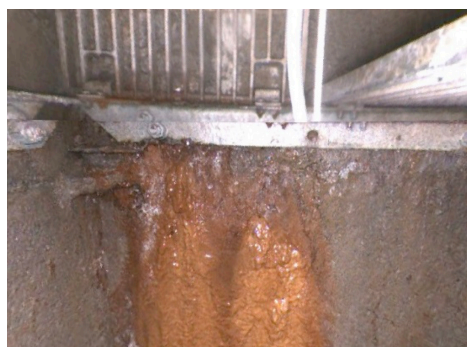
Dist.	Cont.	Code	Char.	Quant.	Location	From	To	Remarks:
3.4		HSP	BL					Staging Platform – fixings appear to be defective
3.4		HED		S	7	9	CH	ED from leakage at Staging platform fixings
3.4		HIP		S	7	9	CH	Seepage – ED surface appears to be wet

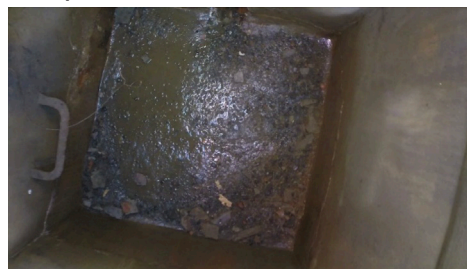
Dist.	Cont.	Code	Char.	Quant.	Location	From	To
X		HBN	N				
Remarks: No benching in the manhole.							
X		HDE		S	C		
Remarks: Silt, stones in the base of the manhole.

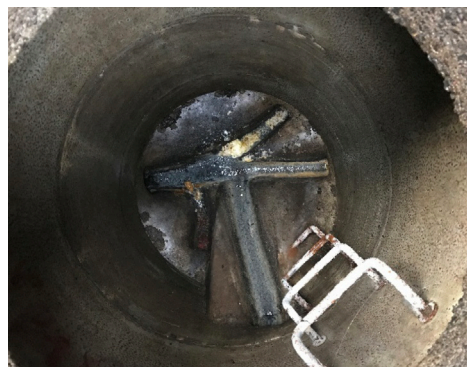
Dist.	Cont.	Code	Char.	Quant.	Location	From	To
X		HDE		L	B		
Remarks: Thick layer of debris on the benching.							
Y		HDE		S	C		
Remarks: Thin layer of silt in the channel.

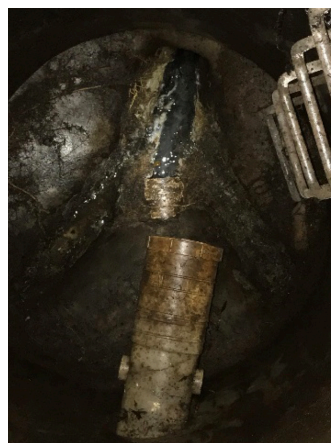
Dist.	Cont.	Code	Char.	Quant.	Location	From	To
2.6		HDG		M			C
Remarks: Fat build in channel.							
2.5		HDE		S	8	11	B
Remarks: Soil deposits on the benching.							
2.6		HL	CB		12		
Remarks: 150mm outlet.							
2.5		HL	CB		4		
Remarks: 100mm.							
1.8		HL	ID		6		
Remarks: 100mm – discharges under benching – slightly obstructing in the channel.							
2.6		HO	P	S	6		
Remarks: Outlet of dropper obstructing flow.							
2.54		HL	CB		8		
Remarks: 100mm.

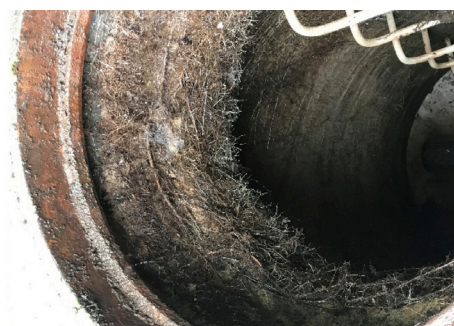
Example:

Dist.	Cont.	Code	Char.	Quant.	Location	From	To
0.1		HRI	M	S	12	12	TH
Remarks: Mass of mostly fine roots.							
1.2		HRI	M	S	12	12	CH

- Where the effective reduction in diameter is >50%, the defect shall be coded using the defect code HB, Blocked. Consideration should be given to the effective reduction in the channel diameter, e.g. a “curtain” of fine roots extending over the full pipe diameter may be coded within the small severity band if the effective actual reduction in the diameter is less than 10% (where the curtain “flaps” out of the way of the flow).
- Where the roots are located on the benching quantification is based on Outlier Method 7.
- Where roots are in the channel, circumferential location is not required.
- Either truly continuous or where roots are interspersed occurring within a metre apart for greater than 1m.

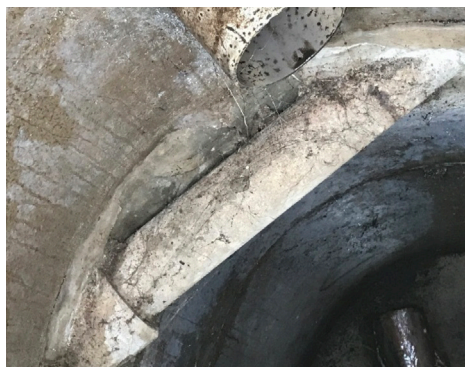
Example:

Dist.	Cont.	Code	Char.	Quant.	Location	From	To
0.8		HSC	NA		4	7	
Remarks: 100mm (Estimated).							
0.5		HL	PD		6		
Remarks: 100mm.							
1.5		HL	CB		6		
Remarks: 150mm.

Code	Description
HSC	Sealed Conduit Through Manhole ¹
Additional Information	
Characterisation ¹ – Record details of the access to the conduit using the following codes:	
CM	Proper Access Provisions Exist but Covers are Missing
CS	Access is Possible, but Covers are Sealed
NA	There is No Access to the Conduit
Quantification – No additional quantification required.	
Circumferential location: Record the location of the feature as a single or pair of clock references.	
Continuous Defect: Not Applicable.	
Descriptive Location: Not Required.	
Notes:	
1. Record the diameter of the conduit, and if possible, the type of service conduit in the remarks.

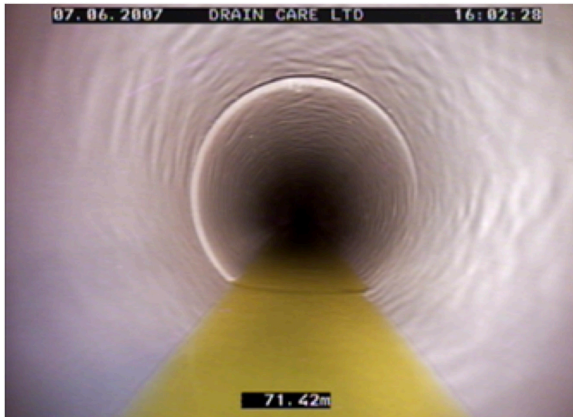
Figure E3.7 – Example of ‘normal’ internal waviness in PVC-U pipe

Internal “Waviness” or cosmetic “rippling” seen in PVC gravity or pressure pipes of thick wall or large diameter is normal and does not constitute any fault to the pipe or its performance.

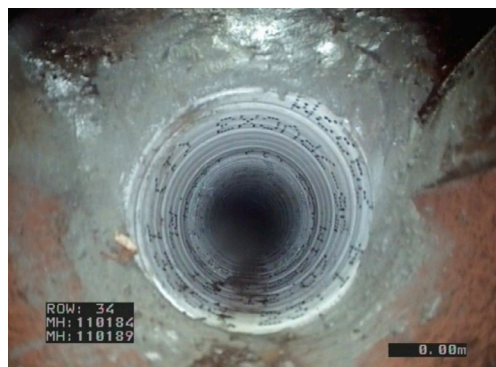
Figure E3.8 – Examples of Liner termination seals (end seals) in manholes

Good example of an end seal and transition in a Spiral Wound pipe.

- A transition or 'ramp' at the liner interface in the manhole – the liner internal diameter is smaller than the existing pipe, so a step is created in the channel invert. A mortar ramp smoothly transitions the flow from the channel into the liner. Ideally this ramp would have at least a 1 in 2 slope, but a 1 in 1 is acceptable to prevent debris building up.
- Provides a smooth and tidy surface within the manhole that prevents paper or other material catching or building up around the entrance to the liner.

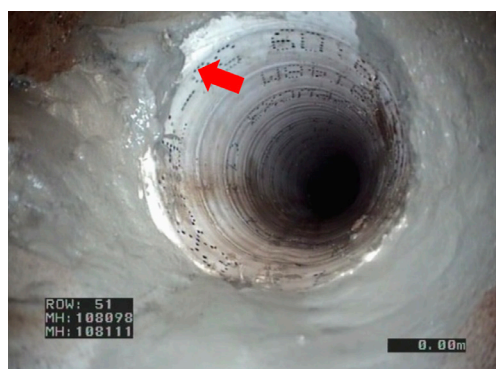
Liner termination is sealed but there is excess mortar causing rough entry and an obstruction

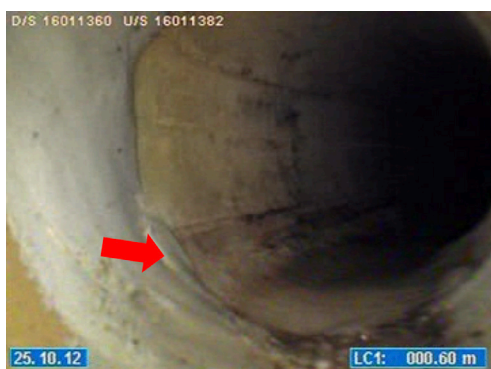
Excess mortar on end seal affecting the transition between the channel and the liner causing an obstruction to the flow

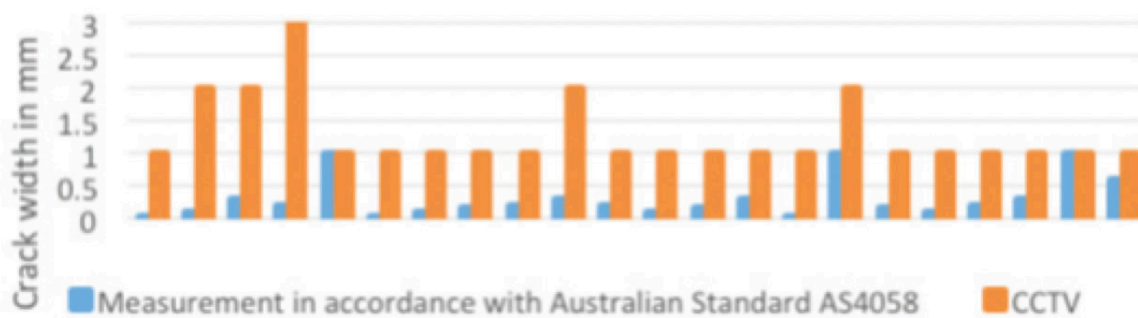
Figure C1 – Results of CPAA study comparing estimated widths of crack from CCTV inspection against actual width measurements

- 90% of the CCTV based estimates were many times greater than the actual readings
- On average, the estimated crack widths were 4 times greater than the actual measurement.
- No estimated width of less than 1mm was recorded by the CCTV operators (e.g. all cracks from 0.05mm to 1mm were recorded as 1mm or more).

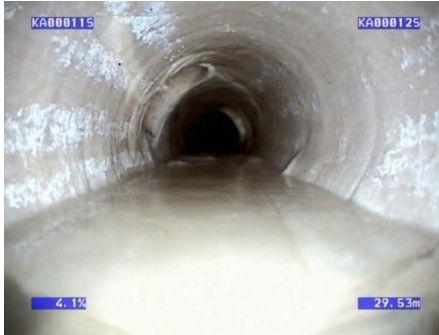
Figure D1 Examples of reflected latent defects and existing features in CIPP and Fold and Form liners

CIPP Lateral Junction Repair, (LJR) installed within a deformed pipe (ovality >20%)

Figure D1 provides some examples of latent defects that could be seen in CIPP and Fold and Form liners. These examples of reflected latent defects are not liner defects but should be noted on inspection reports.

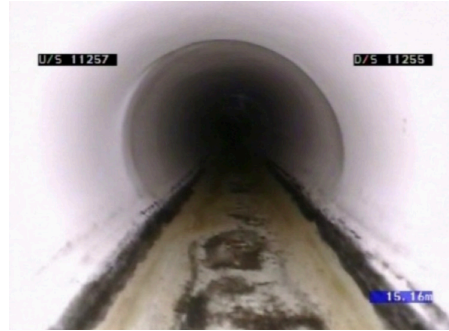
PVC Fold and Form liner installed within a deformed pipe (Ovality >20%)

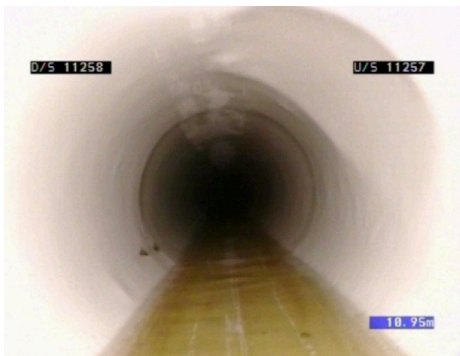
A 'dimple' produced in a PVC fold and Form liner over a lateral connection

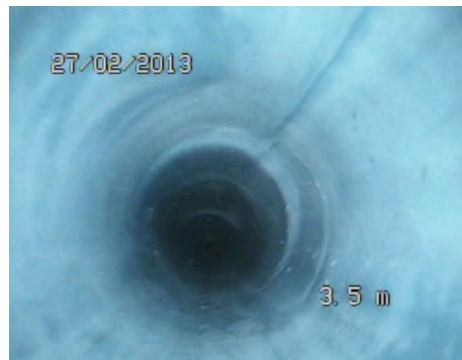
CIPP liner reflecting a joint in an EW pipe

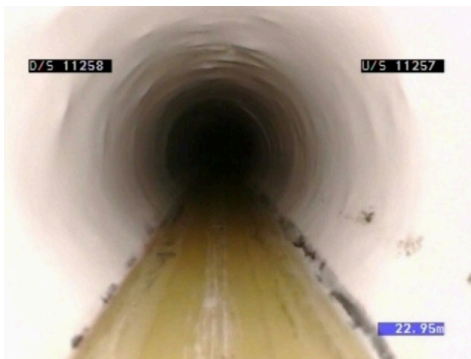
Mirrored irregular shape of the broken existing pipe beneath a Fold and Form liner

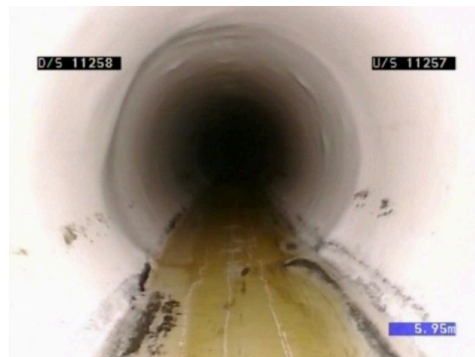
A small displaced and open joint reflected in a Fold and Form liner

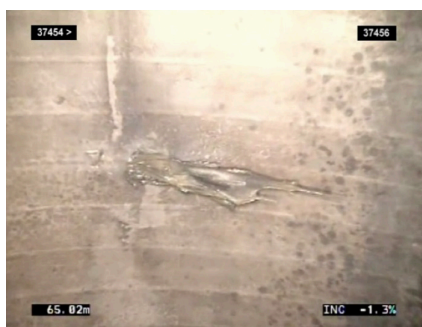
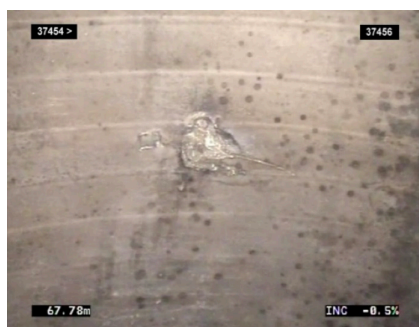
Figure D2 – Examples of vacuum and impregnation patches in CIPP liners

Vacuum/Impregnation patch – hot patch

Welded patches will look a bit like a 'repaired hole'. These will often stain quickly, (and the pipe wall around it, as though there had been infiltration) because of the lubricant used to install the liner. An actual hole in the liner would look like a 'cut out' section in the liner and would not appear to be repaired.

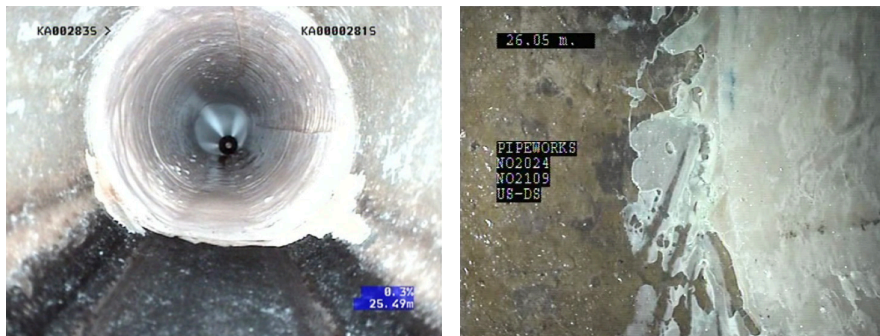
Figure D6 – Examples of extruded resin from a CIPP patch

The photos both show feathering of resin on the edge of a CIPP patch. This epoxy extrusion assists with a smooth transition between the pipe and the patch (i.e. no 'step' between the two).

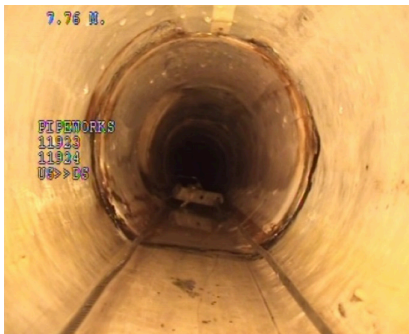
Figure D7 – Examples of staining of liner material not related to leakage

Resin discoloration at the start of an LJR

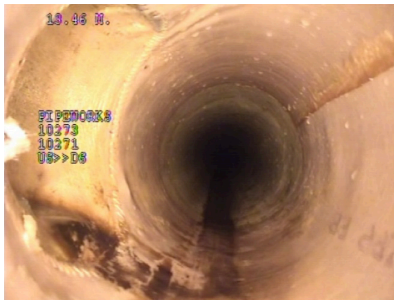
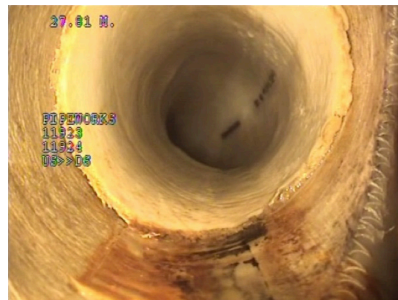
Staining of the LJR invert from flow coming down the lateral. The Lateral has then been lined with a good overlap of lateral liner into LJR. Note the slight discoloration of the resin at the end of the lateral liner.

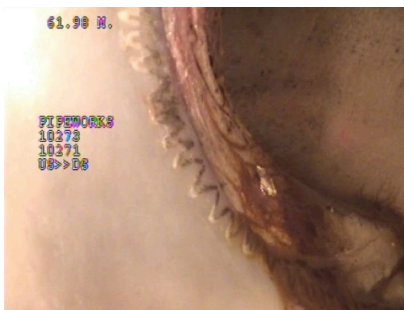
Edge dry, staining present within 'flow zone' of the lateral.

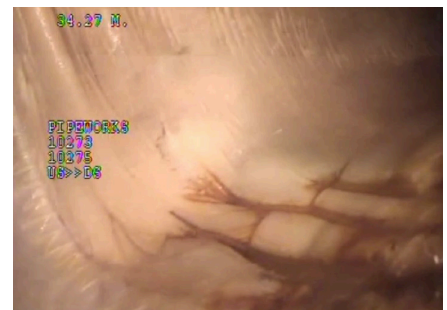
Staining in invert/wrinkles of the 'lateral leg' of the LJR from flow down the lateral.

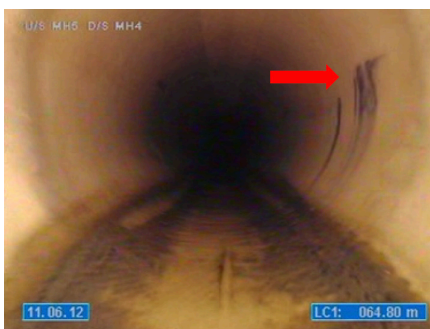
Typical staining from notes written on the liner prior to installation. Staining such as this can also occur where:

- a. The installation lubricant has been concentrated, if water was used during the curing process; or,
- b. It could indicate a pinhole in the liner. If in doubt, a pressure test should be carried out to confirm the integrity of the liner.

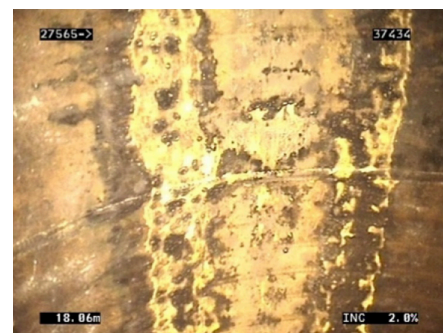
Photo, above, typical staining on the soffit (roof) of a liner, from the lubricants used during installation.
