# Pipe Inspection Manual

**nzwwa**  
New Zealand Water & Wastes Association  
Waiora Aotearoa

Third Edition

# New Zealand Pipe Inspection Manual 3<sup>rd</sup> Edition

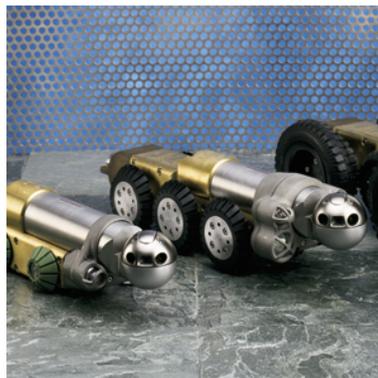
**Figure 3- 1 - Pan & Tilt Camera**

The camera is normally fitted to a self powered tractor or crawler which is controlled from the operator's console, in which case only single ended access is required. Cameras can also be mounted on skids and pulled through the pipeline by winch. This requires access from two points. This method can be appropriate for inspecting lines that are too steep for a tractor camera to traverse. Pan and tilt cameras can be supplied with tractor units to suit pipes from 100mm diameter upwards.

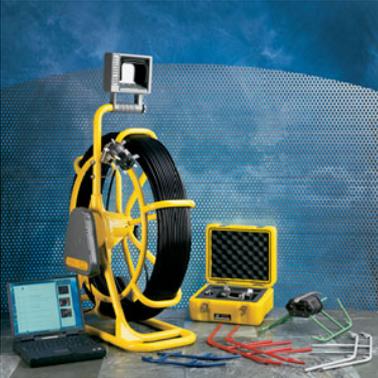
**Figure 3- 2 - Pushrod Camera**

The camera is mounted at the front of a semi rigid cable that is rodded up the pipe from a single access point. The camera is normally fitted with a circular brush or skids to centralise it within the pipe. Lighting is typically provided by either a ring of halogen bulbs or LEDs (light emitting diode) mounted around the lens.

Push rod cameras can only record what is in front of the lens, i.e. they cannot pan or tilt. They are able to be installed in much smaller pipes than pan and tilt cameras, i.e. pipes down to 50mm diameter, and they are able to be pushed around some tight bends. They are usually able to traverse through earthenware gullies. Although installation through the newer PVC gullies with flat bases on the trap is not normally possible.

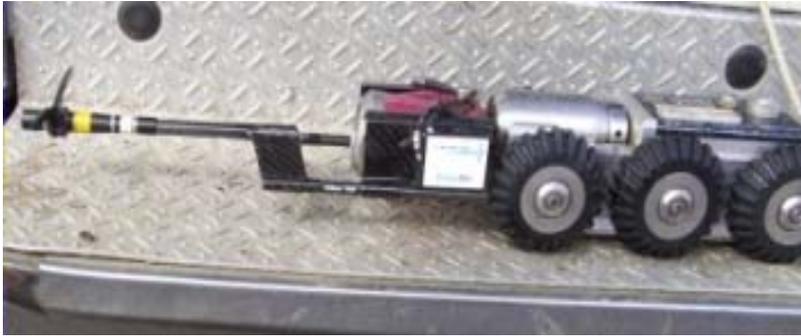
### Figure 3- 5 – Clearline Profiler

Profiler mounted on CCTV Camera

Laser Ring generated by profiler

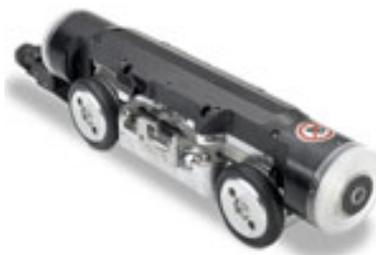
### Figure 3- 6 - Panoramo Opto-Scanner

With the digitised images produced by these cameras the user is able to control what they see. They are able, for example, to zoom in on defects or pan and tilt onto the features they wish to view. They are no longer reliant on the camera operator moving the camera head to show pipe features and defects. The digitised image can also be “unwrapped” and viewed in two dimensions. It is also possible to take accurate measurements of defects such as crack widths.

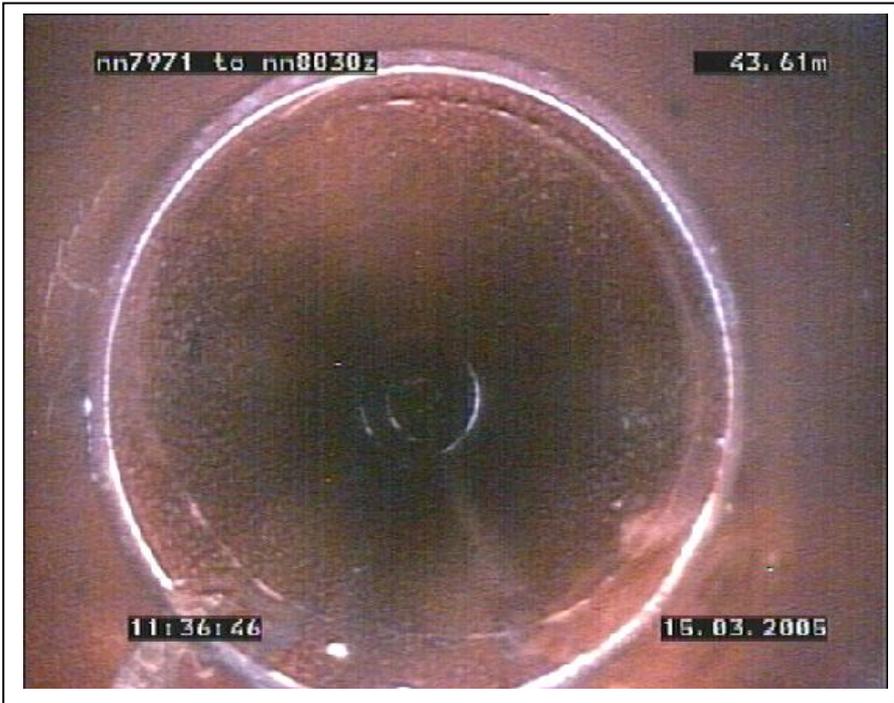
CC, S    Crack visible but not open.

Condition Scores
<ul style="list-style-type: none"> <li>Structural Score - 2</li> </ul>

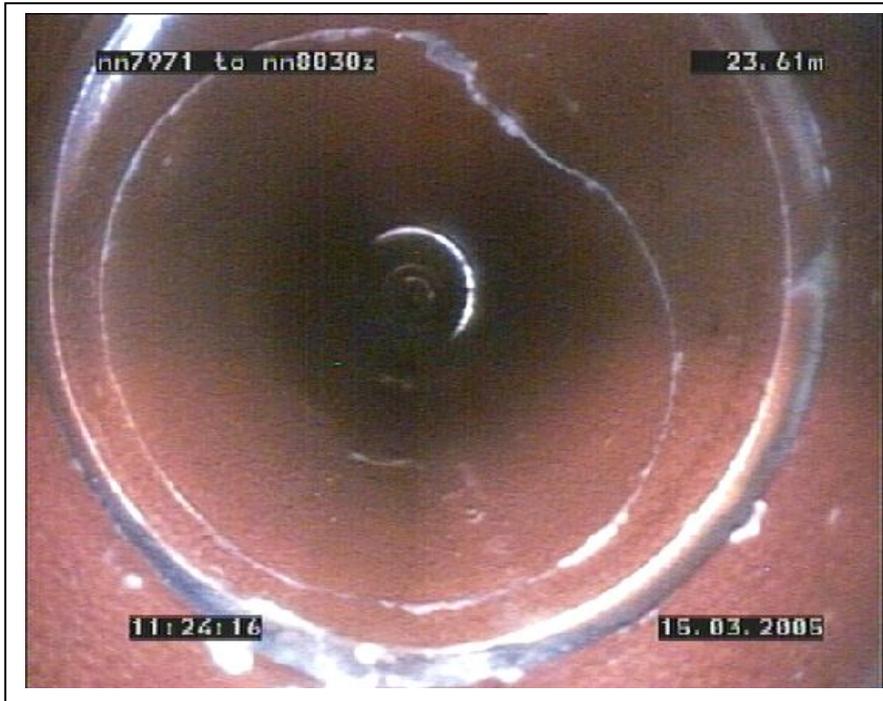
CC, M Crack open but there is no evidence that the crack extends to the outside wall.

- Structural Score - 15

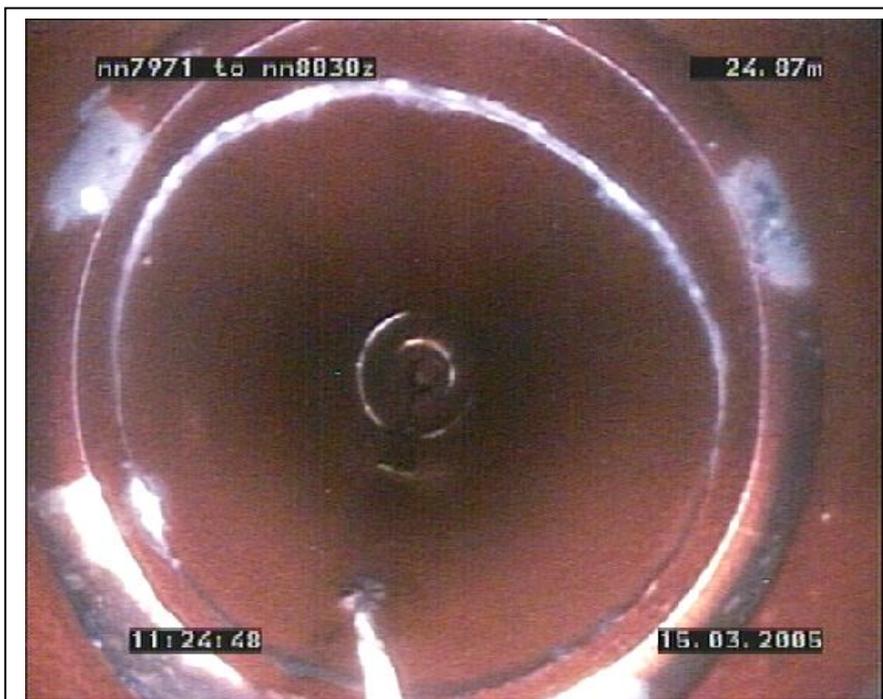
CC, L Crack is open and there is evidence that it extends through to the outside wall. Evidence that the crack extends through to the outside wall may include the width of the crack, displacement of the crack, the presence of roots, infiltration and/or encrustations. The presence of roots, infiltration or encrustations would be coded separately.

- Structural Score - 30

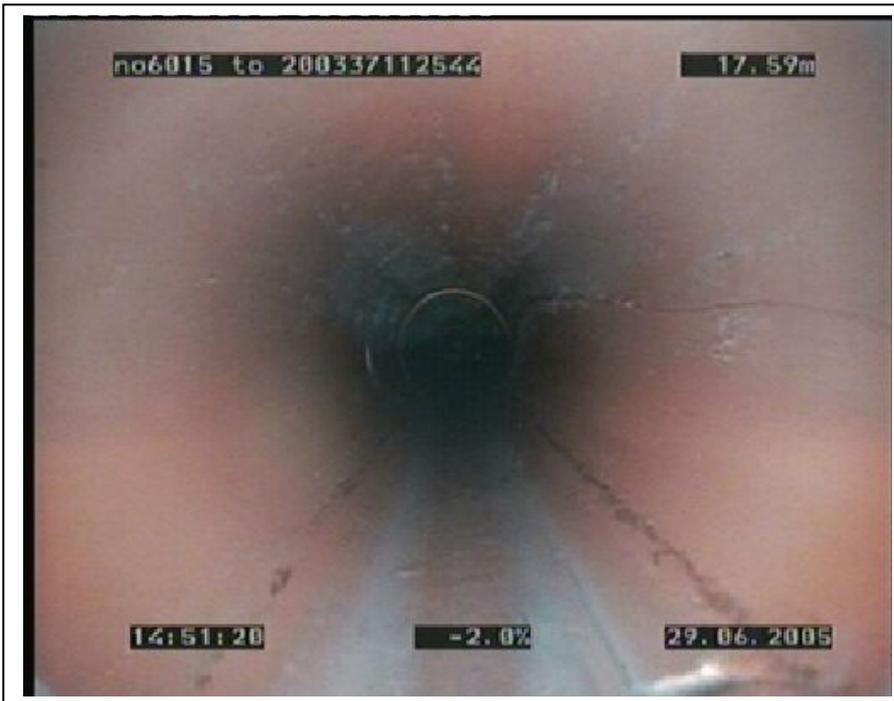
CL, S    Crack visible but not open.

Condition Scores
<ul style="list-style-type: none"> <li>Structural Score - 3</li> </ul>

Comments on the photo
<ul style="list-style-type: none"> <li>The crack extends through the bore of the pipe at 3 o'clock. It does not appear to be open and there is no evidence that it extends through to the outside of the pipe wall.</li> </ul>

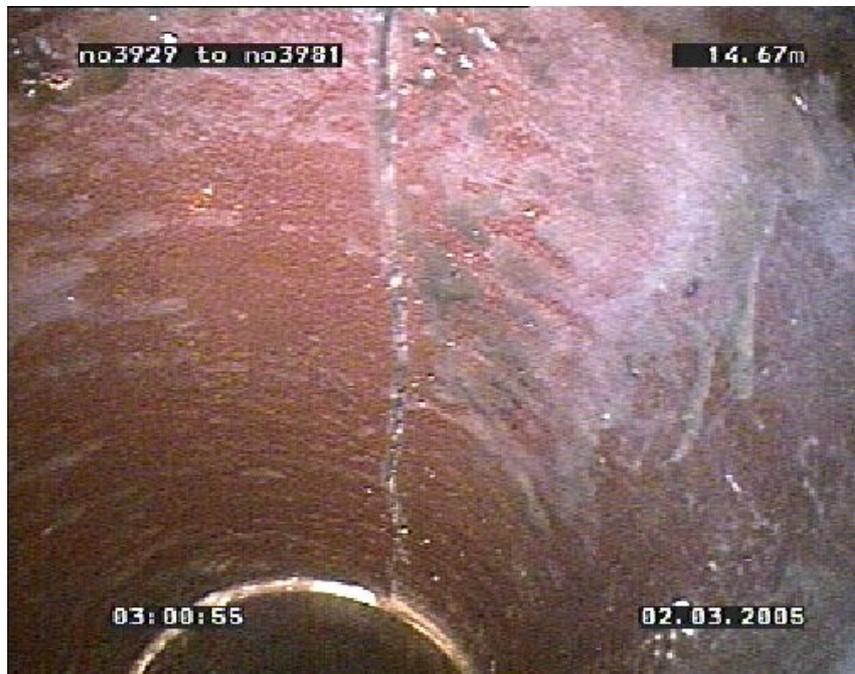
CL, M Crack open but there is no evidence that the crack extends to the outside wall.

- Structural Score - 15

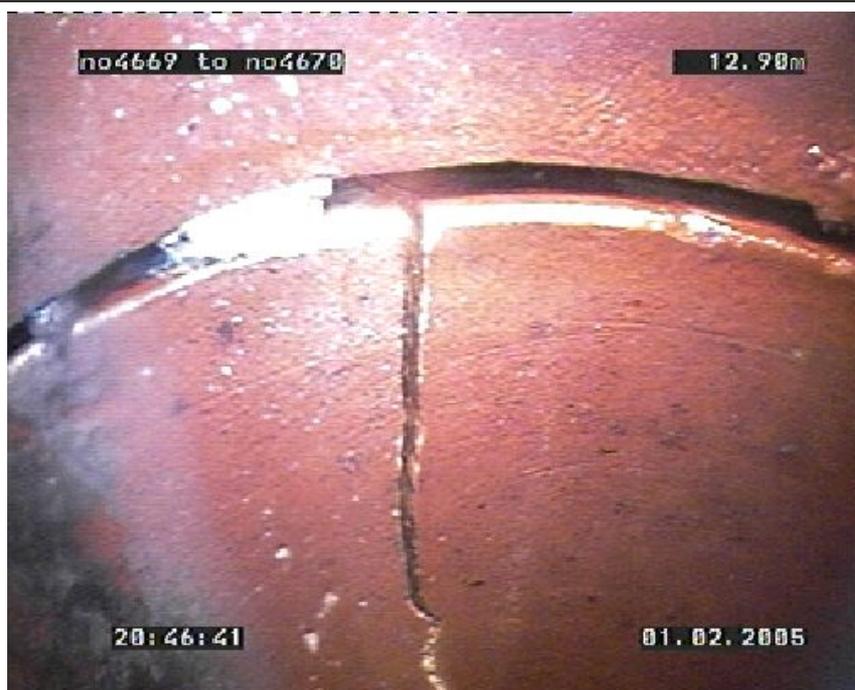
CL, L Crack is open and there is evidence that it extends through to the outside wall. Evidence that the crack extends through to the outside wall may include the width of the crack, displacement of the crack, the presence of roots, infiltration and/or encrustations. The presence of roots, infiltration or encrustations would be coded separately.

- Structural Score - 30

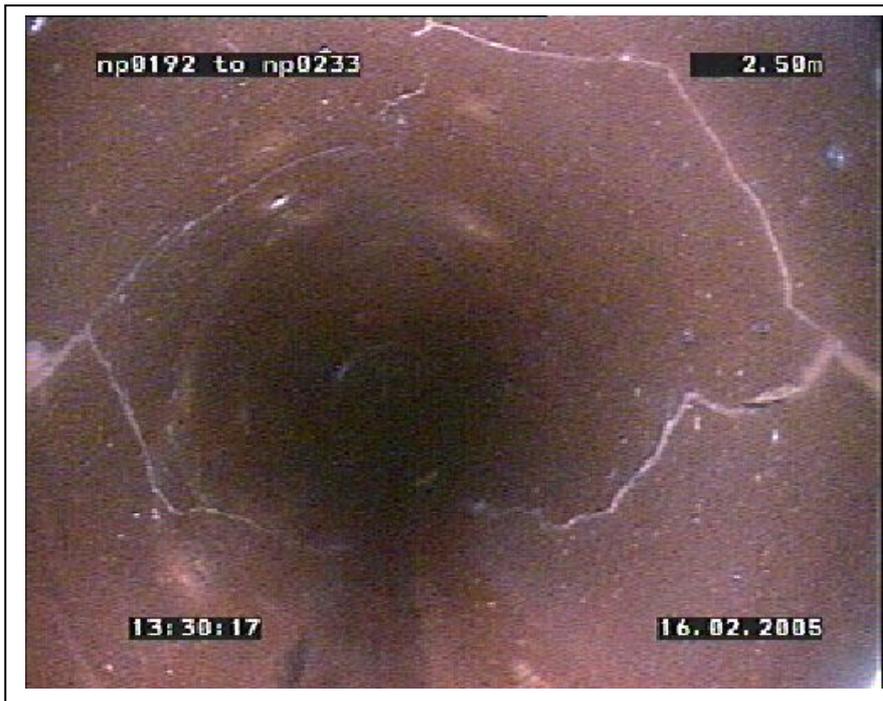
CM, S Crack visible but not open

- Structural Score - 10

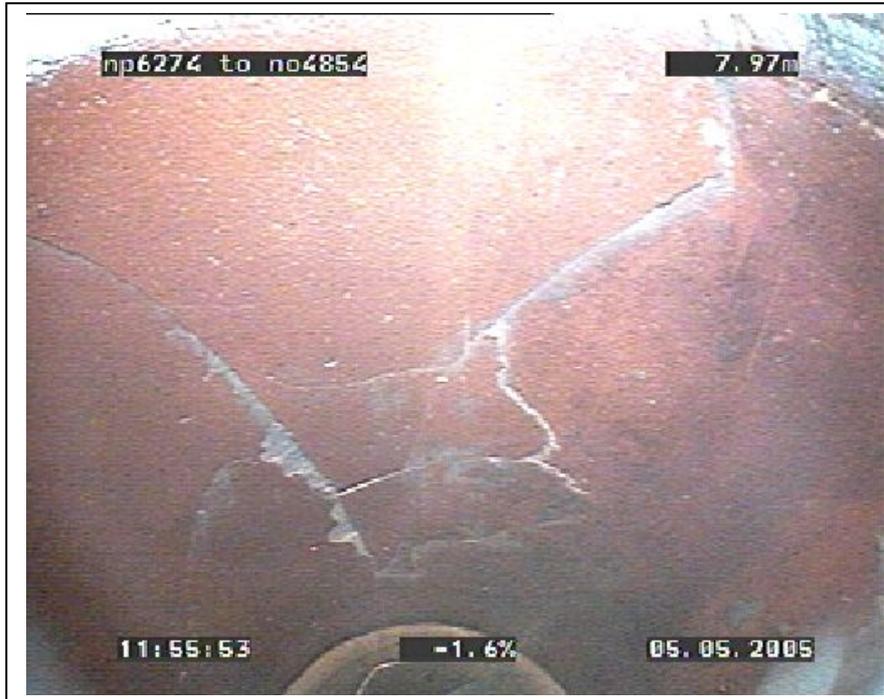
CM, M Crack open but there is no evidence that the crack extends to the outside wall.

- Structural Score - 20

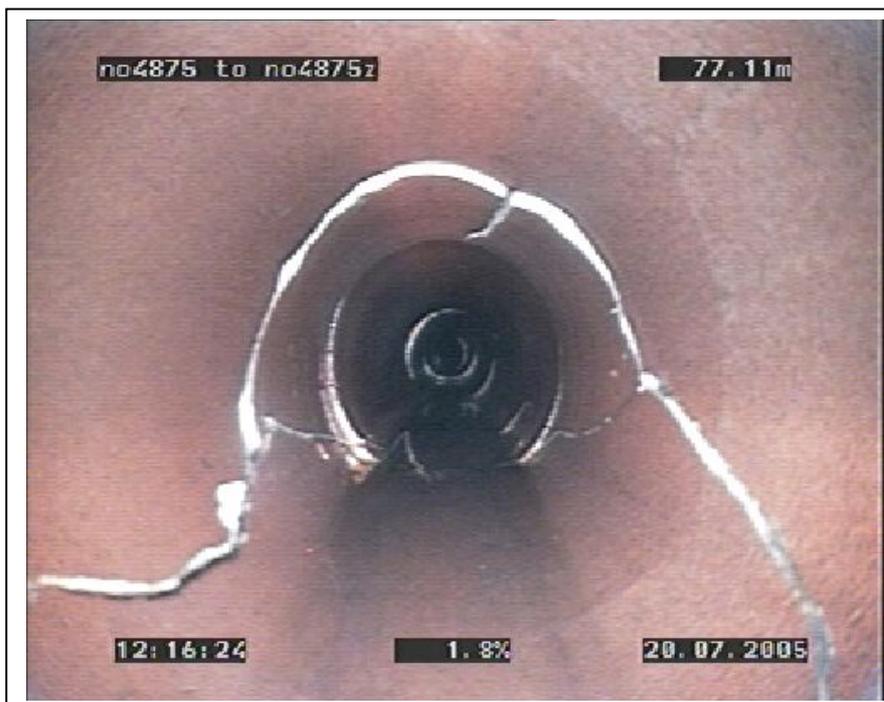
CM, L Crack is open and there is evidence that it extends through to the outside wall. Evidence that the crack extends through to the outside wall may include the width of the crack, displacement of the crack, the presence of roots, infiltration and/or encrustations. The presence of roots, infiltration or encrustations would be coded separately.

- Structural Score - 40

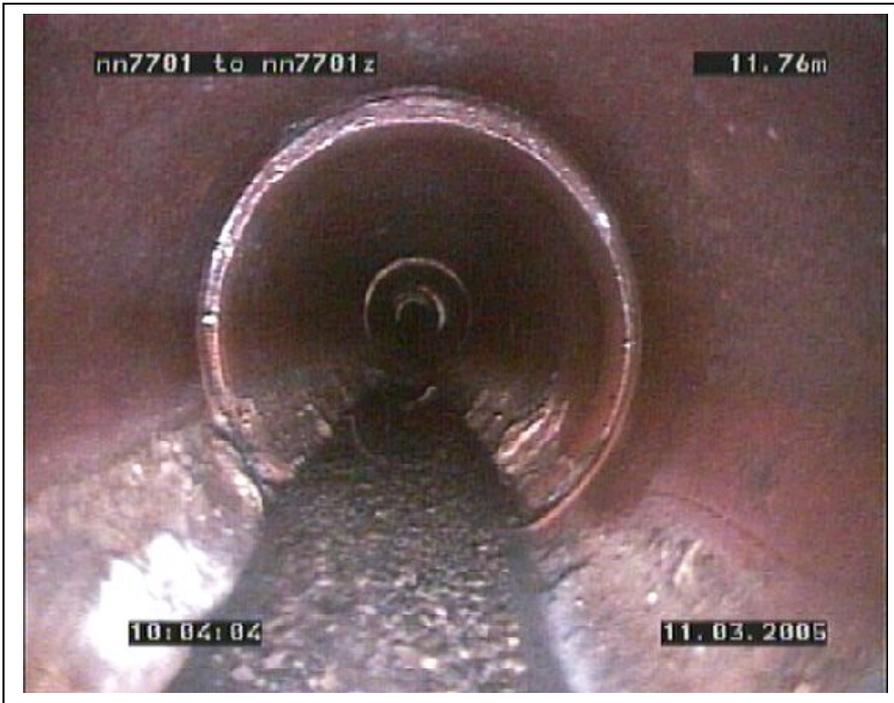
DE, S    The clear diameter is reduced by less than 10%

Condition Scores
• Service Score - 8

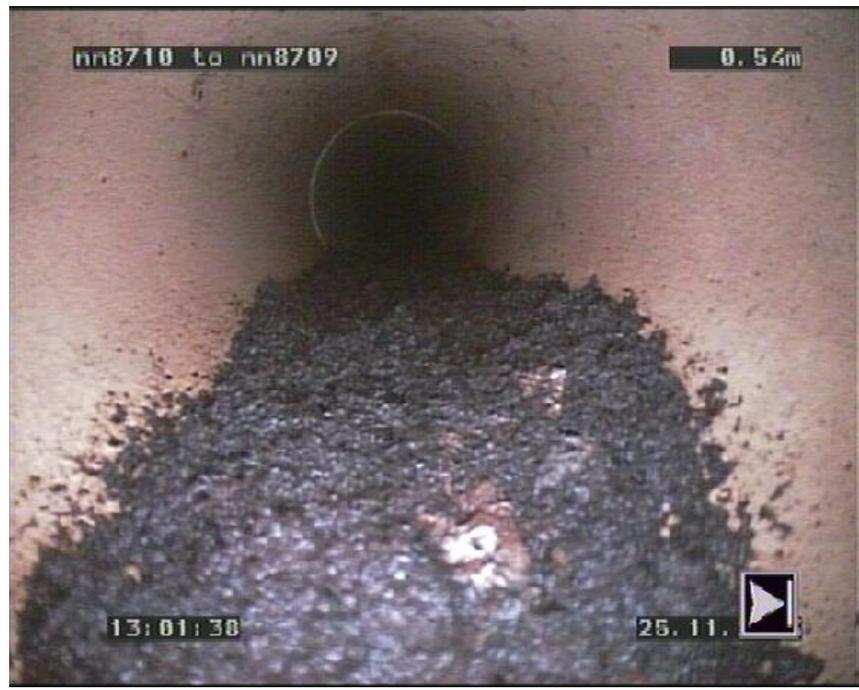
DE, M The clear diameter is reduced by 10% - 25%.

- Service Score - 20

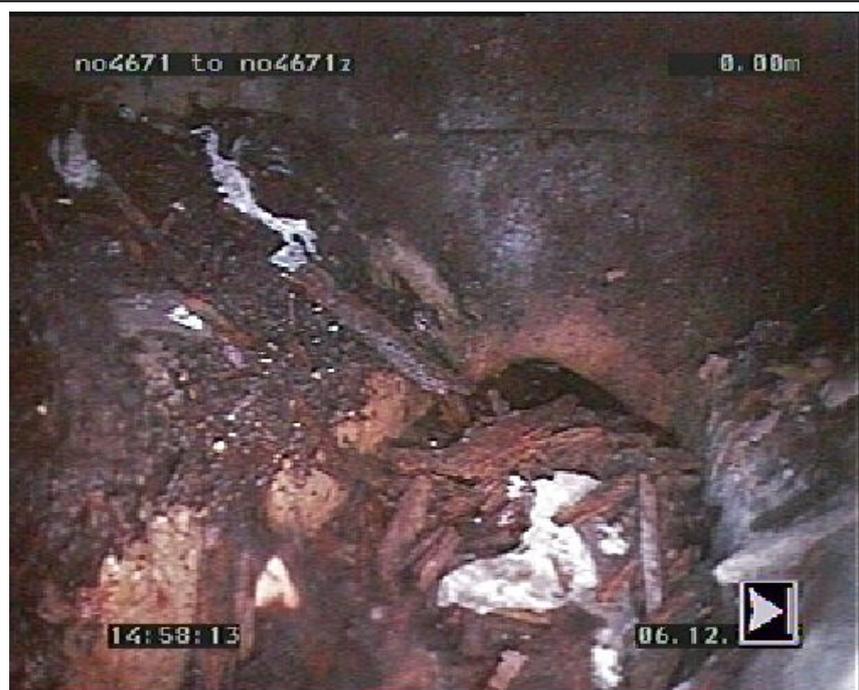
DE, L The clear diameter is reduced by more than 25%.

- Service Score - 40

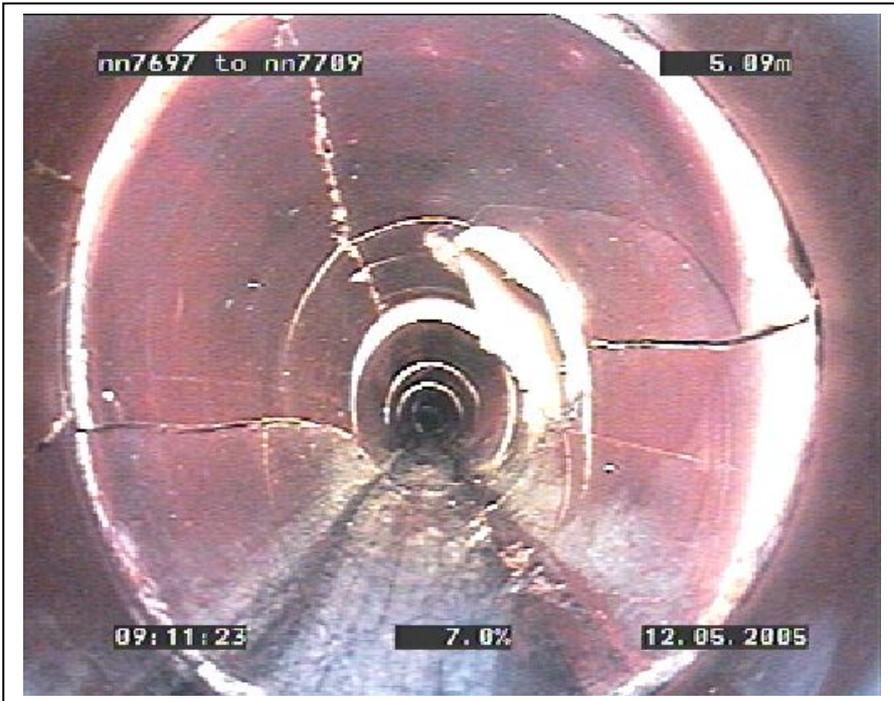
DF, M	i)	Deformation 10% or less of the pipe diameter, and there is continuous longitudinal crackings.
	ii)	Longitudinal cracks are visible at any three of the following points: 12 O'clock, 3 O'clock 6 O'clock or 9 O'clock.

Condition Scores
<ul style="list-style-type: none"> <li>Structural Score - 15</li> </ul>
Comments on the photo
<ul style="list-style-type: none"> <li>Pressure on the pipe has deformed and cracked the pipe at the 4 quadrants which is typical of EW pipe that has been subjected to undue external force.</li> </ul>

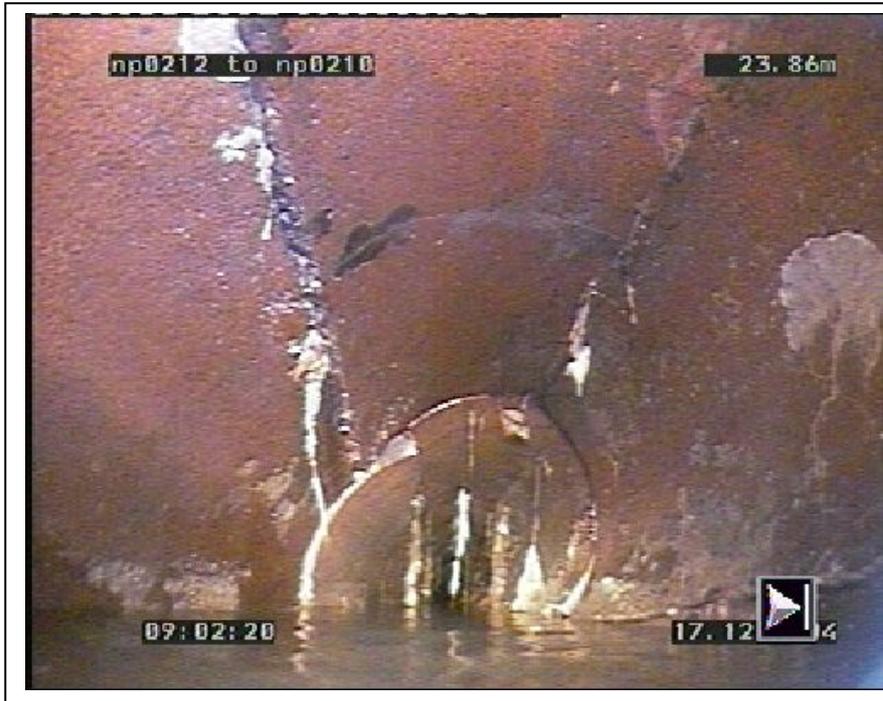
DF, L Deformation greater than 10% of the pipe diameter and there is continuous longitudinal cracking.

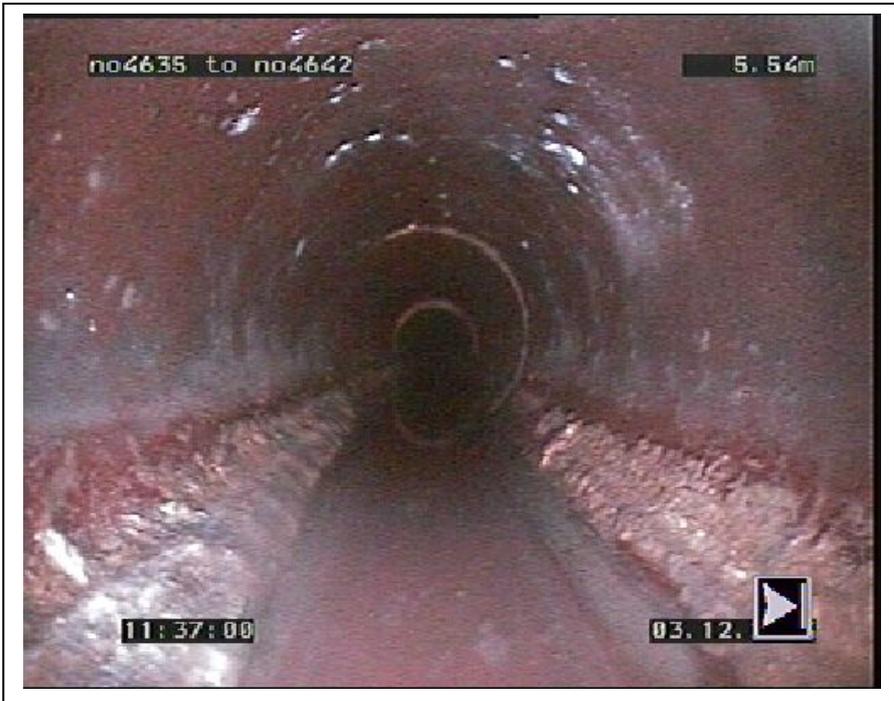
DG, S    Clear diameter is reduced by less than 10%

Comments on the photo
<ul style="list-style-type: none"> <li>A light film of grease is present at the "high tide" mark of the pipe.</li> </ul>

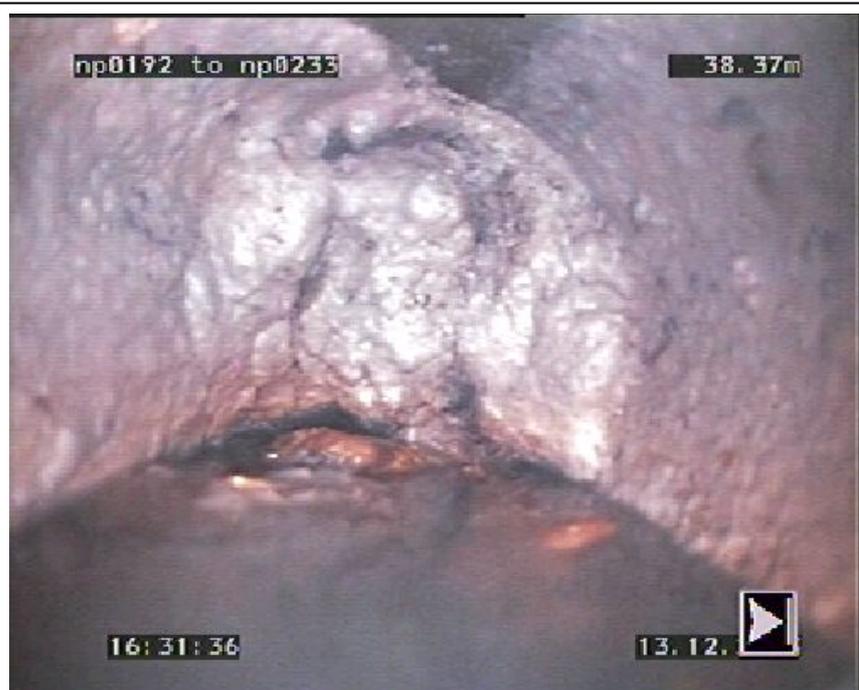
DG, L The clear diameter is reduced by more than 25%.

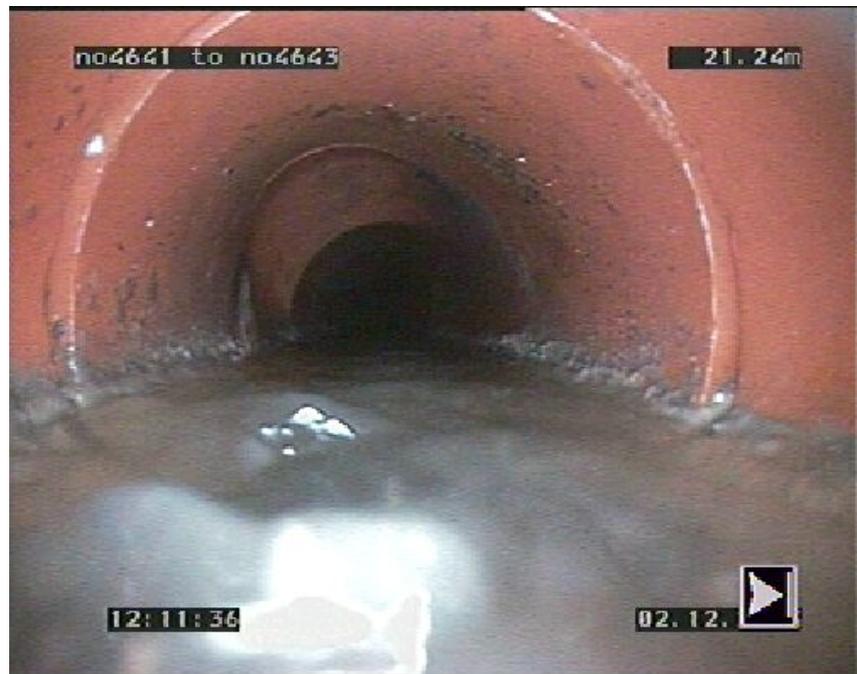
DP, M Dip 25% to 50% of the pipe diameter.

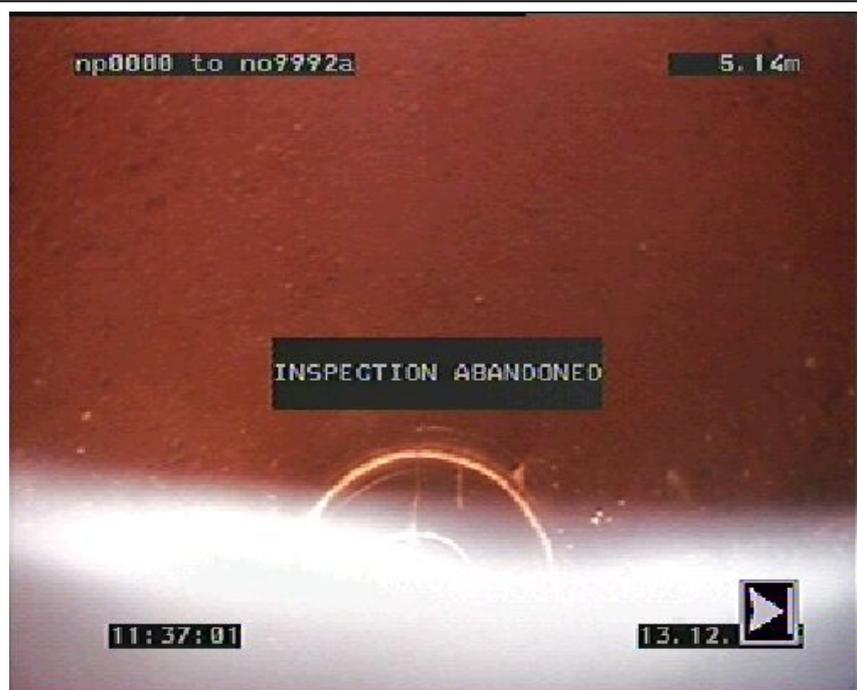
DP, L Dip greater than 50% of the pipe diameter

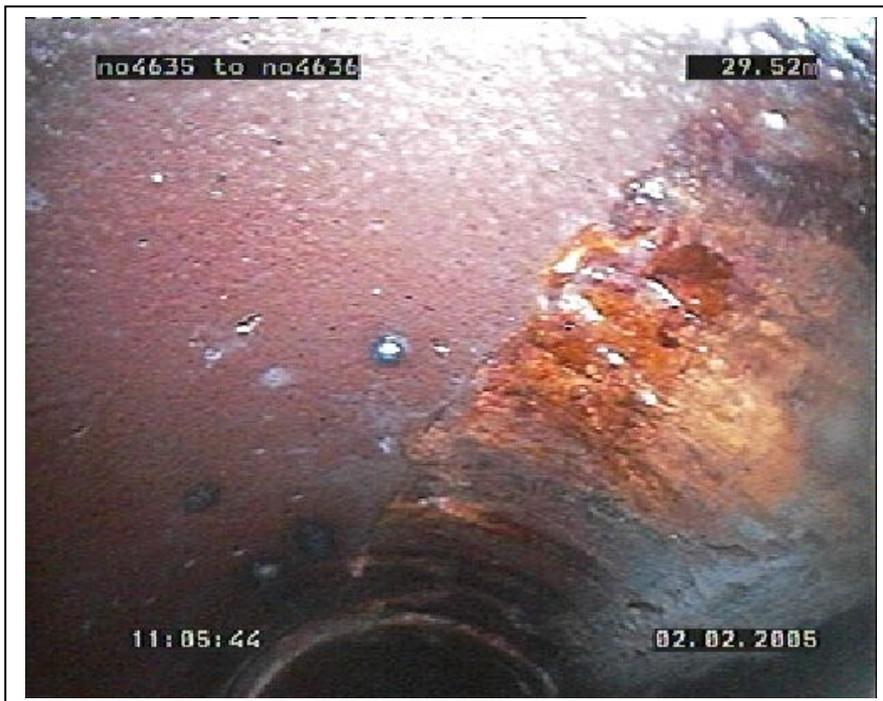
ED, S The clear diameter is reduced by less than 10%

- Light encrustation deposits from infiltration through a crack. The corresponding crack would be coded separately as "CL, L" as the presence of the encrustation indicates that there is infiltration through the crack, which is evidence that the crack is open to the outside wall.

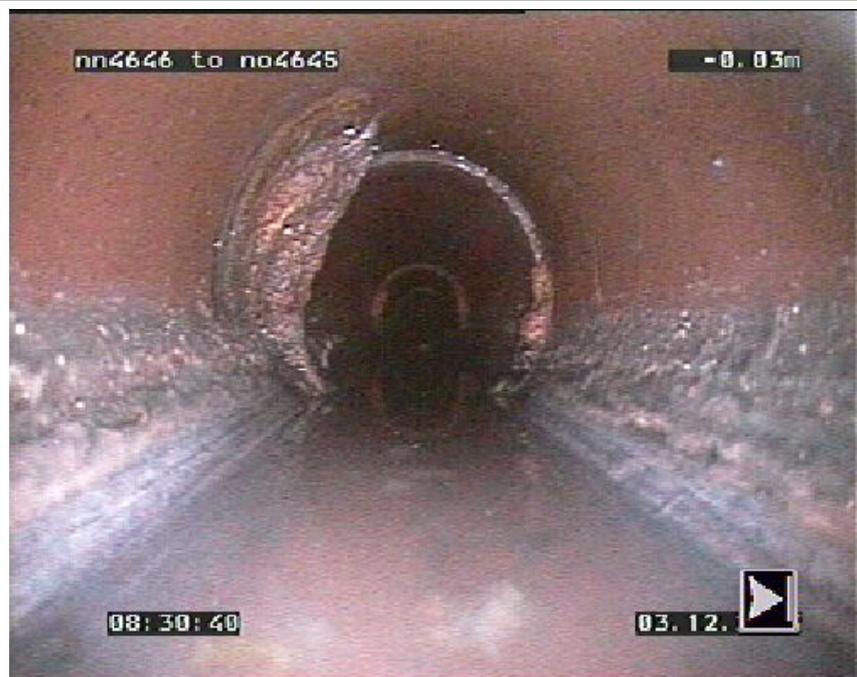
ED, M The clear diameter is reduced by 10% to 25%.

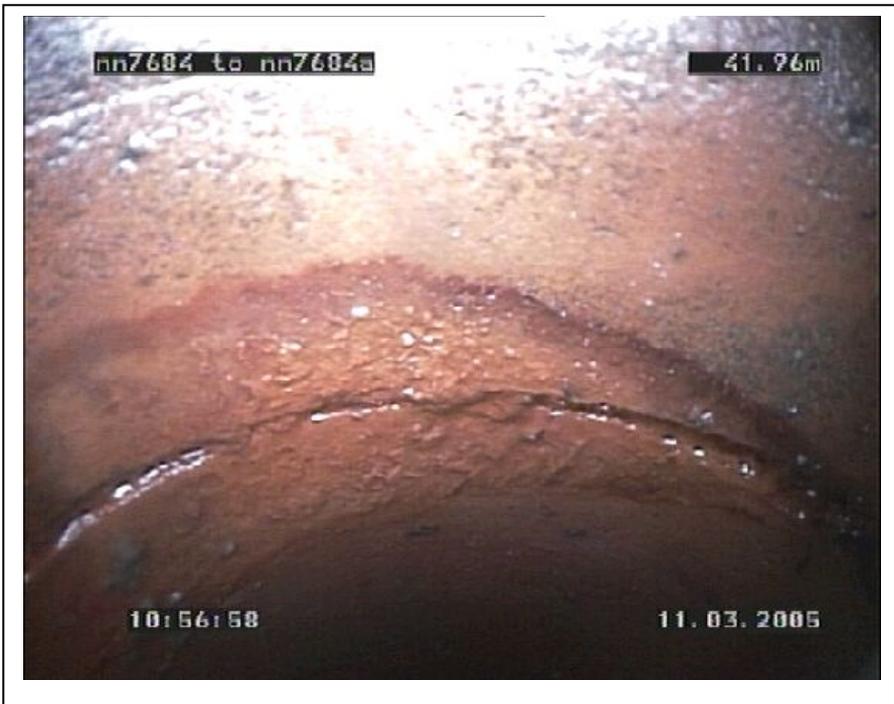
IP, S      Infiltration seeping or dripping.

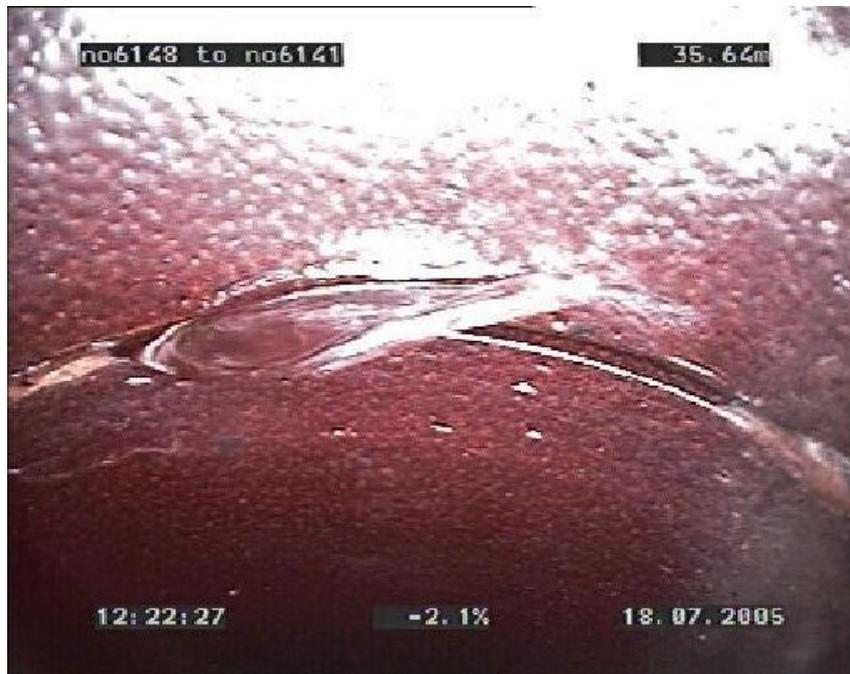
IP, M Running flow. Can also be squirting where the flow section area is small.

- The infiltration shown in this photo is at 3 o'clock. The Pan and Tilt camera used for this survey, has rotated the image 90°.
- This fault was coded by the contractor as large, but as the flow is not under pressure, it should have been coded as medium severity.

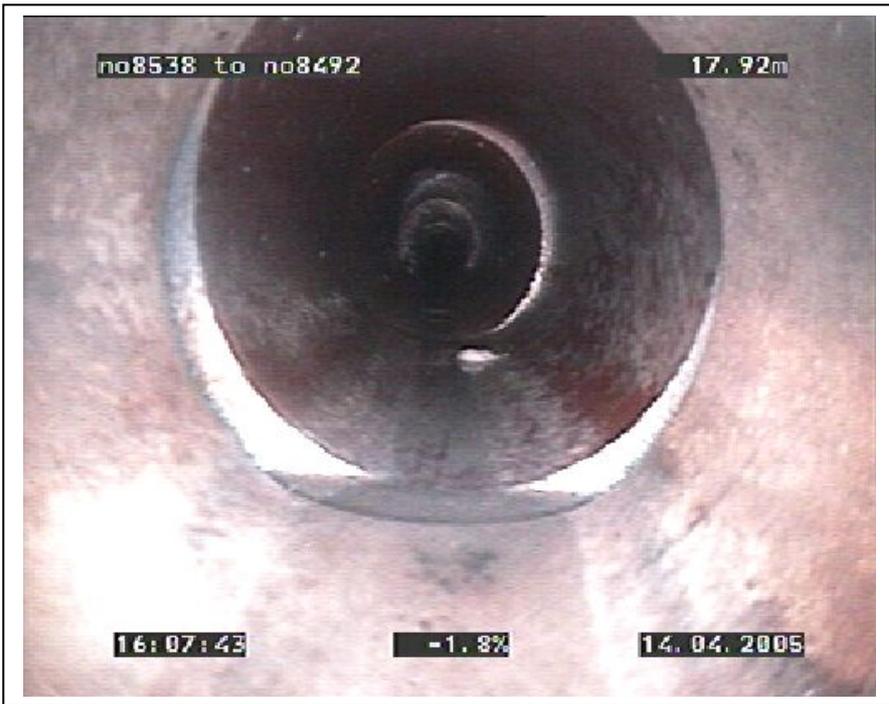
JD, S Displacement less than 10% of the pipe diameter.

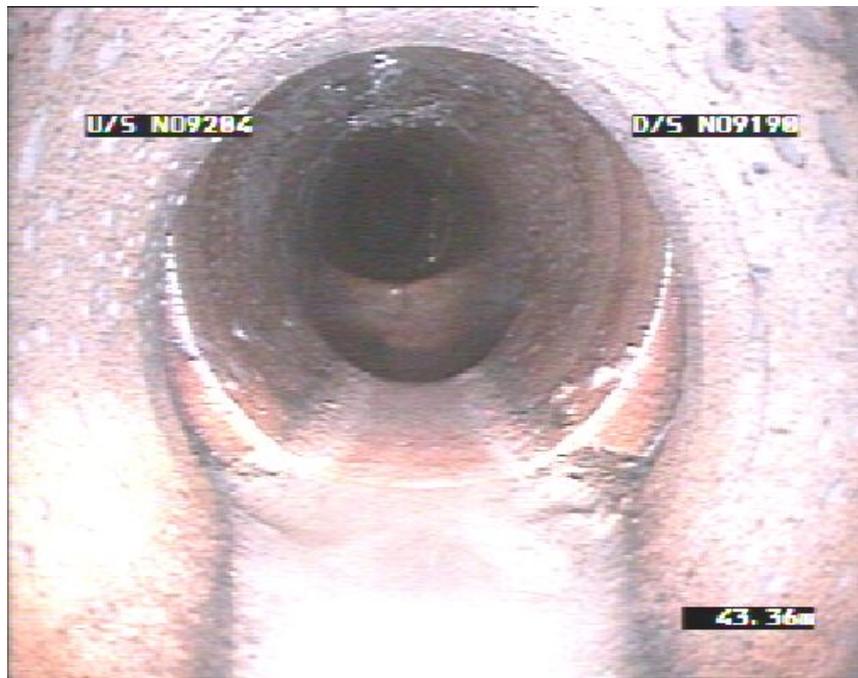
JD, M Displacement 10% to 25% of the pipe diameter.

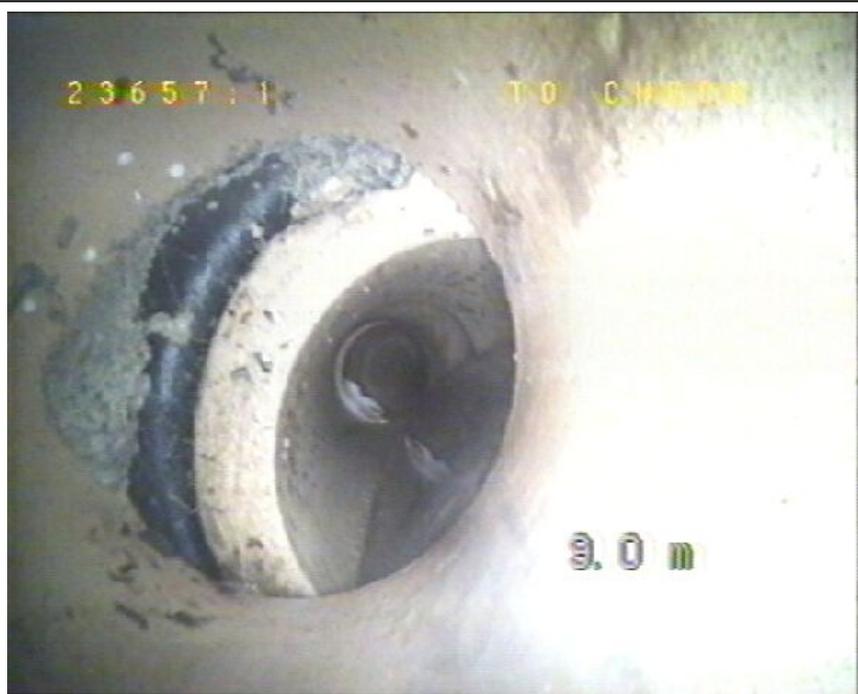
JD, L Displacement greater than 25% of the diameter.

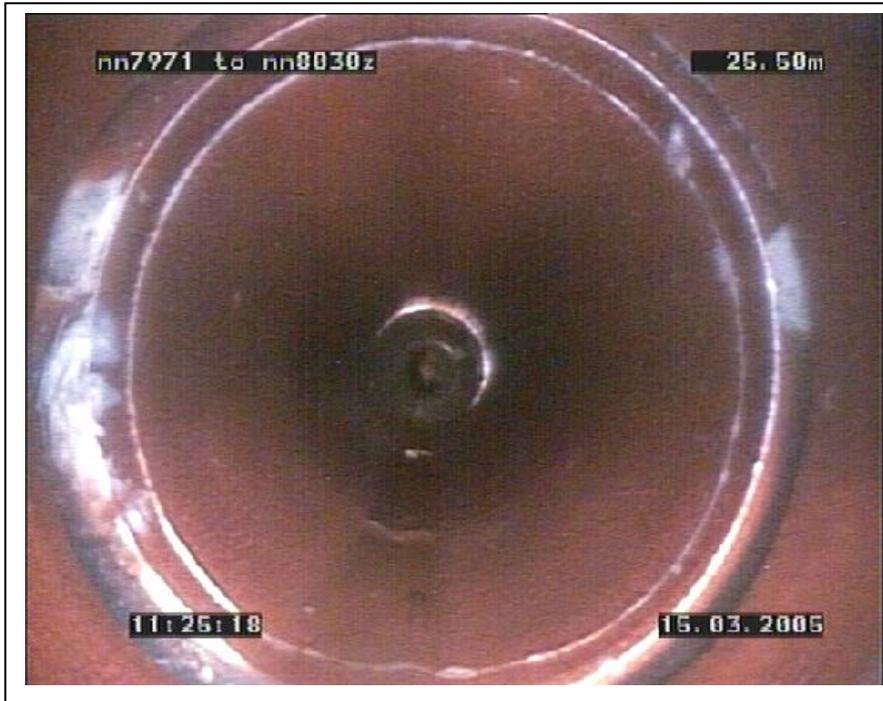
JF, M Cracking or spalling which is open but there is no evidence to suggest that it extends through to the outside wall.

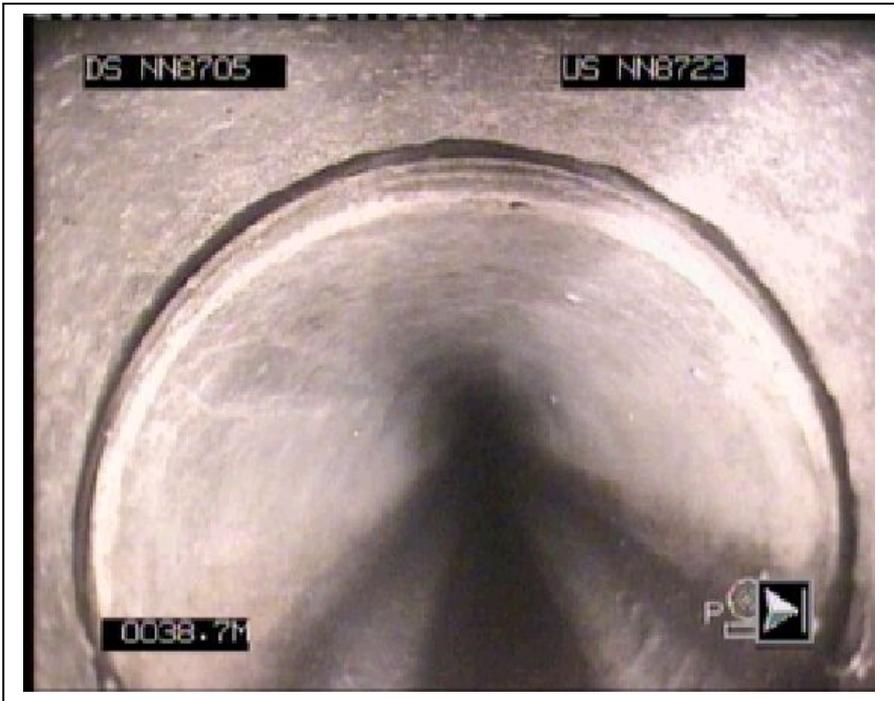
JO, S Displacement is less than 20mm.

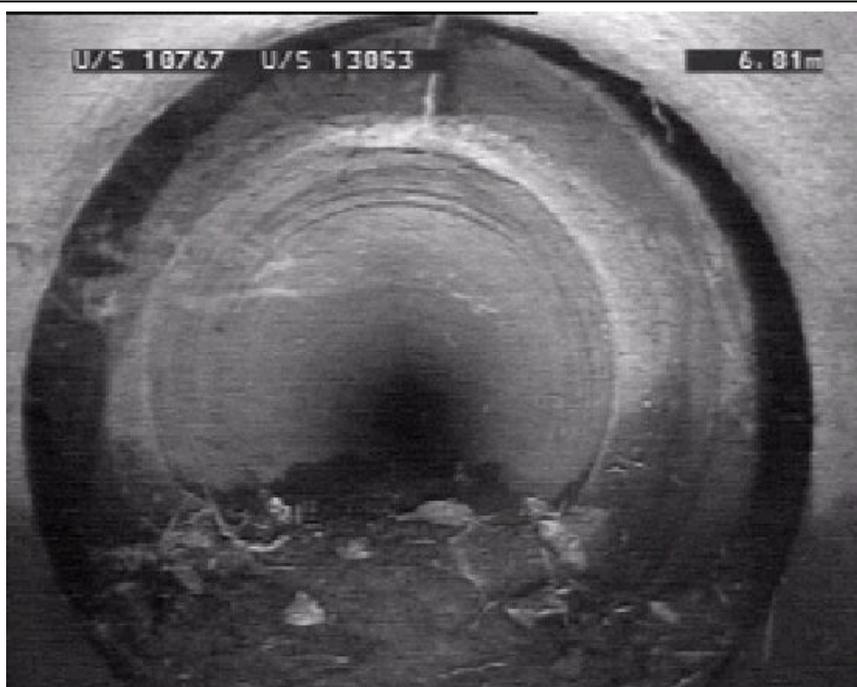
JO, L Displacement is greater than 40mm.

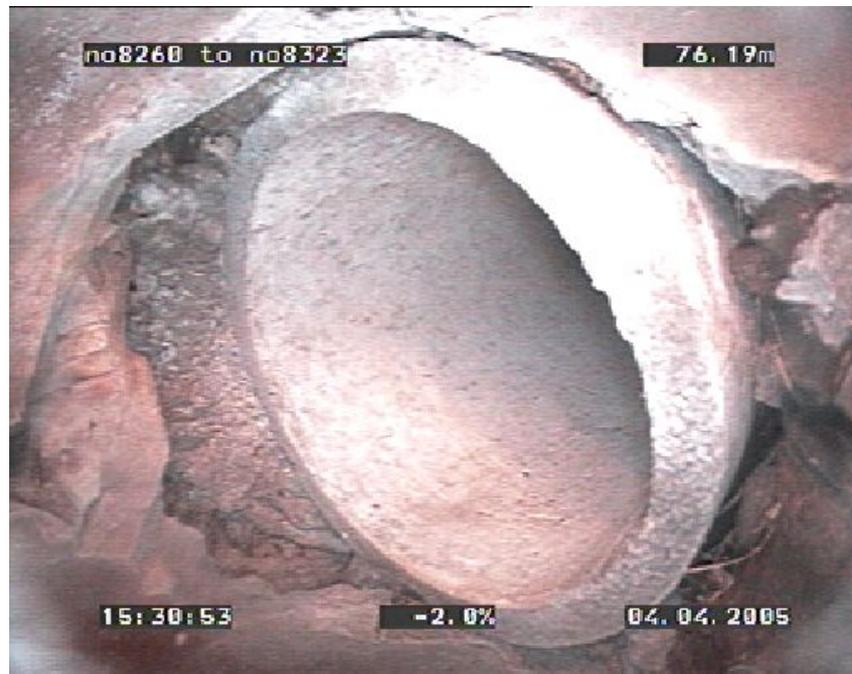
LF, M There are gaps between the lateral pipe and the main pipe that appear open, but there is no evidence that the gap extends through to the outside wall of the main pipe.

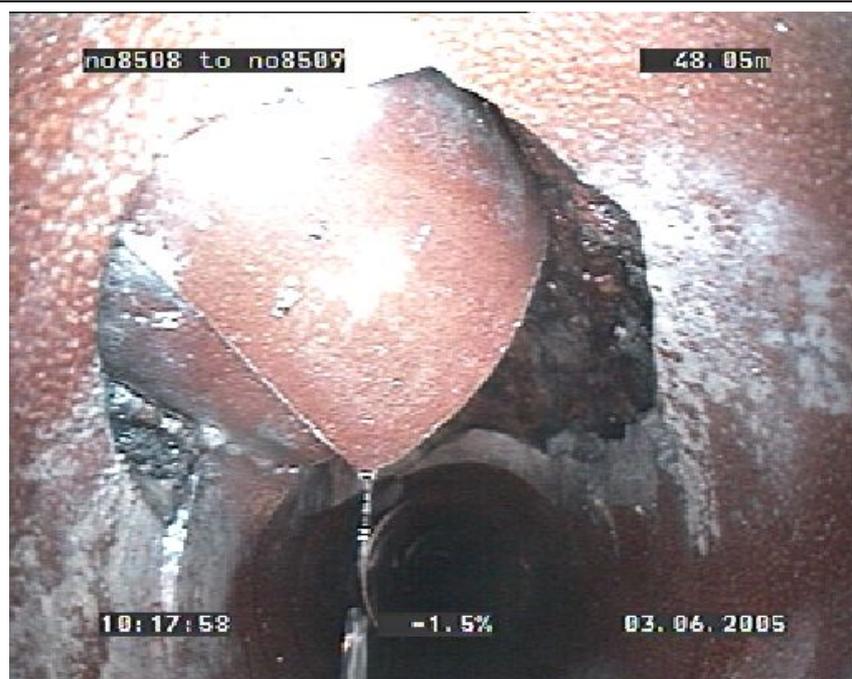
LF, L There is evidence that the connection between the lateral and the main pipe is leaking. Evidence may include the presence of roots, staining, encrustation deposits and/or infiltration.

- Infiltration and encrustation below the lateral indicates a flow path through to the outside. The surrounding bedding and fill is also visible at the top of the lateral. The lateral is also protruding and this is separately recorded.

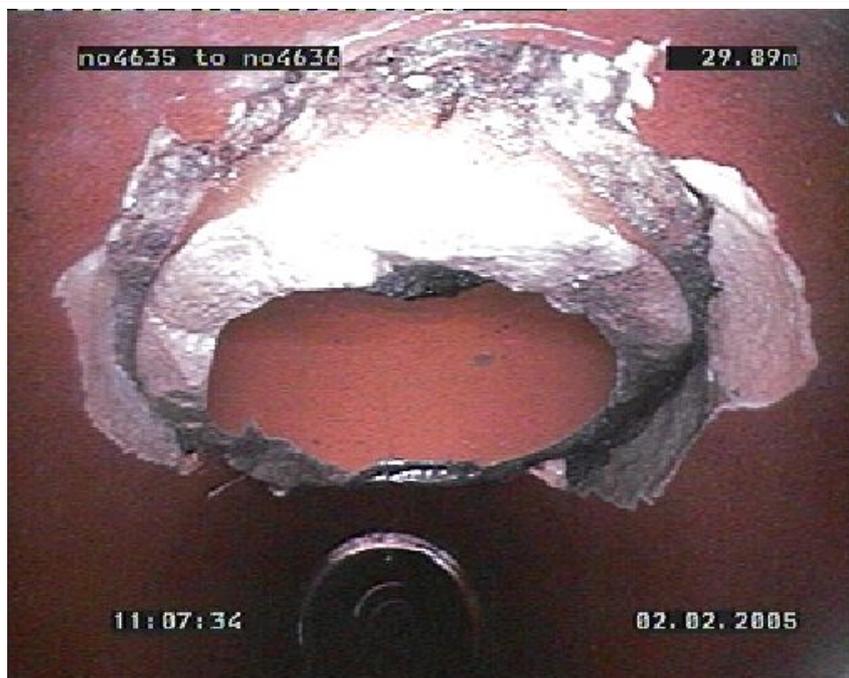
LP, S Lateral protrudes into the sewer main by 10% or less of the diameter of the sewer main.

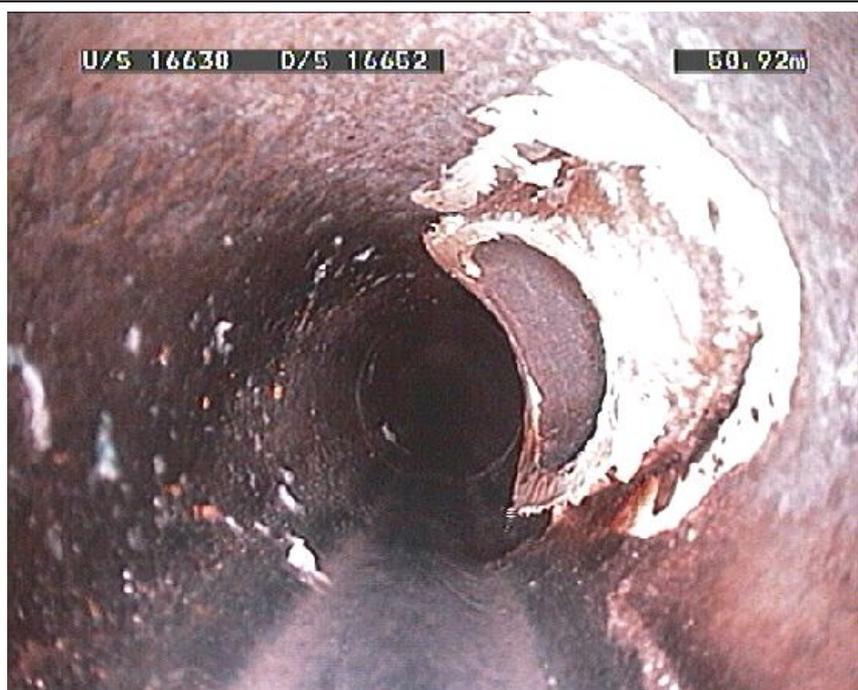
LP, L Lateral protrudes into the sewer main by more than 25% of the diameter of the sewer main.

- Would also attract a LF, L defect code due to infiltration between lateral and the main.

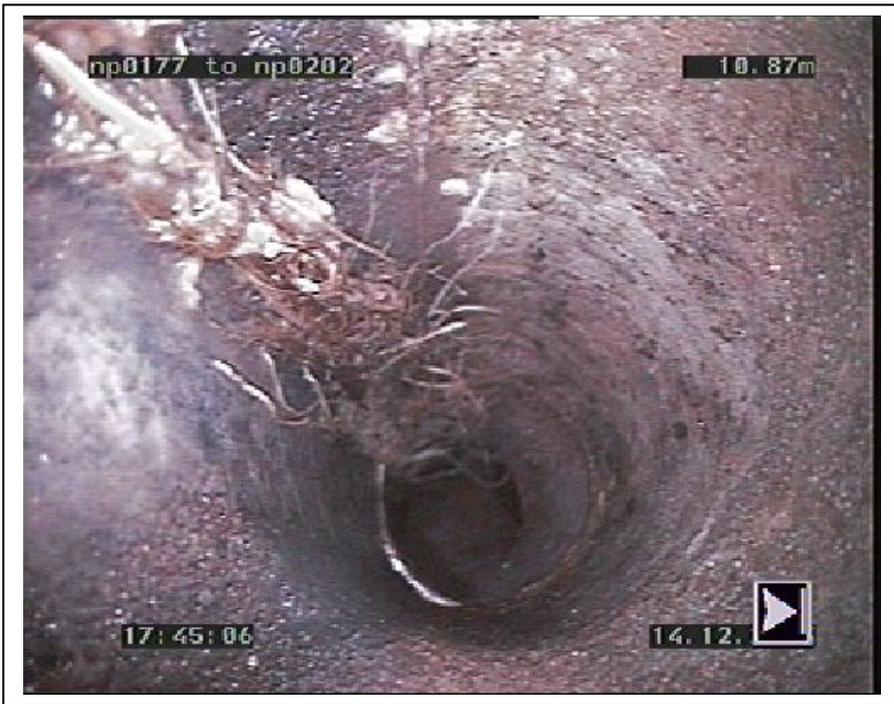
LX, S As defined elsewhere for the type of defect noted in the "Remarks" column.
