# Pipe Inspection Manual

**nzwwa**  
New Zealand Water & Wastes Association  
Waiora Aotearoa

Third Edition

# New Zealand Pipe Inspection Manual 3<sup>rd</sup> Edition

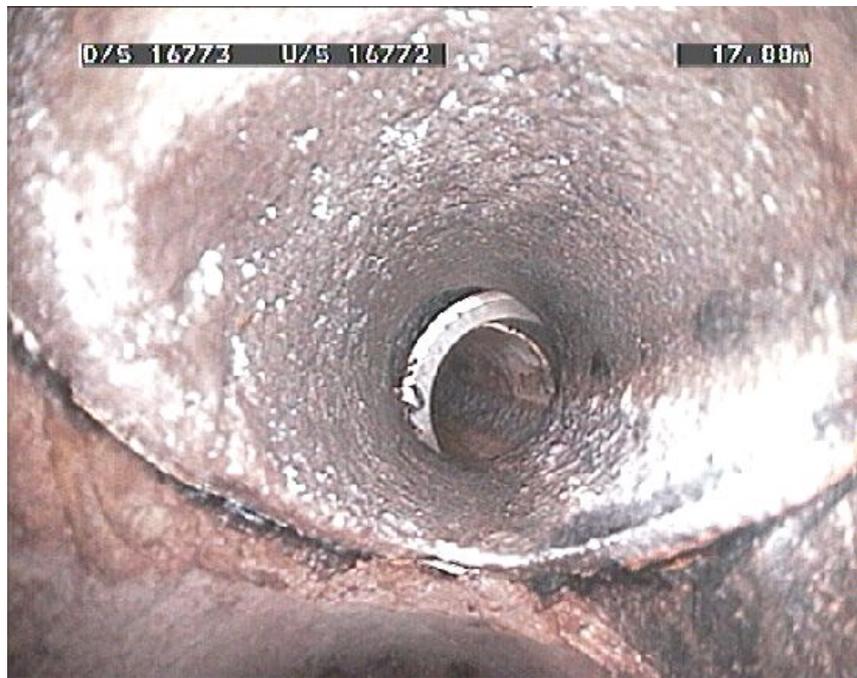
LX, M As defined elsewhere for the type of defect noted in the "Remarks" column.

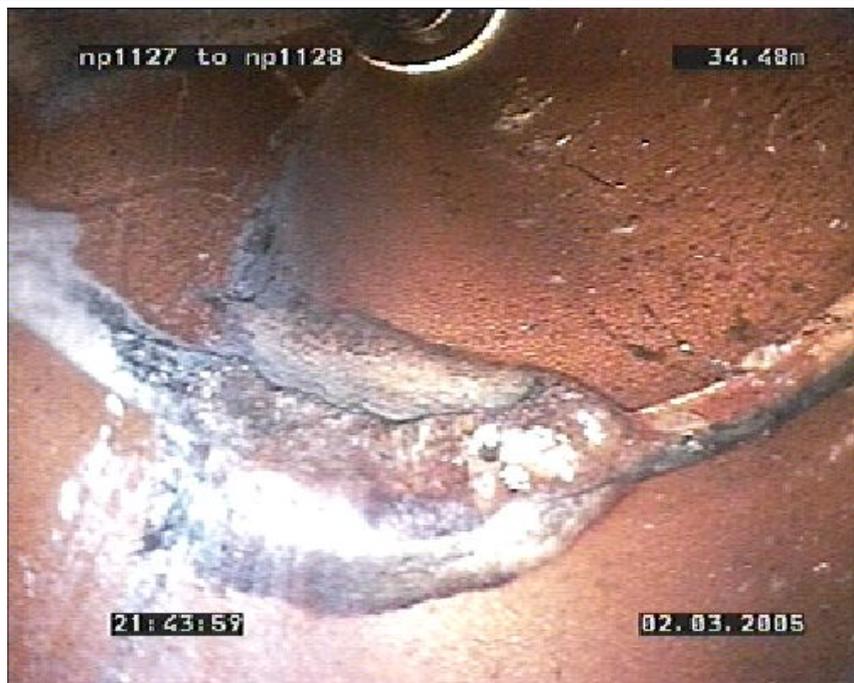
OP, S The clear diameter of the pipeline is reduced by less than 10%.

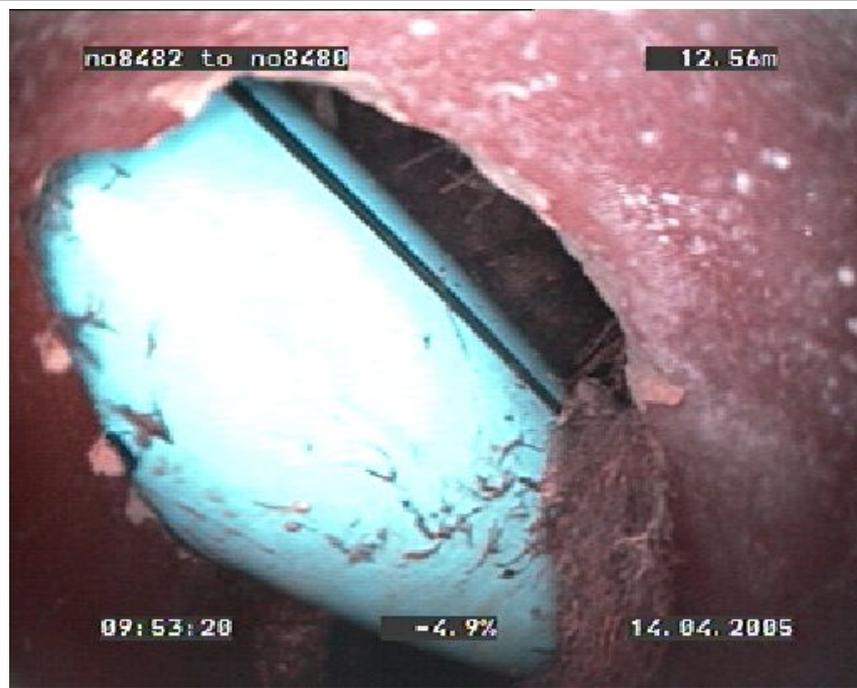
OP, M The clear diameter of the pipeline is reduced by up 10% to 25%.

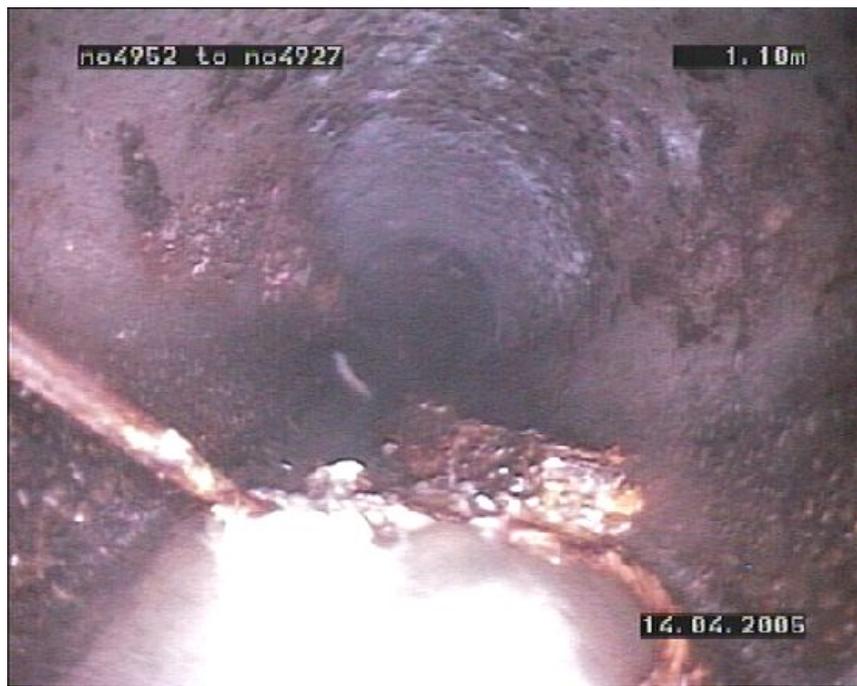
OT, S The clear diameter of the pipeline is reduced by up to 10%.

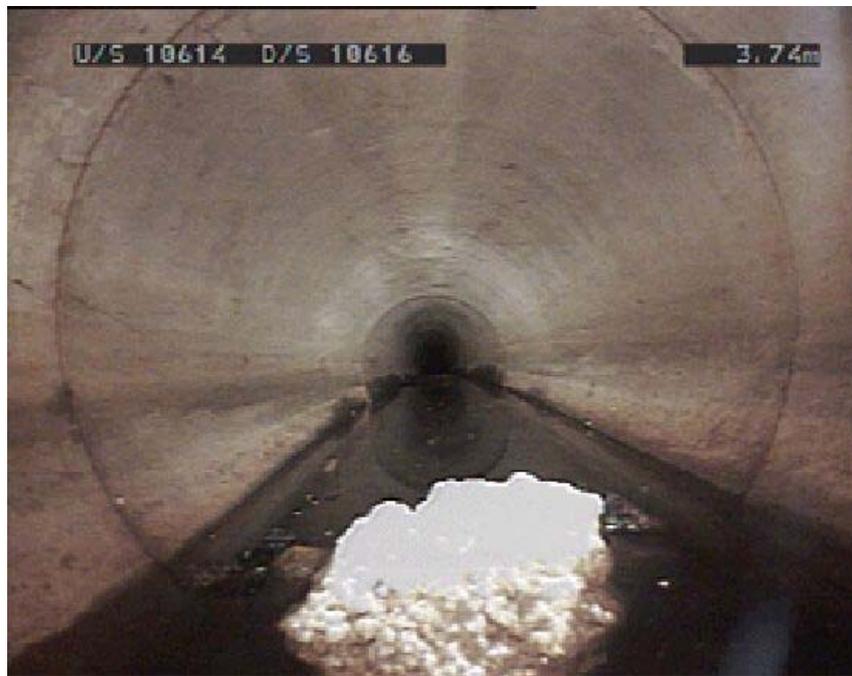
OT, M The clear diameter of the pipeline is reduced by 10% to 25%.

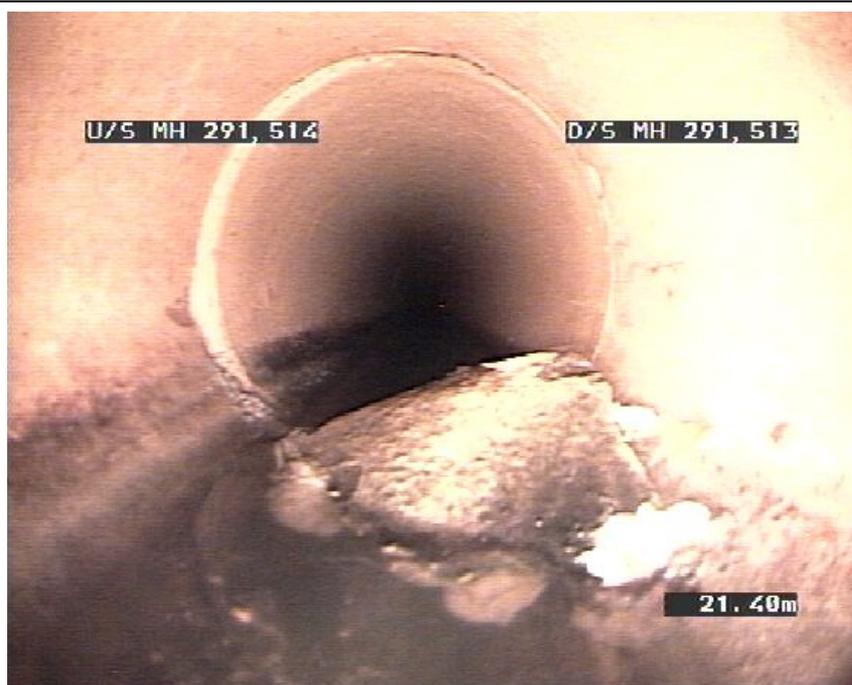
OT, L The clear diameter of the pipeline is reduced by more than 25%.

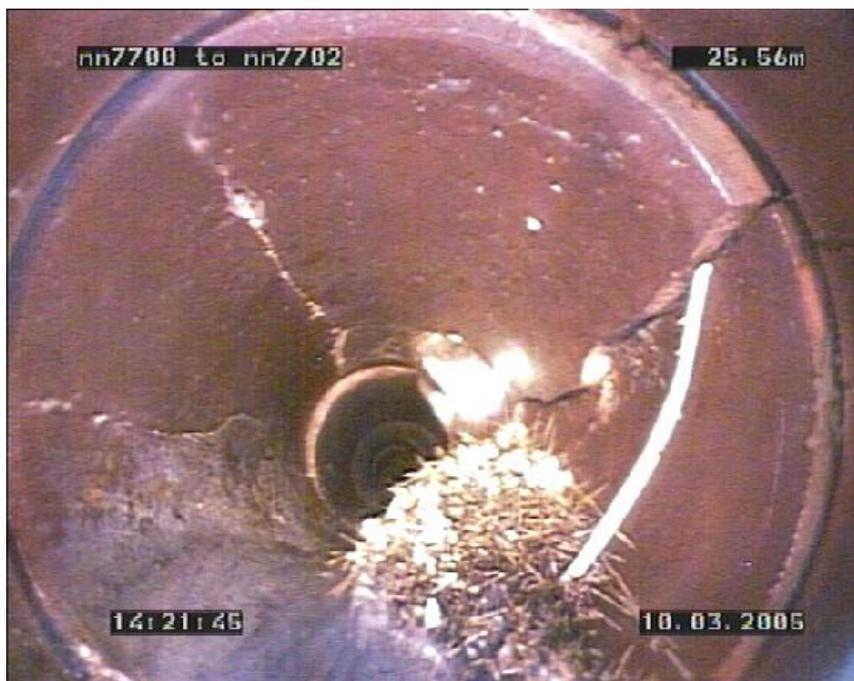
- PB, S
- i) Damage extends up to 10% of the circumference, or
  - ii) parts of the pipe are displaced by less than half the pipe wall thickness.

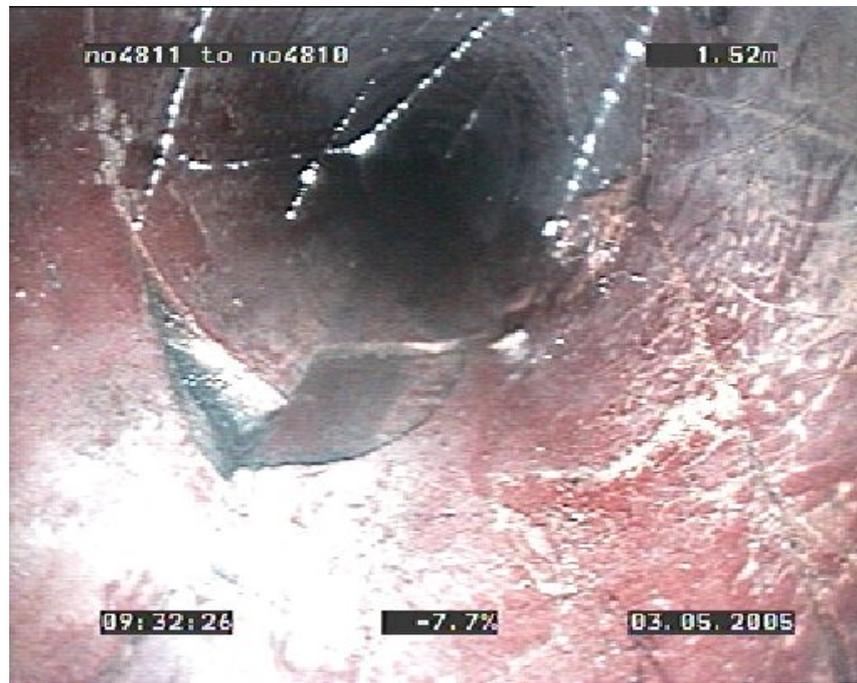
| PB, M | i) | Damage extends between 10% and 25% of the circumference and parts of the pipe are displaced by less than half the pipe wall thickness, or |
| | ii) | Parts of the pipe are displaced between half the pipe wall thickness and the full pipe wall thickness |

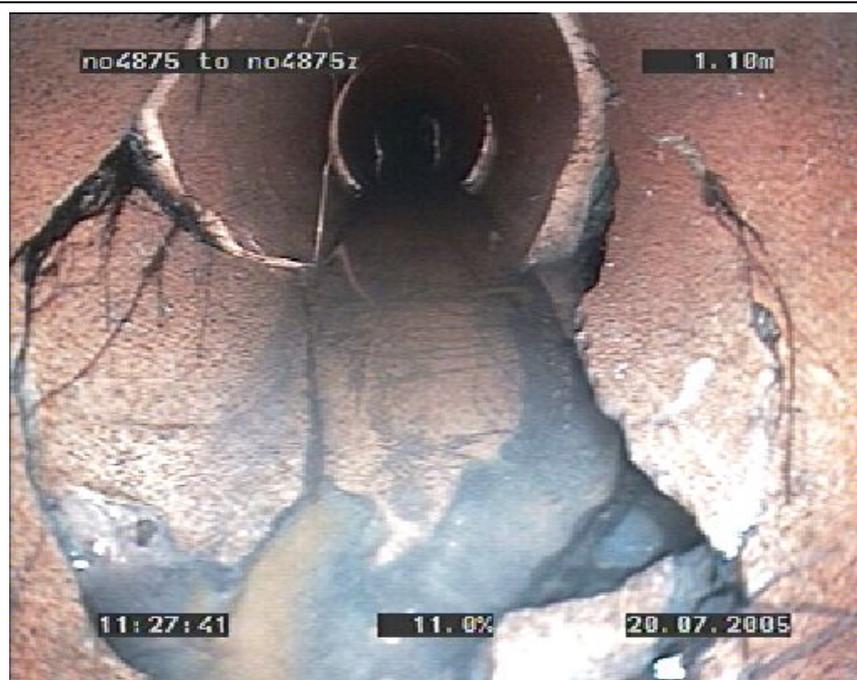
| | iii) | pieces of the pipe have totally dislodged. |
| | iv) | Alternatively in the opinion of the operator, the pipe is close to collapse, in which case alert the Engineer immediately |

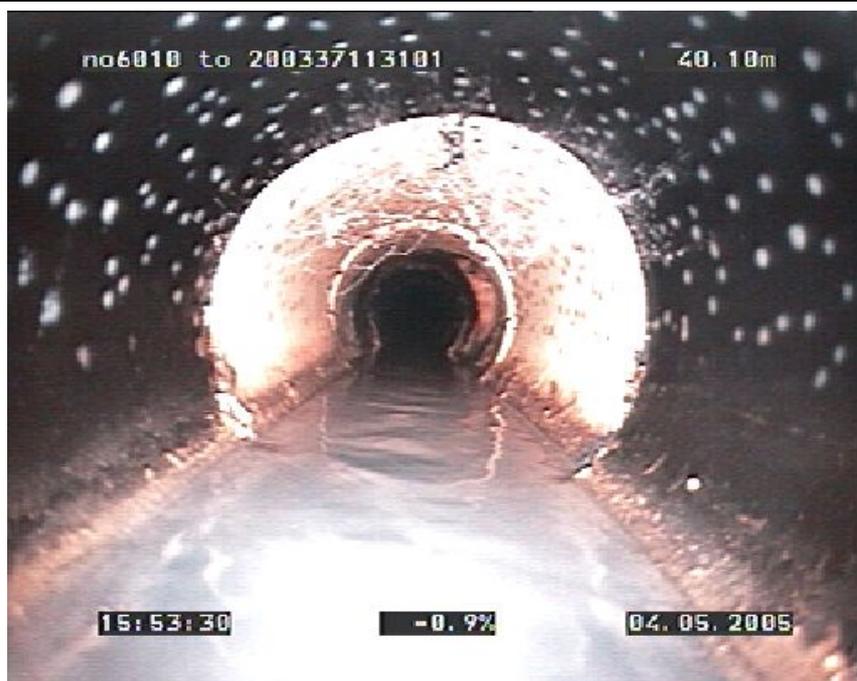
### Small

PF, S Deformation 10% or less of the pipe diameter

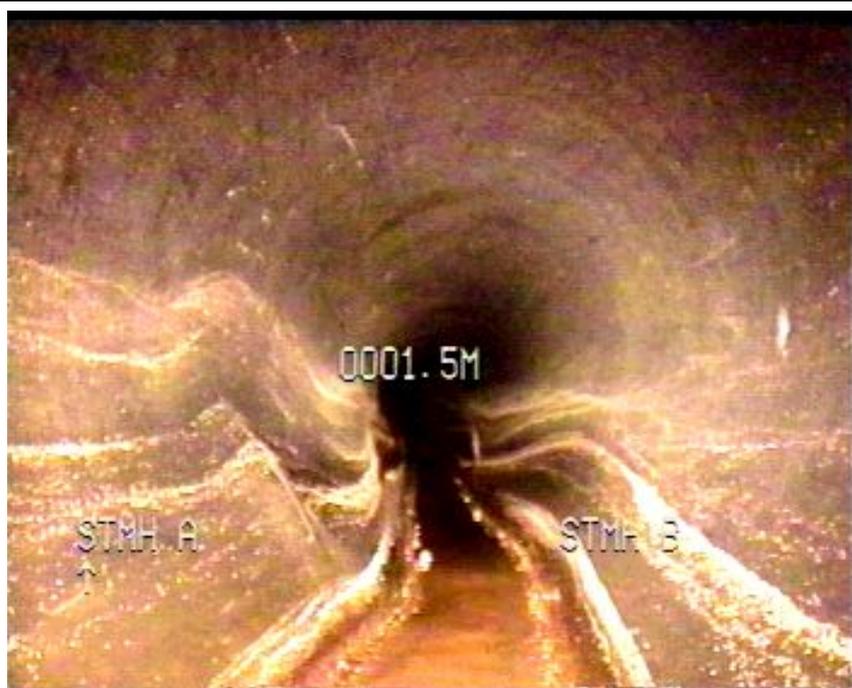
## Large

- PF, L
- i) Deformation greater than 25% of the pipe diameter, or
  - ii) Deformation less than 25% of the pipe diameter and in the opinion of the operator, failure of the pipe is imminent.

- This PE section of pipe has been subjected to external pressures sufficient to cause deformation on the left hand side. There is also an area of point pressure just to the right of the letter "A"

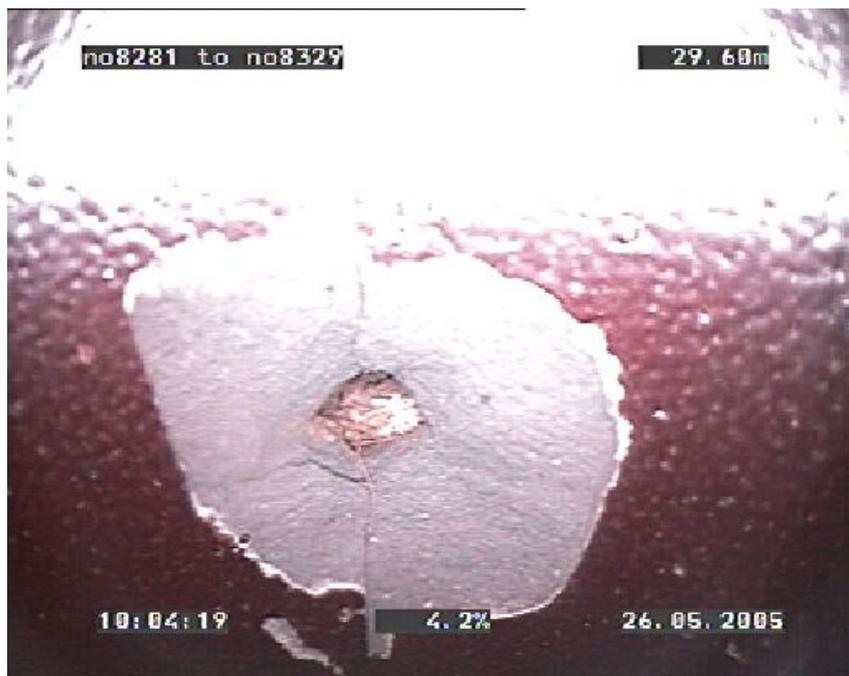
### Small

PH, S The hole has been repaired.

- The photo shows a small puncture hole that appears to have been repaired.

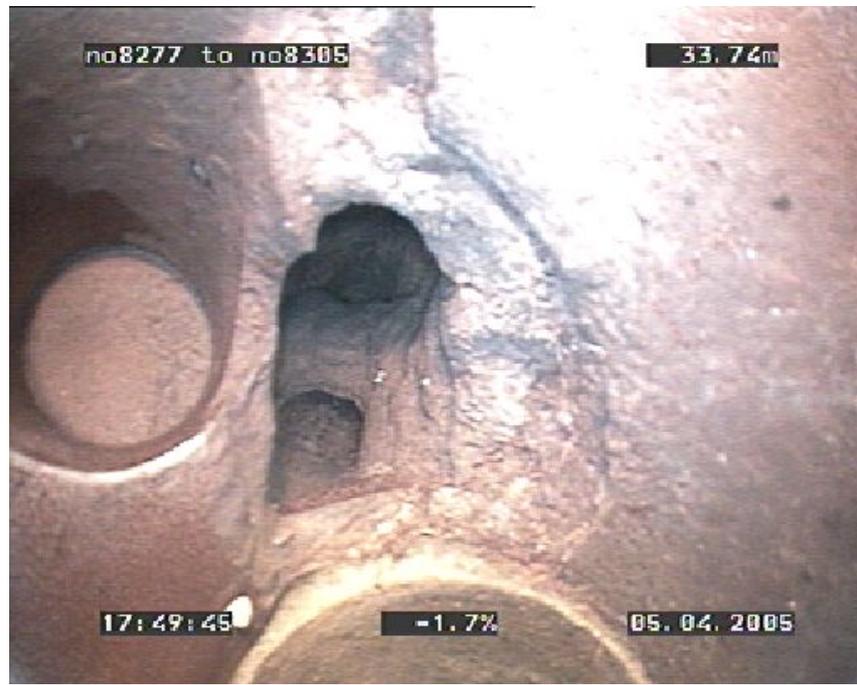
## Medium

PH, M The hole is up to 20% of the pipe circumference and has not been repaired

- The hole is up to 20% of the pipe circumference and has not been repaired.
- An unusual one this, not sure what caused the holes. There is also a blank lateral on the left.

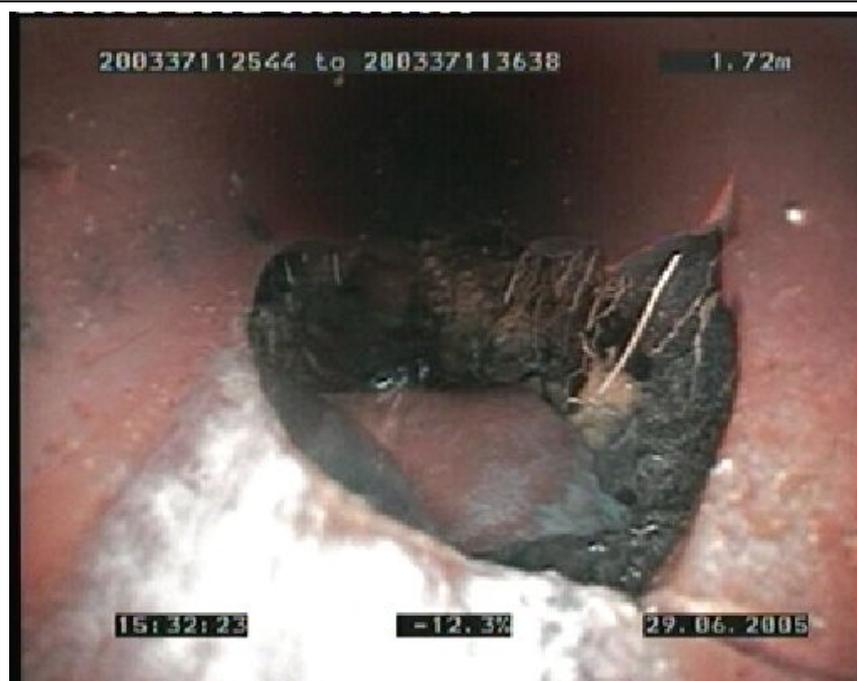
## Large

PH, L The hole is greater than 20% of the pipe circumference and has not been repaired

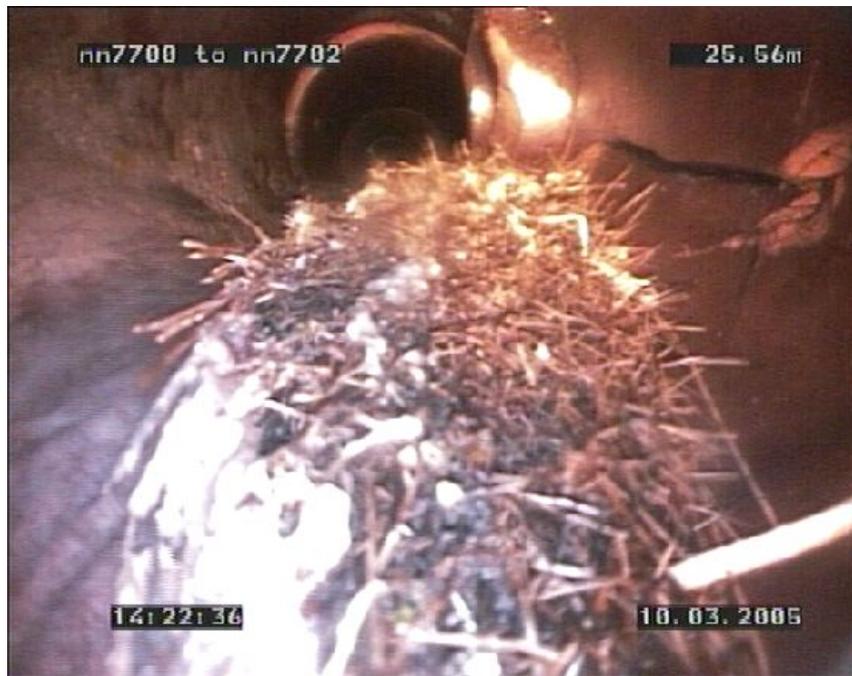
## Medium

RI, M Roots restrict flow by 10% to 25% of full flow.

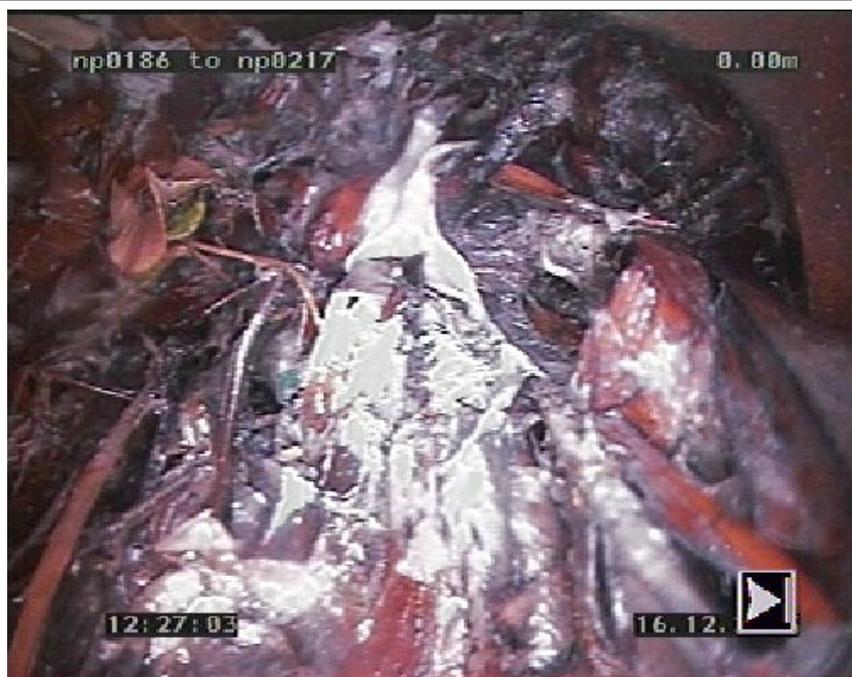
## Large

RI, L Roots restrict flow by more than 25% of full flow.

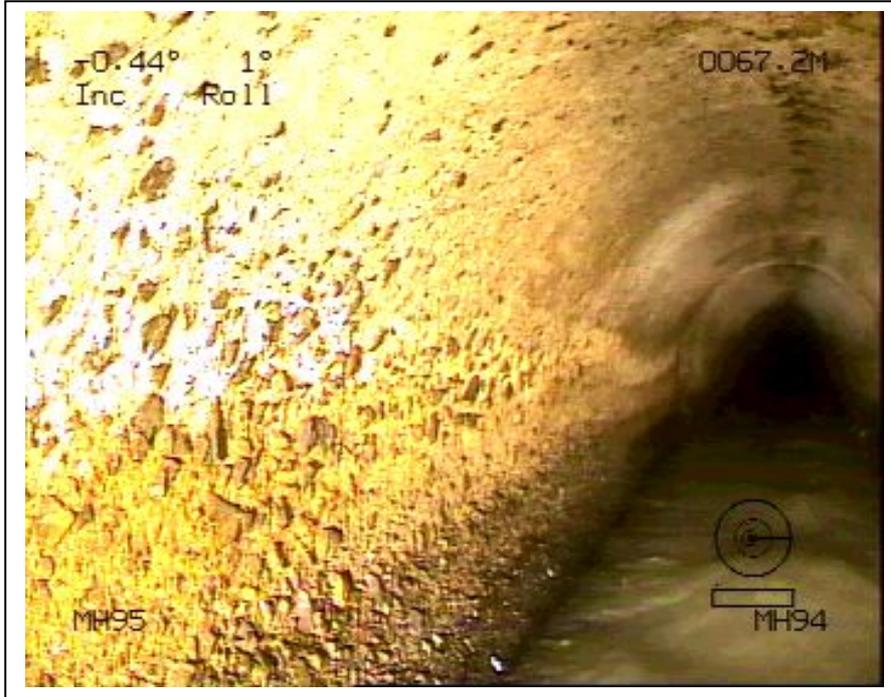
## Medium

SD, M Aggregate exposed or pipe wall otherwise significantly affected. Cement lining spalled from steel pipe and evidence of corrosion in the steel.

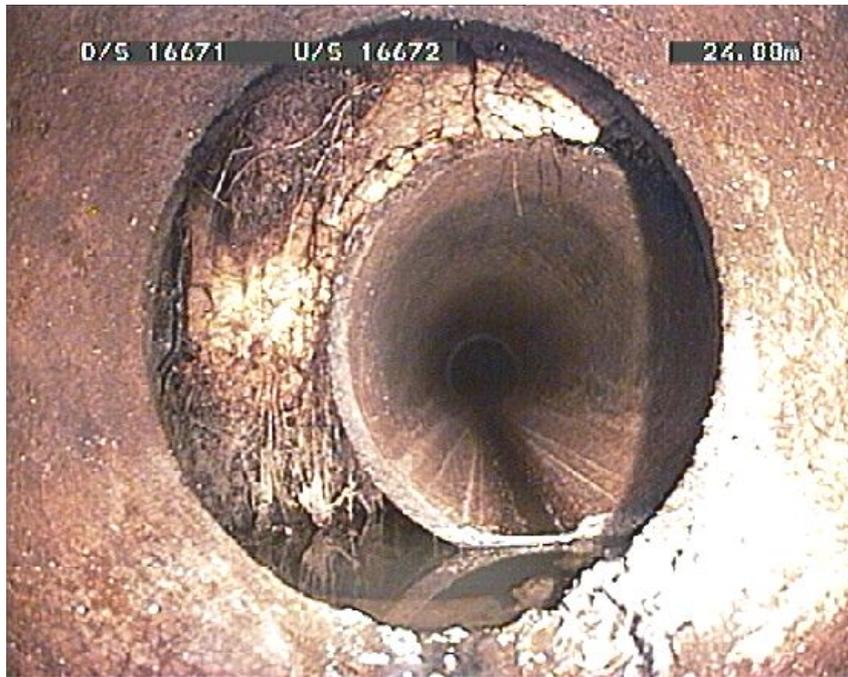
## Large

TM, L There is no S or M severity

- A large joint displacement and large joint open has resulted in the depletion of fill material.
- This fault had been coded prior to the introduction of this new code as "JD, L and JO, L". There was nothing to alert the Engineer to the seriousness of the condition other than the operators comments and a phone call directly to the Engineer.

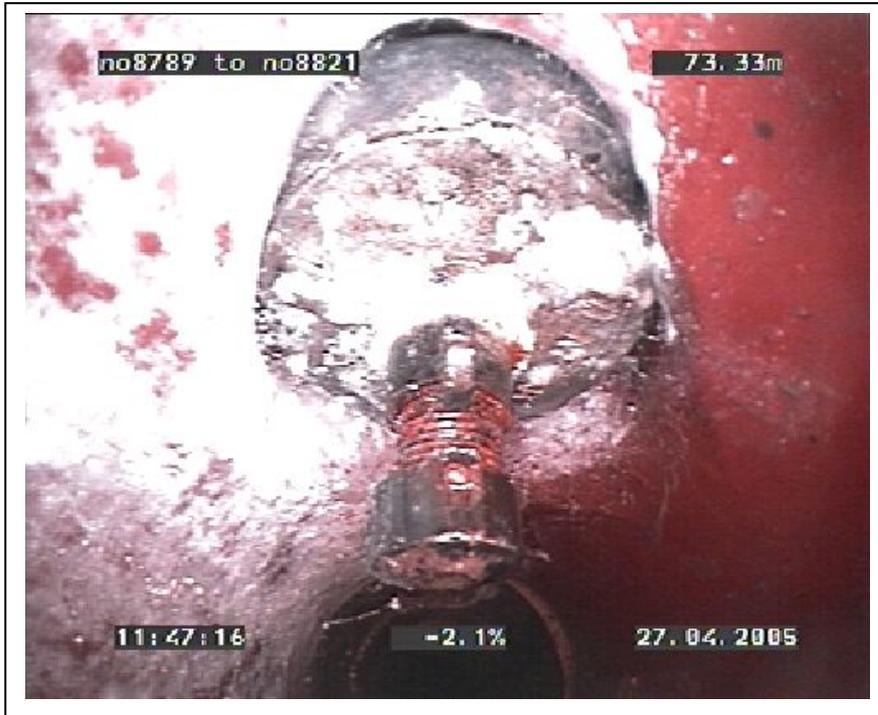
### PLUG IN A LATERAL

- A drainage plug has been installed into a lateral at some point to abandon the lateral. This is generally not standard procedure!
- Defect Code; OP, L

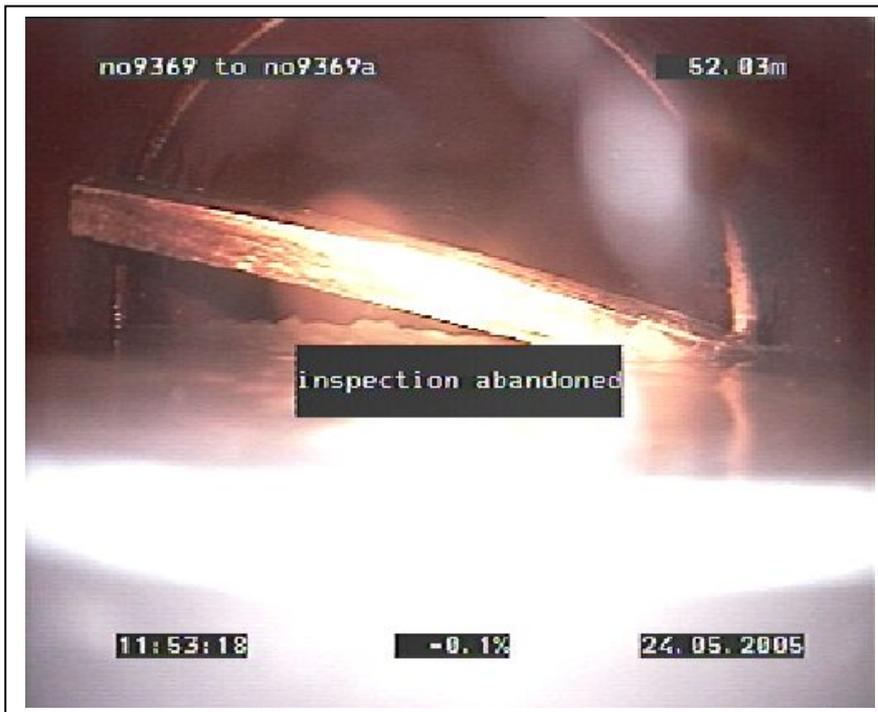
### PIECE OF WOOD JAMMED IN THE LINE

- A piece of wood has floated down the line and is just the right length to jam across a slightly displaced joint.
- Defect Code; OP, L

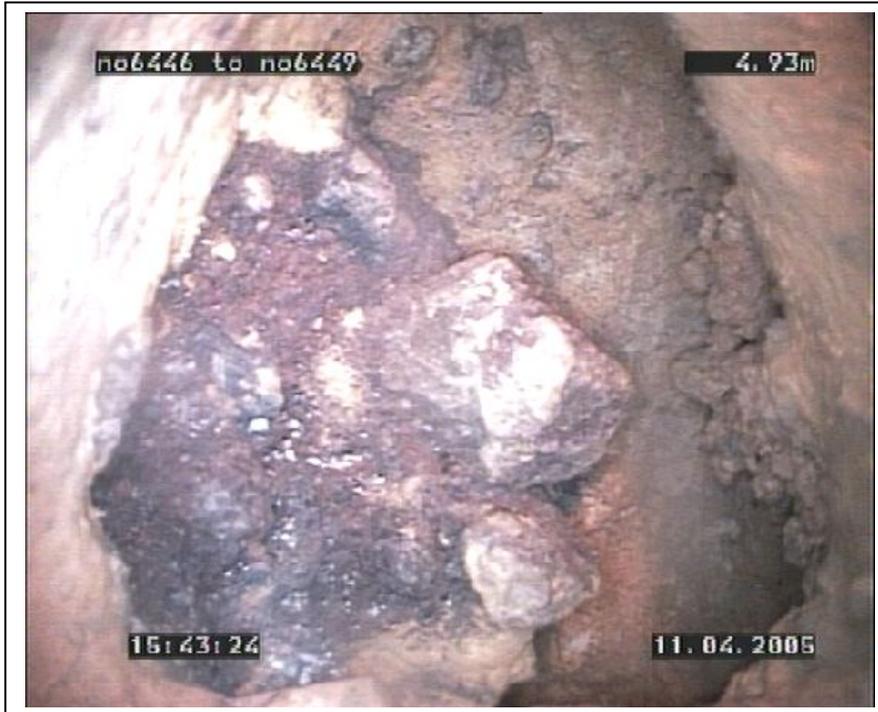
## TOMO

- Difficult to get into perspective, however a large tomo has developed due to a pipe fault.
- Defect Code; TM, L

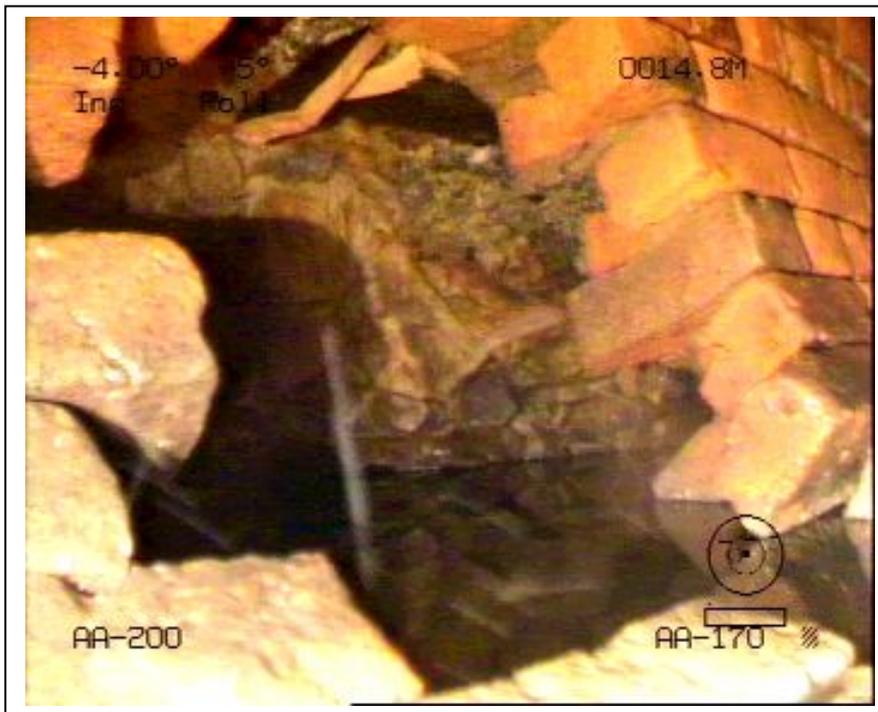
## TOMO, BRICK LINE

- A large oval/egg shape brick line. The catastrophic result of a few missing bricks.
- Defect Code; TM, L

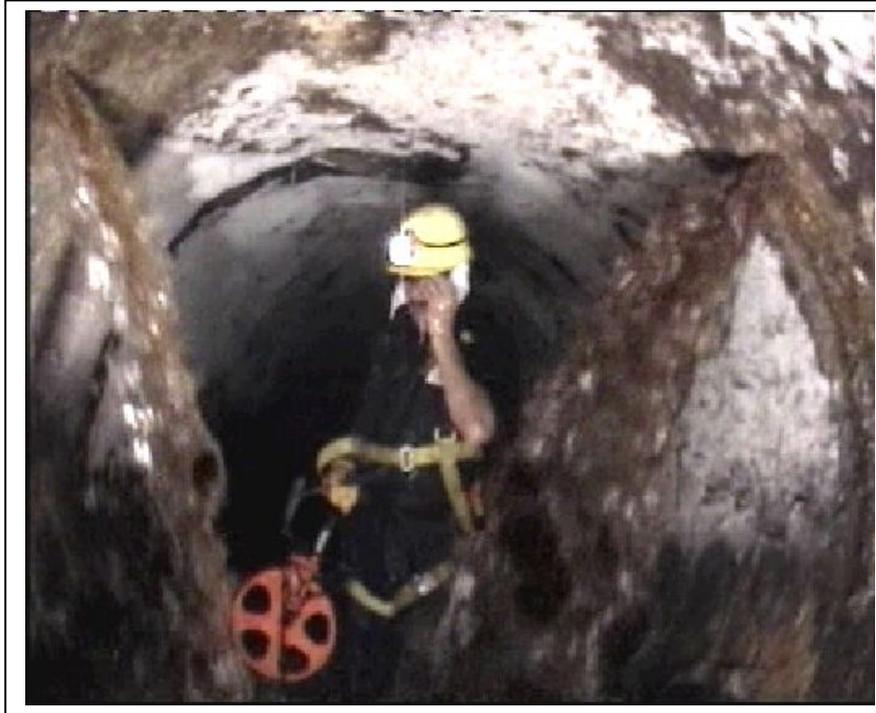
## MAJOR INFILTRATION

- This photo was taken during a walk through inspection of a Watercare trunk sewer in Auckland. Core samples had been taken of the concrete pipe to determine thickness and strength. The resulting ground water infiltration was interesting to say the least. The core sample holes were later repaired.
- Defect Code; IP, L

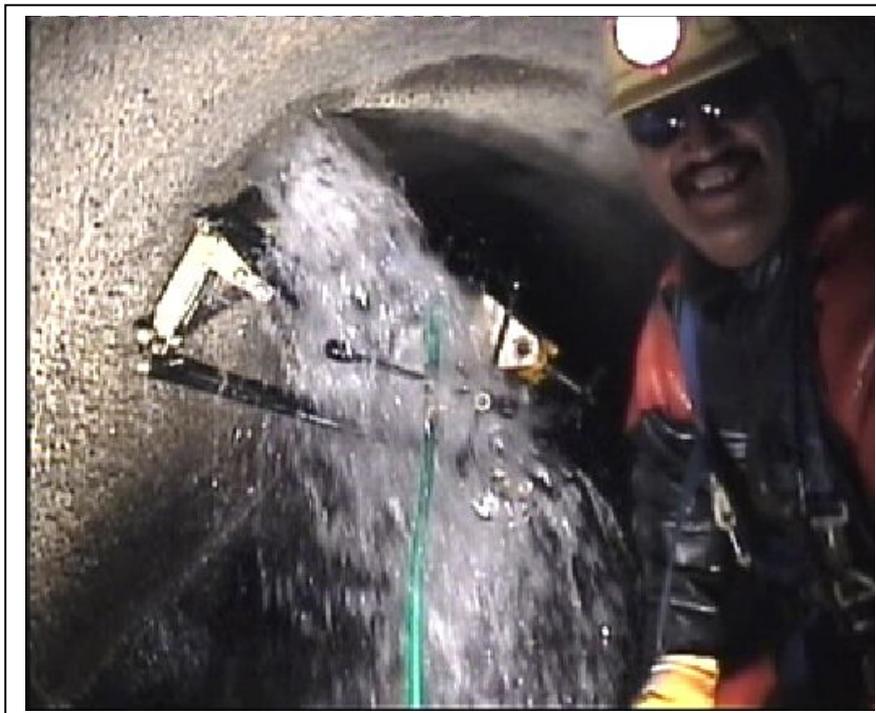
## MAJOR INFILTRATION

- More infiltration
- Defect Code; IP, L

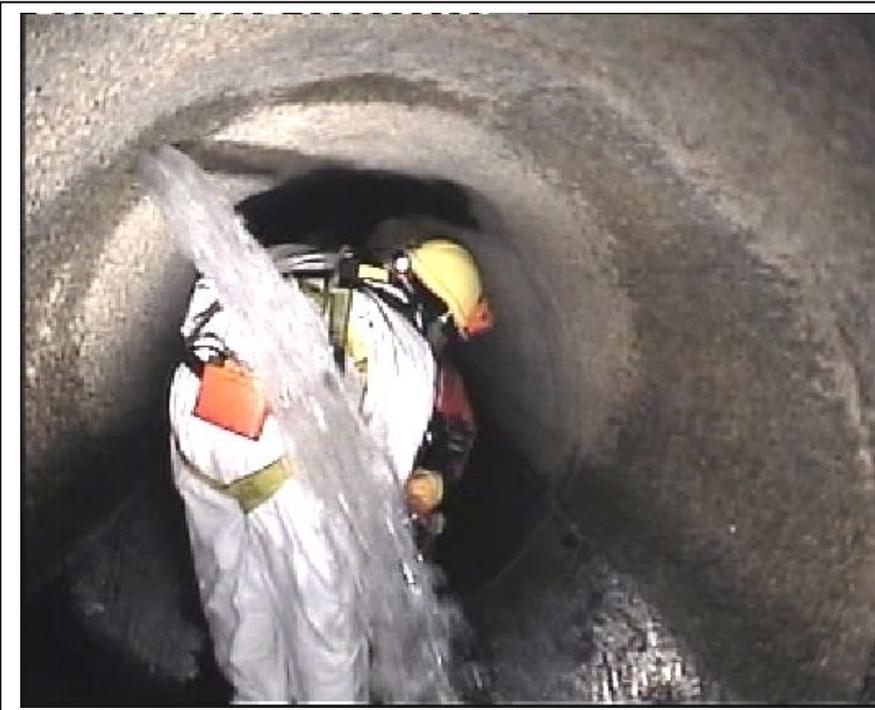
## MAJOR INFILTRATION

- More
- Defect Code; IP, L

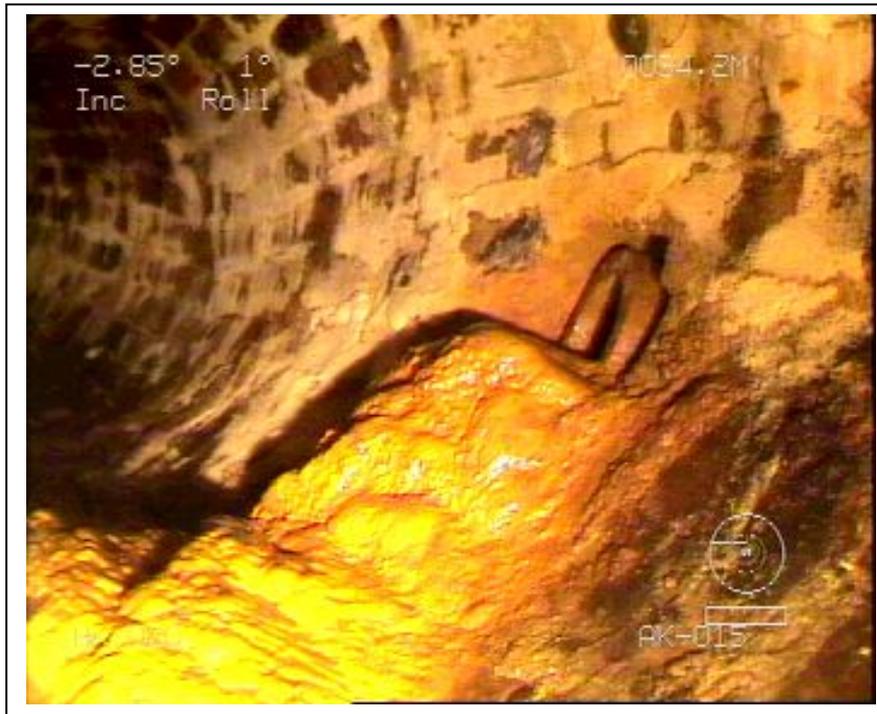
## MAJOR ENCRUSTATION

- Iron Oxide encrustation in a brick sewer.
- Defect Code; ED, L

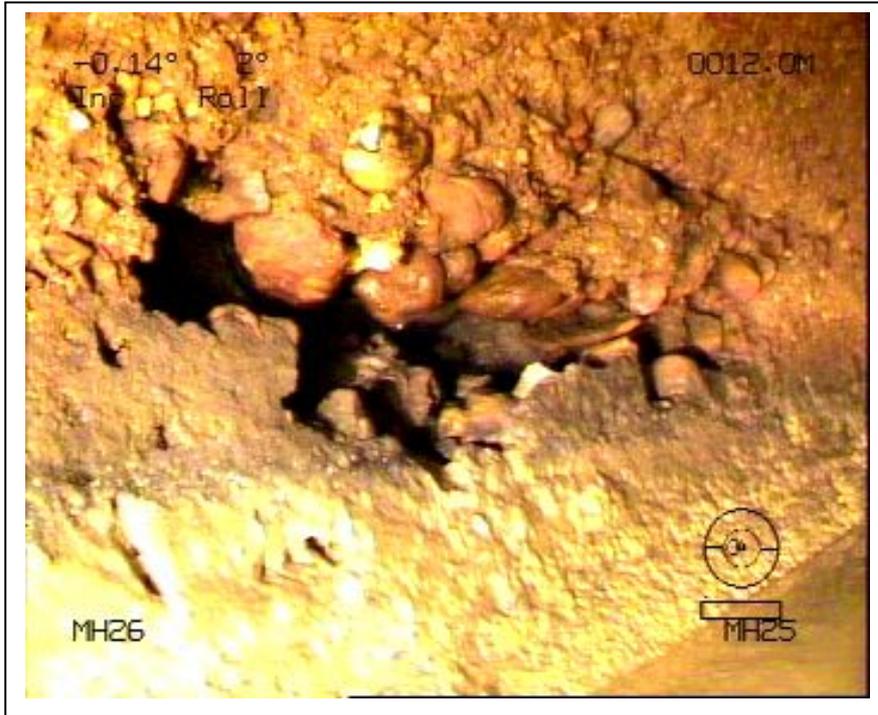
## SURFACE DAMAGE

- Surface damage by way of Hydrogen Sulphide attack extends through the pipe wall thickness
- Defect Code, SD, L with added remarks.
