# NEW ZEALAND GRAVITY PIPE INSPECTION MANUAL

**4<sup>TH</sup> EDITION**

Prepared for WaterNZ by ProjectMax Ltd  
and Citycare Water 2019

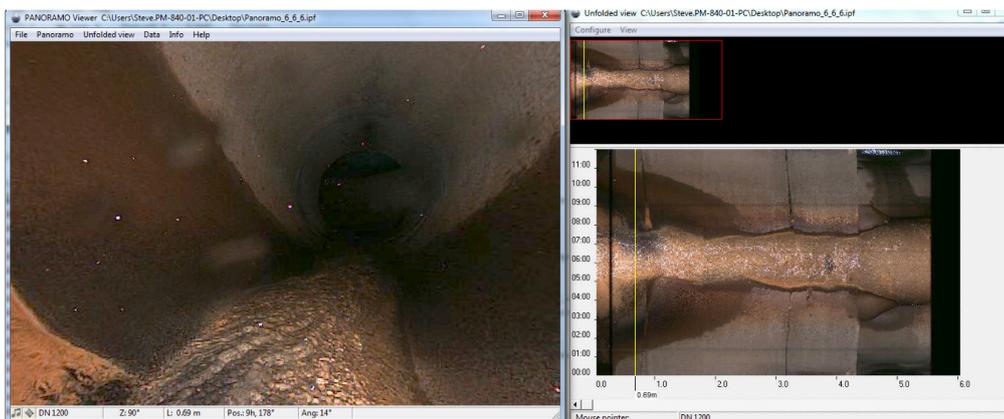
Figure A2.1 – Digital Scanned images of a pipe, both showing a view of the same location within the pipe (IBAK Panorama 3D Optoscanner)

Standard internal view

Unfolded view

3. **Digital Scanning Camera.** High Resolution digital camera (or cameras, some have two or more) that take wide angle (>180°) digital photographs that when processed by software provide a continuous view of the pipeline. The digital scanned images can typically be presented in different views including the standard internal ‘pipe’ view, (as would be seen from a Pan-Tilt-Zoom or Fixed Axial cameras) or an ‘unfolded’ view, (the pipe circumference is laid flat, refer to Figure A2.1). The digital scanned images permits computer-aided measurement of the pipe and allows the person carrying out the assessment to self-navigate through the inspection and view all defects and features through a Virtual Pan-Tilt-Zoom function without the camera operator having to stop to capture the information.

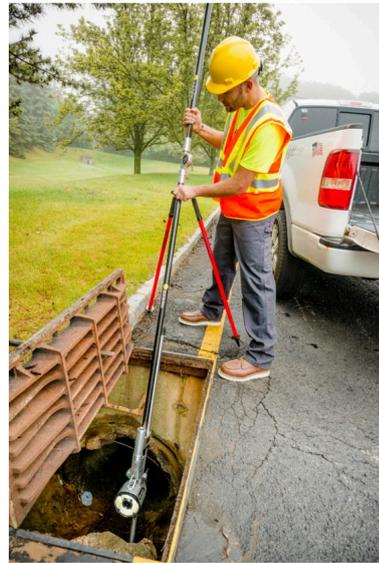
Figure A2.2 – Zoom Camera attached to a pole is lowered into a Catchpit chamber to inspect the pipe (Envirosight Quickview airHD)

4. **Zoom (Pole) Camera.** These cameras capture video images of the pipe by utilising a ‘zoom lens’ to view the pipe from a stationary position within a manhole. This method is a version of what was previously referred to as ‘lamping the line’. The technology does not provide the detailed visual information that traditional moving cameras provide but can identify some defects and identify potential issues that can be prioritised for further detailed investigation.
5. **Action Camera.** A compact camera capable of capturing photos and video. An example of an action camera is a ‘Go-Pro’ camera. When mounted on a pole with extra lighting can perform inspections of manholes or with enough lighting can be used to capture video as part of a person-entry inspection.

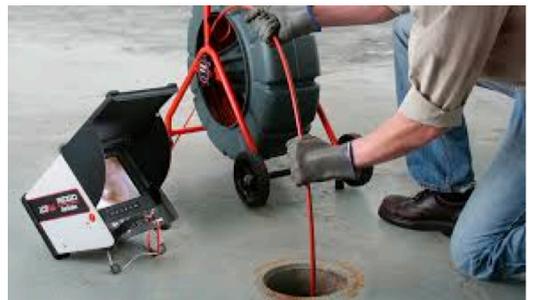
Figure A2.3 – Semi-rigid cable is used to push and pull the camera through the pipe

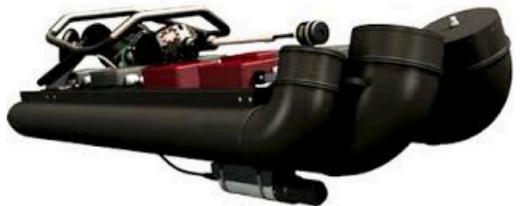
Figure A2.4 – Pipe Inspection float system, transporting in this example rear facing VPTZ camera, laser profiling and Sonar equipment below (MSI HD System, Photo Credit Red Zone Robotics)

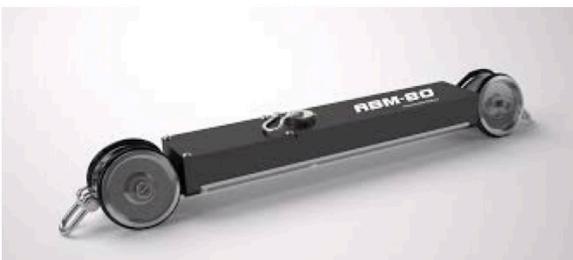
Figure A2.5 – Gyroscope based mapping tool developed for gravity pipelines (Reduct ABM-80)

A mapping probe equipped with inertial sensors (gyroscopes, accelerometer, magnetometer, etc) that can position the X, Y and Z coordinate location of the pipe over its entire length at 100 samples per second. The probe is pulled through the pipeline on wheels at  $\pm 2$ m/second and provide an accuracy of 0.03% XY and 0.01% Z as a percentage of pipeline length surveyed. (e.g. a 100m long pipe the accuracy would be 3mm XY and 1mm Z). Prior to undertaking gyroscopic profiling, the pipeline must be clean with no debris or attached deposits in the pipe invert that may affect the pitch of the profiler

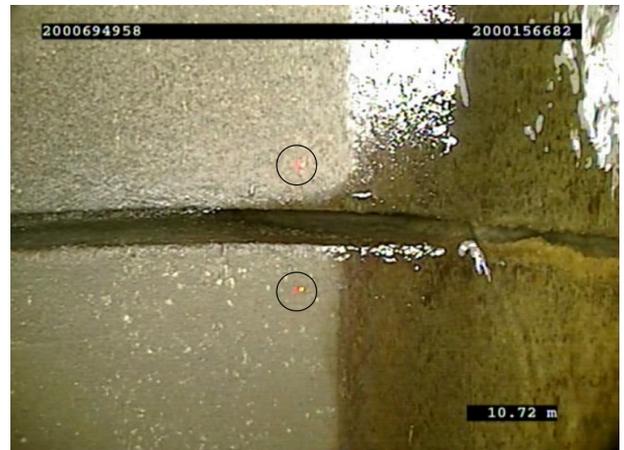
Figure A2.6 – Laser dots projected from the camera head panned towards to pipe wall either side of a joint

- Laser calliper measurement (Laser dots) – the most commonly available measurement enabling tool for Pan-Tilt-Zoom cameras. Laser dots are projected on to the pipe surface which have a known fixed measurement that can then be used to calibrate and measure the width of joints or other smaller features (that can be viewed within the monitor). To use these laser measuring dots, the camera must be panned directly towards the pipe wall (90o to the pipe axis).
- Gyroscopes – enabling the tracking and plotting of the camera to map the position of pipelines.
- Laser profiling – this is limited to some digital scanning cameras

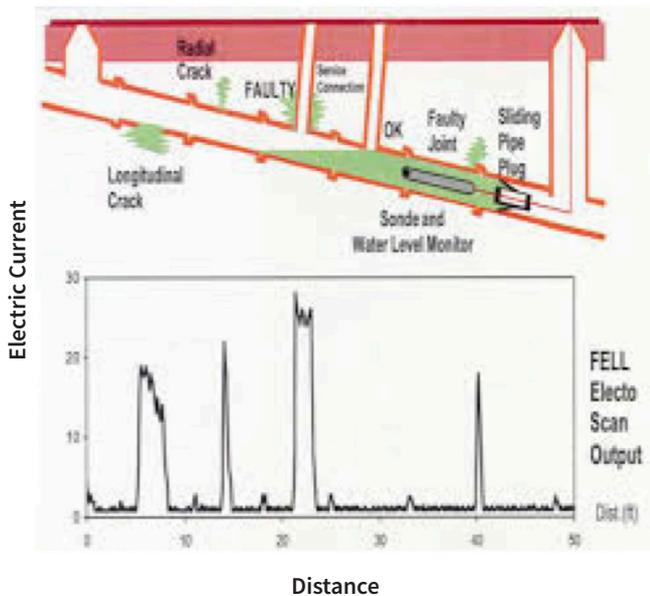
Figure A2.7 FELL Electro Scan Output, locating leaks

FELL identifies defects that allow ground water infiltration into the pipe by measuring the size of an electric current that is able to flow from an electrode probe inside the pipe to a probe at the ground surface. The test is carried out by pushing a probe through a non-conducting (non-metallic) pipe and applying an electric potential of 9 to 11 volts rms with a frequency of 500Hz to 30 kHz between the internal probe and the surface electrode. The resistance of the pipe wall only allows a very small electrical current to flow to the surface electrode, but where there is a defect in the pipe wall that extends through to the outside of the pipe, allowing the current pass through, the strength of the electrical current is much higher. The greater the electric current flow, the larger the size of the leak. The data can be processed to grade the variations of electrode current values into those that represent small, medium or large potential pipe leaks, but do not measure the actual flow of ground water infiltration occurring through the pipe defect. The probe is pushed through the pipe in a similar fashion as a Push Rod Camera. The probe must be fully submerged in water throughout the inspections (either by flooding the whole pipe or just around the probe as it moves through the pipe). The type of soil surrounding the pipe does not affect the data. Some FELL equipment has built in fixed axial CCTV cameras.

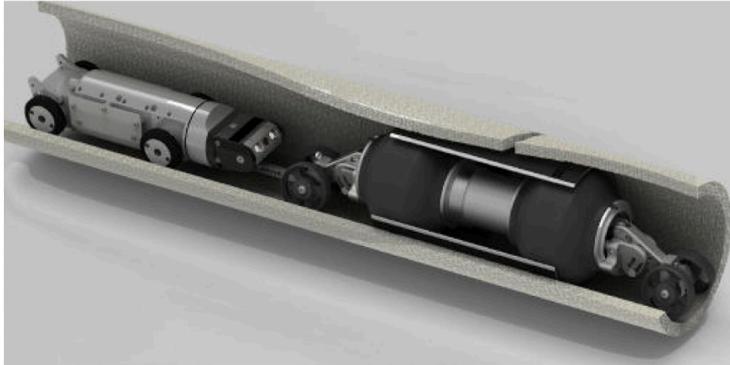
Figure A2.8 combined testing and mechanical repair packer (with a repair sleeve shown) and CCTV camera (IDTEC QLP160, photo credit IDTEC USA)

Packer testing is a technique in which a joint is isolated from the rest of the pipe using inflatable packers and air test is undertaken. The packer ends are expanded so as to isolate the joint from the remainder of the pipe and create a void area between the packer and the pipe joint. The void around the joint is pressurised to 340 mbar (5 psi) held for 15 seconds. Failure to achieve the test pressure or a drop of  $\geq 70$  mbar (1 psi) over the test period indicates a failed test result. The size of the drop in pressure indicates the 'leakiness' of the joint. The testing could also be undertaken on defects such as circumferential cracks. CCTV cameras are used to position the packer(s) to isolate the joint. Some equipment has Pan and Tilt cameras built in.

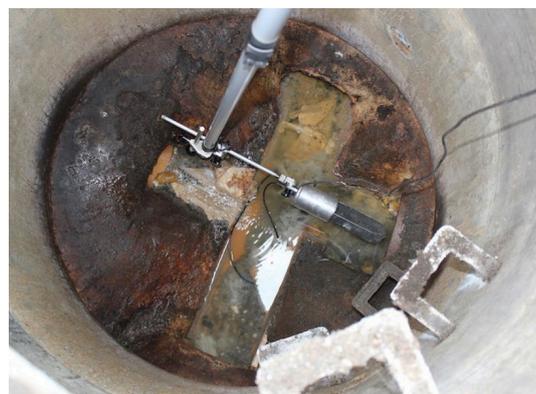
Figure A2.9 – SewerBatt inserted into the pipe for rapid inspection (photo credit Lanes Group plc)

SewerBatt is a portable acoustic sewer inspection tool that consists of an acoustic sensor head that is mounted on a pole (similar to a pole camera) which is lowered into the manhole and inserted into the pipe to be tested. The sensor head contains a sound source (speaker) that transmits an acoustic excitation signal into the pipe. Simultaneously, the acoustic signal response from the pipe is captured by an array of microphones that are also contained in the sensor head. The captured signal responses are used to assess the pipe service condition. An automated condition assessment module that reviews the acoustic signal response, makes allowance for the energy loss from the pipe-ends and lateral connections, and then grades the pipe. The final pipe service condition is simply in the form of a coloured traffic light indicator providing a red, amber (yellow), or green (RAG) grade. A red grade assessment indicates the need for further inspection or cleaning. An amber grade assessment is cautionary, indicating that there may be some blockage issues, but not enough to block the flow. A green assessment indicates the pipe is free of any significant blockages and no further evaluations are necessary.

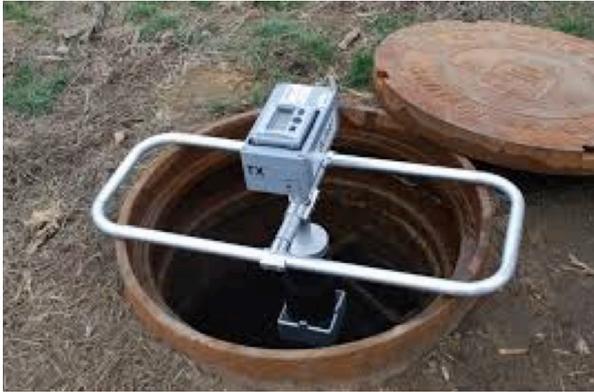
Figure A2.10 – SL-RAT device is positioned at each end of a pipe section to be tested (photo credit www.kci.com)

SL-RAT measures the dissipation of sound energy between a transmission speaker and a separate receiver, device. The transmission and receiver devices are set up in the upstream and downstream manholes at either end of the pipe to be tested. Any single service defect that completely obstructs the pipe will not allow the transmission of sound energy between the two devices. Additionally, defects such as roots, fat etc., increase the sound dissipation. The overall blockage assessment by SL-RAT is provided in the form of a numeric output value on a scale of 0 (completely obstructed) to 10 (completely unobstructed).

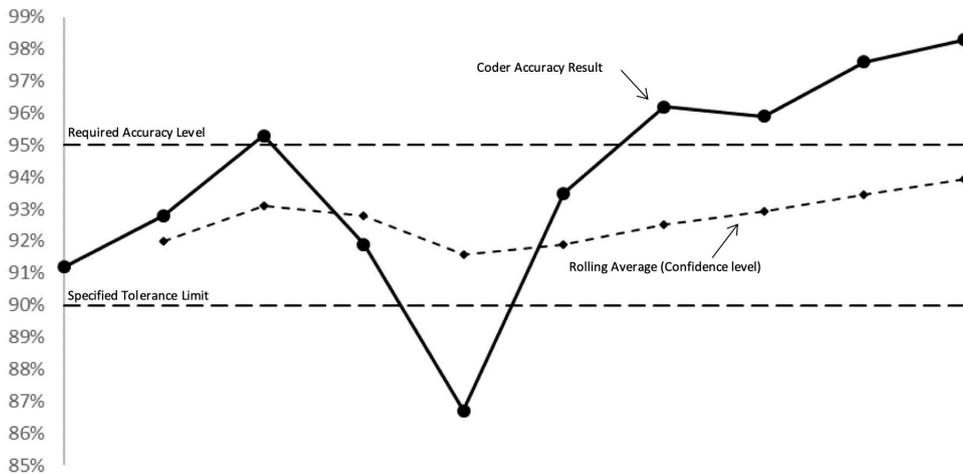
Figure A4.3 – Example Coder Accuracy Monitoring Graph with a Tolerance Limit of 90%

- As the header accuracy result for coder, TJ McKay, is less than 95%, (92.6%) the recommended action, in addition to correcting all identified header errors, shall be that all the inspection headers in Batch 01 coded by TJ McKay shall be checked for errors.
- The observation accuracy result for J. Roger, is less than 95%, (89.4%) and therefore the observation errors identified in the audit for that asset will need to be corrected, and all inspection observations coded by J. Roger in Batch 01 shall also be check for errors.

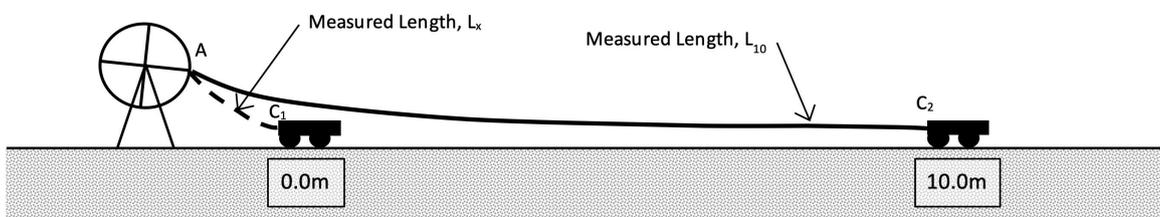
Figure A4.4 – Cable Counter Calibration Test

**Actual measured length of cable pulled off (A to ?)**

**Maximum allowable difference cable counter reading and measured length is 0.2m**

6. Compare the differences between the counter distance and the measured distance for each 10m increment. The largest difference shall not exceed 0.2m.

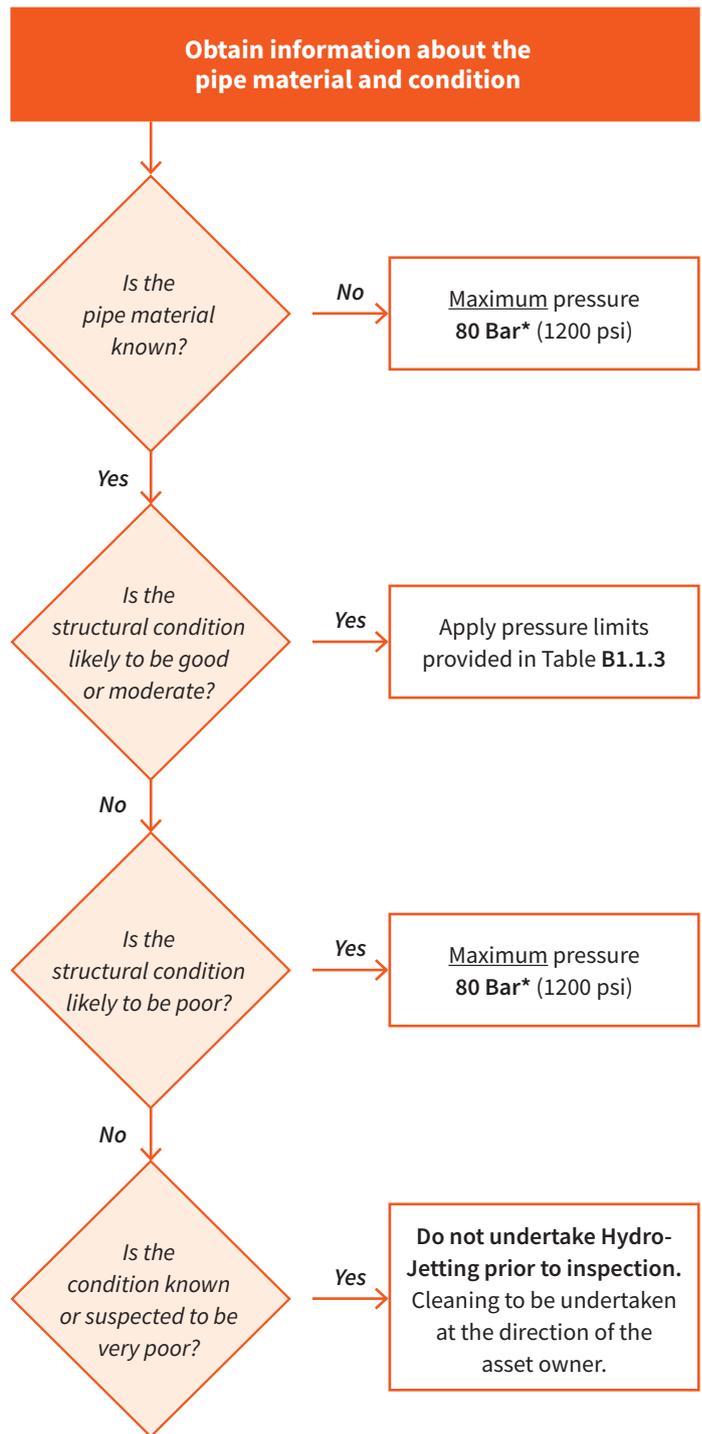
Figure B1.1.1 – Procedure for applying Pressure Limits

\* If trenchless repair patches have possibly been installed, then maximum pressure shall be reduced to 70 Bar/1000 psi (in line with Table B1.1.3)

High pressure/low volume cleaning techniques shall be avoided for pre-inspection cleaning. The maximum pressure applied shall be 130 Bar (1900 psi).

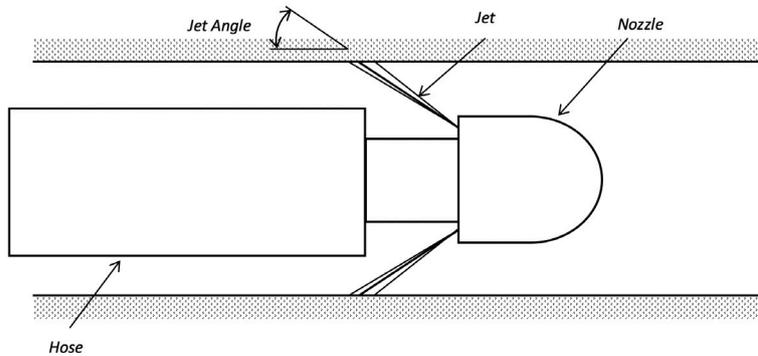
Figure B1.1.2 – Sketch of a nozzle

Nozzle performance for removing non-cohesive debris (silts, sands and gravels) in small diameters (<600mm) is considerably affected by the Jet Angle (refer to Figure B1.1.2) and the depth of the sediment to be removed. Table B1.1.5 shows the optimum nozzle jet inclination for non-cohesive debris.

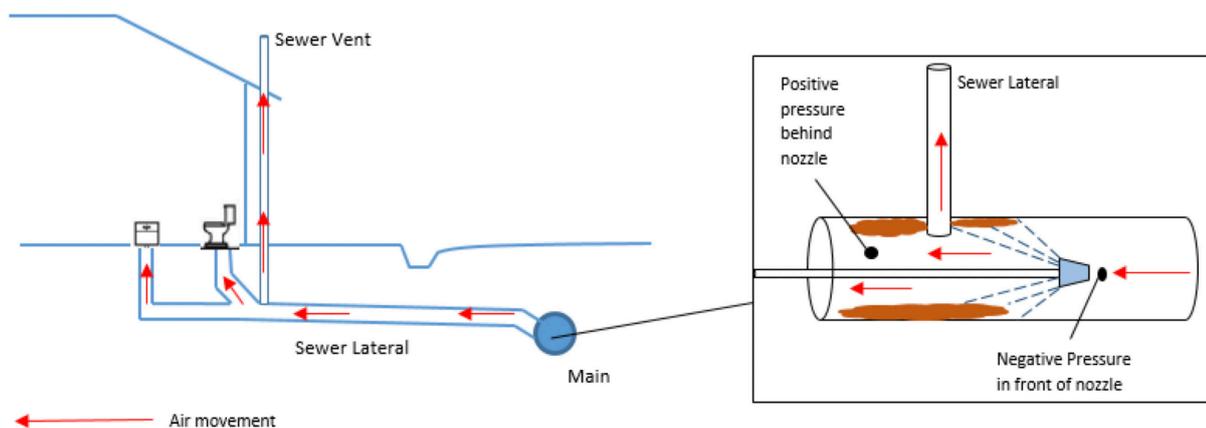
Figure B1.1.3 – Diagram showing how pressure causes blowbacks

Blowbacks may occur during cleaning of the wastewater pipelines, particularly if high pressure is used. During this cleaning process a negative pressure is created ahead of the nozzle while a positive pressure is created behind the nozzle due to the airflow associated with the spray. The amount of pressure created by the nozzle varies with the pump pressure and volume of water. As the nozzle moves through the line the positive pressure pushes into the sewer lateral lines. If there is nowhere for the positive pressure to go, (e.g. through a properly installed vent) air pressure may escape through a toilet water trap, floor drain or the nearest exit it can find (refer Figure B1.1.3). This undesired venting can result in the release of unpleasant odours and, on occasion, sewage/contaminated water from the u-bend and/or sewer into a home or business.

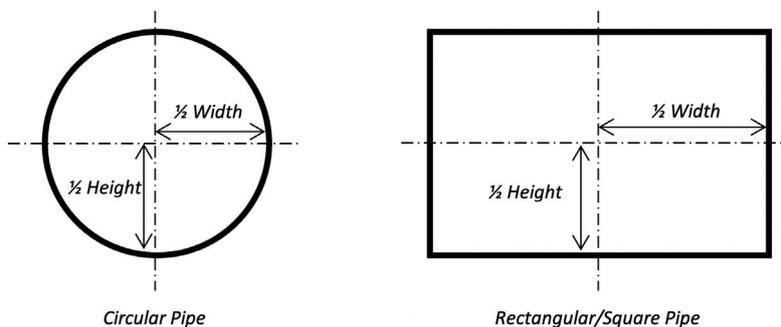
Figure E1.2.1 – Diagram indicating the position for the camera in a circular or rectangular/square pipe in the centre of the pipe

Most pipelines in New Zealand have a circular or rectangular shape. When inspecting these pipes, the camera equipment shall be selected and setup such that the view down the pipe is centred along the central axis of the pipeline. This shall be within 10% of the largest dimension.

If a camera is set to high, or too low, in the pipe it can lead to a reduced view of the pipe walls, or picture distortion resulting in errors when quantifying defects.

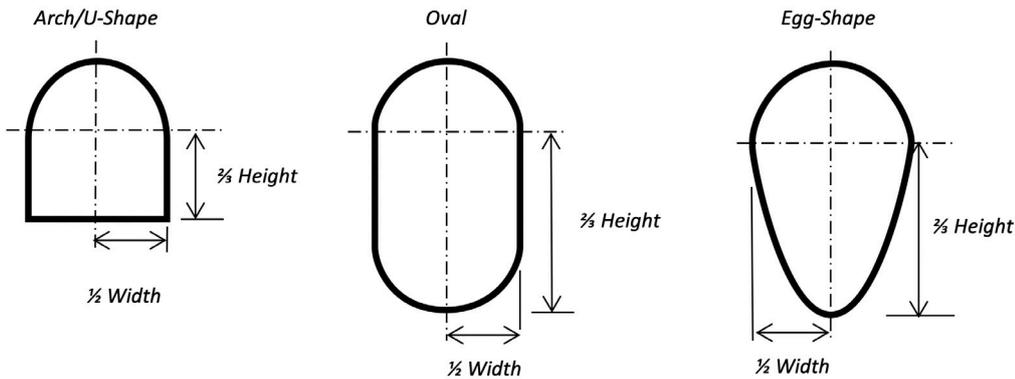
Figure B1.2.2 – Diagrams indicating the preferred position of the camera in other pipe shapes

For other pipe shapes the camera shall generally be aligned with the centre of the upper circle, normally approximately two thirds of the height of the pipe (refer to Figure B1.2.2). For egg-shape pipes, the steep angle of the lower pipe walls is inherently unstable for the camera, with the propensity for the camera to tip over. The likelihood of the camera tipping over is increased if the camera is high in the pipe. Therefore, the height of the camera in egg-shaped pipelines, or any pipe shape where there is a higher risk of instability, shall as close as possible to the ideal height whilst ensuring that the camera is as stable as possible.

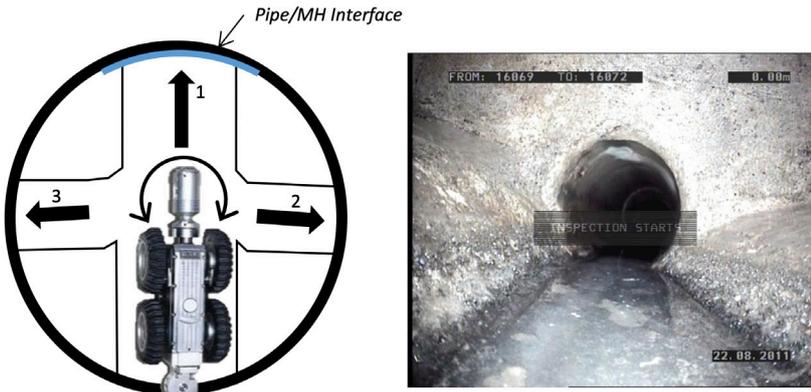
Figure B1.2.2 – Diagrams indicating the preferred position of the camera in other pipe shapes

View of the pipe to be inspected and interface between the manhole wall and the pipe (interface seal).

7. The camera is then tilted upwards to record as much as possible of the manhole walls, lid and any high-level incoming pipes (Droppers). Where components are noted as defective or missing, these shall be noted in the inspection report comments.

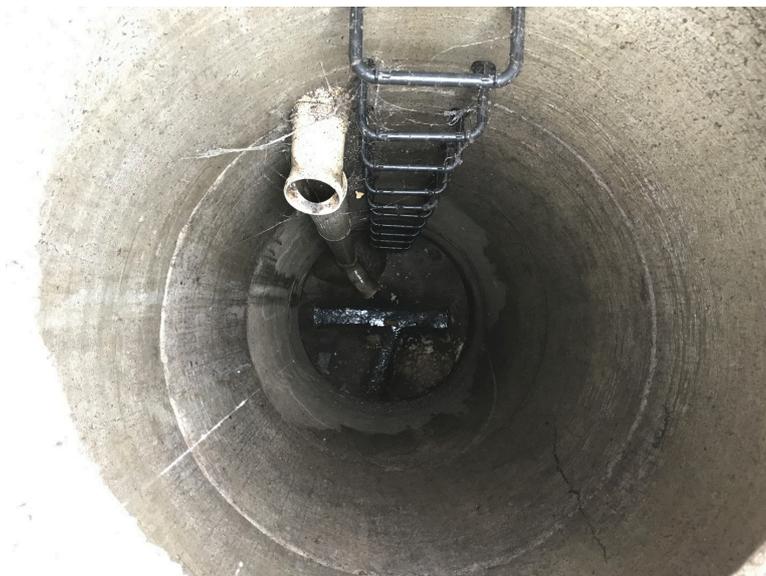
Figure B1.2.4 – Example of view looking down a manhole when the camera (pan and tilt or fixed head) cannot start in the manhole

1. Prior to lowering the camera into the manhole, a view looking down into the manhole from the ground surface shall be recorded, such that the manhole wall, benching and all the incoming and outgoing pipes can be seen on the video.
2. The distance counter is set to zero metres (0.0m). Note later requirement to reset the distance counter when the camera is in the pipe.
3. A screen header is displayed for 5 to 10 seconds notifying the start of the inspection (refer B1.2.2.8 Screen Displays).
4. The recording shall then continue as the camera is lowered into the entrance of the pipeline to be inspected, ensuring that the entire interface between the manhole wall and the pipe can be clearly seen as this is undertaken.

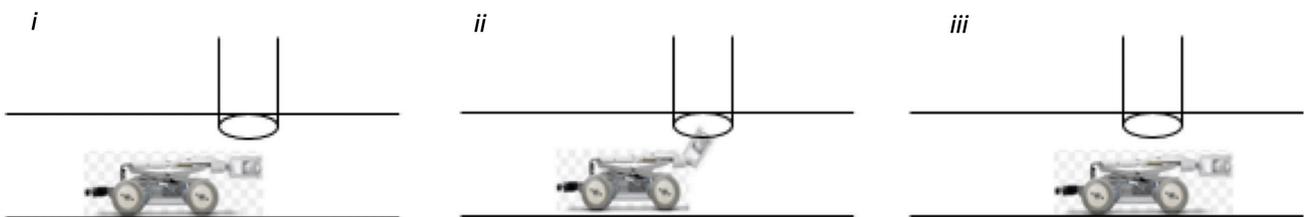
Figure B1.5 – Camera setup when starting in the pipeline at a lateral connection.

- i) starting position of CCTV camera at a lateral connection.
- ii) panning the inside of the lateral and connection zone.
- iii) commencing inspection.

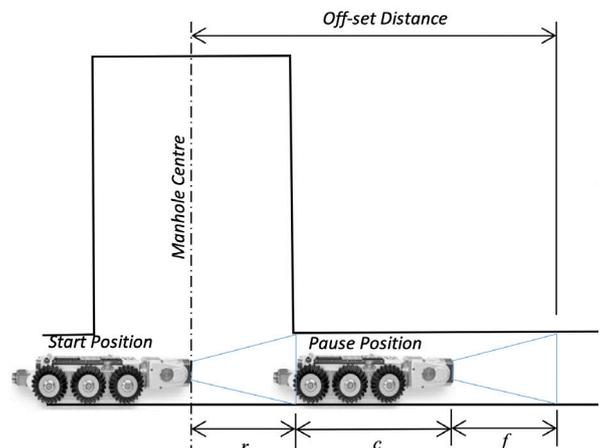
Figure B1.2.6 – Measuring the Off-set Distance

Where the camera is starting at a lateral connection, or similar, within a pipeline, the cable behind the camera shall already be taut, and the distance counter will start to measure as soon as the camera begins to move forward. In this situation an *Offset Distance* does not need to be set.

$r$  = Distance from manhole centre to the pipe entrance

$c$  = Length of the camera

The distance to the defect or feature of interest is measured from the centre of the starting node. The distance counter, however, will not normally start to measure the distance until the cable behind the CCTV camera is taut. Typically, where the camera is starting from a manhole, the cable would not be pulled taut until the rear of the camera is level with the entrance to the pipe. This provides an easily recognised and predictable measurement. It is therefore important that the distance counter is adjusted to allow for any distance that may be travelled, from the camera starting position, before the distance counter begins to operate. This 'Offset Distance' includes the distance from the centre of the manhole to the entrance of the pipe ( $r$ ), the length of the camera ( $c$ ) and the distance from the front of the camera to where the pipe can be clearly seen, referred to as the Focus Length ( $f$ ). Note that this is a measurement and is not related to the optical focussing of the camera.

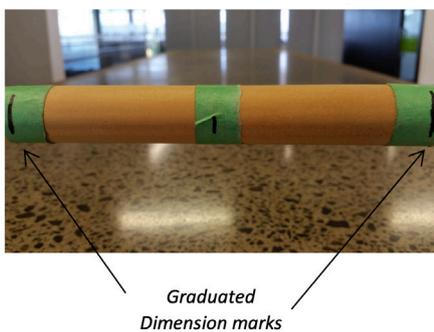
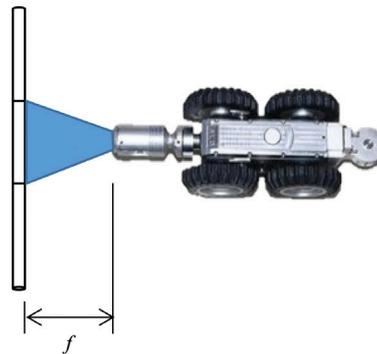
Figure B1.2.6 – Measuring the Off-set Distance

The look-up table could include the length of the camera unit ( $c$ ), such that the CCTV Camera Operator could use the combined values ( $c + f$ ) as pre-set values, that only require the measurement of the manhole centre to the pipe entrance ( $r$ ) to be able to establish the Off-set Distance.

Focus Length ( $f$ ) is measured between the pole and the front of the camera

To be able to accurately enter the Offset Distance at the start of an inspection from a manhole, the operator needs to be able to know what the correct Focus Length is that must be used before commencing an inspection. A look-up reference table is recommended to be populated, by the CCTV contractor, for each camera type, by measuring the focus distance for every pipe diameter over the range of pipe sizes that the camera can inspect.

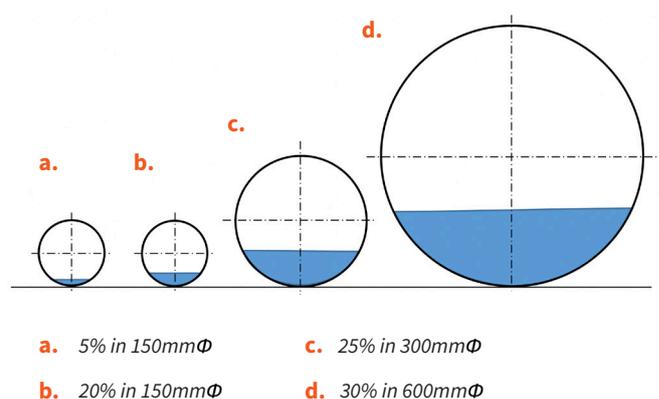
Figure B1.2.8 – Examples of maximum depths of water in various pipe sizes

Pipe Diameter	Maximum Depth of Flow (% of pipe diameter)
<150mm	15%
150-299mm	20%
300-600mm	25%
>600mm	30%
New constructed, any size	5%

The inspection shall be carried out in low flow conditions to maximise the perimeter of the pipe that can be seen. Unless specified or agreed with the asset owner, the maximum depth of flow values in Table B1.2.2 shall not be exceeded at the start of the inspection. Inspection of a new pipe, (as-built inspection) shall ideally be undertaken with no live flows, or a maximum depth of flow of 5% of the pipe diameter.

Many large trunk sewers or stormwater culverts will not conform with these values, as the flow never drops to below 30% of diameter at any time during the day. In such cases the inspection equipment may need to be floated down the pipeline to carry out the inspection (refer to Section A2). If available to the Contractor, sonar technology shall be fitted in these situations to the float to give an indication of debris levels in the large sewers.

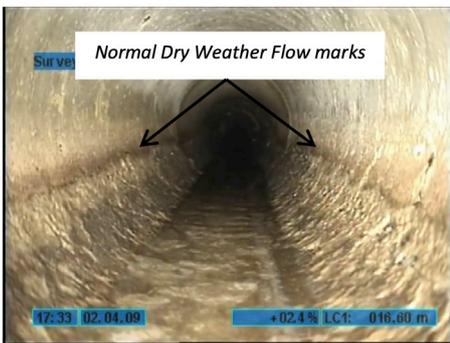
Figure B1.2.9 – Photo of concrete pipe with erosion and staining indicating the level of normal dry weather flows

If there is any sign of erosion or corrosion of the pipe material present, the inspection shall be carried out with the flow direction (setup at the upstream node) and where necessary, the water level must be controlled to a level of at least 10% of diameter below the normal dry weather flow level. The dry weather flow level maybe be indicated by the staining/discoloration of the pipe material from the flow in the pipe.

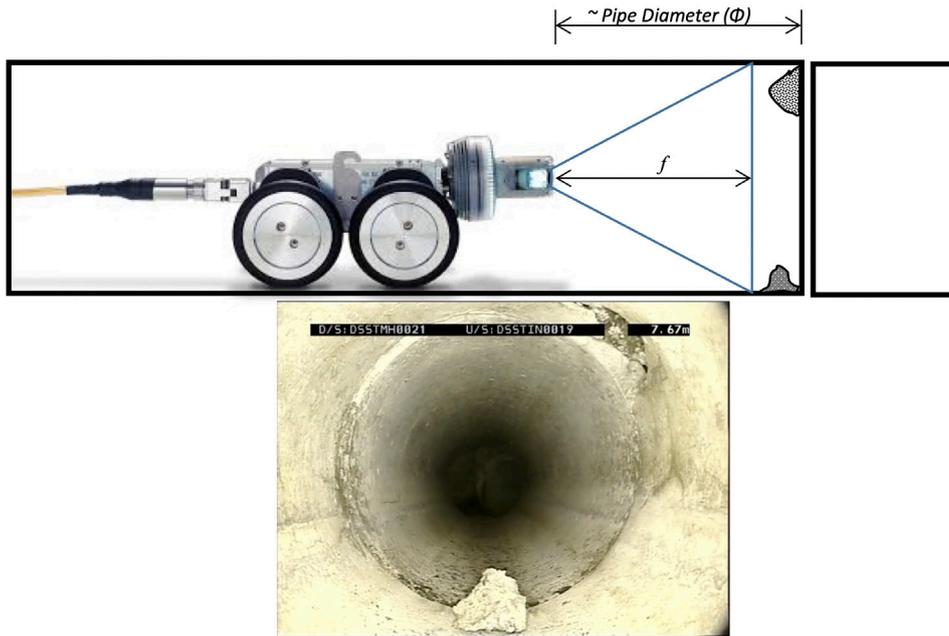
Figure B1.2.10 – Camera stopping position at defects (and features) where it can be clearly seen in focus within the circumferential location

The camera shall be stopped at all defects and features. The stopping position shall be before the camera reaches the defect or feature, where it can be clearly viewed, in focus, within the full circumference of the pipe. This position is approximately a pipe diameter from the defect or feature, and just beyond the Focus Length of the camera. Figure B1.2\_10 shows an example of the ideal stopping distance and camera position. The camera shall remain stationary at this location, looking forward along the pipe axis, while continuing the image recording for 5 to 10 seconds.

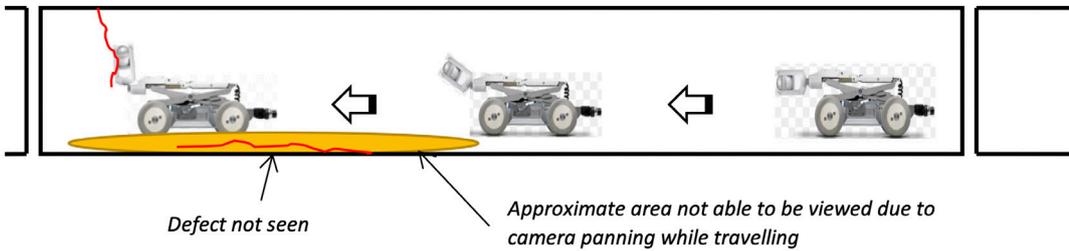
Figure B1.2.11 – As the camera begins to tilt up as it travels towards the upcoming defect, there is a loss of view of the pipe invert and any defects present in that location may not be seen.

When the camera is travelling the image shall have a ‘natural’ alignment with any flowing water at the bottom of the screen and a horizontal horizon.

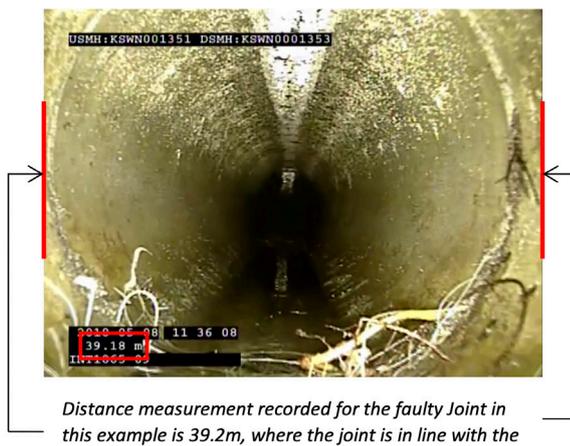
Figure B1.2.12 – Using focal length for distance measurement

The distance reading to defects and features are recorded using the Focal Length, this is the distance recording at the point where the defect or feature 'touches' or is in line with the sides of the monitor. Figure B1.2.12 demonstrates the distance measurement to a defect.

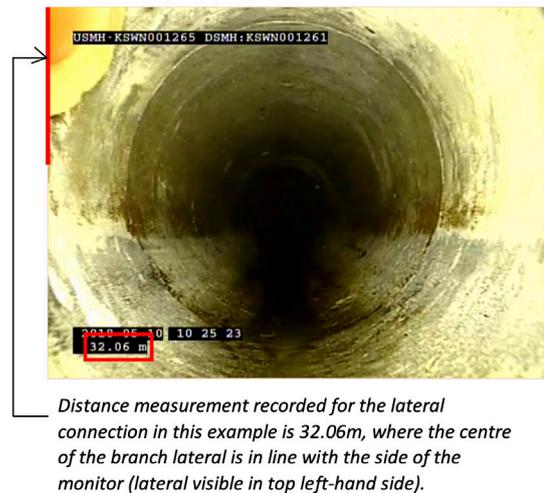
Figure B1.2.13 – Example of measurement to a lateral connection

The distance measurement to features such as lateral connections are recorded when the centre of the lateral connection is in line with the edge of the monitor.

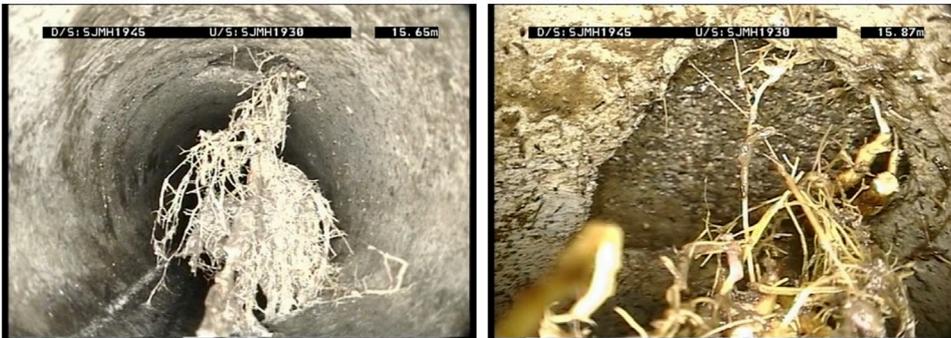
*Figure B1.14 – Example of first photograph and second/subsequent photograph showing defect detail without over zooming*

*First photograph taken looking 'straight ahead' down the pipe axis, with the camera stopping position as described in clause B1.2.3.3, where the defects (pipe hole and root intrusion) can be clearly seen within the pipe circumference.*

*Second photograph taken with the camera tilted and panned towards the defect showing more information that cannot be clearly seen in the first photograph*

The second, and any subsequent, photographs can be in a tilted position or zoomed to show detail or view of the defect or feature that cannot be seen in the first photograph. The second and subsequent photographs shall be added to the log sheet report using the General Photograph code (GP). Remarks shall be provided to describe the view perspective if the image has been zoomed.

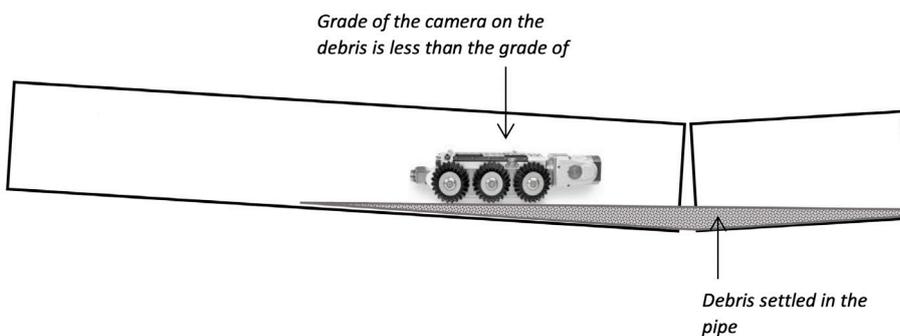
Figure B1.2.15 – Inclinometer reading (grade) measures the grade of the camera not the pipe and can be affected by many factors

During camera movement, the camera inclinometer reading becomes less reliable for indicating the pipe inclination due to several factors. This includes variability in the pipe material (“waviness” or cosmetic “rippling” in PVC pipe, wall thickness variability in concrete pipe) minor deflection/deformation in PVC/PE pipe, camera speed, steering and passing over pipe joints. These factors will affect the way that the camera travels through the pipe and the resulting variable inclinometer reading. Because the inclinometer works in the same way as a spirit level, if the camera is not aligned directly along the pipes longitudinal axis, (as the camera will do at times as it moves and rotates through the pipe) then the inclinometer reading will fluctuate as the camera travels through the pipe. Even if stationary, with a constant actual grade, it could be expected that there may be some variability in the camera inclinometer readings at different points in the pipe. If there is any debris in the pipe, then this potentially makes the inclinometer readings of no value in terms of the pipe gradient.

Although inclinometers are becoming more stable, the inherent issues mean that they are not intended to take the place of a survey tool, but rather to be used as a reference to identify potential problem areas during an inspection.

Using inclinometers to identify dips is fraught with issues. Because of the variability of the readings the dips would need to be sufficiently long enough (or significant enough) to identify a consistent increase in the inclinometer readings, followed by a consistent negative grade reading, that then returns to the consistent expected grade.

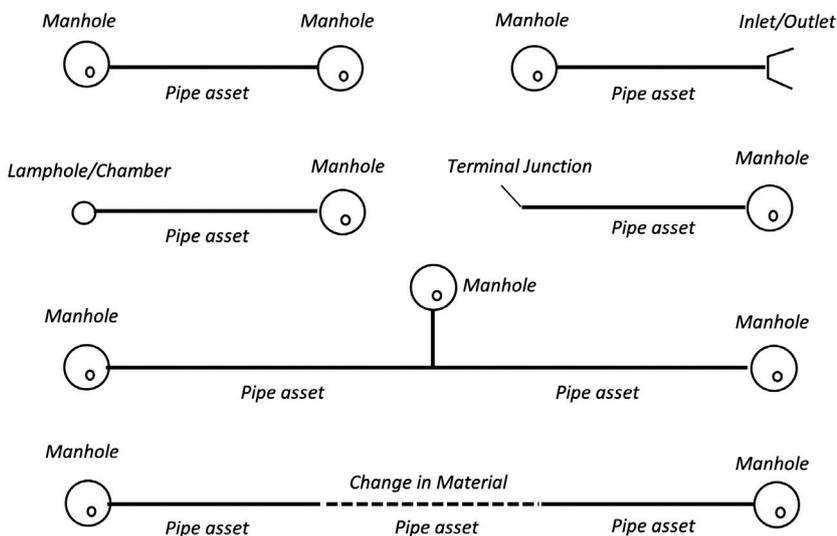
Figure B2.1.1 – Examples of 'typical' pipe asset definitions

As the description of a pipeline asset is not consistently defined between asset owners, it is important that prior to inspection, the extent of the asset to be inspected is correctly identified, and the rules that an asset owner uses to define start and end nodes are understood.

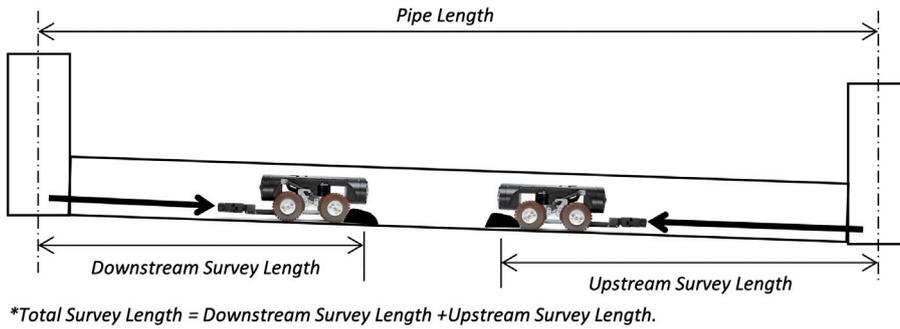
Figure B2.1.2 – Example of the different measurements where the inspection is uncompleted.

The Surveyed Length is the length of pipe asset surveyed. The Surveyed length is recorded from the video display. Where an inspection is completed from both ends under a single header, the Surveyed Length is the sum of the two survey lengths. The Surveyed Length may be less than the Pipe Length if the inspection is not able to be completed.

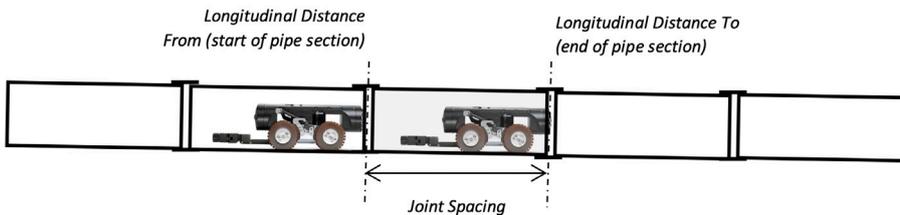
Figure B2.3 – Measuring the pipe segment length to determine the Joint Spacing.

The length of the pipe segment between pipe joints, is referred to as the Joint Spacing. This is measured by observing the difference in the distance shown on the distance video display as the video camera passes each joint. The Joint Spacing is confirmed by measuring several consecutive pipe segments (excluding the manhole shorts, or sometimes referred to as rocker pipes at the start and end nodes).

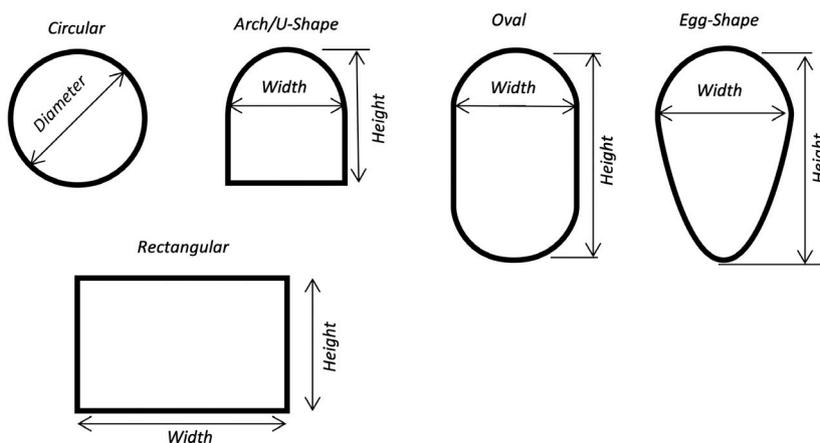
Figure B2.1.4 – Examples of typical pipe shapes and the dimensions used to record the pipe size

Where it is identified during the inspection that the dimensions have changed from the initial “tape” measurements at the start manhole, the change in dimensions shall be noted in the observations using the Dimension Change code, “DC”, at the longitudinal distance they occur.

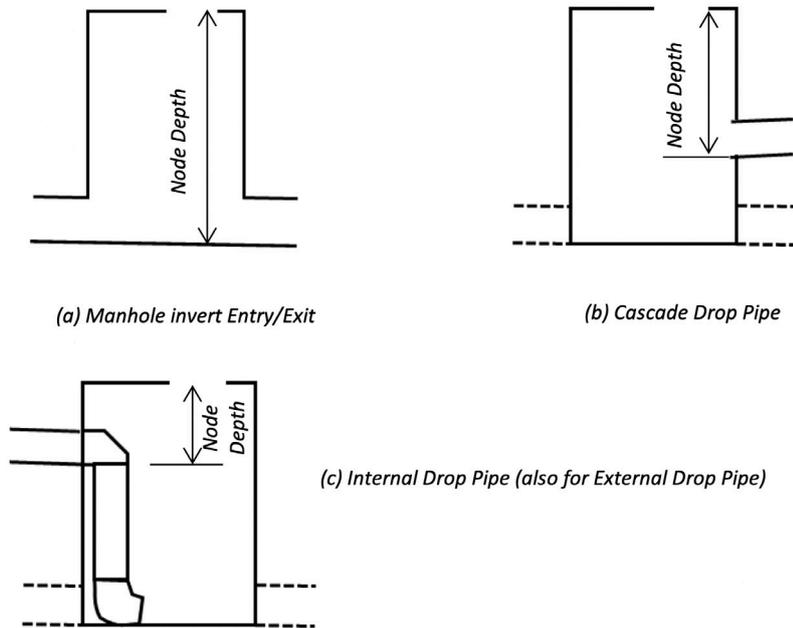
Figure B2.1\_5, examples of typical situations and the measurements for the depth of node (depth of pipe)

The node depth is measured from the ground surface (top of manhole cover) to the invert of the pipeline inspected.

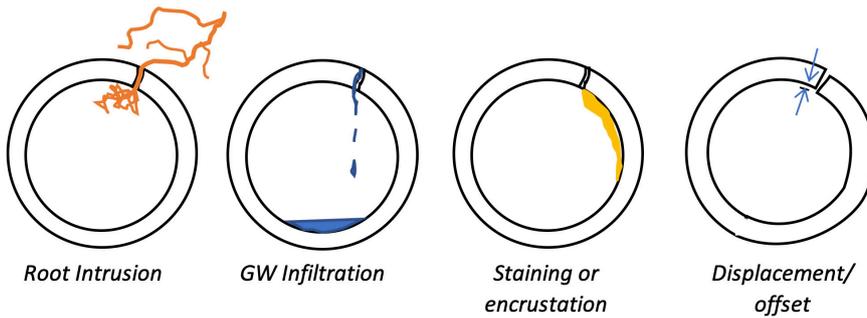
Figure B2.1.6 – Examples of visual evidence of a pathway to the outside of the pipe through a crack

The presence of any of these evidence types would result in a L (Large) code for the defect. The scale of the evidence does not matter e.g. large tap roots Vs fine roots – only their presence. If the type of defect is apparent, but there is no evidence of a pathway, then a S (Small) or M (Medium) code will be recorded.

- S** Small, the defect is visible but there is no evidence that the defect extends all the way through the pipe wall
- M** Medium, there is some visual indication that there may be a pathway through the pipe wall, but there is no clear evidence that is present.
- L** Large, there is clear visual evidence that the defect extends all the way through the pipe wall.

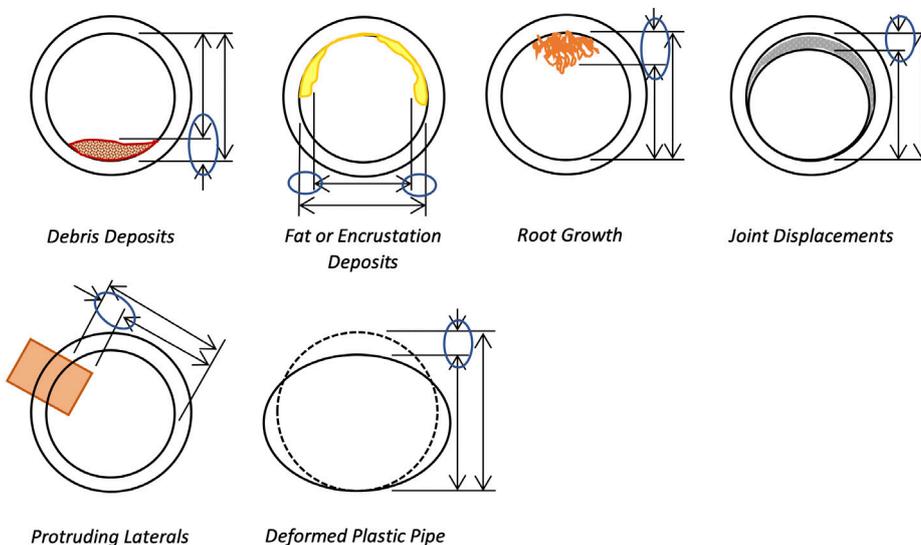
Figure B2.1.7 – Examples of defects that result in reductions in diameter

- S** Small, the defect reduces the diameter up to 10%.
- M** Medium, the defect reduces the diameter between 10% – 25%.
- L** Large, the defect reduces the diameter greater than 25%.

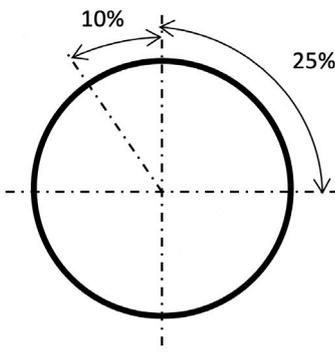
Figure B2.1.8 – Quantifying Pipe Circumference. The figure shows the proportion of the circumference of a pipe for 10% and 25% bands. 25% is equal to one quarter of the ‘circle.’

- S** Small, the defect covers up to 10% of the pipe circumference.
- M** Medium, the defect covers between 10% – 25% of the pipe circumference.
- L** Large, the defect covers greater than 25% of the pipe circumference.

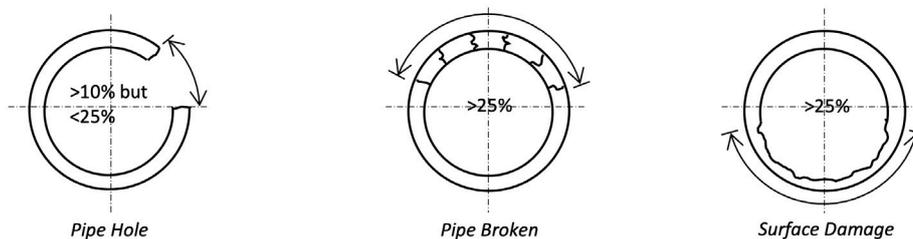
Figure B2.1.9 – Some examples with defects that are quantified by their circumferential measurements.

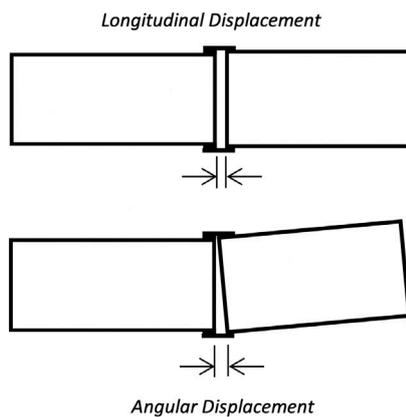
Figure B2.1.10 – Examples of two types of Open Joint

Where there is a straight longitudinal displacement, the width of the gap will be consistent around the joint. If the next pipe segment is deflected, relative to the other, (vertically or horizontally) the joint will have an angular displacement and the width of the joint gap will vary around the joint. Figure B2.10 shows example of the two scenarios, and the gap to be measured.

- S** Small, longitudinal/angular displacement up to 20mm.
- M** Medium, longitudinal/angular displacement between 20mm and 40mm.
- L** Large, longitudinal/angular displacement greater than 40mm.

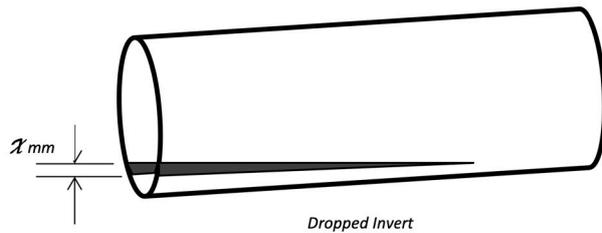
Figure B2.1.11 – Dropped Invert with measurement of the horizontal gap separation on both sides of the pipe.

The method of quantification requires the measurement of the width of the separation gap between the bricks. Code applies when there is a minimum separation of 2x standard mortar joint width (or 20mm, whichever is the smaller)

- S** Small, longitudinal displacement up to 20mm.
- M** Medium, longitudinal displacement between 21mm and 50mm.
- L** Large, longitudinal displacement greater than 50mm.

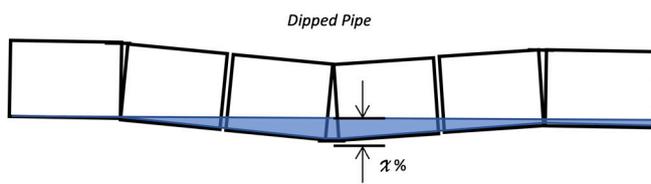
Figure B2.1.12 – Dipped Pipe with maximum depth estimated as a % of diameter

This quantification method applies to Dipped pipes, or where the pipe grade deflects downward, before returning the original grade. There is not a continuous fall in the pipe and water, and solids, will pool. (Code Reference S5.7, Section B2.3). The method of quantification is the depth of the dip, (depth that water will pool before being able to flow down the pipe) at the deepest point, expressed as a % of the pipe diameter.

- S** Small, depth of dip up to 25% of the pipe diameter.
- M** Medium, depth of dip between 25% and up to 50%
- L** Large, depth of dip 50% or greater.

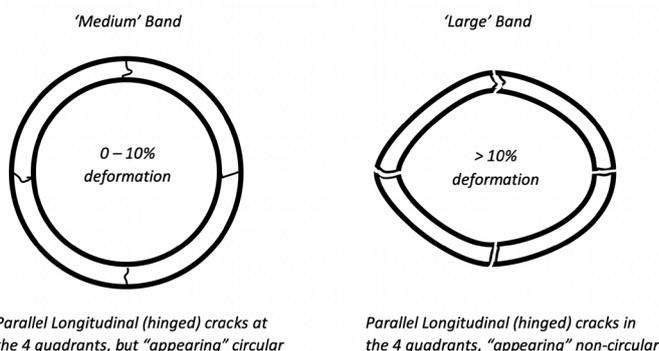
Figure B2.1.13 – Deformed (Rigid) Pipe

This quantification method applies to rigid pipes where deformation is occurring, (Code Reference PW1.6, Section B2.3) identified by parallel longitudinal cracking through the pipe segment, (between joints). typically occurring at points: 12 O'clock, 3 O'clock, 6 O'clock and 9 O'clock.

- S** Not Used.
- M** Medium, deformation resulting in a reduction in diameter of up to 10%.
- L** Large, deformation resulting in a reduction in diameter of greater than 10%.

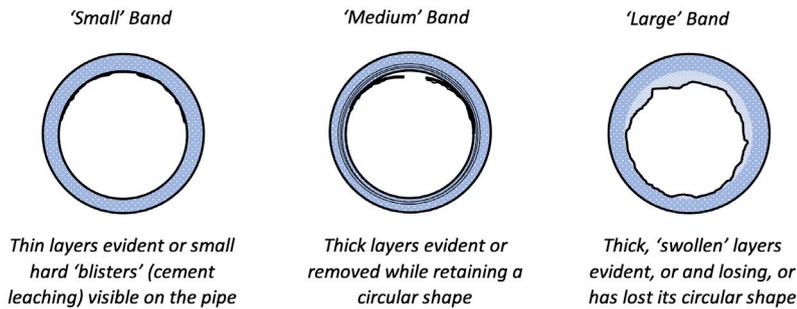
Figure B2.1.14 – Delamination at different levels in AC pipe

- S** Small, delamination of thin (one or more) layers of pipe wall is evident and/or have been removed from the pipe surface, or evidence of cement leaching present on the pipe surface.
- M** Medium, delamination of thick layers of pipe wall is evident and/or have been removed from the pipe surface without evidence of the pipe losing its (circular) shape.
- L** Large, delamination of thick layers of pipe wall is evident and/or have been removed from the pipe surface such that the pipe is losing/lost its (circular) shape.

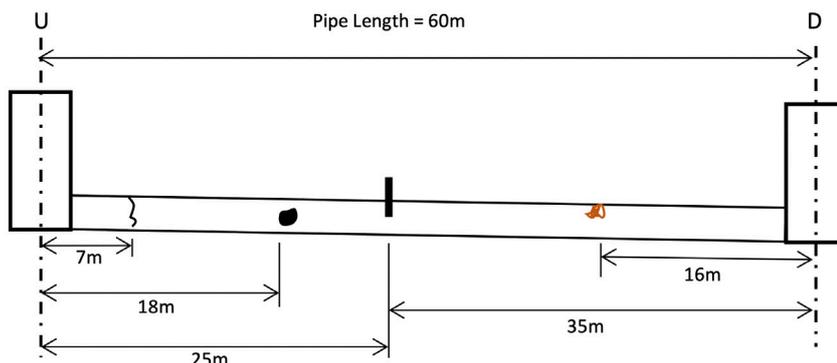
Figure B2.1.15 – Example of showing the location of defects where an inspection has been completed by inspecting from both ends. The combination of the “Longitudinal Distance” and “Measured From” fields, makes the reporting of the location of the defects and features within the pipe clear.

Longitudinal Distance	Measured From	Main Code	Characterisation Sub-Code	Quantification Sub-Code	Position From	Position To	Remarks
0	U	IS					Centre of upstream manhole
7		CC		M	12	5	
18		PH		M	2	4	
25		LP		L	12		
25		IA					Stopped by protruding lateral
0	D	IS					Re-Start at centre of Downstream MH
16		CF			12		Lifting eye
16		RI	F	M	10	2	
35		IE					Ends at previous abandonment

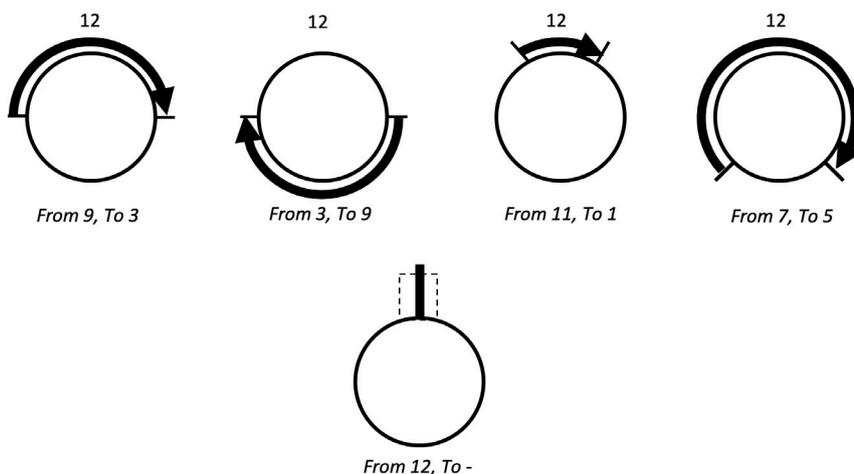
Figure B2.1.16 – Examples of Clock References

The position of a defect or feature relative to the circumference of the pipe are described using the hours of an imaginary clock face, with 12 o'clock being the soffit (top) of the pipe and 6 o'clock the invert. The circumferential position is defined between a starting “Position From” data field, and the ending “Position To” data field. For coding purposes any single clock reference shall occupy the first clock reference position and shall relate to the centre/mid - point of the feature. The circumstances in which a single clock reference or two clock references are used are described in Section B2.3. Clock references shall be given to the nearest hour, as shown in examples given in Figure B2.16.
