# NEW ZEALAND GRAVITY PIPE INSPECTION MANUAL

**4<sup>TH</sup> EDITION**

Prepared for WaterNZ by ProjectMax Ltd  
and Citycare Water 2019

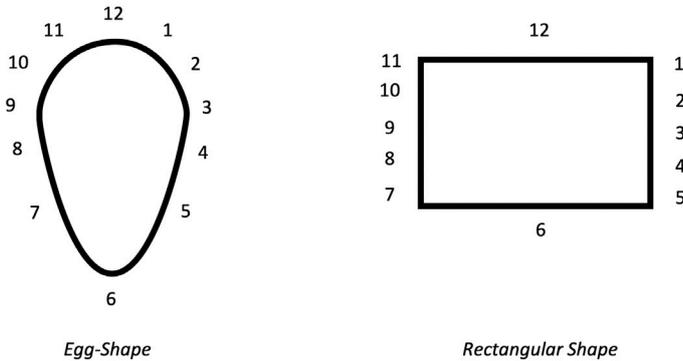
Figure B2.1.17 – Example clock positions for non-circular pipe shapes

For non-circular pipes the hour clock reference positions are adjusted to maintain the traditional clock arrangement as best possible. In egg-shaped and oval pipes, the imaginary reference clock shall be centered around the circular portion of the pipe shape. For box or rectangular shaped pipes, the Roof and base of the pipe are defined as 12 o'clock and 6 o'clock respectively, with the rest of the positions distributed along the vertical sides.

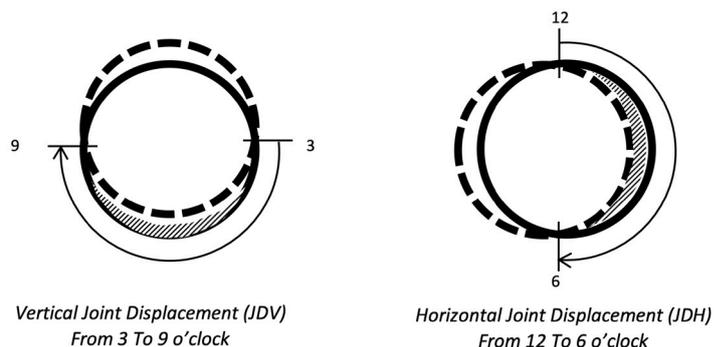
Figure B2.1.19 – Examples of clock positions using vertical and horizontal joint displacements

Vertical Joint Displacement (JDV)  
From 3 To 9 o'clock

Horizontal Joint Displacement (JDH)  
From 12 To 6 o'clock

Position From and Position To are represented by a pair of clock references at the points at which the two pipe segments appear to intersect each other, in the clockwise direction of the exposed joint face.

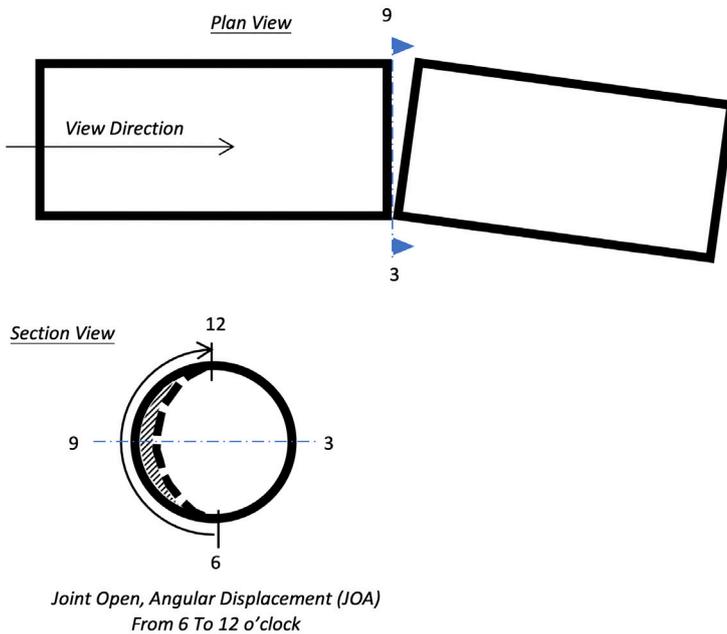
Figure B2.1.20 – Example of clock positions for an open joint with an angular displacement

'Position From' and 'Position To' are represented by a pair of clock references at the points at which the two pipe segments appear to intersect each other, in the clockwise direction of the open joint gap.

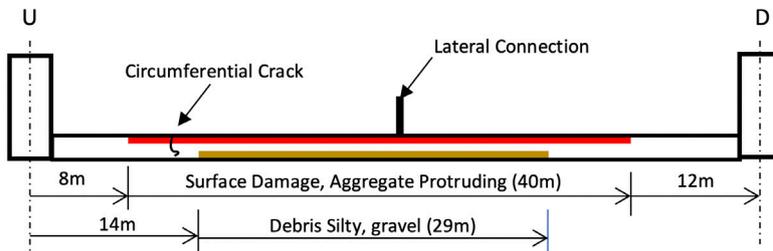
Figure B2.1.21 – Example of encoding continuous defects

Continuous Obs.	Long. Distance	Measured From	Main Code	Char. Sub-Code	Quant. Sub-Code	Position From	Position To	Remarks
	0	U	IS					Centre of upstream manhole
S1	8	U	S	AP	M	10	2	Start of exposed aggregate
	11	U	CC		M	12	6	
S2	14	U	DE		S			Start of Gravel Deposits
	30	U	LO			12		100mm
F2	43	U	DE		S			End of gravel Deposits
F1	48	U	S	AP	M	10	2	End of exposed aggregate
	60	U	IE					Centre of downstream MH

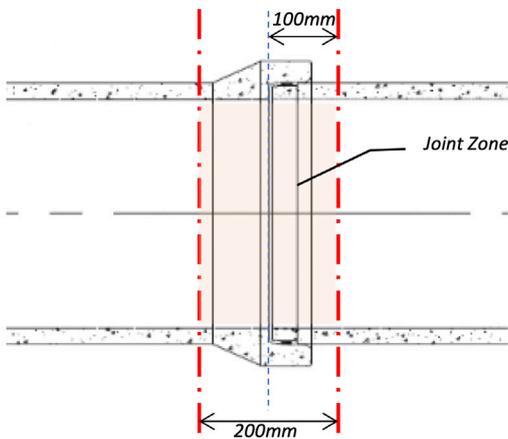
Figure B2.1.22 – Illustration of the Joint Zone

Defects at a joint are recorded in a special manner. Where there is a faulty sealing mechanism, or structural defects occurring only within 100mm either side of the joint gap (200mm length centered on the joint), the defects are coded using the Joint Faulty code, JF (refer code reference J3.1, Section B2.3 Condition Classification Codes) for all defects occurring within that 200mm band. Defects outside of the Joint Zone, or that start within the Joint Zone, but extend beyond it, are recorded as discrete defects.

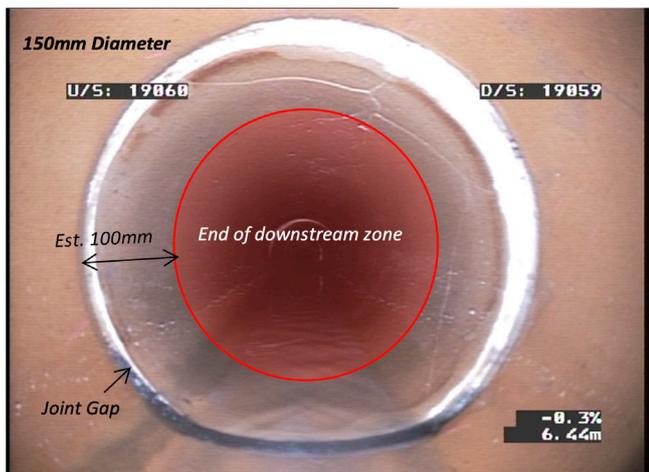
Figure B2.1.23 – Photograph and illustration of the extent of the downstream limit of a Joint Zone, as can be estimated (100mm distant from the Joint Gap).

The Joint zone dimensions remain the same regardless of pipe diameter, type of joint or material. There is no marking to indicate the extent of the joint zone on the inside of the pipe, and therefore the 100mm length upstream and downstream must be estimated (within reasonable tolerance) or measured if the inspection equipment provides this functionality (e.g. laser measurement).

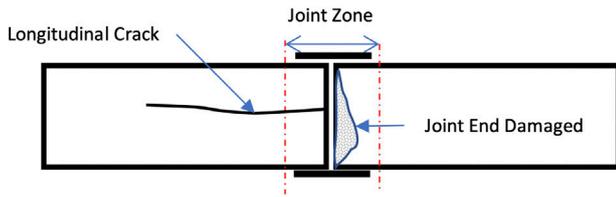
Figure B2.1.24 – Example of encoding defects within and outside the Joint Zone

Main Code	Char. Sub-Code	Quant. Sub-Code	Position From	Position To	Remarks
CL		M	9		Crosses through Joint zone
JF	D	M	12	6	Joint damaged/Chipped limited to only within the Joint Zone

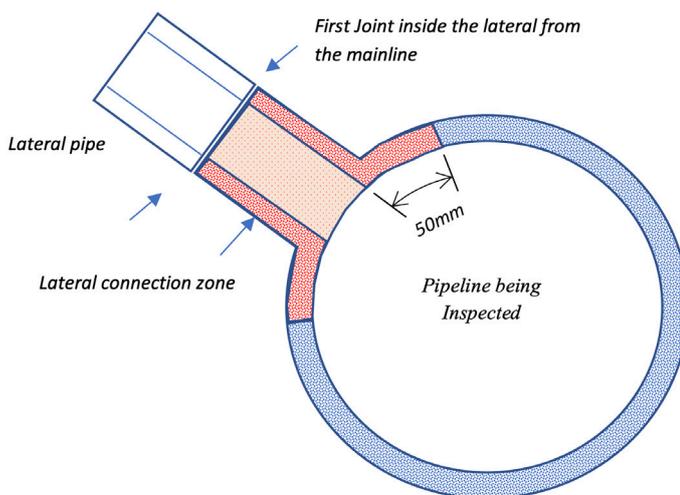
Figure B2.1.25 – Illustration of the Lateral Connection Zone (Cross-Section through the inspected pipe)

As with defects at joints, defects occurring at a lateral connection are recorded in a special manner. Where structural damage or faulty sealing of the connection occurs within 50mm of the internal face of the lateral connection pipe, and up to the first joint inside the lateral, the defects are coded using the Lateral Faulty code, LF (refer to code reference L4.2, Section B2.3 Condition Classification Codes).

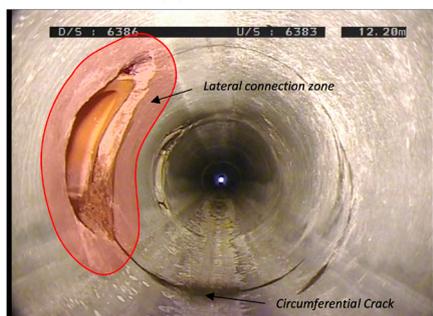
Figure B2.1.26 – Photograph and illustration of the extent of a Lateral Connection Zone, inside the pipe, as can be estimated (50mm perimeter around the lateral pipe, shown within red area). Observation reporting example also provided.

Long. Distance	Measured From	Main Code	Char. Sub-Code	Quant. Sub-Code	Position From	Position To	Remarks
12.4	U	LF	X	M	9		No internal seal, possible pathway to the outside
12.4	U	CC		M	10	8	Crosses through lateral connection zone

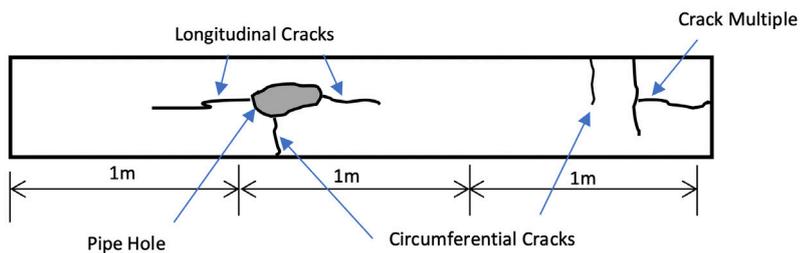
Figure B2.27 – Example of application of the structural defect Hierarchy rule for multiple defects included in the Cracked Pipes Group occurring within any 1m

Long. Distance	Measured From	Main Code	Char. Sub-Code	Quant. Sub-Code	Position From	Position To	Remarks
0.5	U	PH		M	2	3	Pipe hole with CC and 2x CL's
2.5	U	CC		S	12	3	
2.8	U	CM		M	12	5

In the example given in Figure B2-27 above, only PH is coded between 0.5m to 1.5m, as it ranks higher than the CL's/CC within the same Hierarchy Group B within the same metre of pipe. Both CC & CM are each coded in between 2.5m to 3m, because they are beyond 1m from the Pipe Hole and are equally ranked within the same Hierarchy Group B.

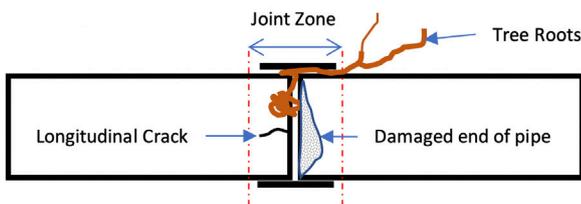
Figure B2.28 – Example of application of the structural defect Hierarchy rule for multiple defects included in the Joint Faulty Group occurring within a Joint Zone

Main Code	Char. Sub-Code	Quant. Sub-Code	Position From	Position To	Remarks
JF	D	L	12	12	Pipe end damaged (Chipped). Also 1x CL and root intrusion through the defect seal
RI	T	M	12	2	Tap root through faulty joint seal

In the example given in figure B2-28, above, the Characterisation code “D” (Damaged) was used and not “C” (Cracked) or “X” (Sealing fault) because Damaged Pipe present within a Joint Zone ranks higher than either Cracks or Defective Seals. The other Joint Faulty defects present are added as remarks. The tree root intrusion is coded separately because it is not part of the Joint Faulty Group, and service defects are always coded in addition to structural defects.

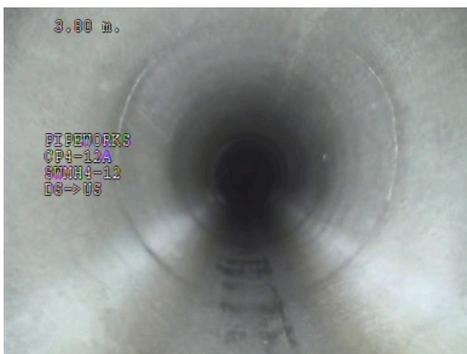
**PW1.1 – Cracking Circumferential**

Dist.	Cont.	Code	Char.	Quant.	From	To
4		CC		S	1	11

**Remarks:** Autogenous (self-healed) crack

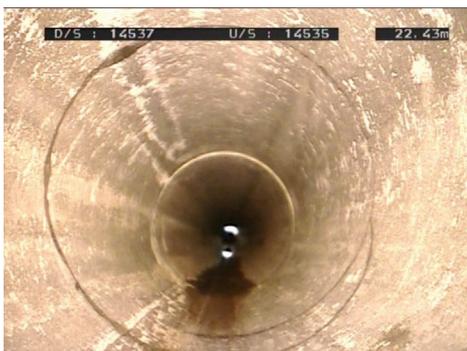
**PW1.1.1 – Branch Cracking**

Dist.	Cont.	Code	Char.	Quant.	From	To
22.6		CC		M	12	12

**Remarks:** Small branching crack extending < 100mm between 3 and 9 o'clock

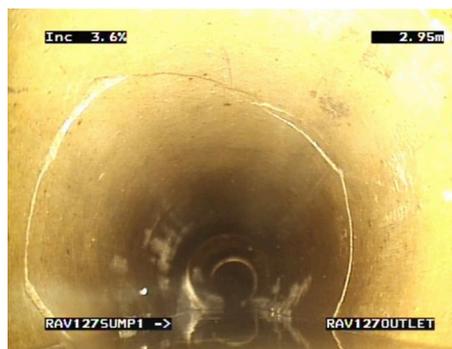
## PW1.1.2 – Chipping of Crack Edges (C)

Dist.	Cont.	Code	Char.	Quant.	From	To
3		CC	C		7	5

**Remarks:** Chipped edges along the crack circumference, particularly obvious from 7 to 11 o'clock

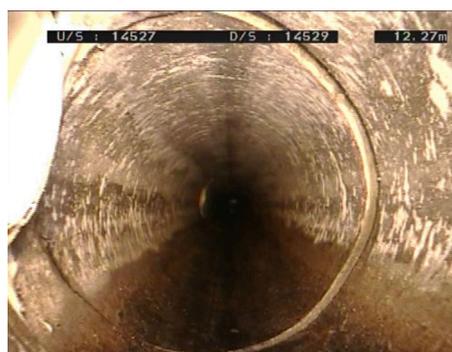
## PW1.1.3 – Vertical Displacement of the crack (D)

Dist.	Cont.	Code	Char.	Quant.	From	To
12.5		CC	D		12	12

**Remarks:** Crack is open and has a slight displacement (left)

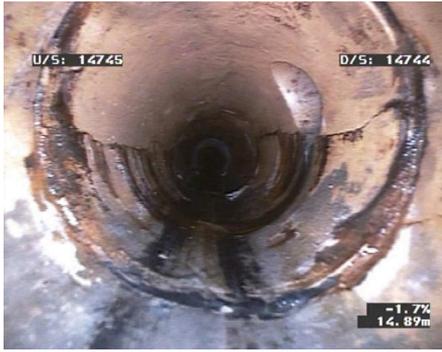
PW1.2.1 – More than one longitudinal crack present

Dist.	Cont.	Code	Char.	Quant.	From	To
15	S1	CL		L	9	
<b>Remarks:</b> Encrustation Deposits on pipe wall from leakage through the crack						
15	S2	CL		L	3	
<b>Remarks:</b> Encrustation Deposits on pipe wall from leakage through the crack						
15		JF	X	L	7	5
<b>Remarks:</b> Encrustation deposits on the joint due to leakage through joint						
15	S3	ED		S	7	5
<b>Remarks:</b> On Joint and below cracks

Although the longitudinal crack at 3 o'clock intersects the lateral connection, LF is not recorded as the crack extends (through) beyond the lateral connection zone.

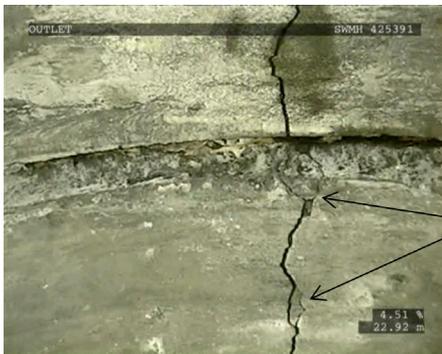
PW1.2.2 – Chipping/Splintering (C)

Dist.	Cont.	Code	Char.	Quant.	From	To
4.5		CL	C		12	
<b>Remarks:</b> Small splinters along crack edges

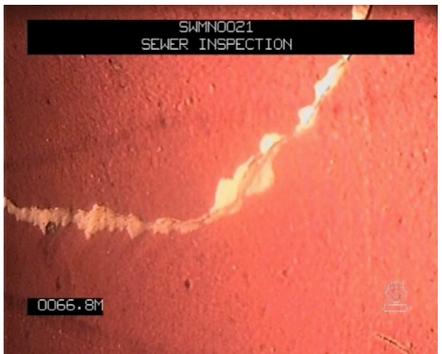
Dist.	Cont.	Code	Char.	Quant.	From	To
66.8		CL	C		3	
<b>Remarks:</b> Chipping evident along the visible length of the crack.

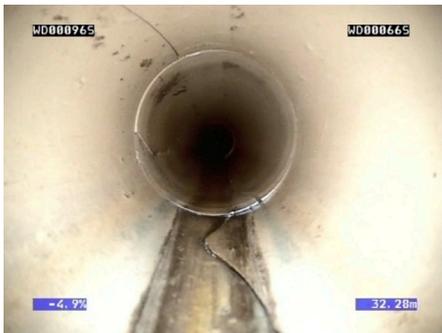
PW1.2.3 – Vertical Displacement (D)

Dist.	Cont.	Code	Char.	Quant.	From	To
32.3		CL	D		6	
<b>Remarks:</b> Vertical displacement of crack face. Crack wanders between 5 – 6 o'clock						
32.3		CL		M	11	
<b>Remarks:</b> Open but no clear evidence the crack extends through the pipe wall

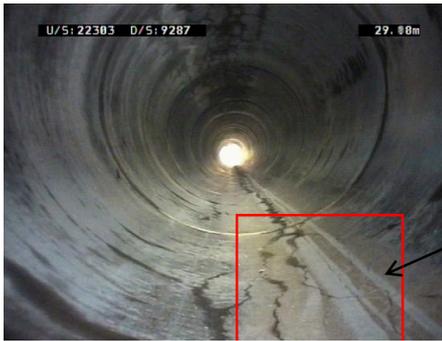
PW1.2.4 – Slabbing (B)

Dist.	Cont.	Code	Char.	Quant.	From	To
29.8		CL	B		6

Remarks: Slabbing in the pipe invert

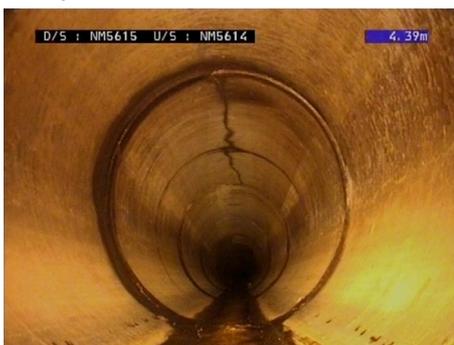
Dist.	Cont.	Code	Char.	Quant.	From	To
5	S1	CM		M	7	3

Remarks: Simple CM with CL & CC intersecting. Crack appears to be damp (would need to confirm if Infiltration was present)

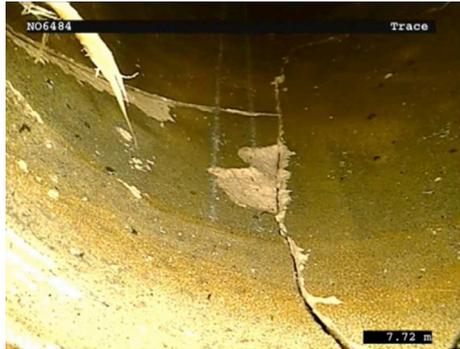
PW1.3.1 – Chipping/Splintering (C)

Dist.	Cont.	Code	Char.	Quant.	From	To
7.7		CM	C		6	9

**Remarks:** Edges of crack chipped.

This example shows a portion of the multiple crack. The cracking extends beyond the joint zone (edge of joint visible in immediate foreground) and the branching (circumferential) cracks do not connect back with the joint to form a 'block(s)'. If they do this defect would be coded PB.

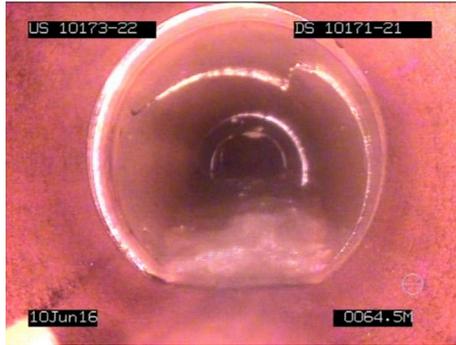
PW1.3.2 – Vertical Displacement (D)

Dist.	Cont.	Code	Char.	Quant.	From	To
65		CM	D		10	5

**Remarks:** Displaced crack faces extending beyond joint zone with both circumferential and longitudinal directions.

For this example, additional investigation would be required by panning and tilting the camera at the joint to check if the cracks, extending towards the joint, at 10 o'clock and 5 o'clock, do not connect back with the joint to form a 'block'. If they do, then this defect would be coded PB.

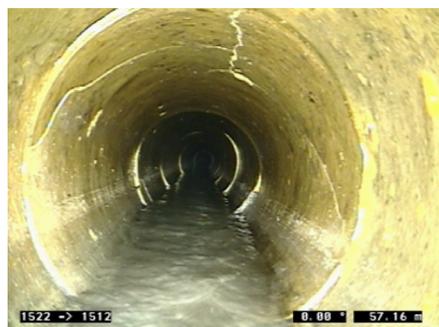
Dist.	Cont.	Code	Char.	Quant.	From	To
57.4		PB		L	9	4

**Remarks:** Cracks extending beyond the joint zone have formed ‘blocks’ (> 25% of the pipe circumference) with the joint

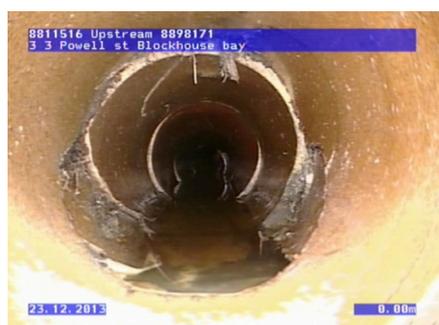
Dist.	Cont.	Code	Char.	Quant.	From	To
0.5		PB		L	3	9

**Remarks:** Broken pipe pieces have displaced more than half the pipe wall thickness and some have fallen out

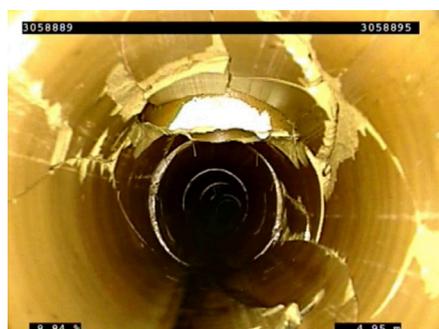
Dist.	Cont.	Code	Char.	Quant.	From	To
8.8		PB		L	9	6

**Remarks:** Broken pipe pieces >25% of circumference and have displaced more than half the pipe wall thickness

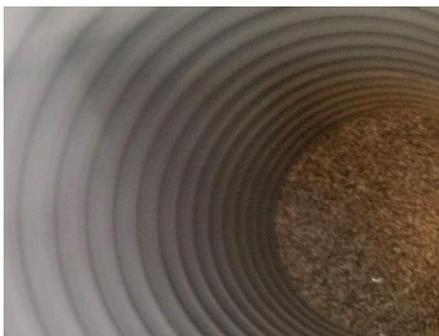
### BossPipe Twin wall drainage pipe

Regarding characterisation code G, corrugation growth, it should be noted that some types of profile walled pipes are manufactured with corrugated internal pipe walls, e.g. BossPipe twin wall drainage pipe, and the corrugations in these pipes should not be recorded as a defect.

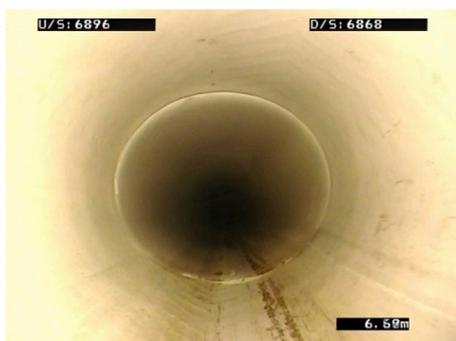
#### PW1.5.1 – Vertical/Horizontal Deformation (V/H)

Dist.	Cont.	Code	Char.	Quant.	From	To
6.6	S1	PF	V	M

**Remarks:** PVC pipe with vertical deformation resulting in approx. 10% reduction in pipe diameter

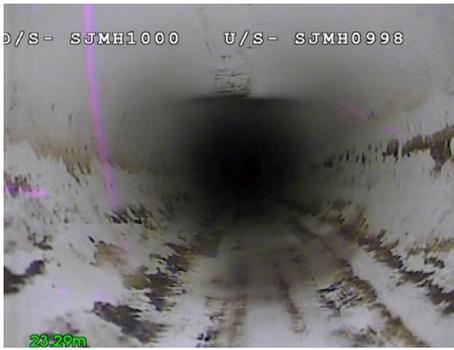
Dist.	Cont.	Code	Char.	Quant.	From	To
23.4		PF	IC	M	10	2
<b>Remarks:</b> Bulge in the soffit of the PVC pipe

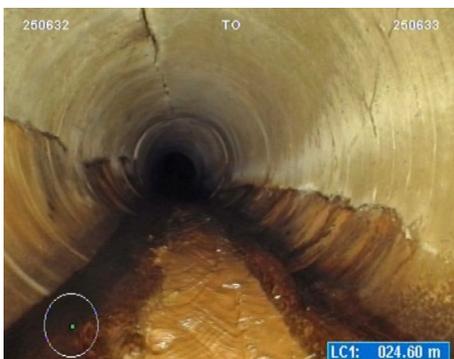
Dist.	Cont.	Code	Char.	Quant.	From	To
24.6	S1	DF	V	M		
<b>Remarks:</b> 3 longitudinal cracks are visible at 12, 3 and 9 o'clock. Expect 4th crack is hidden beneath the deposits in the invert. Reduction in diameter (due to deformation) <10%						
24.6	S2	GC			3	9
<b>Remarks:</b> Pipe wall below the longitudinal cracks is stained from leakage						
24.6	S3	DE		S		
<b>Remarks:</b> Silty deposits

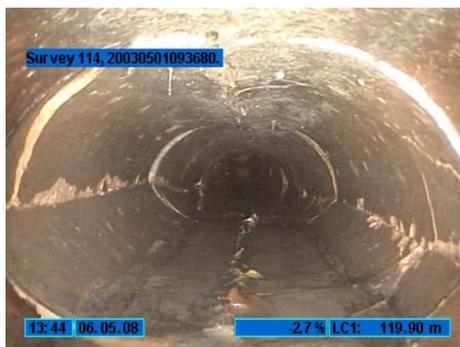
Dist.	Cont.	Code	Char.	Quant.	From	To
119.9	S1	DF	V	L

**Remarks:** 4 longitudinal cracks are visible at 12, 3, 6 and 9 o'clock. Reduction in diameter 25%

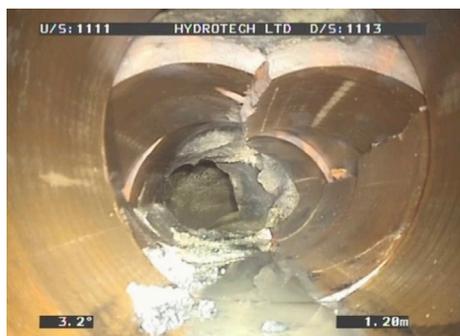
Dist.	Cont.	Code	Char.	Quant.	From	To
1.3		DF	V	L

**Remarks:** EW pipe has deformed to an extent that the pipe has moved out of place >25% (but <50%)

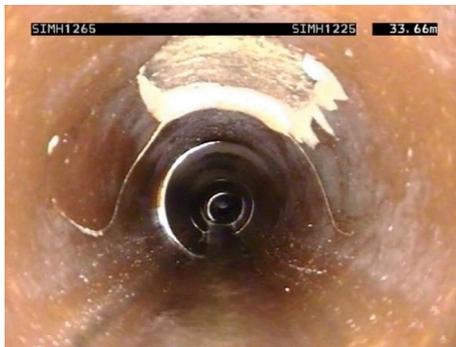
Dist.	Cont.	Code	Char.	Quant.	From	To
33.9		PH		S	10	2

**Remarks:** ‘Impact’ pipe hole has been covered and there is no evidence of a pathway to the outside of the pipe. Cracks not coded separately (refer to B2.1.6.7)

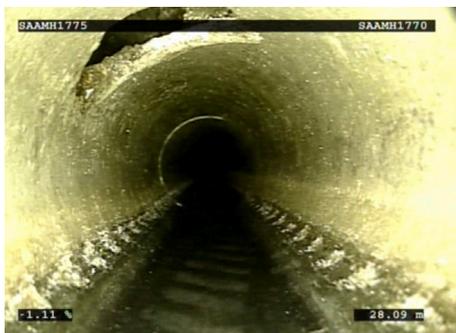
Dist.	Cont.	Code	Char.	Quant.	From	To
28.2		PH		M	10	1

**Remarks:** Pipe hole up to 25% of the pipe circumference, the cause of the hole is not known

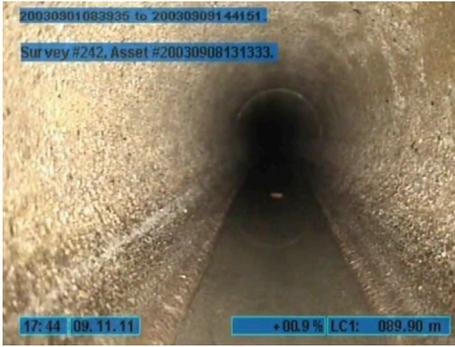
PW1.8.1 – Wall Roughened (W)

Dist.	Cont.	Code	Char.	Quant.	From	To
89.9	S1	S	W		12	12

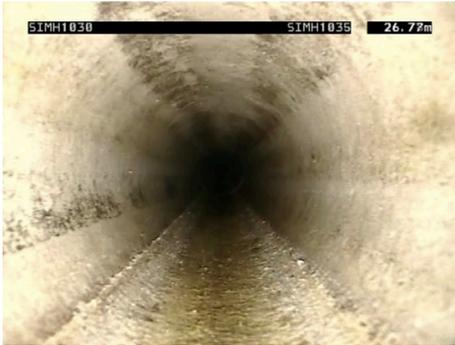
Dist.	Cont.	Code	Char.	Quant.	From	To
26.7	S1	S	W		5	7

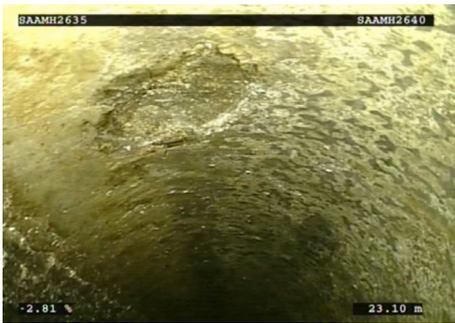
PW1.8.2 – Spalling (S)

Dist.	Cont.	Code	Char.	Quant.	From	To
23.2		S	S		8	10

Remarks: No reinforcement visible

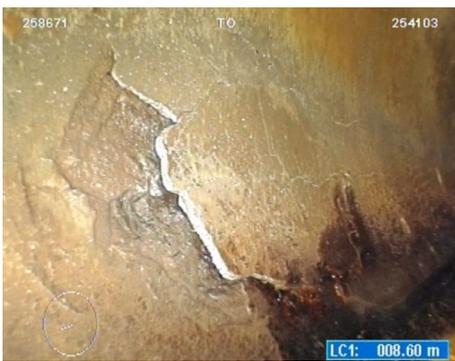
Dist.	Cont.	Code	Char.	Quant.	From	To
8.6		S	S		7	9

Remarks: Cement surface spalling. Reinforcement corrosion staining at the base of spalling area

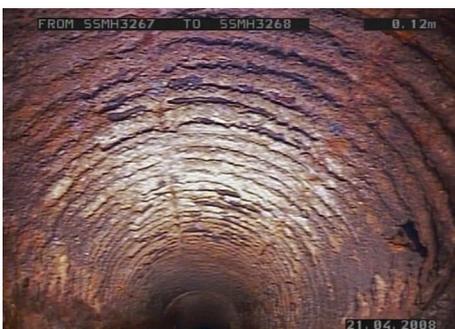
PW1.8.3 – Pipe Missing (PM)

Dist.	Cont.	Code	Char.	Quant.	From	To
0.12	S1	S	PM		8	4

Remarks: Corrosion beyond the reinforcement with only a paper-thin veneer of pipe wall remaining

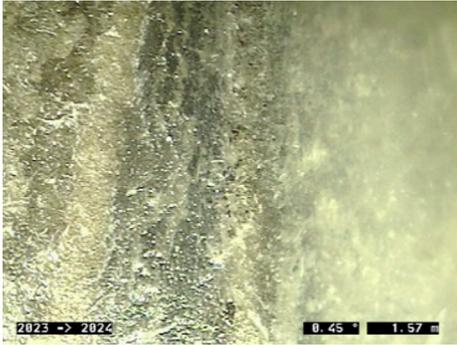
PW1.8.4 – Delamination (DL)

Dist.	Cont.	Code	Char.	Quant.	From	To
1.6	S1	S	DL	S	3	9

**Remarks:** Thin layers of AC pipe wall delamination

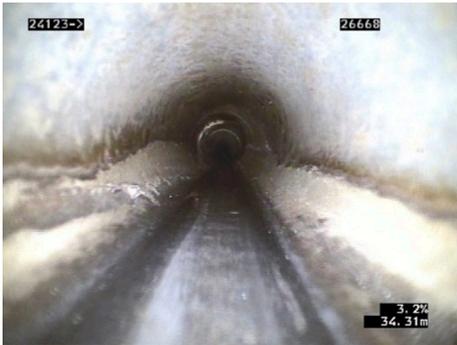
Dist.	Cont.	Code	Char.	Quant.	From	To
1.6	S1	S	DL	S	3	9

**Remarks:** Thin layers of AC pipe wall delamination

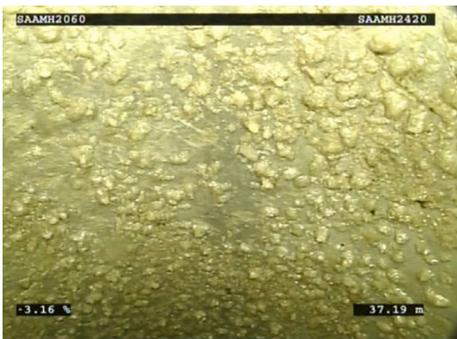
Dist.	Cont.	Code	Char.	Quant.	From	To
37.2	S1	S	DL	S	9	3

**Remarks:** Cement deposits on the pipe surface that have leached from the AC pipe wall

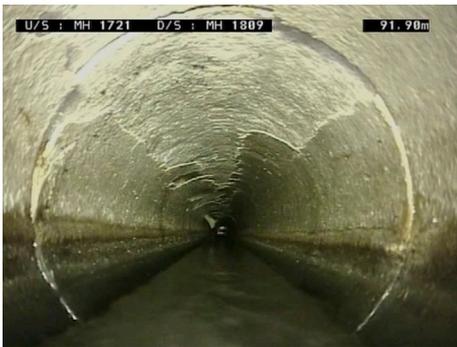
Dist.	Cont.	Code	Char.	Quant.	From	To
91.9	S1	S	DL	M	9	2

**Remarks:** Thick layers of AC pipe wall are delaminating but the pipe still retained its circular shape

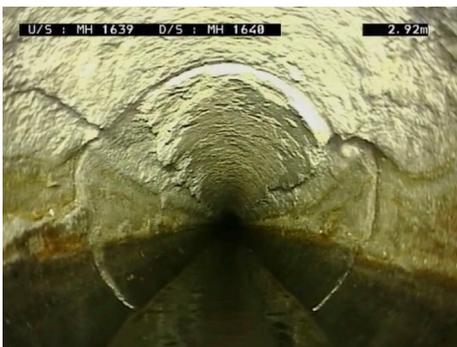
Dist.	Cont.	Code	Char.	Quant.	From	To
2.9	S1	S	DL	L	9	3

**Remarks:** Thick layers of AC pipe wall are delaminating and the pipe is losing its circular shape

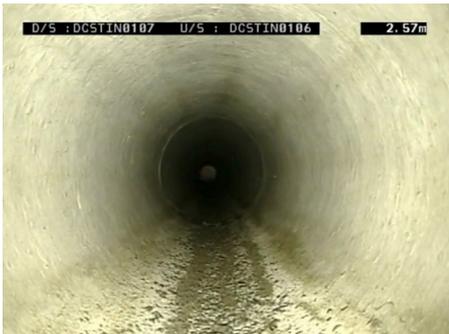
**PW1.8.5 – Aggregate Exposed (AE)**

Dist.	Cont.	Code	Char.	Quant.	From	To
2.6	S1	S	AE	M	5	7

**Remarks:** Aggregate exposed in the invert (up to 25% of pipe circumference) because of erosion from the flow in the pipe.

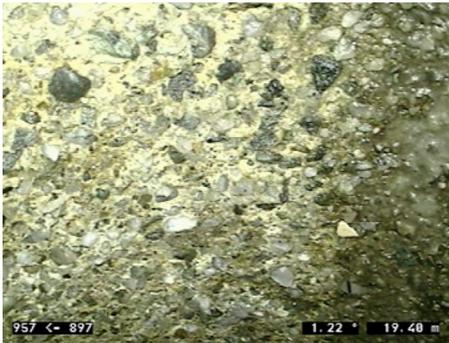
**PW1.8.6 – Aggregate Projecting (AP)**

Dist.	Cont.	Code	Char.	Quant.	From	To
19.4	S1	S	AP	L	8	4

**Remarks:** Coarse aggregate protruding above the pipe surface over >25% of the pipe circumference

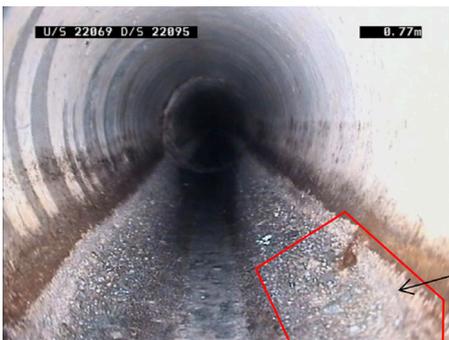
**PW1.8.7 – Aggregate Missing (AM)**

Dist.	Cont.	Code	Char.	Quant.	From	To
0.77	S1	S	AM	L	4	7

**Remarks:** Coarse aggregate protruding with evidence that some aggregate has been lost (>25% of the pipe circumference)

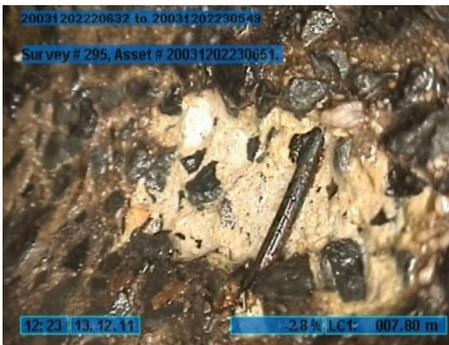
**PW1.8.8 – Reinforcement Visible (RV)**

Dist.	Cont.	Code	Char.	Quant.	From	To
7.8		S	RV	S	3	5

**Remarks:** Circumferential reinforcement exposed

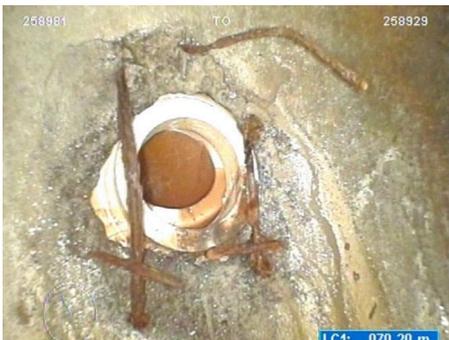
Dist.	Cont.	Code	Char.	Quant.	From	To
70.2		S	RV	S	9	10

**Remarks:** Circumferential reinforcement exposed where saddle connection has been installed

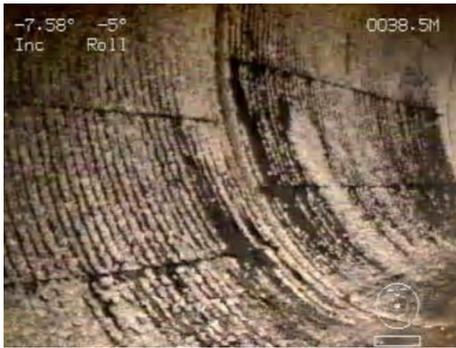
**PW1.8.9 – Reinforcement Corrosion (RC)**

Dist.	Cont.	Code	Char.	Quant.	From	To
38.5	S1	S	RC		6	12

**Remarks:** Wall loss due to corrosion exposing reinforcement steel (which is corroded)

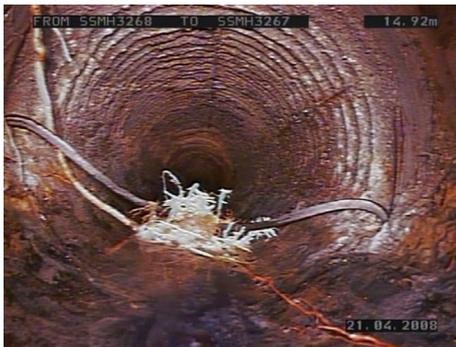
Dist.	Cont.	Code	Char.	Quant.	From	To
15	S1	S	RC		8	4

**Remarks:** Wall corrosion starting to pass reinforcing steel leaving the corroded reinforcement protruding from the surface

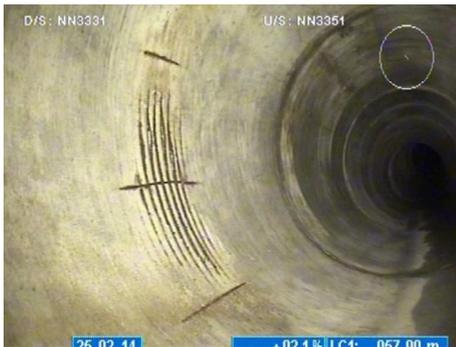
**PW1.8.10 – Steel Reinforcement is Visible and Projecting into the Pipe (RVP)**

Dist.	Cont.	Code	Char.	Quant.	From	To
58.4		S	RVP	M	9	11

**Remarks:** Reinforcement projecting above the pipe surface due to manufacturing defect (up to 25% of the pipe circumference)

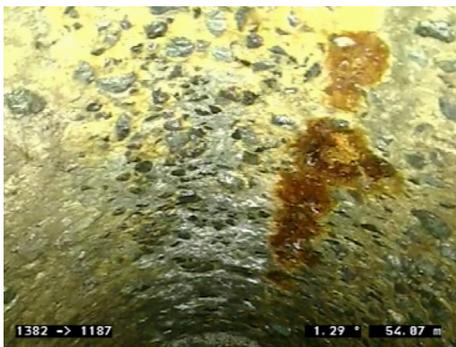
**PW1.8.11 – Wall Staining (WS)**

Dist.	Cont.	Code	Char.	Quant.	From	To
54.7		S	WS	S	9	11

**Remarks:** Staining on the pipe wall from steel reinforcement corrosion

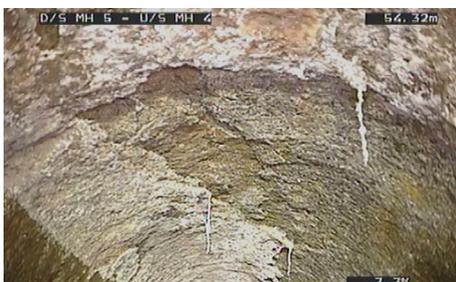
**PW1.8.12 – Corrosion Products (CP)**

Dist.	Cont.	Code	Char.	Quant.	From	To
54.3	S1	S	CP	L	10	2

**Remarks:** Calcium Carbonate buildup on the pipe surface (some has been removed) >25% of the pipe circumference

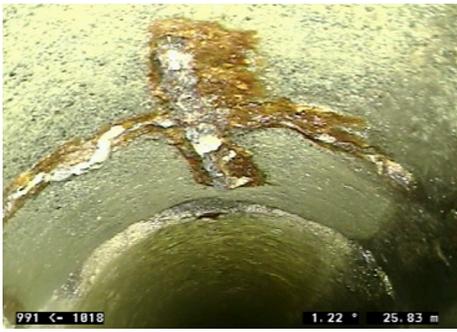
Dist.	Cont.	Code	Char.	Quant.	From	To
25.8		S	CP	L	12	5

**Remarks:** Steel corrosion products on the pipe wall

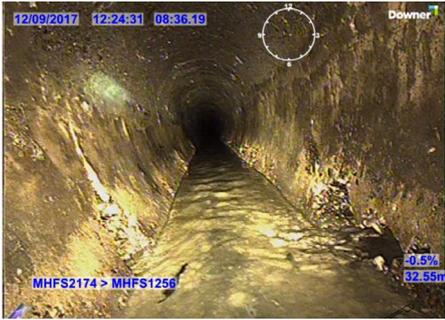
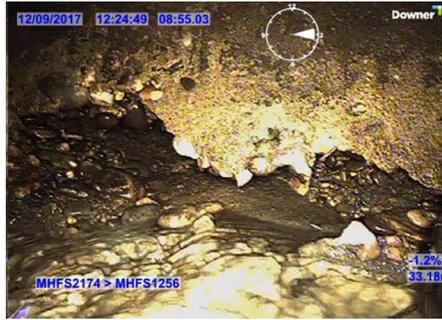
PW1.8.13 - Holed (H)

Dist.	Cont.	Code	Char.	Quant.	From	To	Remarks
33.2		S	H	L	4	8	Hole(s) eroded through cast-in-situ pipe wall.
33.2		SV

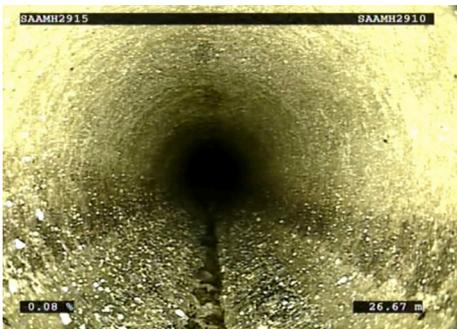
Dist.	Cont.	Code	Char.	Quant.	From	To
26.7	S1	S	H	L	4	8

**Remarks:** Erosion of the AC pipe wall in the invert causing a 'slot' to open to the outside

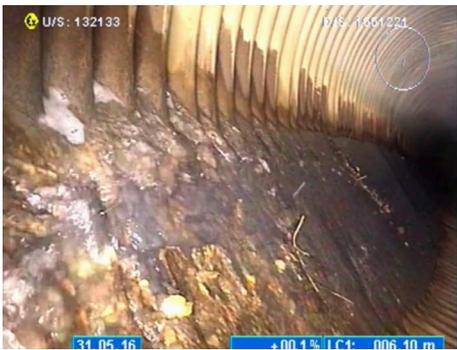
Dist.	Cont.	Code	Char.	Quant.	From	To
6.1		S	H	M	5	7

**Remarks:** Rusting of the steel in the invert of this corrugated steel pipe causing a hole to open to the outside

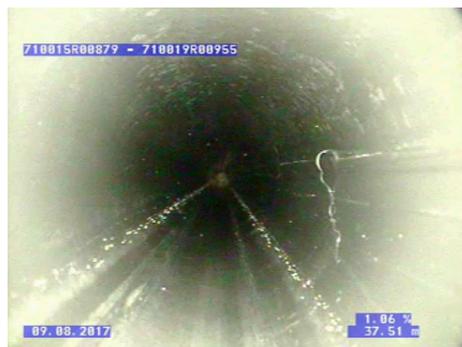
PW1.8.14 – Mechanical Damage (MD)

Dist.	Cont.	Code	Char.	Quant.	From	To
37.6		S	MD	S	2	3

**Remarks:** Scratch at 3 o'clock peeling a thin layer of PE

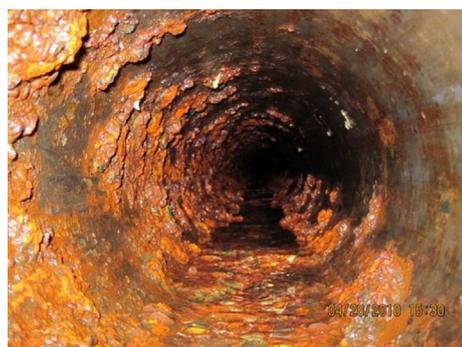
Dist.	Cont.	Code	Char.	Quant.	From	To
X	S1	S	T	M	12	12

**Remarks:** Steel tubercles buildup on the pipe wall reducing the pipe diameter >10%

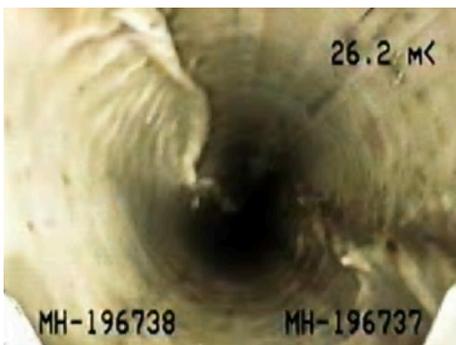
**PW1.9.1 – Wrinkling Longitudinal (WL)**

Dist.	Cont.	Code	Char.	Quant.	From	To
26.2	S1	PL	WL	M	4	10

**Remarks:** Two longitudinal wrinkles

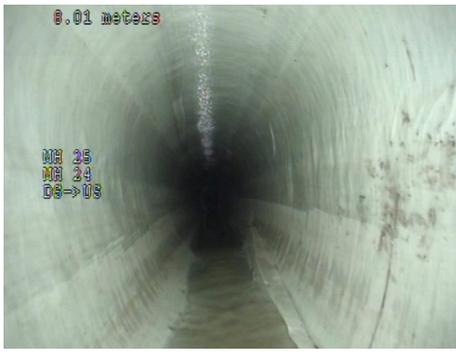
Dist.	Cont.	Code	Char.	Quant.	From	To
8	S1	PL	WL	S	5	6

**Remarks:** Thin Longitudinal (fin) wrinkle @ 5 o'clock

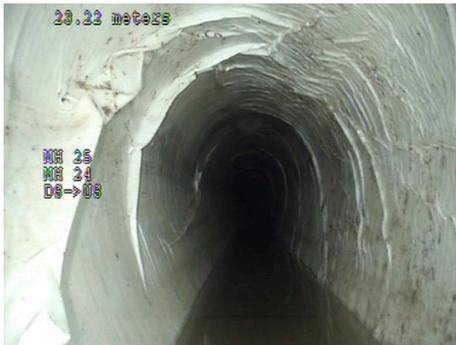
**PW1.9.2 – Wrinkling Circumferential (WC)**

Dist.	Cont.	Code	Char.	Quant.	From	To
23.2	S1	PL	WC	S	8	4

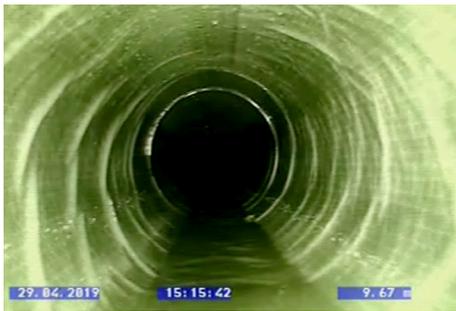
Dist.	Cont.	Code	Char.	Quant.	From	To
9.7	S1	PL	WC	S	1	10

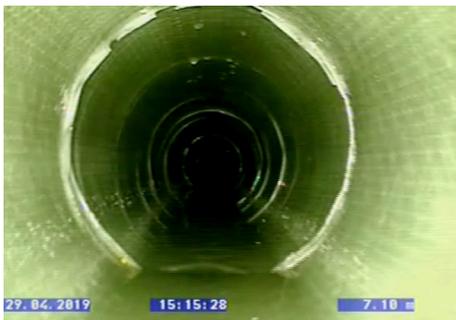
Dist.	Cont.	Code	Char.	Quant.	From	To
7.2		PL	WC	S	12	12

**Remarks:** Residual Polyester Resing

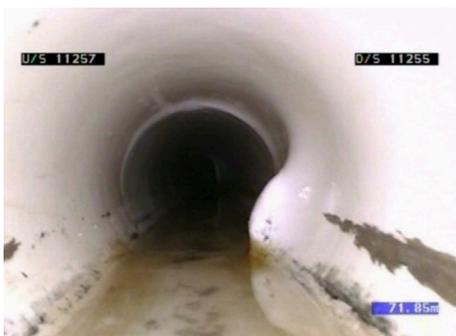
**PW1.9.3 – Bulged or Deformed liner (BU)**

Dist.	Cont.	Code	Char.	Quant.	From	To
72		PL	B	L	1	6

**Remarks:** Bulge in fold & form liner

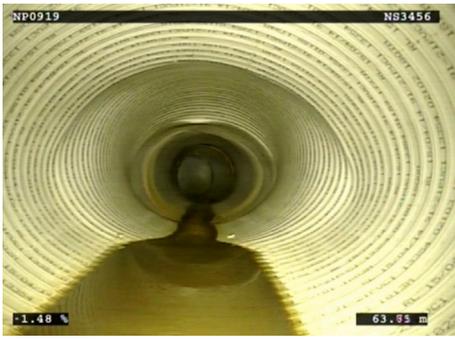
Dist.	Cont.	Code	Char.	Quant.	From	To
63.8	S1	PL	BU	L

**Remarks:** Liner is deformed

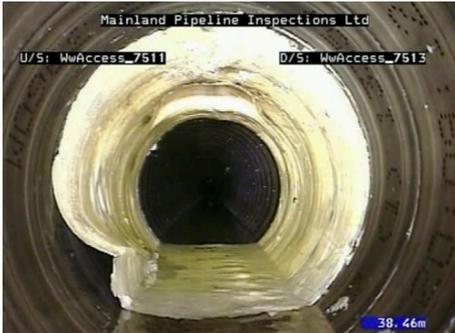
**PW1.9.4 – Detached (D)**

Dist.	Cont.	Code	Char.	Quant.	From	To
38.6		PL	D	M	7	9

**Remarks:** LJR Patch has become detached and lifted from the liner wall

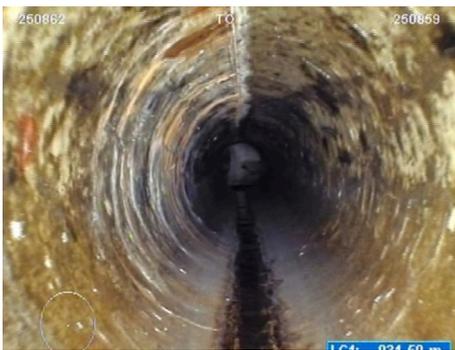
**PW1.9.5 – Discoloration (C)**

Dist.	Cont.	Code	Char.	Quant.	From	To
31.5		PL	C		6	12

**Remarks:** Staining of the liner wall due to leaking seam

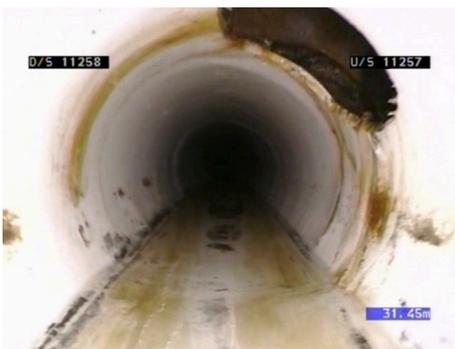
Dist.	Cont.	Code	Char.	Quant.	From	To
31.6		PL	C		8	5

**Remarks:** Staining of the liner wall due to Ground water infiltration through unsealed lateral connection

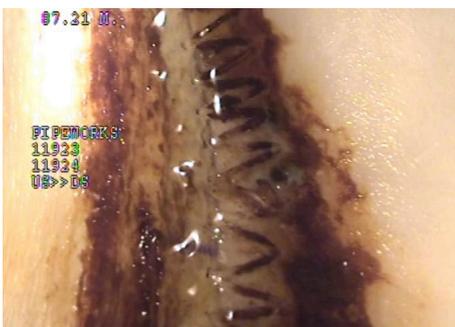
**PW1.9.7 – Leak (L)**

Dist.	Cont.	Code	Char.	Quant.	From	To
87.2		PL	L		2	4

**Remarks:** Laminar (water sheen) flow over stitching and normal beading on LJR – Leakage through the stitching

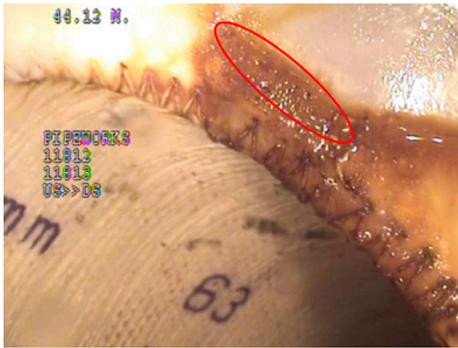
**PW1.9.8 – Holes or Perforations are evident in the liner (H)**

Dist.	Cont.	Code	Char.	Quant.	From	To
44.1		PLH	H		2

**Remarks:** Split or tear in the LJR

44.1		IP		S	2	4
------	--	----	--	---	---	---

**Remarks:** Seeping infiltration

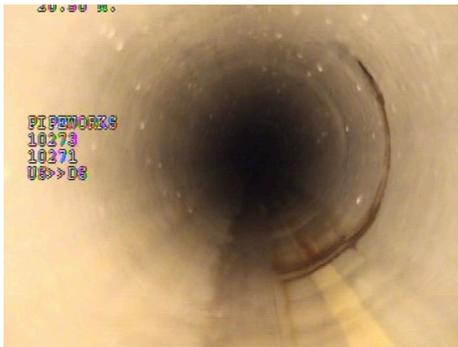
Dist.	Cont.	Code	Char.	Quant.	From	To
20.7		PL	H		2

**Remarks:** Small hole/perforation in the liner.

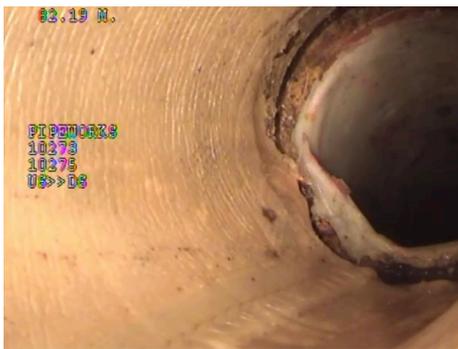
**PW1.9.9 – Re-establishment of Connection done improperly (RC)**

Dist.	Cont.	Code	Char.	Quant.	From	To
82.2		PL	RC		3

**Remarks:** LJR leg does not extend to cover the first joint inside the lateral

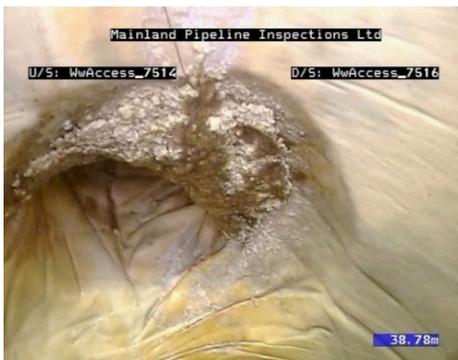
Dist.	Cont.	Code	Char.	Quant.	From	To
38.8		PL	RC		12

**Remarks:** Only just beyond the point of connection. Appears that an incorrect size LJR/LCR used, with excess resin, obstructing/blocking the lateral

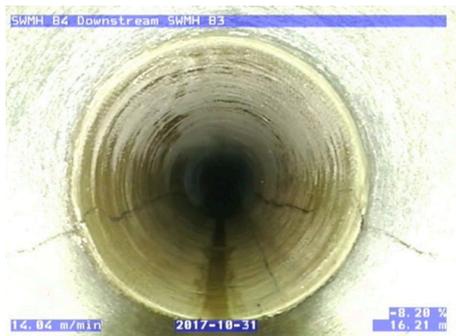
#### PW1.10.1 – Localised Lining (Patch Repair) (L)

Dist.	Cont.	Code	Char.	Quant.	From	To
16.4		PR	L			
<b>Remarks:</b> CIPP Patch Repair						
16.2		GC			4	8
<b>Remarks:</b> Marks (lines) on the pipe wall

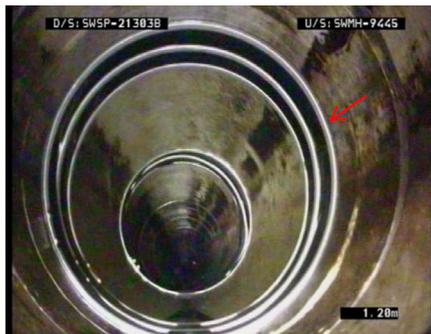
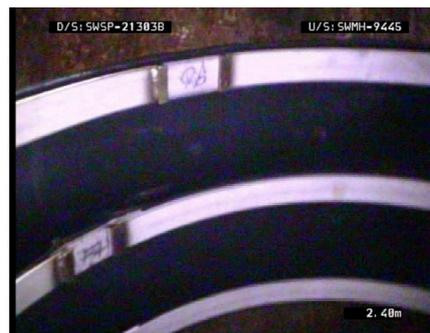
#### PW1.01.2 – Internal ‘Clip’ Seal (IC)

Dist.	Cont.	Code	Char.	Quant.	From	To	Remarks
2.4		PR	IC				Internal sealing repair band

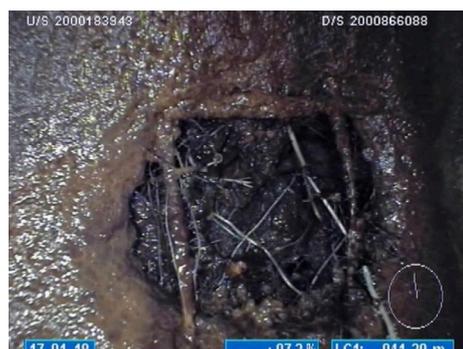
Dist.	Cont.	Code	Char.	Quant.	From	To
11.2		SV				
<b>Remarks:</b> Soil visible through pipe hole						
11.2		PH		M	9	11
11.2		S	RV		9	11

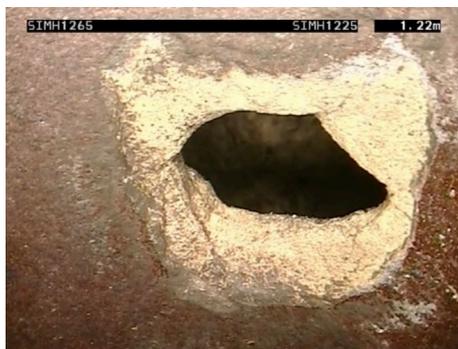
Dist.	Cont.	Code	Char.	Quant.	From	To
1.2		TM				
<b>Remarks:</b> Tomo (Cavity) visible through pipe hole						
1.2		PH		M	12	1

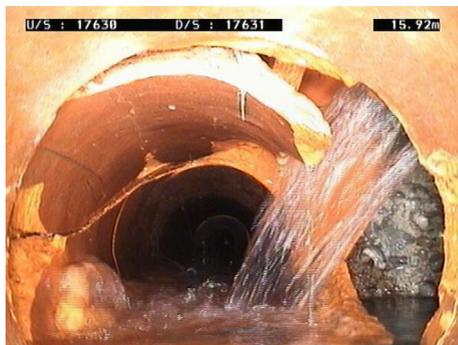
Dist.	Cont.	Code	Char.	Quant.	From	To
16		TM				
<b>Remarks:</b> Tomo (Cavity) visible missing piece of broken pipe						
16		PB		L	12	12
16		GC				
<b>Remarks:</b> Broken section of pipe is a junction and the water entering is flow from the lateral pipe (obscured)

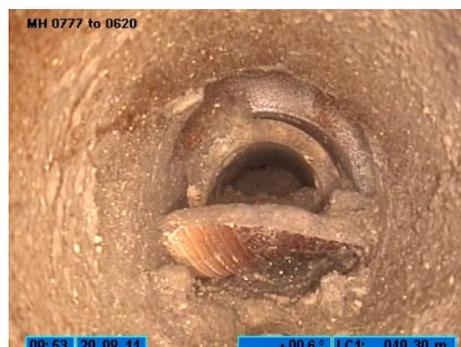
Dist.	Cont.	Code	Char.	Quant.	From	To
49.5		PX

**Remarks:** Pipe roof collapsed in with broken pipe and debris reducing pipe diameter >50% and pipe no longer functioning as a free flowing conduit.

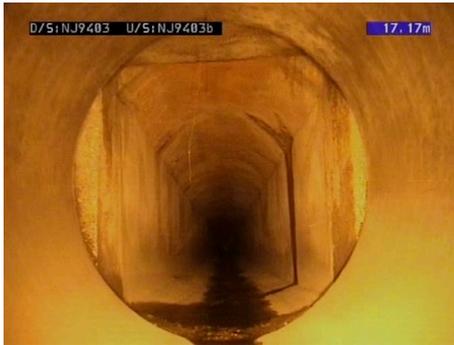
Dist.	Cont.	Code	Char.	Quant.	From	To
18.2		DC

**Remarks:** Change in pipe shape from Circular to Arch

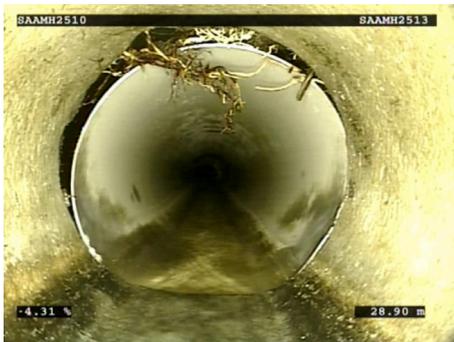
Dist.	Cont.	Code	Char.	Quant.	From	To
29.1		MC

**Remarks:** Concrete to PVC

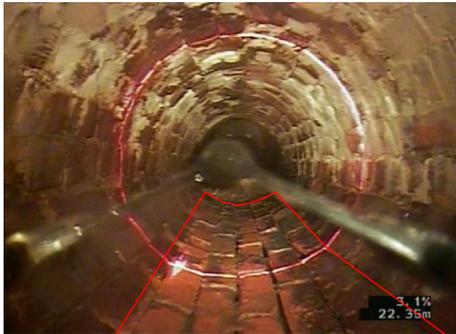
Dist.	Cont.	Code	Char.	Quant.	From	To
22.4	S1	MM		M	4	7

**Remarks:** Part or all the mortar is missing between bricks in the pipe invert

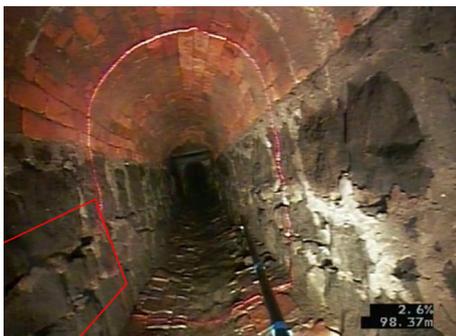
Dist.	Cont.	Code	Char.	Quant.	From	To
98.4		MM		S	7	8

**Remarks:** Part or all the mortar is missing between basalt block

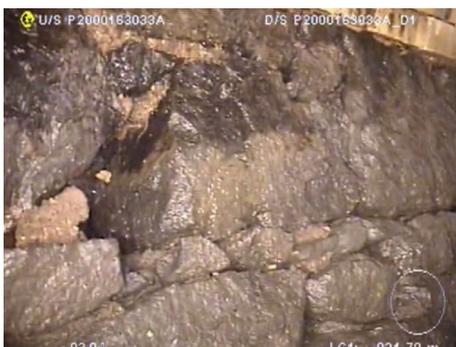
Dist.	Cont.	Code	Char.	Quant.	From	To
21.7		MM		S	7	10

**Remarks:** Part or all the mortar is missing between basalt block

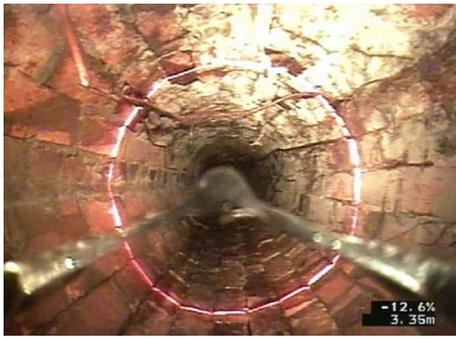
Dist.	Cont.	Code	Char.	Quant.	From	To
3.35	S1	MM		L	10	3

**Remarks:** Roots growing through the mortar joints indicating that some or all of the mortar is missing where the roots are present.

3.35	S2	RI	F	S	10	3
------	----	----	---	---	----	---

**Remarks:** Mostly fine Roots entering through mortar joints

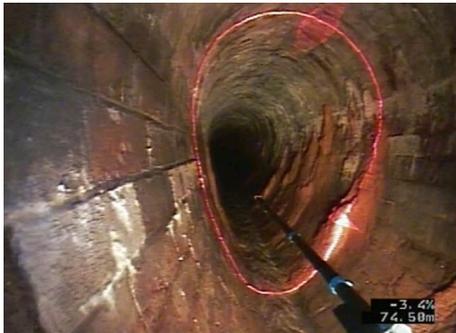
Dist.	Cont.	Code	Char.	Quant.	From	To
74.5	S1	MM		L	2	6

**Remarks:** Leakage through mortar joints indicating that some or all of the mortar is missing

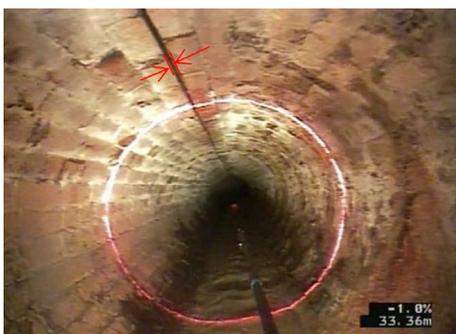
Dist.	Cont.	Code	Char.	Quant.	From	To
33.4	S1	MUS		S	11

**Remarks:** Single continuous separation

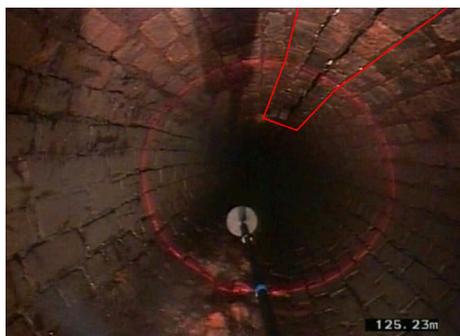
Dist.	Cont.	Code	Char.	Quant.	From	To
125.2	S1	MUS		S	1	2

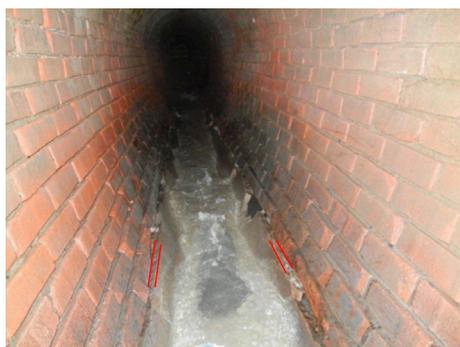
Dist.	Cont.	Code	Char.	Quant.	From	To
X	S1	DI		M	5	7

**Remarks:** 2 clear gaps between masonry units near the invert indicating a dropped invert

Dist.	Cont.	Code	Char.	Quant.	From	To
X		DE		S

**Remarks:** Debris in pipe invert

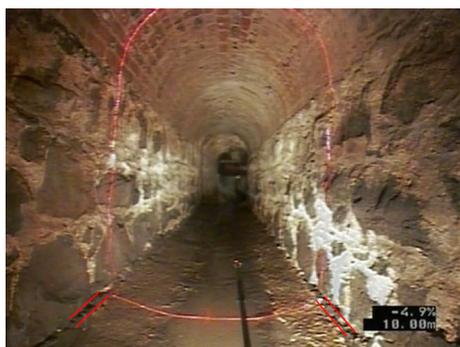
Dist.	Cont.	Code	Char.	Quant.	From	To
10	S1	DI		M	5	7

**Remarks:** 2 clear gaps between masonry units near the invert indicating a dropped invert

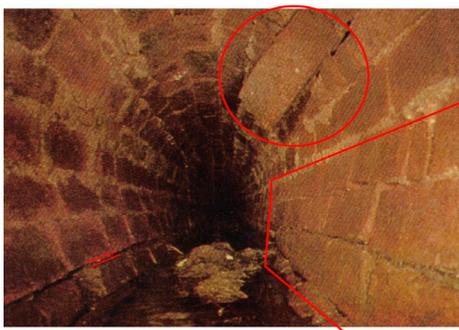
Dist.	Cont.	Code	Char.	Quant.	From	To
X		DMU	I	L	1	7

**Remarks:** 1 brick has moved out of position (1 o'clock) close to falling out. At least 2 other courses between 3 and 5 o'clock appear to be moving inwards.

Dist.	Cont.	Code	Char.	Quant.	From	To
X	S1	DI		S	5	7

**Remarks:** 2 longitudinal gaps near the invert indicating the invert has dropped relative to the grade of the pipe (coded as defect is continuous passing through the location of the displaced bricks)

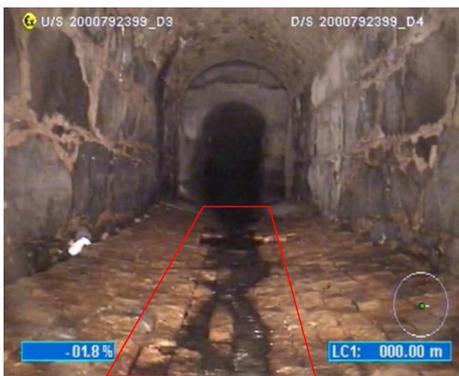
Dist.	Cont.	Code	Char.	Quant.	From	To
0.0	S1	DMU	O	S	5	7

**Remarks:** Bricks in the invert of the pipe have displaced down (outwards)

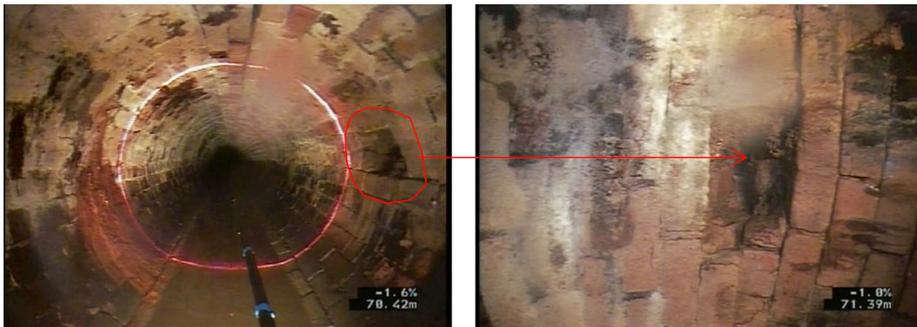
Dist.	Cont.	Code	Char.	Quant.	From	To	Remarks
70.9		MMU	NV	S	2	3	2 brick courses missing. Leakage through mortar joints evident by ED
70.9		ED		S	7	10	
70.4	SI	GC			5	7	Possible that invert is beginning to drop but gap is not wide enough to record as such.

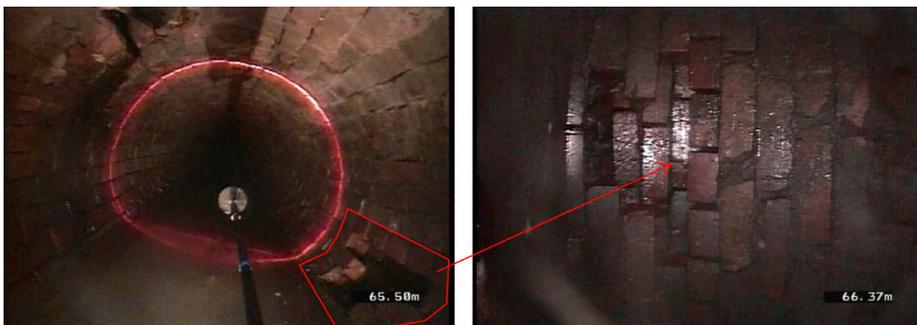
Dist.	Cont.	Code	Char.	Quant.	From	To	Remarks
65.6		MMU	V	S	4	5	At least 3 brick courses missing (more visible behind)

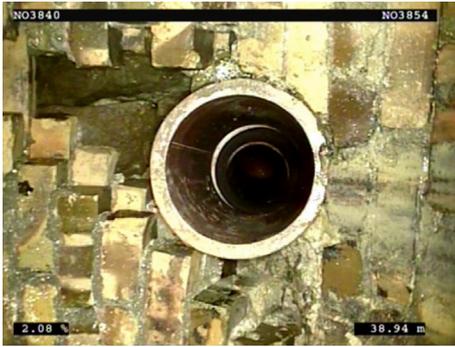
Dist.	Cont.	Code	Char.	Quant.	From	To
38.9		MM	NV	M	3	5

**Remarks:** Bricks below the lateral are missing (2 courses)

38.9		TM				
------	--	----	--	--	--	--

**Remarks:** Cavity visible

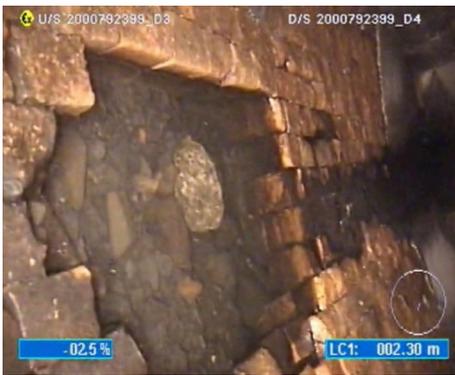
Dist.	Cont.	Code	Char.	Quant.	From	To
38.9		MM	NV	M	5	7

**Remarks:** Bricks in the invert are missing (camera is tilted)
