# NEW ZEALAND GRAVITY PIPE INSPECTION MANUAL

**4<sup>TH</sup> EDITION**

Prepared for WaterNZ by ProjectMax Ltd  
and Citycare Water 2019

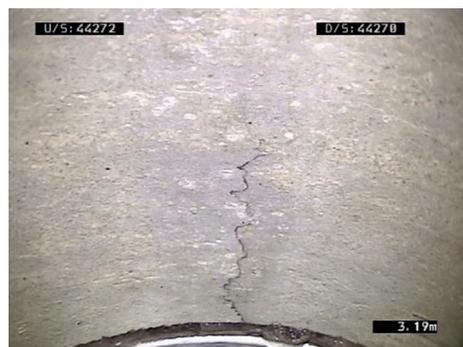
##### J3.1.1 – Cracking within Joint Zone (C)

Dist.	Cont.	Code	Char.	Quant.	From	To
3.2		JF	C	S	11	1

**Remarks:** Longitudinal crack within Joint zone (<100mm from joint centre)

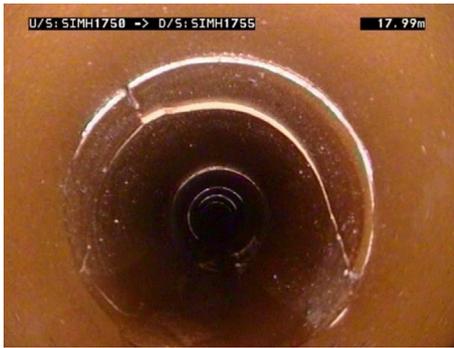
J3.1.2 – Broken Pipe within Joint Zone (B)

Dist.	Cont.	Code	Char.	Quant.	From	To
18.2		JF	B	L	7	4

**Remarks:** Pipe broken with displaced pieces within the joint zone extending more than 25% of the pipe circumference and displaced by more than half the pipe wall thickness.

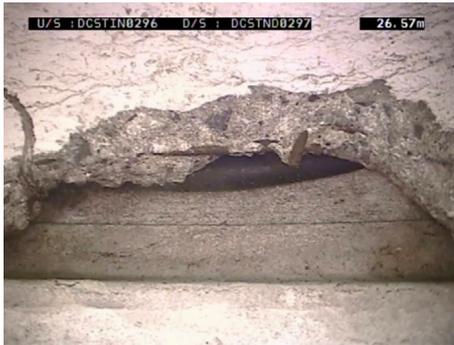
J3.1.3 – Damaged end of pipe (D)

Dist.	Cont.	Code	Char.	Quant.	From	To
26.6		JF	D	L	7	8

**Remarks:** End of the spigot is chipped exposing edge of displaced rubber ring.

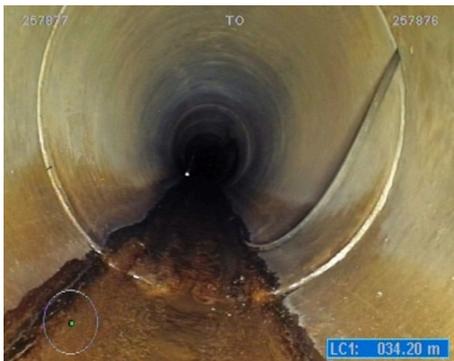
J3.1.4 – Faulty Seal (X)

Dist.	Cont.	Code	Char.	Quant.	From	To
34.5		JF	X	L	12	12

**Remarks:** Sealing rubber ring is broken and hanging inside the pipe

Dist.	Cont.	Code	Char.	Quant.	From	To
34.5		O	P	S	2	5

**Remarks:** Rubber ring

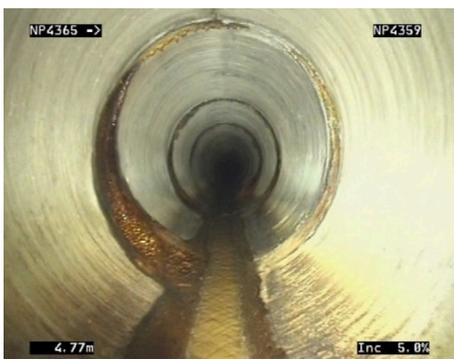
Dist.	Cont.	Code	Char.	Quant.	From	To
6		JF	X	L	12	12

**Remarks:** Encrustation deposits (left) and staining (right) from leakage through joint

Dist.	Cont.	Code	Char.	Quant.	From	To
6		ED		S	6	12

**Remarks:** Buildup on joint

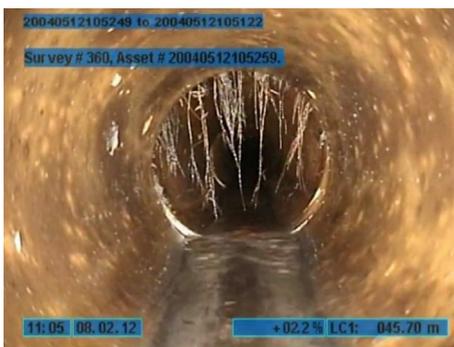
Dist.	Cont.	Code	Char.	Quant.	From	To
46		JF	X	L	12	12

**Remarks:** Roots entering through faulty joint seal

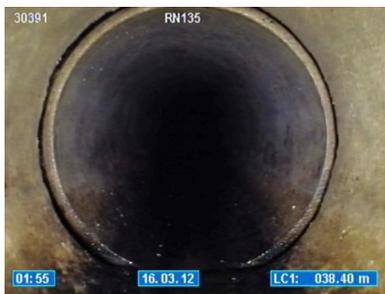
Dist.	Cont.	Code	Char.	Quant.	From	To
1.7		JO		S

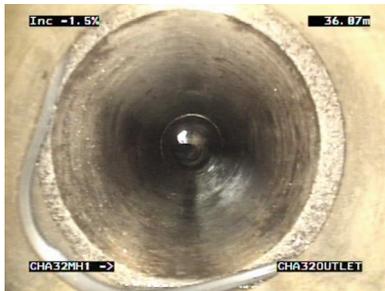
Dist.	Cont.	Code	Char.	Quant.	From	To
3.8		JO		S		
3.8		JF	X	L	4	10

**Remarks:** Rubber sealing ring displaced

Dist.	Cont.	Code	Char.	Quant.	From	To
3.8		O	P	S	5	9

**Remarks:** Rubber ring hanging inside the pipe

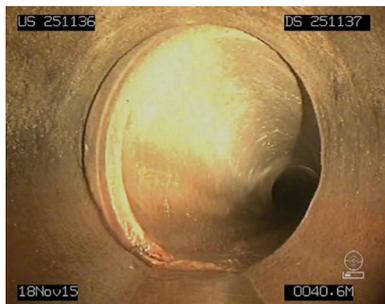
Dist.	Cont.	Code	Char.	Quant.	From	To
40.9		JO	A	L	6	12
40.9		LD	R

**Remarks:** Pipe deviates right >45°

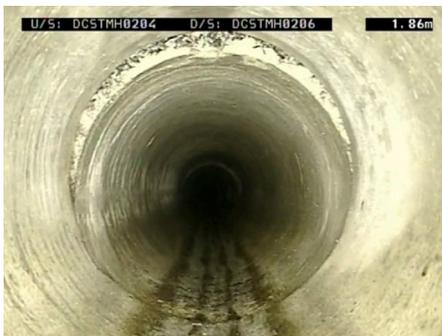
Dist.	Cont.	Code	Char.	Quant.	From	To
2.1		JD	V	S	9	3

**Remarks:** Vertical displacement up to 10% of the pipe diameter

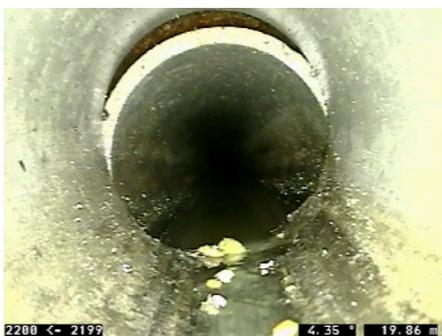
Dist.	Cont.	Code	Char.	Quant.	From	To
20.1		JD	V	M	8	2

**Remarks:** Vertical displacement down > 10% of the pipe diameter

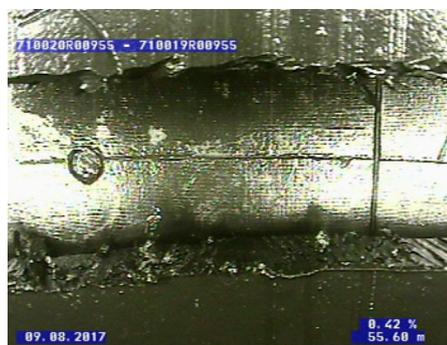
**J3.4.1 – Incorrect Insertion (I)**

Dist.	Cont.	Code	Char.	Quant.	From	To
55.6		W	I		12	12

**Remarks:** Poorly prepared pipe ends with internal gap within the electrofusion coupler of >5% of the pipe diameter (more than 10mm)

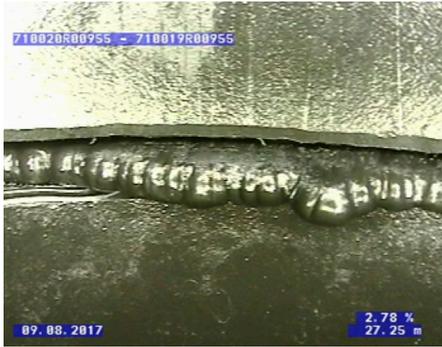
J3.4.2 – Electrofusion coupler (PE welding only) has partially melted (M)

Dist.	Cont.	Code	Char.	Quant.	From	To
2.8		W	M		10	2

**Remarks:** Melt has flowed out and filled the gap between the two pipe ends and is slightly protruding

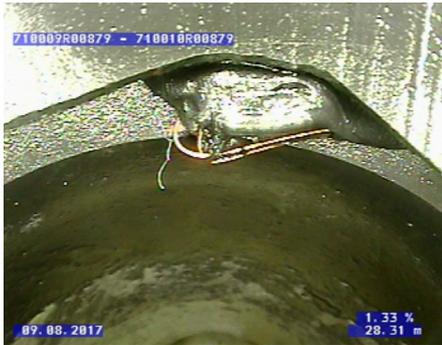
Dist.	Cont.	Code	Char.	Quant.	From	To
28.3		W	M		10

**Remarks:** Melt has flowed out a small gap between the cut-out pipe and EF saddle with wires exposed

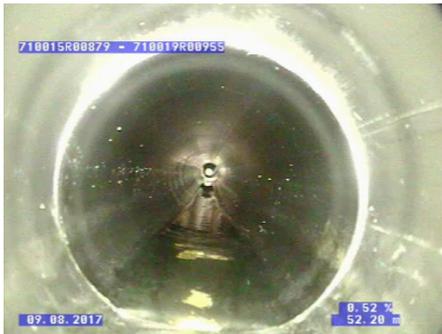
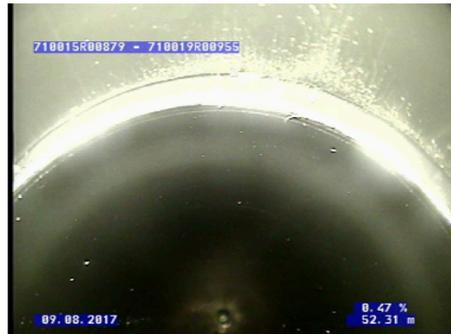
J3.4.3 – Ovality (O)

Dist.	Cont.	Code	Char.	Quant.	From	To	Remarks
52.3		W	O		12	12	2 brick courses missing. Leakage through mortar joints evident by ED
52.3		WL	C				Flow depth increases to approx. 5% due to EF joint ovality

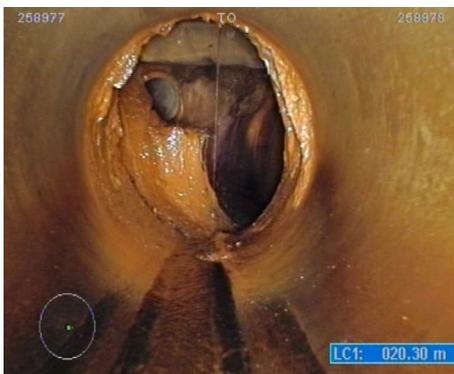
Dist.	Cont.	Code	Char.	Quant.	From	To
20.7		MHJ			12	12
<b>Remarks:</b> Manhole joint seal defective						
20.7		ED		S	7	5
<b>Remarks:</b> Buildup on the end on the pipe at entrance to the manhole						
20.7		IP		M	12	6
<b>Remarks:</b> From Manhole seal

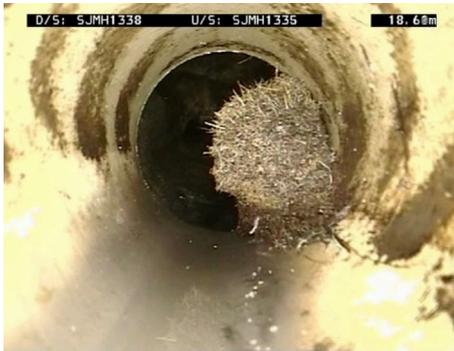
Dist.	Cont.	Code	Char.	Quant.	From	To
20.2		MHJ			12	12
<b>Remarks:</b> Manhole joint seal defective, roots intruding						
20.2		BRI			2	6
<b>Remarks:</b> Roots growing through manhole connection reducing cross-section by >50%

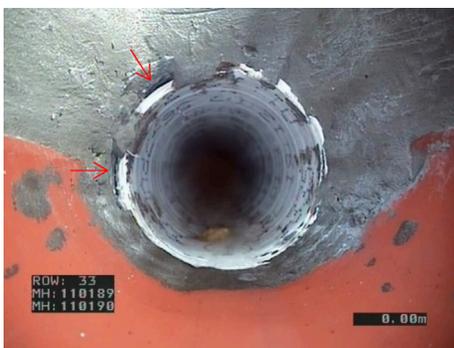
**J3.5.1 – Liner Terminations with Manholes/Chambers**

Dist.	Cont.	Code	Char.	Quant.	From	To
0.5		MHJ			8	11
<b>Remarks:</b> Gaps/defects in the end seal with the manhole

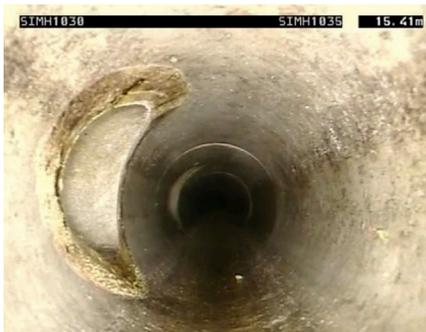
**L4.1.1 – Open (O)**

Dist.	Cont.	Code	Char.	Quant.	From	To
15.6		L	O		9

**Remarks:** AC Junction 100mm

14.4	S1	S	W	M	4	8
------	----	---	---	---	---	---

**Remarks:** Minor abrasion in the invert

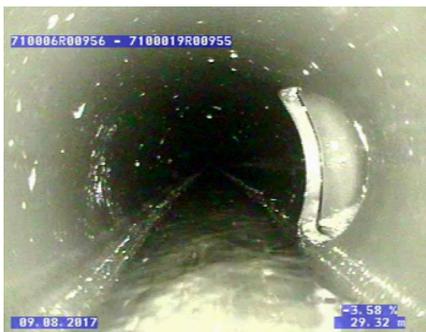
Dist.	Cont.	Code	Char.	Quant.	From	To
29.5		L	O		3

**Remarks:** PE Fusion saddle connection, 100mm

29.3	S1	DG		S	4	8
------	----	----	--	---	---	---

**Remarks:** Slight fat buildup above the flow level

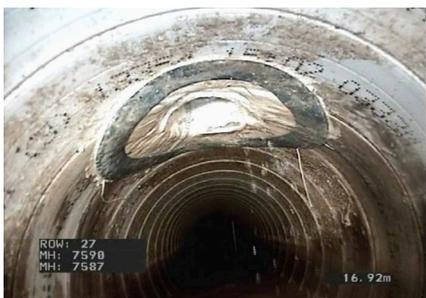
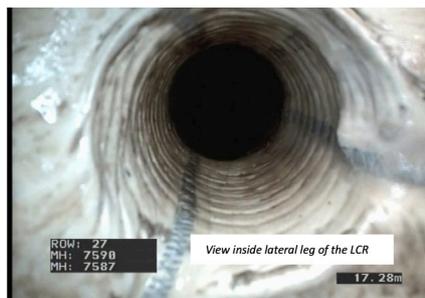
Dist.	Cont.	Code	Char.	Quant.	From	To	Remarks
17.3		L	O		12		Lateral Connection Repair, 100
17.3		PR	L		10	2	CIP Lateral Connection Repair (LCR)

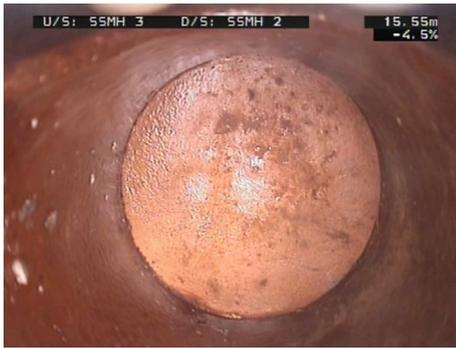
L4.1.2 – Blank (B)

Dist.	Cont.	Code	Char.	Quant.	From	To
15.6		L	B		3

Remarks: Lateral is capped

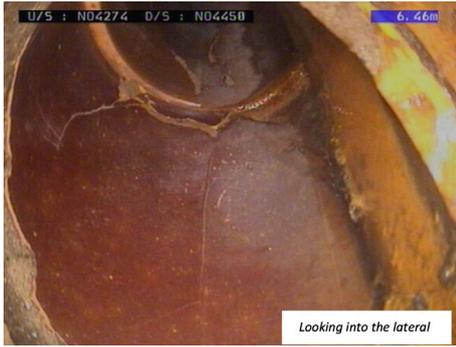
L4.2.1 – Cracks (C)

Dist.	Cont.	Code	Char.	Quant.	From	To
6.5		LF	C	L	3

**Remarks:** Displaced cracks inside the lateral stub. Poor seal around lateral connection

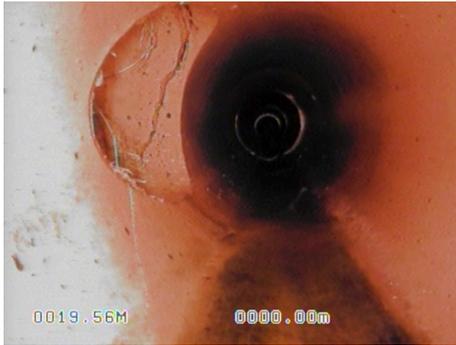
Dist.	Cont.	Code	Char.	Quant.	From	To
19.7		LF	C	L	9

**Remarks:** Circumferential crack (Large). Roots visible inside lateral but not extending into the main

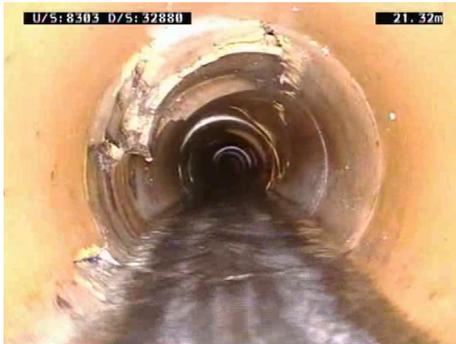
L4.2.2 – Broken Pipe (B)

Dist.	Cont.	Code	Char.	Quant.	From	To
19.7		LF	B	L	11

**Remarks:** Lateral connection is broken and the lateral partially protruding into the main

19.7		LP		M	11	
------	--	----	--	---	----	--

**Remarks:** Broken lateral connection protruding >10% in to the main

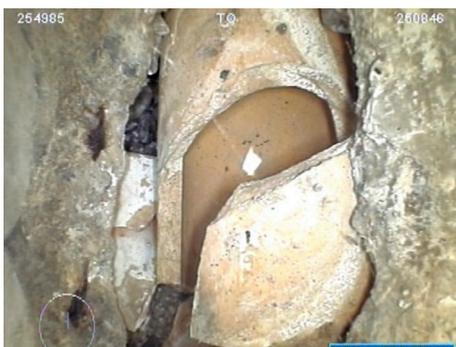
Dist.	Cont.	Code	Char.	Quant.	From	To
4.2		LF	B	L	12

**Remarks:** Lateral connection is broken with the broken pipe partially blocking the lateral

4.2		SV				
-----	--	----	--	--	--	--

**Remarks:** Stones/bedding visible through gap around the broken lateral connection

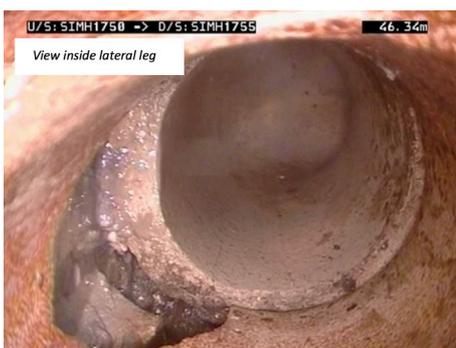
Dist.	Cont.	Code	Char.	Quant.	From	To
46.3		LF	B	L	2

**Remarks:** Lateral stub pipe is broken with the broken pipe missing

**Remarks:** Small cavity (Tomo) visible through broken stub

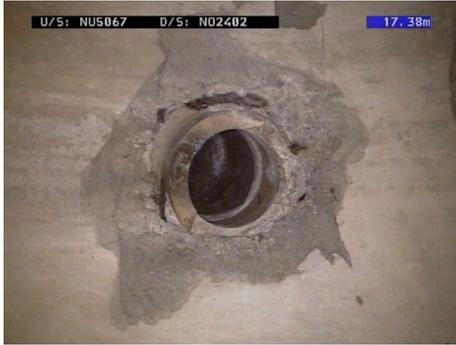
L4.2.3 – Seal (X)

Dist.	Cont.	Code	Char.	Quant.	From	To
17.4		LF	X	M	12

**Remarks:** Missing internal mortar. Possible pathway around the saddle connection

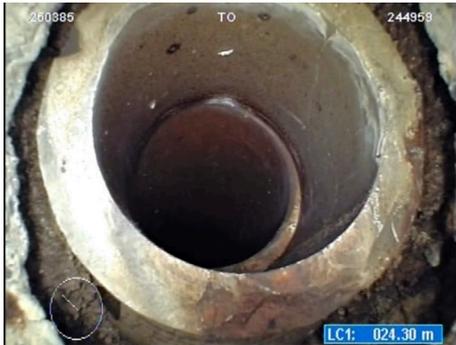
Dist.	Cont.	Code	Char.	Quant.	From	To
24.3		LF	X	L	10

**Remarks:** Missing mortar and Tomo visible through wall gap at lateral connection

24.3		TM				
------	--	----	--	--	--	--

**Remarks:** Small cavity evident around lateral faulty lateral connection

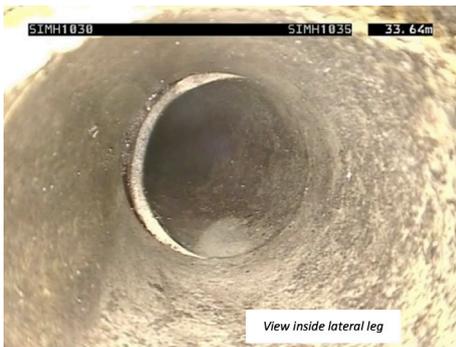
Dist.	Cont.	Code	Char.	Quant.	From	To
33.6		LF	X	M	2

**Remarks:** First joint is displaced with possible pathway through joint.

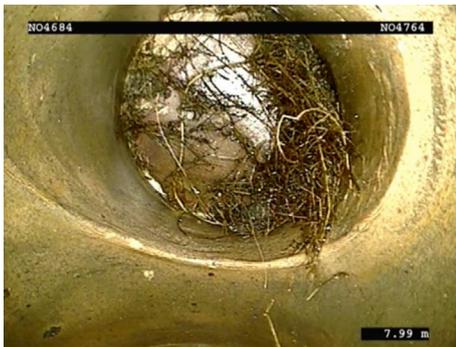
Dist.	Cont.	Code	Char.	Quant.	From	To
8		LF	X	L	3

**Remarks:** Roots entering through faulty seal of the blank cap

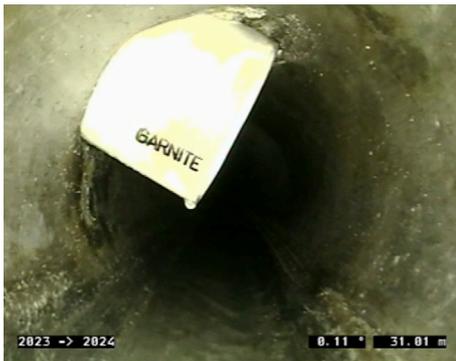
Dist.	Cont.	Code	Char.	Quant.	From	To
31.2		LP		L	10	
<b>Remarks:</b> Lateral protruding >25% (almost 50%)						
31.2		LF	X	M	10	
<b>Remarks:</b> Missing internal mortar, possible staining below lateral connection

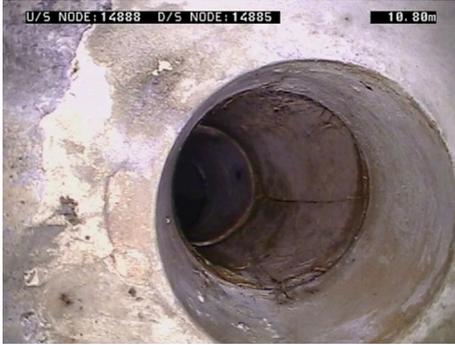
**L4.4.1 – Branch Cracked (C)**

Dist.	Cont.	Code	Char.	Quant.	From	To
10.8		LX	C		9

**Remarks:** Longitudinal Crack in the Lateral pipe beyond the first Joint

**Remarks:** First joint seal is faulty with leakage staining (2 – 4 o'clock) and minor root intrusion

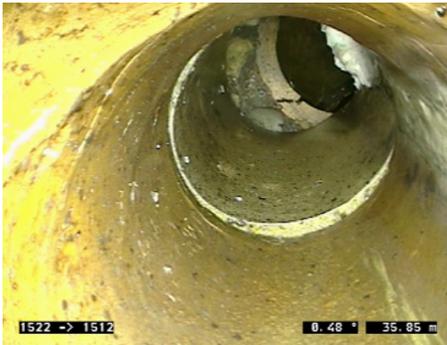
**L4.4.2 – Displaced (D)**

Dist.	Cont.	Code	Char.	Quant.	From	To
35.9		LX	D		3

**Remarks:** Significant joint displacement beyond the first joint

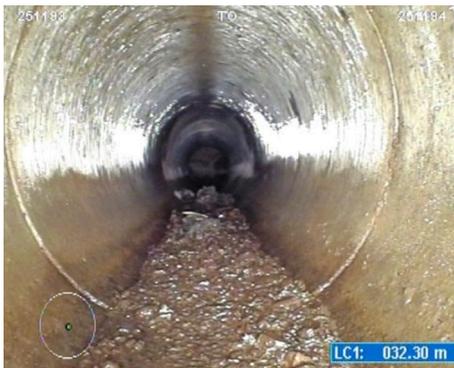
Dist.	Cont.	Code	Char.	Quant.	From	To
32.3	S1	DE		S

**Remarks:** Silty Gravels up to 10% reduction in diameter

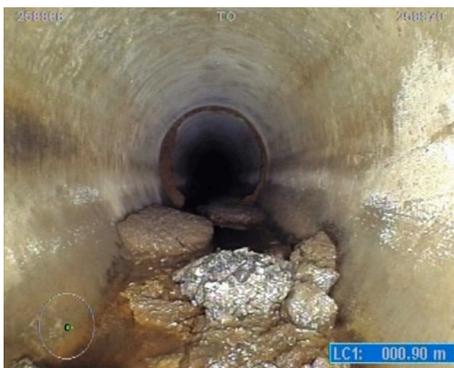
Dist.	Cont.	Code	Char.	Quant.	From	To
0.9		DE		M

**Remarks:** Rocks and Stones up to 25% reduction in diameter

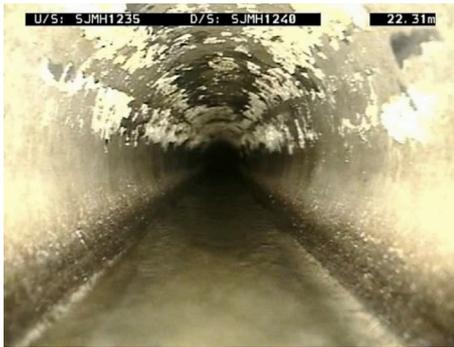
Dist.	Cont.	Code	Char.	Quant.	From	To
22.3	S1	DG		S	9	3

**Remarks:** Thin layer of fat on the pipe roof

22.3	S2	S	W		4	9
------	----	---	---	--	---	---

**Remarks:** From flow in the pipe

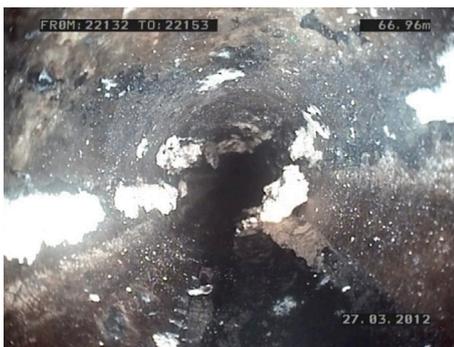
Dist.	Cont.	Code	Char.	Quant.	From	To
67	S1	DG		M	8	6

**Remarks:** “chunks” of fat remaining attached to the pipe wall post cleaning (pipe was blocked before the cleaning)

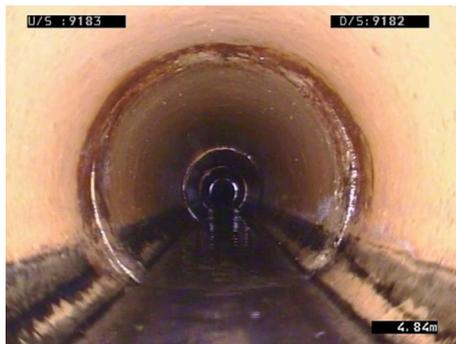
Dist.	Cont.	Code	Char.	Quant.	From	To
5		ED		S	8	4
<b>Remarks:</b> Thin layer buildup of encrustation deposits on the pipe wall around joint with faulty joint seal						
5		JF	X	L	7	4

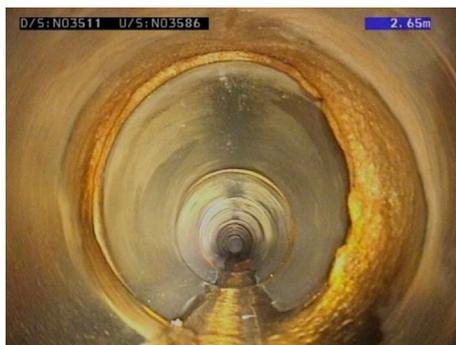
Dist.	Cont.	Code	Char.	Quant.	From	To
2.8		ED		M	7	5
<b>Remarks:</b> Buildup of encrustation deposits on the pipe wall around joint with faulty joint seal						
5		JF	X	L	7	5

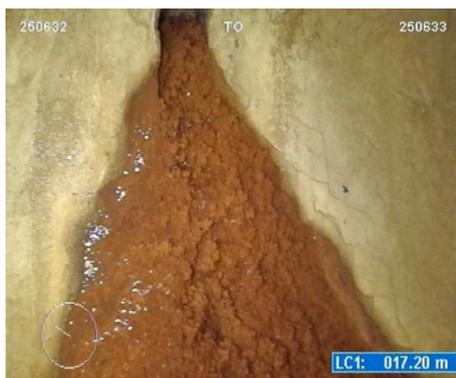
Dist.	Cont.	Code	Char.	Quant.	From	To
17.2		ED		S	7	10
<b>Remarks:</b> Build up of encrustation deposits on the pipe wall around joint with faulty joint seal						
17.2		JF	X	L	7	10
17.2		JO		S		
<b>Remarks:</b> Joint open up to 20mm						
17.2		IP		S	7	10
<b>Remarks:</b> Seeping infiltration evident on the ED (visible as the wet sheen)

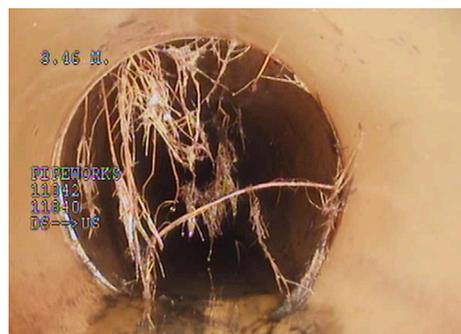
#### S5.4.1 – Fine Root Intrusion Through Joint

Dist.	Cont.	Code	Char.	Quant.	From	To
3.6		RI	F	S	12	12

**Remarks:** Fine roots through faulty joint seal. Although the location of the roots almost covers a substantial portion of the pipe diameter, they only effectively reduce the pipe diameter by <10% as flow in the pipe would push the roots up

**Remarks:** Faulty joint seal evidenced by the roots growing through the joint

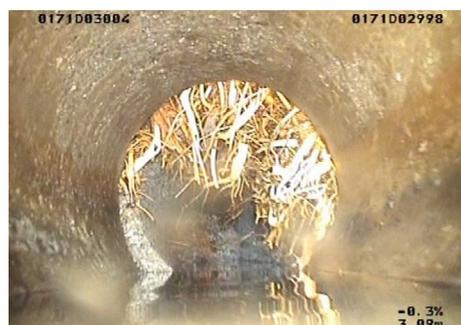
#### S5.4.2 – Recently Cut Root Beard

Dist.	Cont.	Code	Char.	Quant.	From	To
3.3		RI	RB	L	9	5

**Remarks:** Root beard post pipe cleaning (fine roots have been removed)

3.3		JD	H	S	10	5
-----	--	----	---	---	----	---

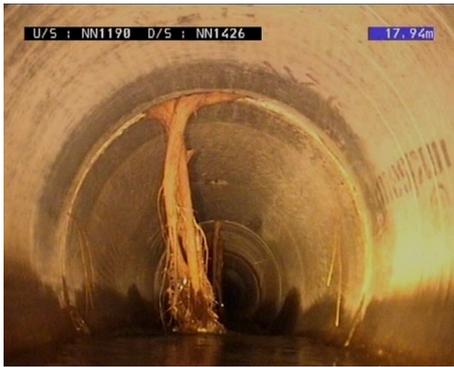
### S5.4.3 – Tap Root

Dist.	Cont.	Code	Char.	Quant.	From	To
18.8		RI	T	M	6	12
<b>Remarks:</b> Tap root growing through faulty joint seal						
3.6		JF	X	L	12	12
<b>Remarks:</b> Faulty joint seal evidenced by the root growing through the joint

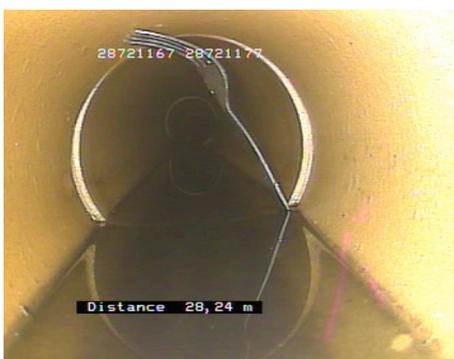
##### S5.5.1 – Temporary Obstruction (T)

Dist.	Cont.	Code	Char.	Quant.	From	To
28.4		O	T	S	11	5
<b>Remarks:</b> Fork stuck in pipe joint						
28.4		JO	A	S	10	2

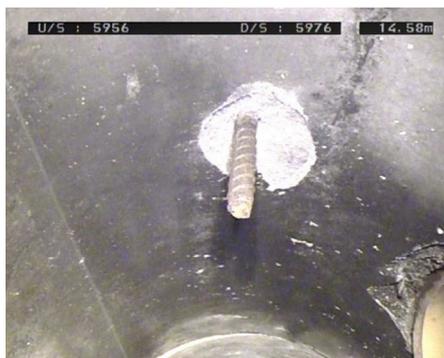
S5.5.2 – Permanent Obstruction (P)

Dist.	Cont.	Code	Char.	Quant.	From	To
14.6		O	P	S	12

Remarks: Steel bar intruding into the pipe

14.6		LF	X	S	3	
------	--	----	---	---	---	--

Remarks: Internal mortar seal missing

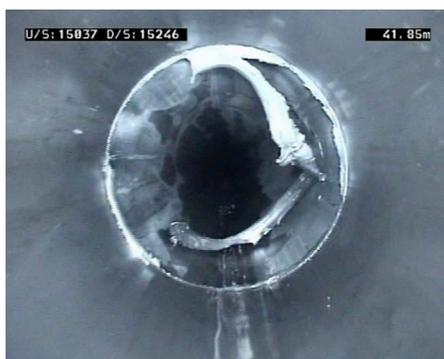
Dist.	Cont.	Code	Char.	Quant.	From	To
42		O	P	M	12	7

Remarks: PE Butt Weld bead partially removed

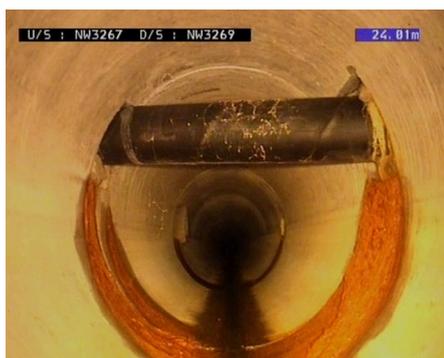
Dist.	Cont.	Code	Char.	Quant.	From	To
24.5		O	S	M	10	2

Remarks: Service strike with steel pipe crossing the pipe

24.5		ED		S	2	10
------	--	----	--	---	---	----

Remarks: Slight buildup of ED on pipe wall as a result of ground water infiltration through the pipe holes (also possible IP that cannot be seen from this distance)

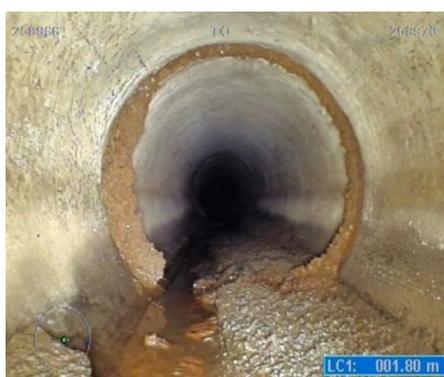
Dist.	Cont.	Code	Char.	Quant.	From	To
1.8	S1	O	P	M	5	7

Remarks: Concrete in the pipe invert

Remarks: Buildup of ED on pipe wall as a result of ground water infiltration through faulty joint seal

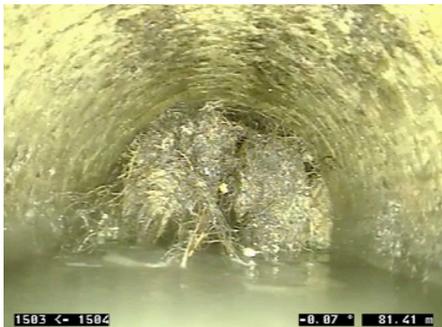
**S5.6.1 – Root Blockage (RI)**

Dist.	Cont.	Code	Char.	Quant.	From	To
81.6		B	RI

**Remarks:** Roots fill the pipe

**Remarks:** Flow depth approx. 40% of pipe diameter – holding due to blockage

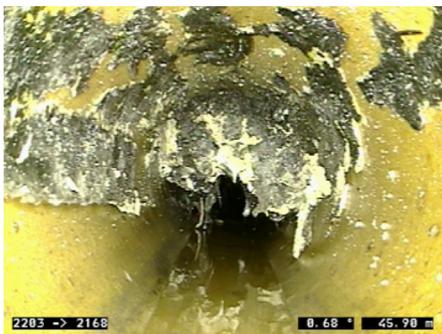
**S5.6.2 – Fat Blockage (DG)**

Dist.	Cont.	Code	Char.	Quant.	From	To
46.1		B	DG

**Remarks:** Fat Blockage - obstructing >50% of the pipe diameter

46.1	F1	DG		S	9	4
------	----	----	--	---	---	---

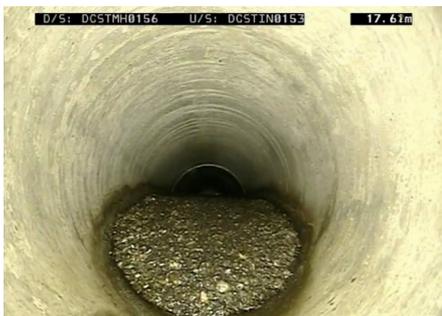
**S5.6.3 – Other (Z)**

Dist.	Cont.	Code	Char.	Quant.	From	To
17.7		B	Z

**Remarks:** Blockage – concrete obstruction in pipe >50% of pipe diameter

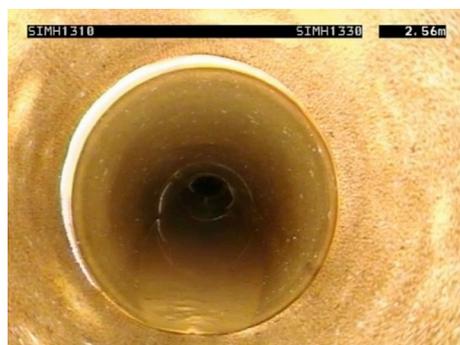
Dist.	Cont.	Code	Char.	Quant.	From	To
2.7	S1	DP		M

**Remarks:** Start of the dip indicated by the increasing flow depth

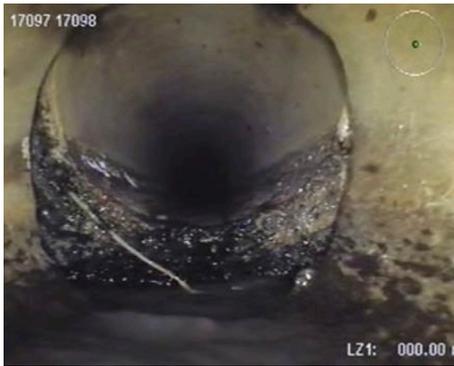
Dist.	Cont.	Code	Char.	Quant.	From	To
0.5		EX			5	7
<b>Remarks:</b> Flowing out of the pipe through displaced joint						
0.5		JD	V	L	3	11
0.5		JF	X	L	12	12

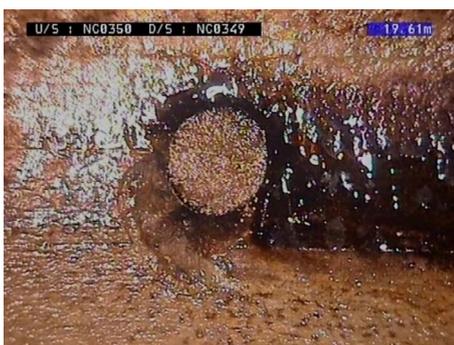
Dist.	Cont.	Code	Char.	Quant.	From	To
19.6		IP		S	12	5
<b>Remarks:</b> Seeping infiltration through lifting eye. Seeping infiltration visible as the wet sheen on the pipe wall						
19.6		CF			12	
<b>Remarks:</b> Lifting eye

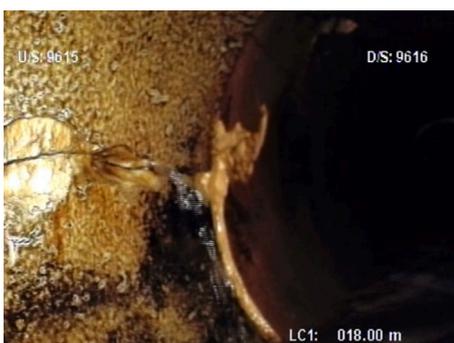
Dist.	Cont.	Code	Char.	Quant.	From	To
18.1		IP		M	7	9
<b>Remarks:</b> Running infiltration from longitudinal crack near joint						
17.6		CL	C		9	
<b>Remarks:</b> Crack edges chipped and IP through crack

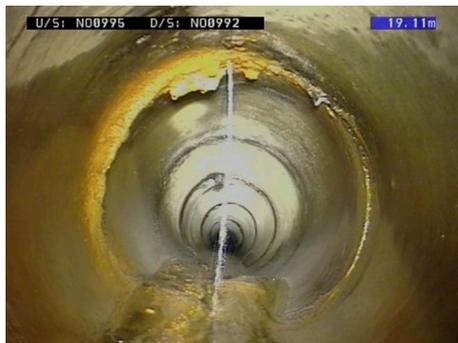
Dist.	Cont.	Code	Char.	Quant.	From	To
19.3		IP		L	6	12
<b>Remarks:</b> Jetting infiltration through faulty joint seal						
19.3		JF	X	L	7	2
<b>Remarks:</b> Infiltration through joint and build-up of ED						
19.3		ED		S	8	2
<b>Remarks:</b> Build-up on pipe wall around joint

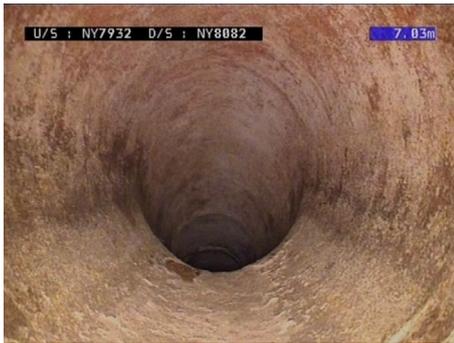
S5.11.1 – Down (D)

Dist.	Cont.	Code	Char.	Quant.	From	To
7.2		LD	D			
<b>Remarks:</b> 45° ramp down						
7.2		CF				
<b>Remarks:</b> Start of Syphon (top of syphon)						
7.0		LC				
<b>Remarks:</b> Cement lining (steel pipe) not present

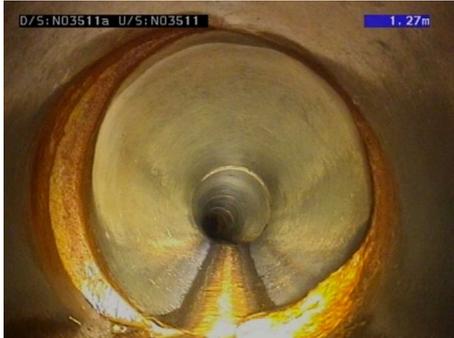
S5.11.2 – Up (U)

Dist.	Cont.	Code	Char.	Quant.	From	To
1.5		LD	U			
<b>Remarks:</b> 15° -20° ramp up						
1.5		JD	H	S	6	12
<b>Remarks:</b> Horizontal displacement (10% of pipe diameter)						
1.5		JO	A	M	2	11
1.5		JF	X	L	12	12
<b>Remarks:</b> Joint seal faulty with staining and ED on pipe wall around the joint						
1.5		ED		S	3	6
<b>Remarks:</b> Buildup on pipe joint

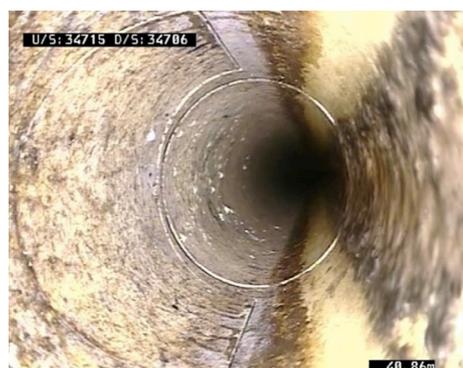
Dist.	Cont.	Code	Char.	Quant.	From	To
40.9		CF			9	3

**Remarks:** PVC inspection point (camera is rotated 90 degrees)

40.8	S1	DG		S	9	3
------	----	----	--	---	---	---

**Remarks:** Thin layer of fatty deposits on the pipe wall

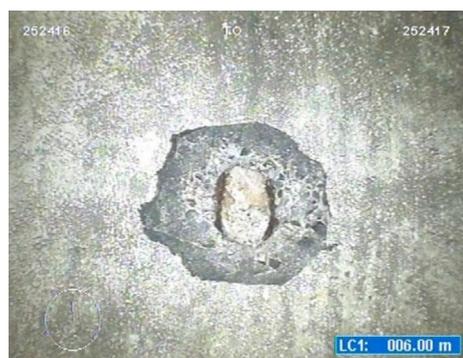
Dist.	Cont.	Code	Char.	Quant.	From	To
6		CF			12

**Remarks:** Sealed lifting eye with chipping and small amount of reinforcing steel exposed. (Exposed reinforcement is not coded separately)

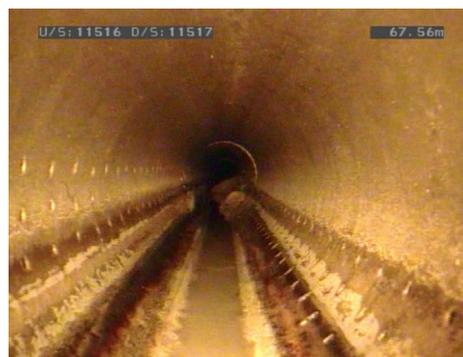
Dist.	Cont.	Code	Char.	Quant.	From	To
67.6	S1	CF			4	9

**Remarks:** Drainage 'weep' holes in rows

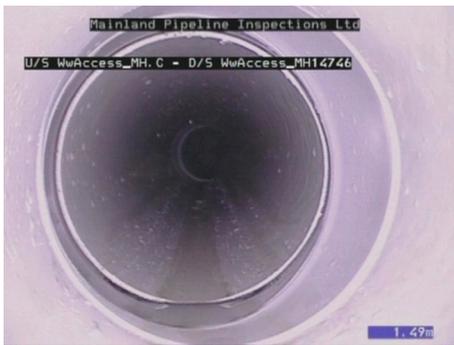
Dist.	Cont.	Code	Char.	Quant.	From	To
1.6		CF				
<b>Remarks:</b> Factory bend (PVC)						
1.6		LD	R			
<b>Remarks:</b> 15° bend right

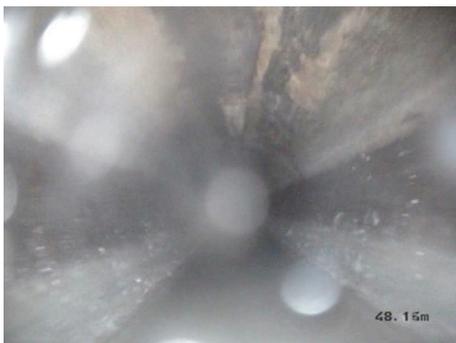
**16.4.2 – Grease on Lens (G)**

Dist.	Cont.	Code	Char.	Quant.	From	To
48.1		LOV	G			
<b>Remarks:</b> Unable to see the pipe due to Waterdrops/grease on the lens

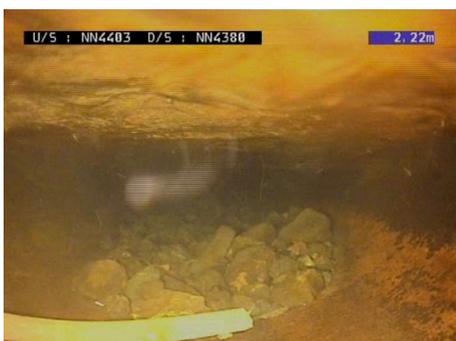
**16.4.3 – Underwater (UW)**

Dist.	Cont.	Code	Char.	Quant.	From	To
2.22		LOV	UW			
<b>Remarks:</b> Unable to see the pipe due to the camera being under water						
2.3		DE		M		
<b>Remarks:</b> Gravels

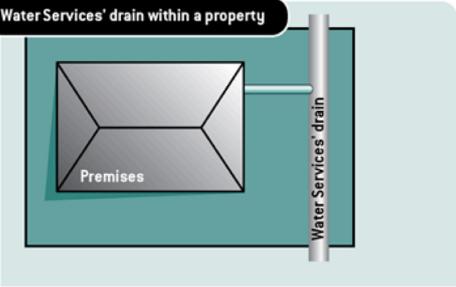
Scenario	Ownership
<p>1</p> <p><b>Water Services' drain within a property</b></p>

<p>All Local Authorities consider where a lateral serves one property and the lateral is entirely within that private property it would be a private lateral.</p>
<p>2</p> <p><b>Water Services' drain within a legal road or reserve</b></p>

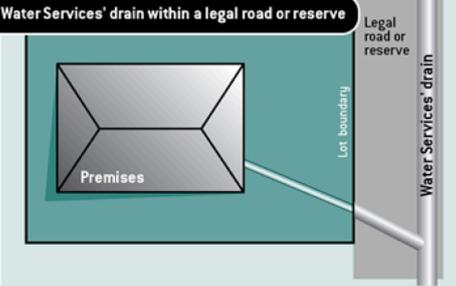
<p>Most Local Authorities consider where a private lateral crosses a property boundary into a legal road or reserve, the lateral ownership will change to public.</p> <p>Some will define the lateral to be private right up to the connection to the council main, even if this is under the public road.</p>
<p>3</p> <p><b>Water Services' drain outside a property</b></p>

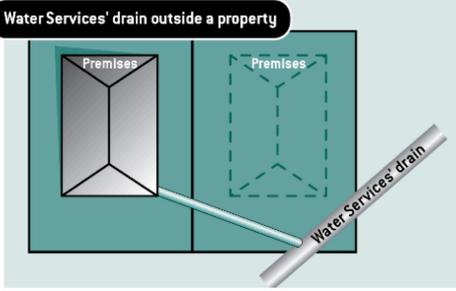
<p>Some Local Authorities consider where a lateral crosses a property (Lot) boundary into a neighbouring private property, the ownership would remain private, (owned by the property it serves) up to the public main.</p> <p>Conversely some Local Authorities, like scenario 2, consider where a private lateral crosses any property (Lot) boundary the ownership changes to public.</p>

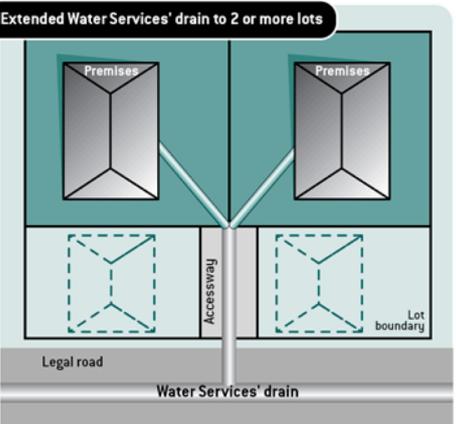
<p>4</p> <p><b>Extended Water Services' drain to 2 or more lots</b></p>

<p>Most Local Authorities consider where a lateral serves two or more properties it is public.</p> <p>A shared drain could also have been installed as a 'Drain in Common' and considered to be private.</p>
<p>5</p> <p><b>Cross-lease or Unit title</b></p>

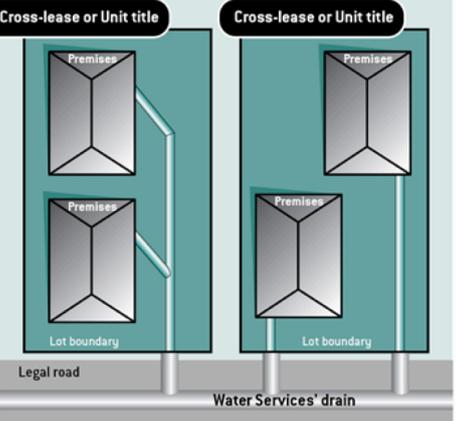
<p>Most Local Authorities consider where a lateral serves two cross leased properties then it is private, and the owners of the cross leased properties jointly own, and are responsible for, its maintenance.</p>

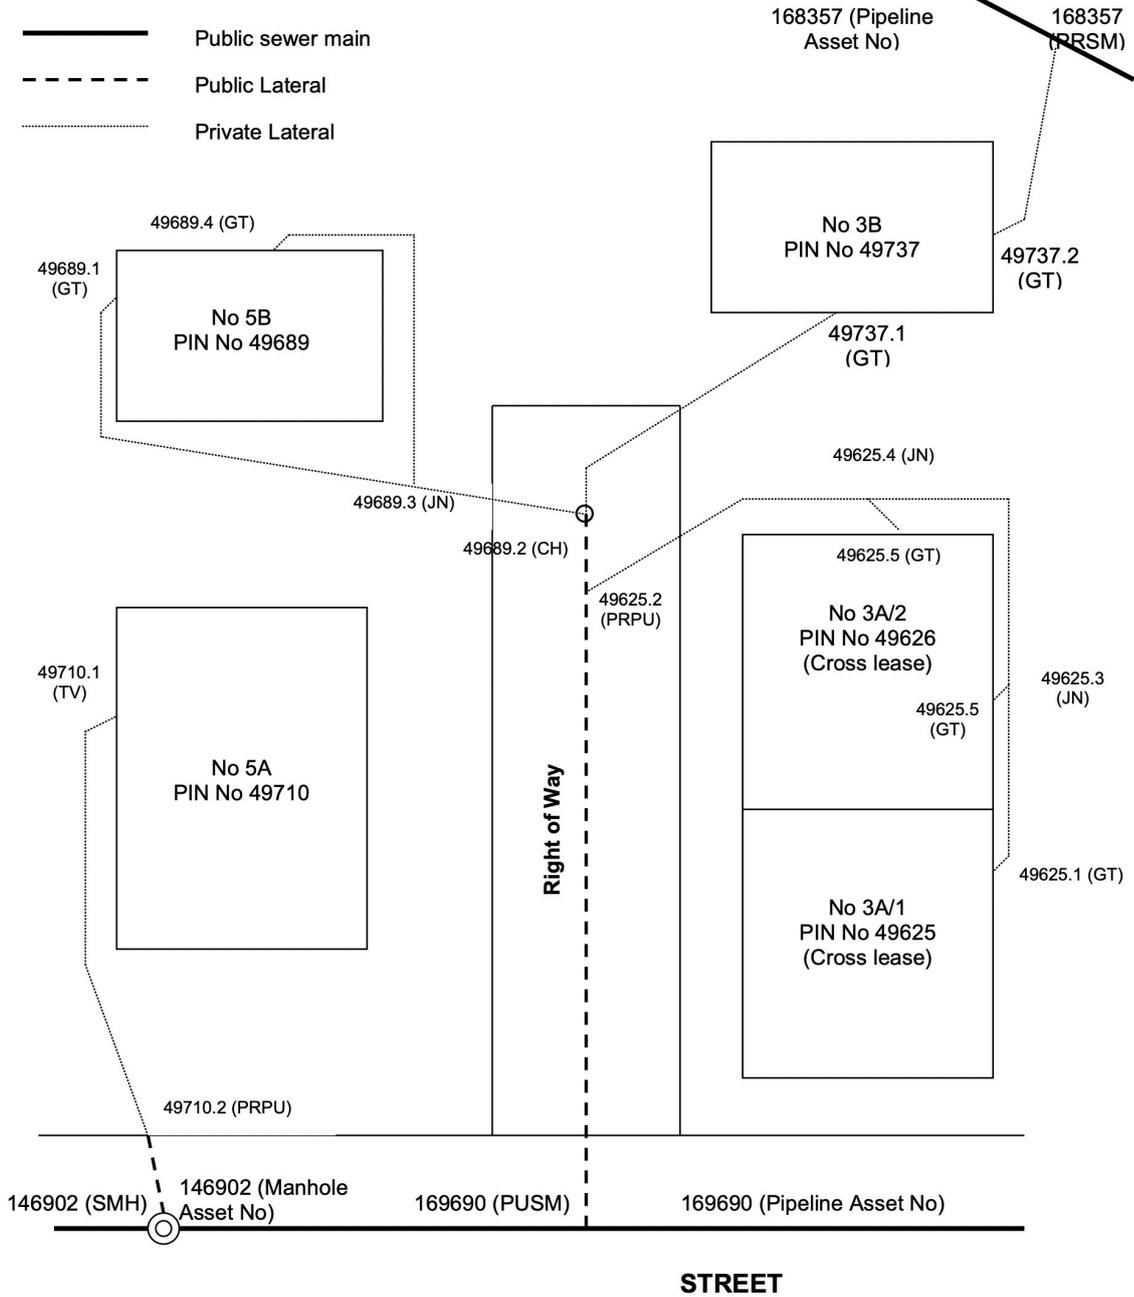
Figure C1.1 – Examples of node identification using different scenarios.

Refer to C4.2 for new node codes

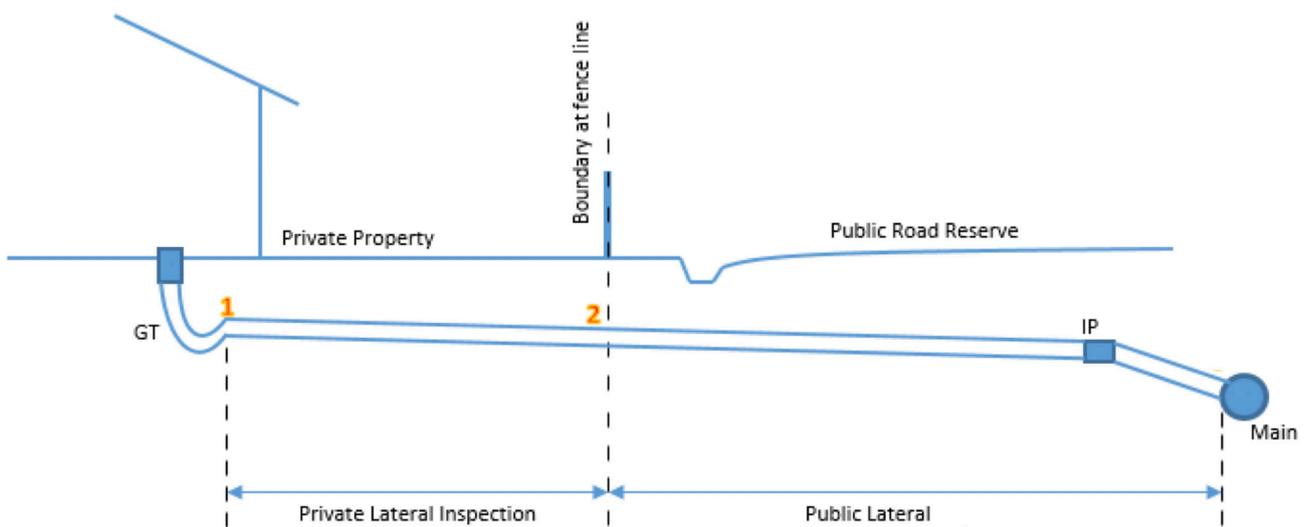
Figure C1.2 – Diagram showing example of the start and end point for the private lateral inspection

- 1** – Start point of the inspection (entering through the Gully Trap (GT))
- 2** – End point of the inspection (private lateral connection to the public lateral (PRPU))

The Inspection should commence or end (dependant on whether the inspection is commencing from public main or at the building) at the furthest gully trap from the connection to the public main (PRMN) or public lateral (PRPU). The Contractor shall identify the status of all branch laterals connecting onto private drain or sewer, (JN) i.e. confirm whether they are live, blank or dead. All live branch laterals shall be inspected.

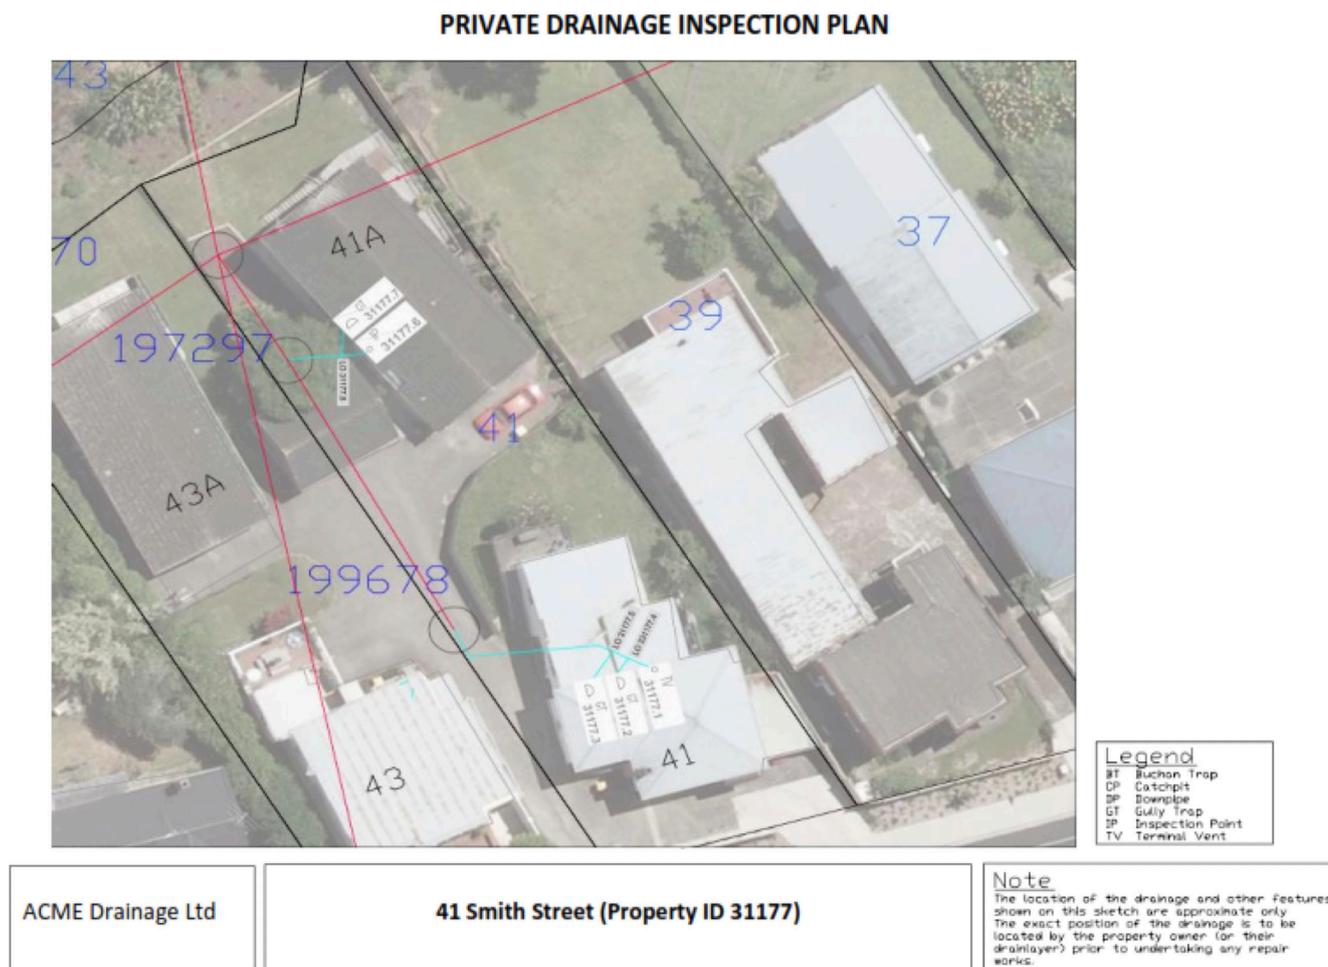
Figure C.3 – Example of a Private Drainage Inspection Plan

The best format for the plan is one taken from a GIS with aerial view showing the property boundaries and position of the public pipes.

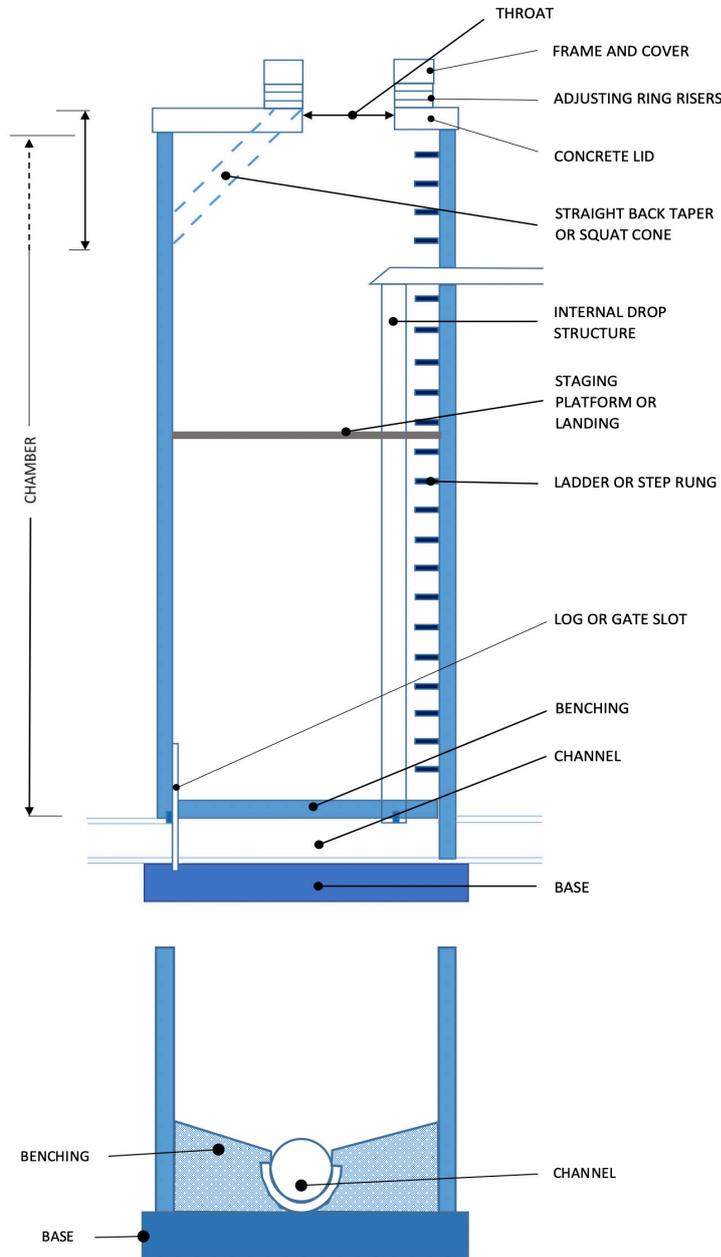
Figure D1.2.1 – Illustration of the layout of a typical manhole and naming of components

There are many manhole designs and layouts. Figure D1.2.1 shows a typical manhole layout with common components labelled. This is given for general illustrative purposes and reference only and is not technically correct about location and scale.

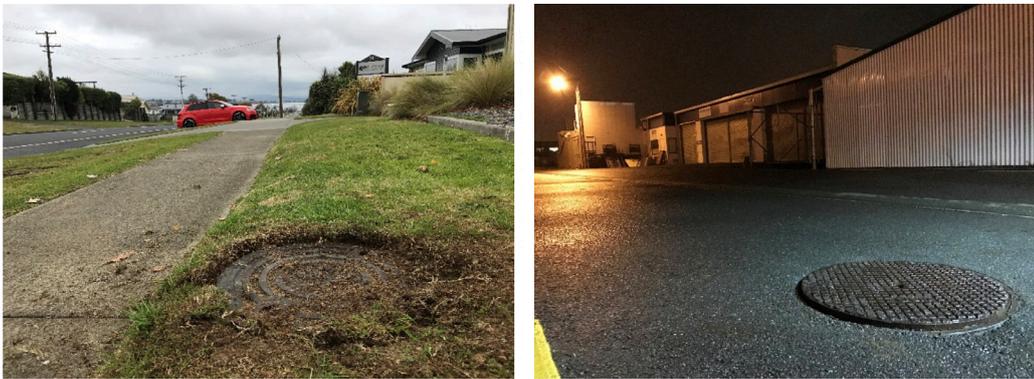
Figure D1.2.2 – Examples of manhole location images

- The location can be seen relative to structures or features nearby the manhole, i.e. fences, roads, buildings etc.
- The position of the manhole cover to the surrounding surfaces and its height. The footage or images shall clearly show whether the manhole cover is sitting higher than, lower than, or flush with the ground surface.
- The condition of the manhole cover and frame and how it is seated can be seen.
- Any settlement issues with the surface around the manhole cover can be observed.

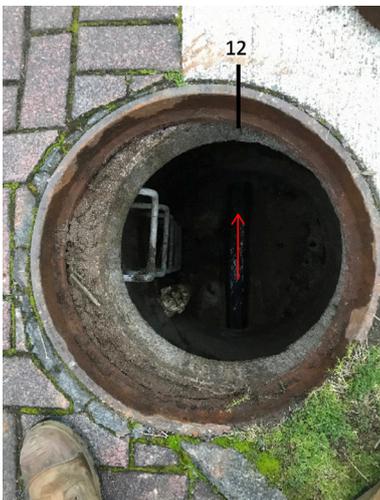
An initial view of manhole shall be provided looking down the manhole, so all features can be seen in relation to each other with the outlet shown in the 12 o'clock position. The manhole cover frame must be included in the initial inspection footage.

Figure D1.2.3 Initial view at the start of the inspection, outlet at 12 o'clock and the cover frame visible

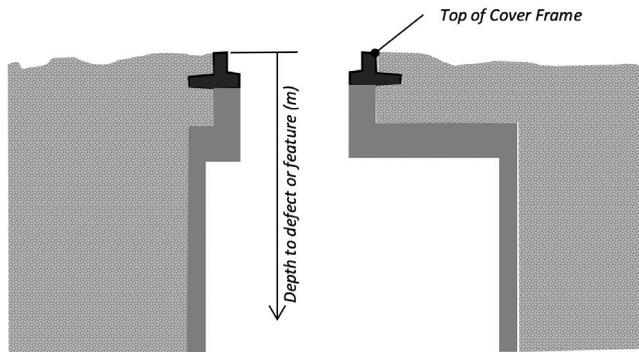
All measurements to manhole features or defects shall be measured from the top of the manhole cover frame.

Figure D1.2.4 – Measurements to all features and defects are measured from the top of the cover frame

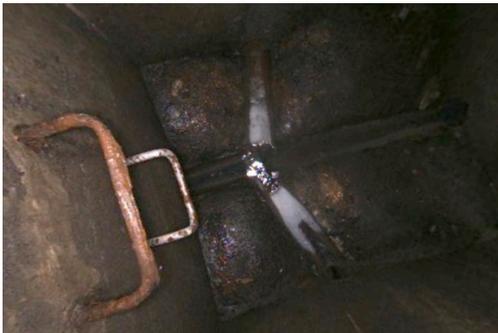
Figure D1.2.5 – Examples of photos

Example 1<sup>st</sup> photo showing corroded step rung

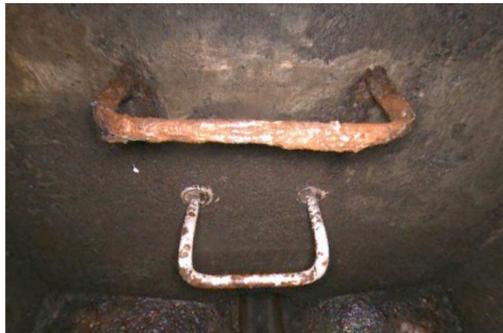
Example 2<sup>nd</sup> photo providing a panned view of corroded step rung

For all other inspections, Pole Cameras or Action Cameras that are not able to view vertically down the manhole chamber, or the second/subsequent photographs (with CCTV camera) is in a panned position (zoomed if required). The second or subsequent photographs shall be added to the log sheet report using the General Photograph code (GP). Remarks shall be provided to describe the view perspective if the image has been zoomed.

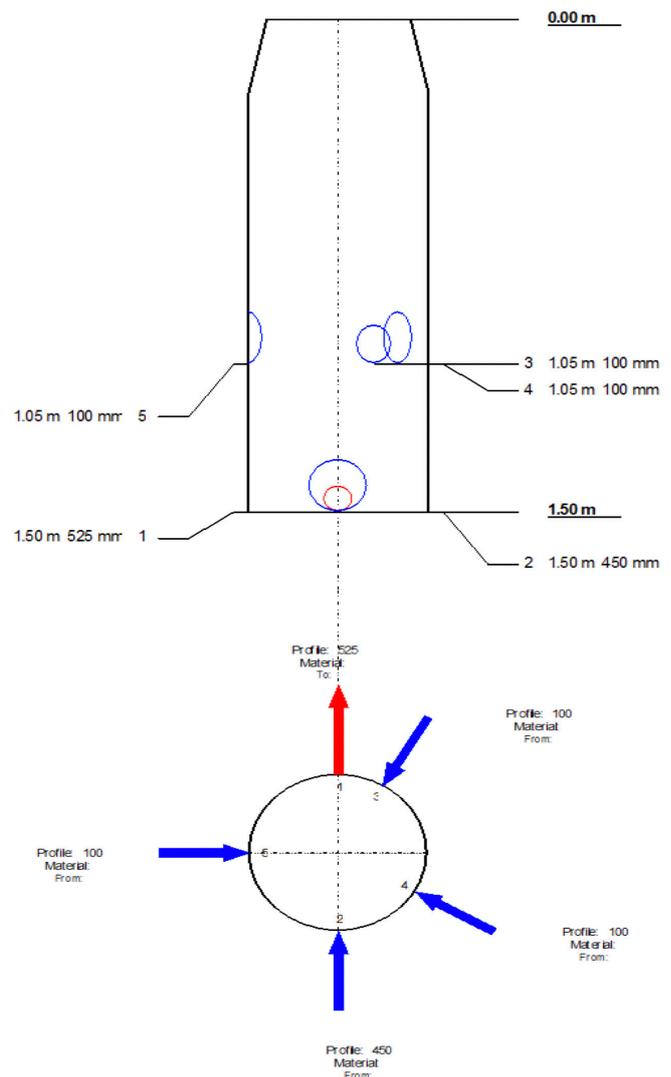
Figure D1.2.6 – Example Manhole Diagram

- Each inlet and outlet gravity sewer main pipe labelled with the pipe asset ID or the closest upstream or downstream manhole ID.
- Each private lateral inlet pipe labelled with the property address(es) that it services.
- Observed connecting pipe material.

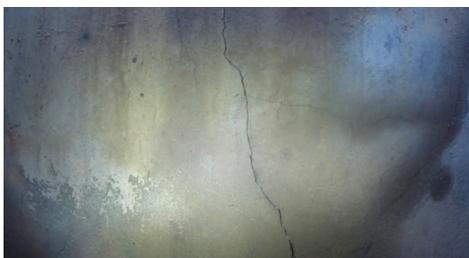
Dist.	Cont.	Code	Char.	Quant.	Location	From	To
X		HCV	C		CH	12

**Remarks:** Vertical crack with chipping of the edges

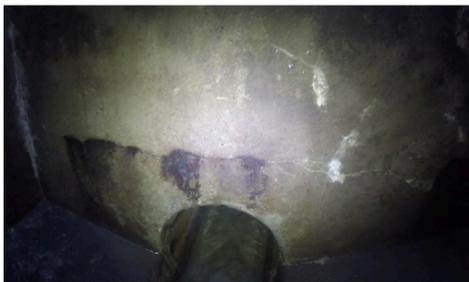
Dist.	Cont.	Code	Char.	Quant.	Location	From	To
X		HCC		L	CH	11	1
<b>Remarks:</b> Vertical crack with chipping of the edges							
Y		HL	CB			12	
<b>Remarks:</b> 225mm Outlet.

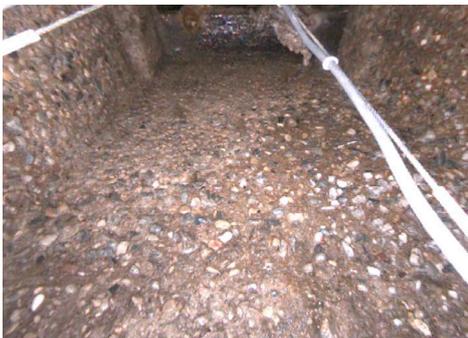
Dist.	Cont.	Code	Char.	Quant.	Location	From	To
18.54	S1	HS	AP		12	12	CH
<b>Remarks:</b> Corrosion of chamber wall – aggregate protruding							
19.29	F1	HS	AP		12	12	CH
