# NEW ZEALAND GRAVITY PIPE INSPECTION MANUAL

**4<sup>TH</sup> EDITION**

Prepared for WaterNZ by ProjectMax Ltd  
and Citycare Water 2019

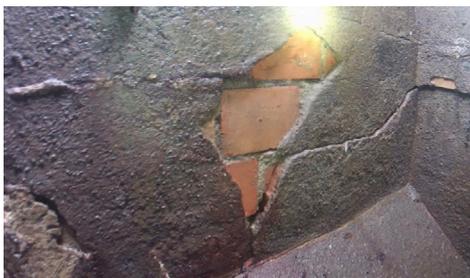
Dist.	Cont.	Code	Char.	Quant.	Location	From	To
X		HPL	RM		CH	7	11

**Remarks:** Rendered mortar has bulged and some of the mortar is missing.

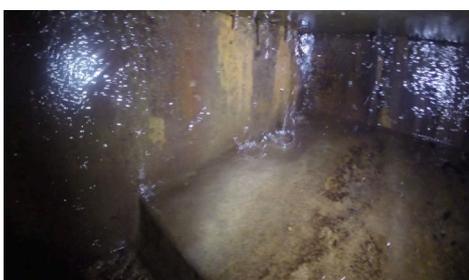
Dist.	Cont.	Code	Char.	Quant.	Location	From	To
X		HJFX		L	CH	6	9
<b>Remarks:</b> Joint seal between Chamber and Lid is faulty with infiltration.							
X		HIP		M	CH	6	9
<b>Remarks:</b> Running infiltration through joint 'splashing' on benching.

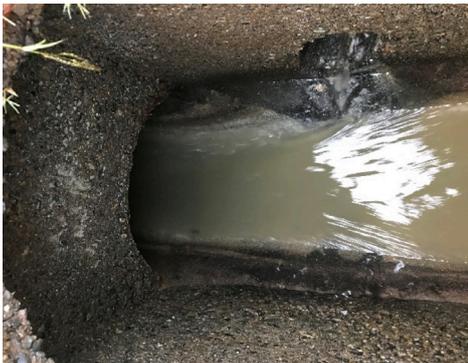
Lateral connecting pipe – Under Benching

Dist.	Cont.	Code	Char.	Quant.	Location	From	To
1.02		HL	UB		3		
<b>Remarks:</b> 100mm Connecting under benching.							
0.2		HS	AP		12	12	CH
<b>Remarks:</b> Down to channel.							
1.3		HL	CB		12		
<b>Remarks:</b> 300mm Outlet.

**Note:** appears that HS AP is also present in the throat or lid.

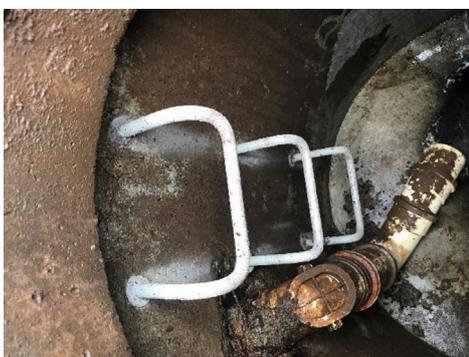
Dist.	Cont.	Code	Char.	Quant.	Location	From	To
0.88		HL	ID		8		
<b>Remarks:</b> 100mm Internal Drop.							
0.88		HLF	X		8		
<b>Remarks:</b> No internal seal around connection – possible pathway to the outside.

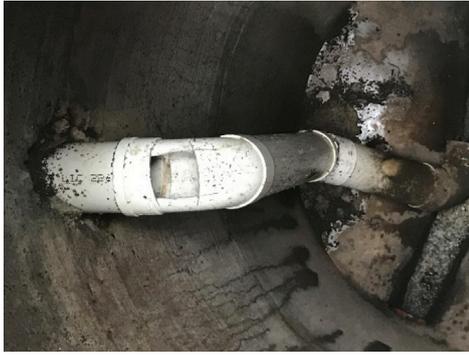
Dist.	Cont.	Code	Char.	Quant.	Location	From	To
1.4		HL	ID		8		
<b>Remarks:</b> 100mm Internal Drop – outlet obstructing channel							
0.88		HLF	X		8		
<b>Remarks:</b> No internal seal around connection No evidence of a pathway							
1.9		HDE		S	7	9	B
<b>Remarks:</b> Soil deposits on benching.							
2.15		HL	CB		6		
<b>Remarks:</b> 100mm							
2.15		HO	P	L			
<b>Remarks:</b> Dropper outlet obstruction the channel.							
2.15		HDE		L			C
<b>Remarks:</b> Paper buildup due to obstructing dropper outlet.

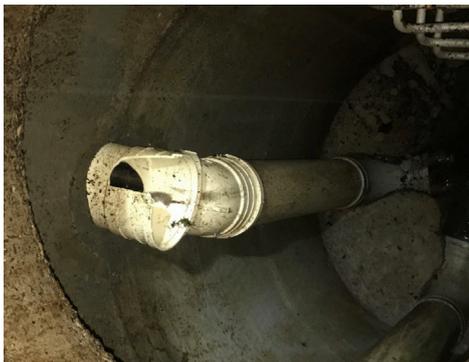
Drop Pipe is Cracked

Dist.	Cont.	Code	Char.	Quant.	Location	From	To
1.02		HL	ID		9		
<b>Remarks:</b> 150mm Internal Drop.							
1.02		HDP	C		9		
<b>Remarks:</b> Top of the Dropper (inspection) is cracked and broken.							
1.1		HL	ID		6		
<b>Remarks:</b> 150mm.

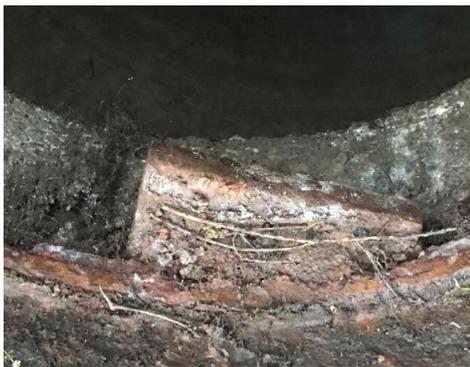
Defective Cover and/or frame – Gap or hole between frame and Lid.

Dist.	Cont.	Code	Char.	Quant.	Location	From	To
0.1		HFR	G

**Remarks:** Frame sitting upon a brick with a gap between the frame and lid.

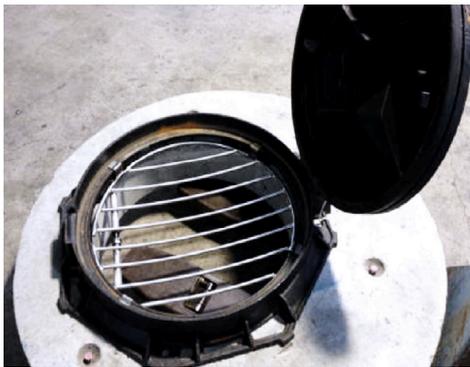
Device Cover and frame – Access Barrier

Dist.	Cont.	Code	Char.	Quant.	Location	From	To
0.1		HUF	AB

**Remarks:** Impact Safety Grille.

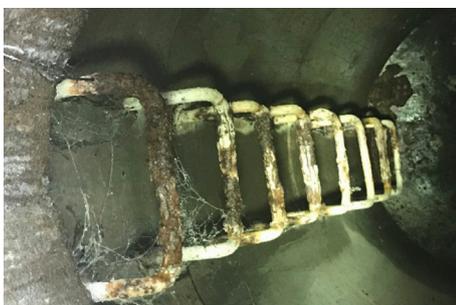
Dist.	Cont.	Code	Char.	Quant.	Location	From	To
0.6	S1	HSL	SC		9

**Remarks:** Steps Significantly corroded.

2.7	F1	HSL	SC		9		
3.1		HDE		S	9	10	B

**Remarks:** Soil deposits on the benching.

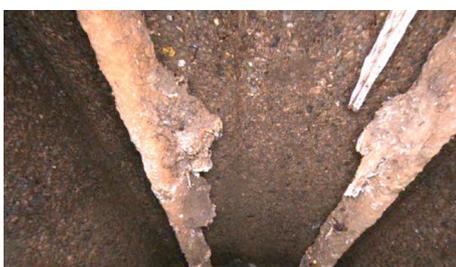
Dist.	Cont.	Code	Char.	Quant.	Location	From	To
15.3	S1	HSL	LRM		12

**Remarks:** Ladder significantly corroded, and rungs are missing.

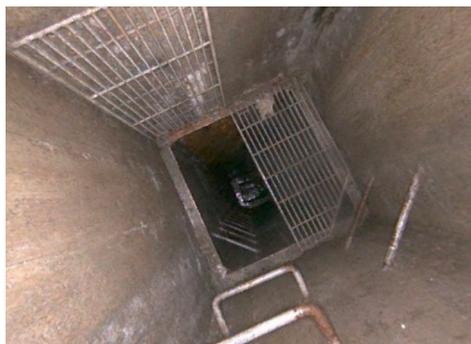
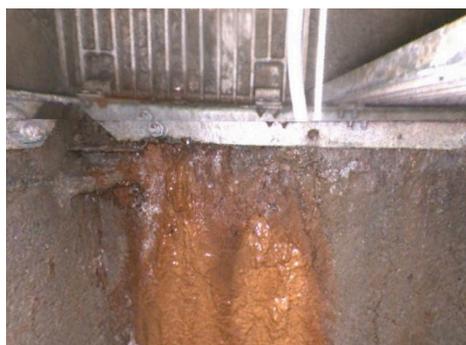
## Example:

Dist.	Cont.	Code	Char.	Quant.	Location	From	To	Remarks:
3.4		HSP	BL					Staging Platform – fixings appear to be defective
3.4		HED		S	7	9	CH	ED from leakage at Staging platform fixings
3.4		HIP		S	7	9	CH	Seepage – ED surface appears to be wet

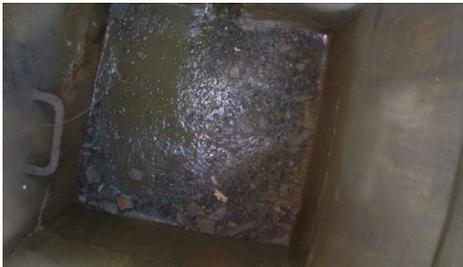
### Example:

Dist.	Cont.	Code	Char.	Quant.	Location	From	To
X		HBN	N				
<b>Remarks:</b> No benching in the manhole.							
X		HDE		S	C		
<b>Remarks:</b> Silt, stones in the base of the manhole.

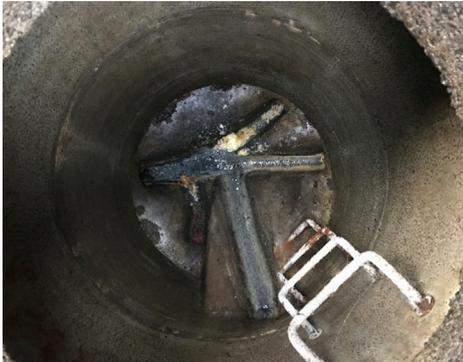
#### Example:

Dist.	Cont.	Code	Char.	Quant.	Location	From	To
2.23		HDE		M			C
<b>Remarks:</b> Paper buildup from 100mm lateral and other debris in channel from blank lateral.							
0.7	S1	HSL	SC		8		
<b>Remarks:</b> Step rungs has slight corrosion.							
2.25		HL	CB		12		
<b>Remarks:</b> 150mm outlet.							
2.21		HL	CB		4		
<b>Remarks:</b> 100mm paper debris in channel.							
2.22		HL	CB		6		
<b>Remarks:</b> 100mm.							
1.9	F1	HSL	SC		8		
<b>Remarks:</b> End of steps partially in buried in benching slight corrosion.							
1.9		HL	CB		9		
<b>Remarks:</b> 150mm.							
2.22		HL	B		10		
<b>Remarks:</b> 100mm blank connection – debris in the channel.

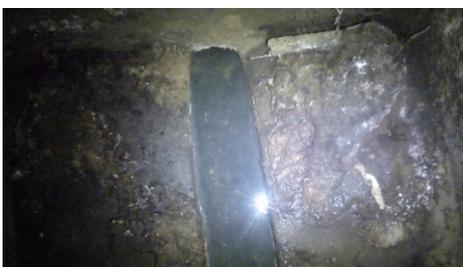
Dist.	Cont.	Code	Char.	Quant.	Location	From	To
X		HDE		L	B		
<b>Remarks:</b> Thick layer of debris on the benching.							
Y		HDE		S	C		
<b>Remarks:</b> Thin layer of silt in the channel.

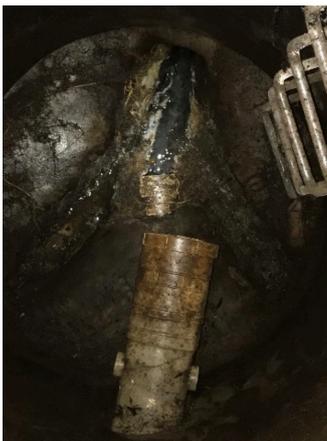
**Example:**

Dist.	Cont.	Code	Char.	Quant.	Location	From	To
2.6		HDG		M			C
<b>Remarks:</b> Fat build in channel.							
2.5		HDE		S	8	11	B
<b>Remarks:</b> Soil deposits on the benching.							
2.6		HL	CB		12		
<b>Remarks:</b> 150mm outlet.							
2.5		HL	CB		4		
<b>Remarks:</b> 100mm.							
1.8		HL	ID		6		
<b>Remarks:</b> 100mm – discharges under benching – slightly obstructing in the channel.							
2.6		HO	P	S	6		
<b>Remarks:</b> Outlet of dropper obstructing flow.							
2.54		HL	CB		8		
<b>Remarks:</b> 100mm.

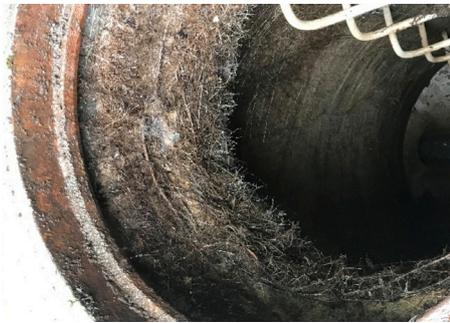
**Example:**

Dist.	Cont.	Code	Char.	Quant.	Location	From	To
0.1		HRI	M	S	12	12	TH
<b>Remarks:</b> Mass of mostly fine roots.							
1.2		HRI	M	S	12	12	CH

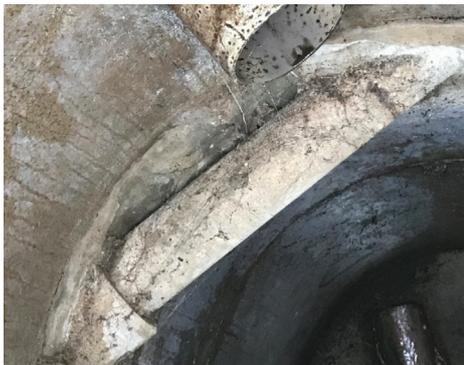
**Example:**

Dist.	Cont.	Code	Char.	Quant.	Location	From	To
0.8		HSC	NA		4	7	
<b>Remarks:</b> 100mm (Estimated).							
0.5		HL	PD		6		
<b>Remarks:</b> 100mm.							
1.5		HL	CB		6		
<b>Remarks:</b> 150mm.

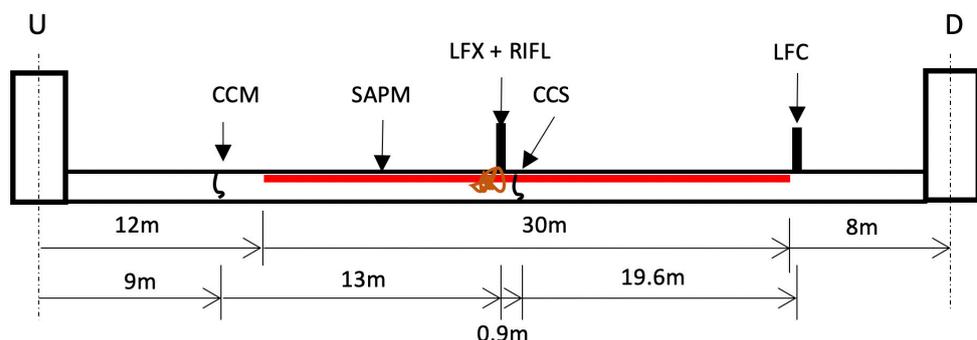
Figure E1.1, example of scoring analysis carried out on a completed pipe inspection

Longitudinal Distance	Continuity	Main + Characterisation Codes	Quantification	Structural Defect Score
0.0		IS		0
9.0		CC	M	7
12.0	S.1	SAP		30
22.0		LFX	L	10
22.0		RIF	L	10
22.9		CC	S	2
42.0	F.1	SAP		30
42.5		LFC	M	6
60		IE		0

Aggregated score  
22m to 23m  
+(10 + 10 + 2) + 30 SAP  
continuity  
= 52

Figure E1.1 provides a worked example of the calculation of the structural scores using pipe inspection results.

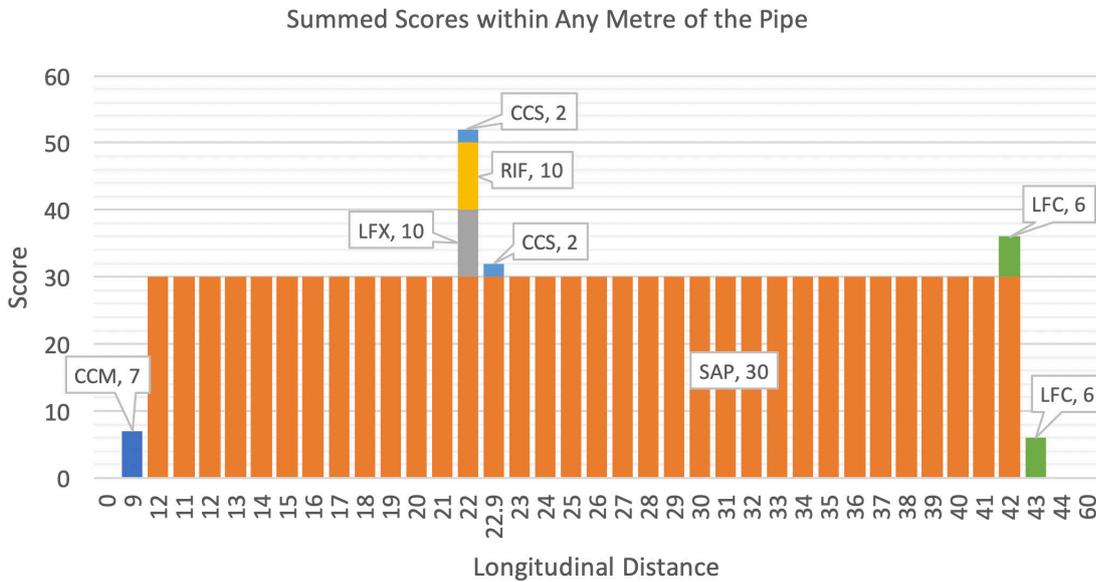
Figure E1.2, graphical example of determining Peak Score for the example given in Figure E1.1

Peak Score = 52 (highest score over any 1m of pipe, refer to Figure E1.2)

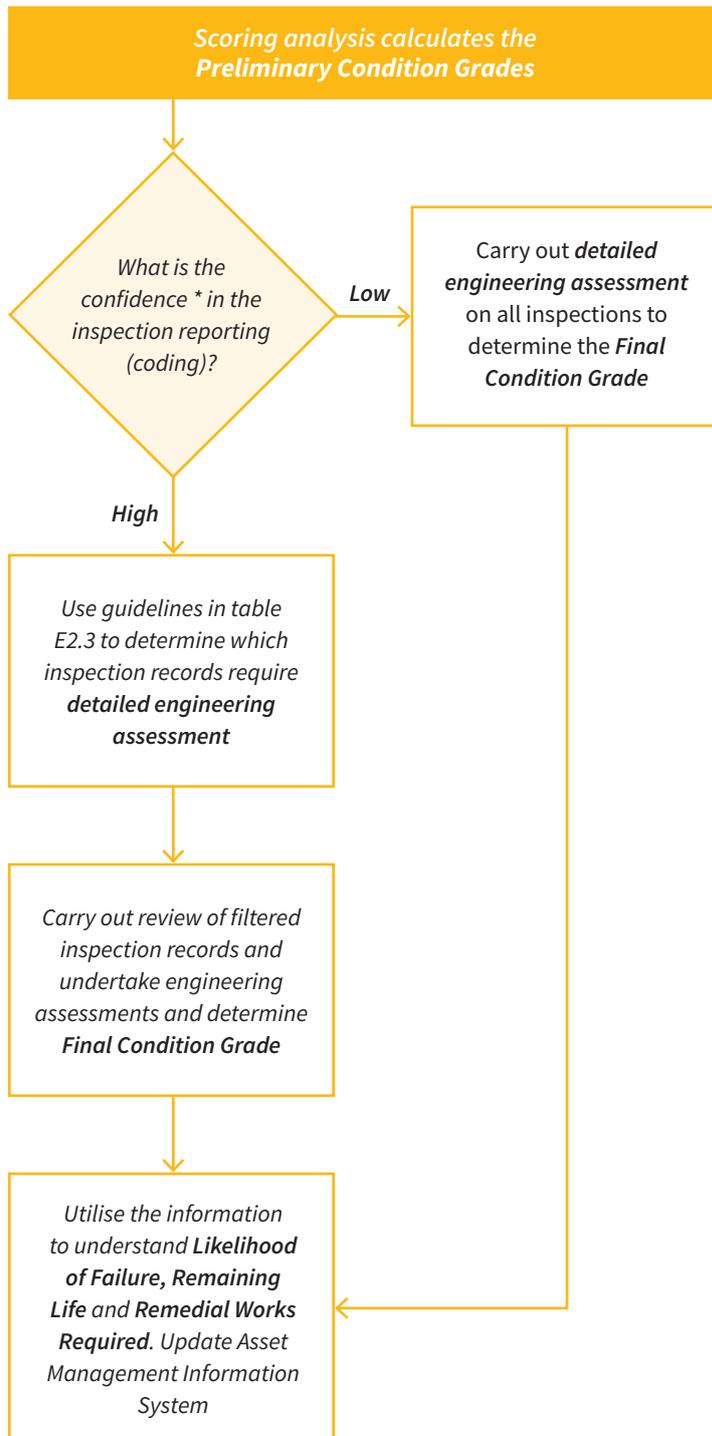
Figure E2.1 – Overview process for carrying out a detailed condition assessment

Figure E2.1 provides an overview of the process for carrying out a detailed condition assessment to determine a *Final Condition Grade*. The *Preliminary Condition Grades* provide a useful filter when considered in relation to the purpose of the inspection (refer to Table E2.5). Understanding the accuracy of the inspection reporting is therefore an important consideration for the asset manager, as it determines the level of confidence in the *Preliminary Condition Grades*, and how much time and resource needs to be invested into undertaking a further assessment.

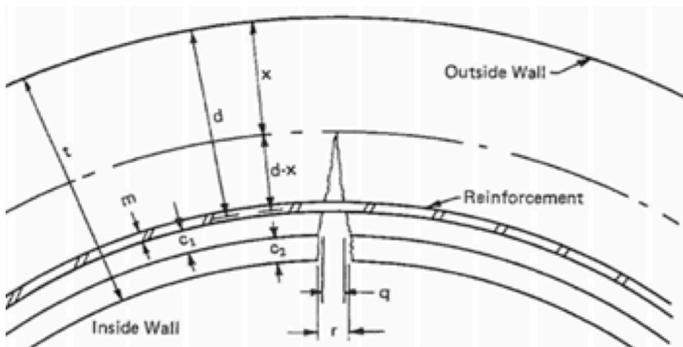
*Figure E3.1 – Forces carried by “cracked” section reinforced concrete pipe wall (American Concrete Pipe Association (ACPA) 1980)*

*Note: Longitudinal cracking transfers the stress in from the concrete to the steel reinforcement in the pipe wall.*

Pipes under service loads are designed to crack longitudinally within the internal face tension zone with a maximum crack width of 0.15mm for pipes with 10mm cover to the reinforcing. The allowable crack width increases proportionally with the increase of cover, as shown in the figure E3.1 below:

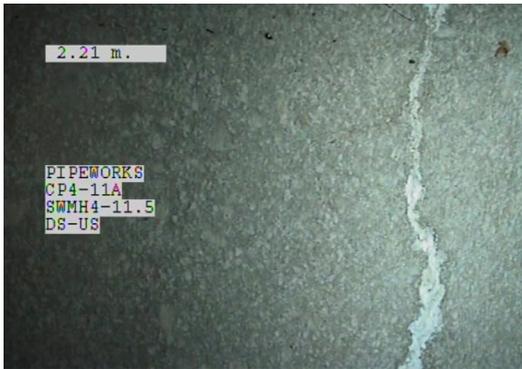
Figure E3.2 – Autogenously healed crack

Concrete has the ability to repair or heal cracks in the presence of moisture. This process is known as autogenous healing. Water passing through cracks in concrete dissolves small amounts of calcium in the cement. It has been found that, given favorable conditions, the dissolved calcium will be deposited in the void spaces of the crack and eventually will seal them, and re-establish any lost structural integrity of the concrete structure. The autogenous healing process in concrete pipe is particularly common because the service conditions often provide an ideal environment for autogenous healing to take place. Autogenously healed defects, observed in CCTV inspection of concrete pipe, are considered acceptable unless the project specific or Asset Owners specification specifies otherwise.

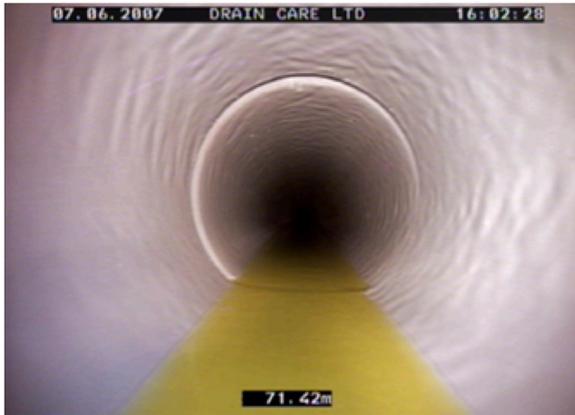
Figure E3.7 – Example of ‘normal’ internal waviness in PVC-U pipe

Internal “Waviness” or cosmetic “rippling” seen in PVC gravity or pressure pipes of thick wall or large diameter is normal and does not constitute any fault to the pipe or its performance.

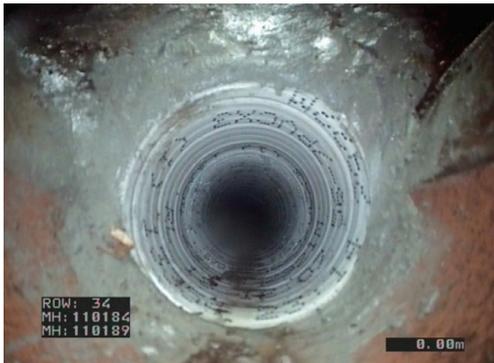
Figure E3.8 – Examples of Liner termination seals (end seals) in manholes

Good example of an end seal and transition in a Spiral Wound pipe.

- A transition or 'ramp' at the liner interface in the manhole – the liner internal diameter is smaller than the existing pipe, so a step is created in the channel invert. A mortar ramp smoothly transitions the flow from the channel into the liner. Ideally this ramp would have at least a 1 in 2 slope, but a 1 in 1 is acceptable to prevent debris building up.
- Provides a smooth and tidy surface within the manhole that prevents paper or other material catching or building up around the entrance to the liner.

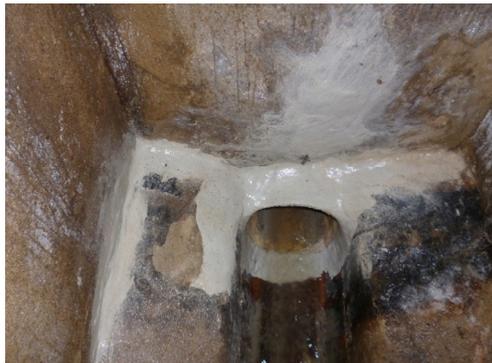
Good example of an end seal and transition for a CIPP liner.

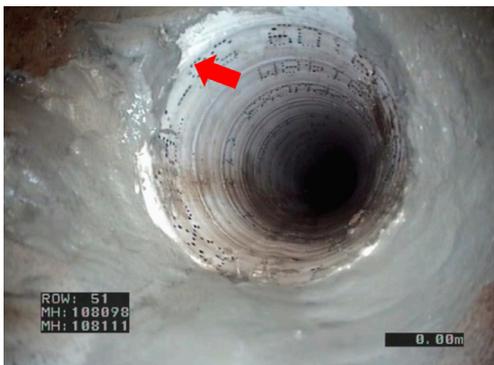
Liner termination is sealed but there is excess mortar causing rough entry and an obstruction

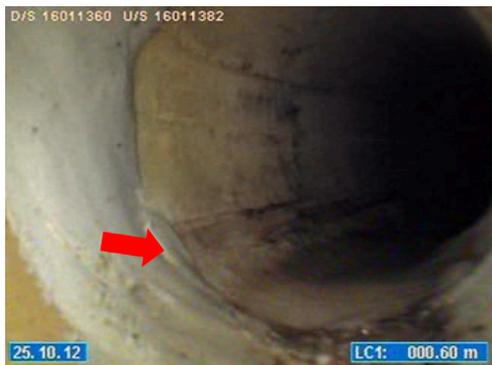
Excess mortar on end seal affecting the transition between the channel and the liner causing an obstruction to the flow

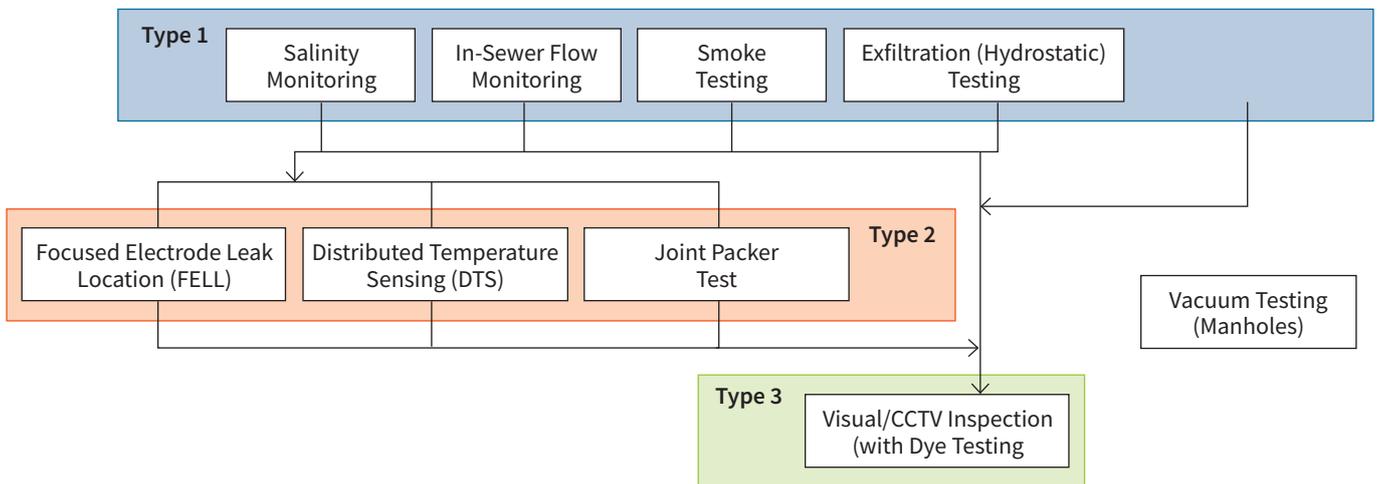
Figure F1.3 – Infiltration Source Detection Pipe and Manhole Investigation methods

Figure F1.3 shows the methods, and Types, as a process plan. This provides an indicative approach to the implementation of the investigation methods, starting from quantification (Type 1) through to defect identification (Type 3). Source detection investigations do not require the Types to be completed in a sequential manner and investigations can start at any relevant type. However, the extent of information may be limited, as described above.

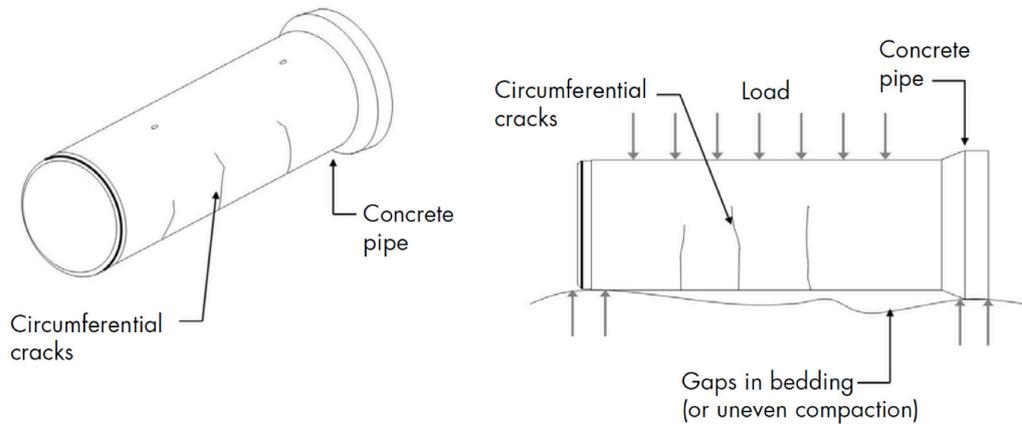
Figure C3 – Circumferential cracks at the bottom of the pipe (CPAA Engineering Guideline, Circumferential Cracking)

- Pipes can crack circumferentially at the bottom of the pipe (invert) where uniform pipe support is not achieved and the pipe is acting like a beam.

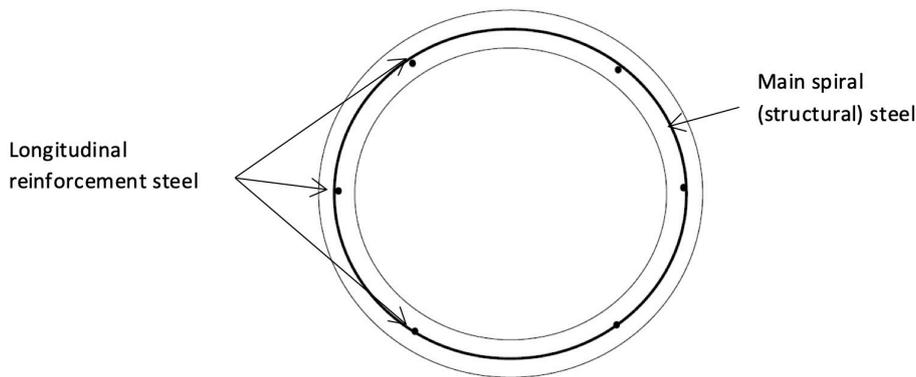
Figure C4 – Typical reinforcement arrangement of small diameter concrete pipes

The Typical reinforcement arrangement for small diameter pipes are as shown in the figure C4. The longitudinal reinforcement are small diameter wires, arranged as shown in figure C4. The longitudinal reinforcement is securely welded to the main structural spirals, and it is typically not designed to reinforce the pipe section so that it can work as a beam.

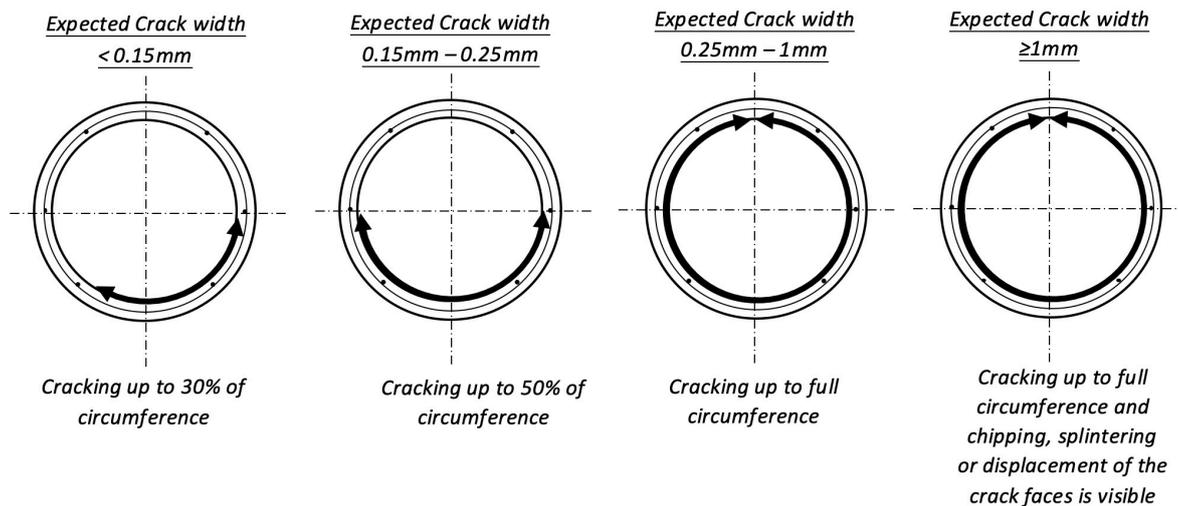
Figure C5 – Provides some examples of expected crack widths based on the above notes.

- If the static load on the pipe is substantial (e.g. depth of the pipe more than 1500mm) and the crack extends fully around the circumference of the pipe, then the residual crack width at the highest stress point may be up to 0.5mm.
- If the load or compaction load is high enough to cause yielding of the reinforcement steel, the crack width might increase to 1.00mm or more. A clear distortion of the pipe section and a displacement would be observed in such cases.
- In rare cases, a crack might open during construction and fine soil particles enter the crack preventing the steel from returning to its original length. A residual crack of up to 0.5mm might be left in localised locations.

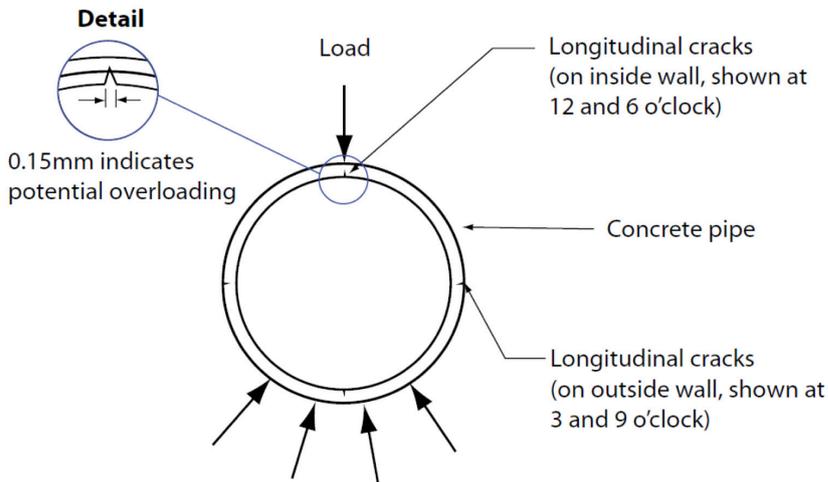
Figure C6 – Cross-section of a concrete pipe showing the typical location of where longitudinal cracks will occur (CPAA Engineering Guideline, Longitudinal Cracking)

Longitudinal cracks run along the axis of the pipeline. They generally occur when the pipe is over loaded. When this type of cracking occurs, it is usually evident at the top or bottom, (i.e. at 12 o'clock or 6 o'clock) of the pipe and usually does not penetrate the pipe wall. Longitudinal cracks are likely to be found in the larger diameter concrete pipes ranging from DN600 upwards.

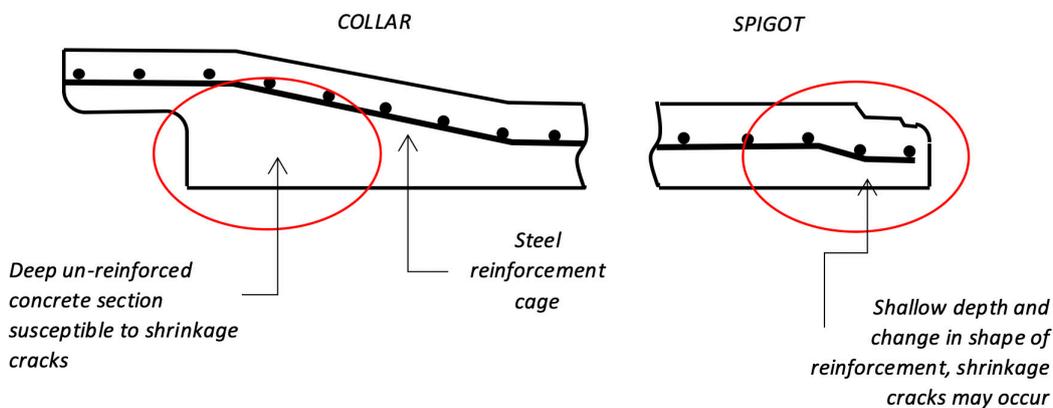
Figure C7 – Typical geometry and reinforcement at the collar and spigot end of a concrete pipe.

The steel reinforcement in concrete pipes stops a little short of the spigot end of the pipe, (as part of acceptable manufacturing tolerances) and the wall is always thinner than the rest of the pipe wall. The combination of these factors and the normal setting shrinkage of the concrete results in the formation of a very short shrinkage crack at the spigot end that appears in the CCTV as a longitudinal crack. This type of crack will stop when it reaches the steel reinforcement zone and should be assessed as a shrinkage crack with no significant effect on structural integrity and durability of the pipe.

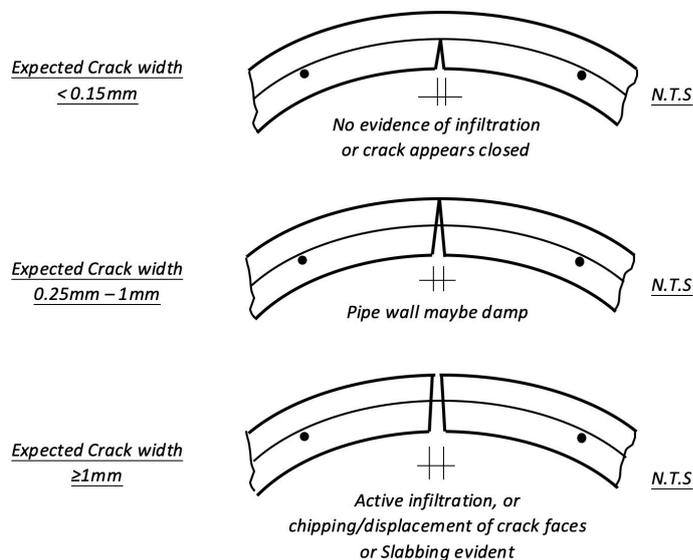
Figure C8 – Expected longitudinal crack widths based on the crack mechanism and evidence

- Pipes subjected to a load equal to their serviceability limit state may have longitudinal cracks up to 0.15mm wide at the invert or crown (proof load crack).

- Proof load cracks generally extend the full length of a pipe segment (joint to joint) and will have a width of 0.15mm extending not less than 300mm along the pipe.

- Proof load cracks do not extend further through the pipe wall than the neutral axis. Therefore, they remain mostly dry and do not allow infiltration.

- Cracks occurring in pipes that have been load tested in the factory to a proof crack width are usually 'closed' when the test load is released. However, they are still likely to be visible in a CCTV inspection. The width of this type of crack after installation is typically less than the proof load crack width of 0.15mm. (Note: the crack width is limited to 0.1mm for a load tested pipe after the test load is removed)

- Cracks more than 0.15mm wide are generally observed in overloaded pipes where the stress exceeds the capacity of pipe sections.
- Cracks wider than 0.15mm and up to 0.5mm are generally associated with stresses in reinforcement that are within the steel's elastic range. These cracks may extend to the outer face of the pipe wall and show dampness from capillary action.

- Autogenous healing is usually observed on elastic state cracks up to 0.5mm width.
- When the stress in the reinforcement exceeds the yield point of the steel (beyond elastic action), the pipe starts to lose its structural capacity. Cracks with a width greater than 0.5mm and up to 1.0mm and more occur, ground water infiltration becomes more extensive and autogenous healing will not be capable of reinstating the structural capacity of the pipe.

- Over stressed pipe sections generally show slabbing or spalling on the side of the crack. Slabbing is where the stress in the reinforcement steel causes the bars to straighten, causing the concrete surface to 'slab'.

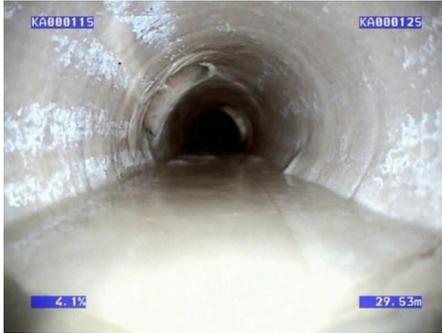
Figure D1 Examples of reflected latent defects and existing features in CIPP and Fold and Form liners

CIPP Lateral Junction Repair, (LJR) installed within a deformed pipe (ovality >20%)

Figure D1 provides some examples of latent defects that could be seen in CIPP and Fold and Form liners. These examples of reflected latent defects are not liner defects but should be noted on inspection reports.

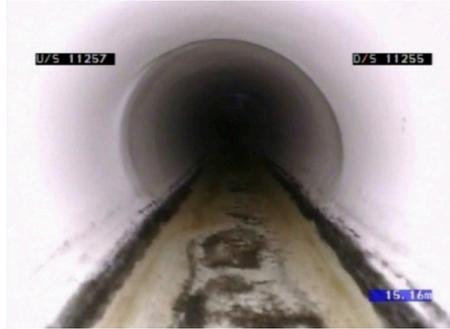
PVC Fold and Form liner installed within a deformed pipe (Ovality >20%)

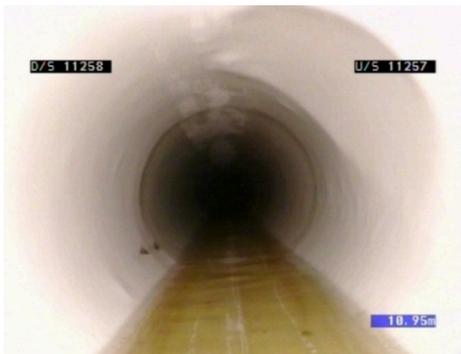
A 'dimple' produced in a PVC fold and Form liner over a lateral connection

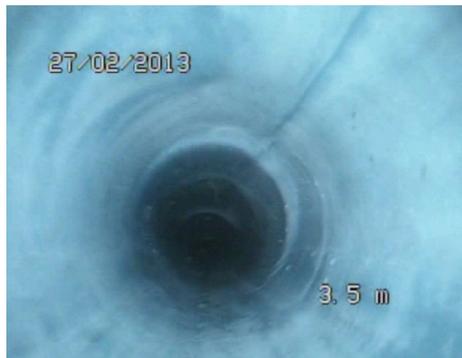
CIPP liner reflecting a joint in an EW pipe

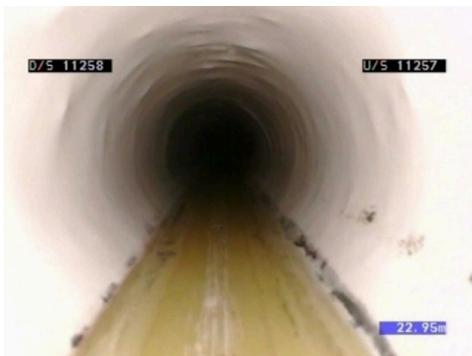
Mirrored irregular shape of the broken existing pipe beneath a Fold and Form liner

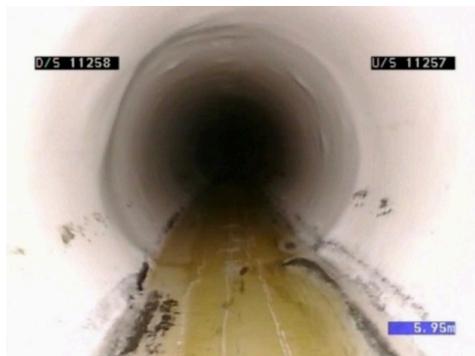
A small displaced and open joint reflected in a Fold and Form liner

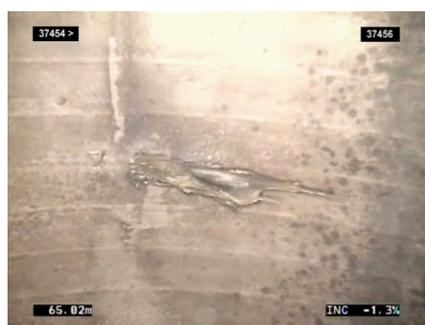
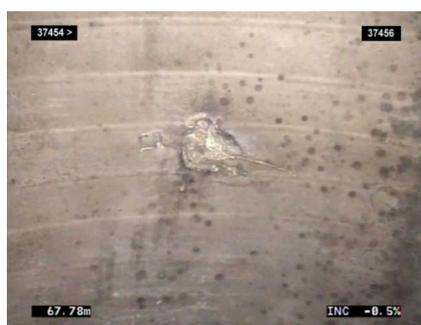
Figure D2 – Examples of vacuum and impregnation patches in CIPP liners

Vacuum/Impregnation patch – hot patch

Welded patches will look a bit like a ‘repaired hole’. These will often stain quickly, (and the pipe wall around it, as though there had been infiltration) because of the lubricant used to install the liner. An actual hole in the liner would look like a ‘cut out’ section in the liner and would not appear to be repaired.

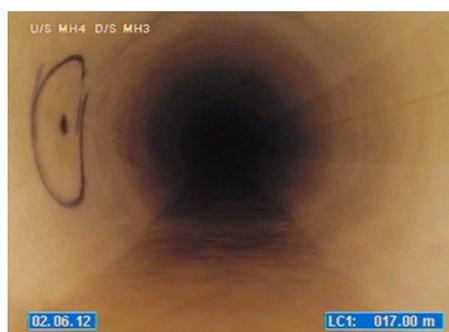
Vacuum/Impregnation patch – glued

Glued patches are a circular or rectangular patch sealed (glued) onto the liner to contain the epoxy while it cures. They appear very similar to a tyre puncture repair patch. The example in the picture also has a visible mark drawn onto the liner to guide the placement of the patch (this may not always be visible). Patches may come loose with jetting, which is not a defect in the liner, as the patch is only required for the installation (record if the patch is loose in the remarks)

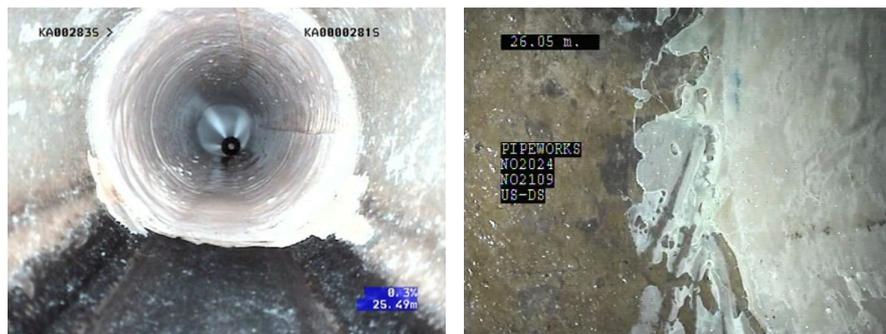
Figure D6 – Examples of extruded resin from a CIPP patch

The photos both show feathering of resin on the edge of a CIPP patch. This epoxy extrusion assists with a smooth transition between the pipe and the patch (i.e. no 'step' between the two).

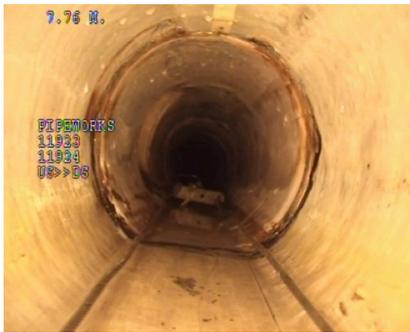
Figure D7 – Examples of staining of liner material not related to leakage

Resin discoloration at the start of an LJR

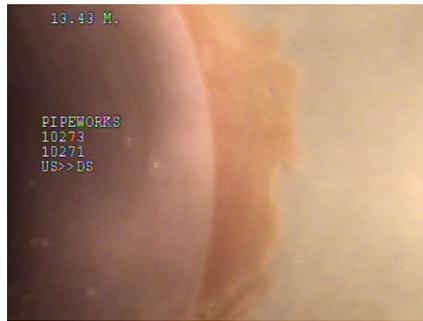
Typical gel tapered out from end of patch or LJR

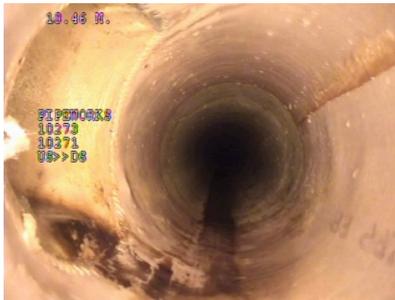
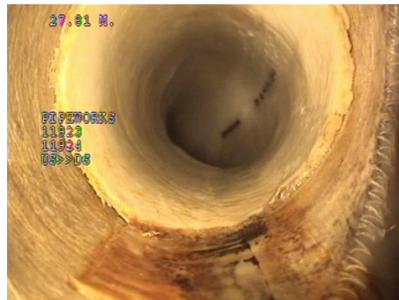
Staining of the LJR invert from flow coming down the lateral. The Lateral has then been lined with a good overlap of lateral liner into LJR. Note the slight discoloration of the resin at the end of the lateral liner.

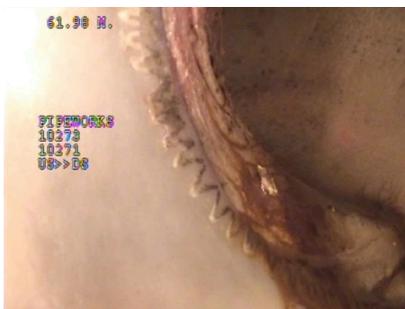
Edge dry, staining present within 'flow zone' of the lateral.

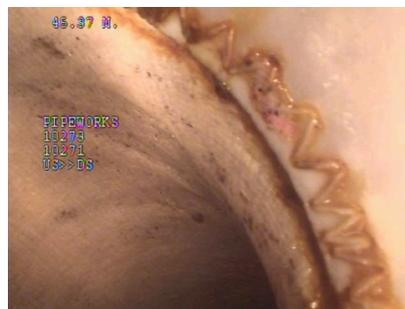
Bacterial growth on the stitching of the LJR and water beading.

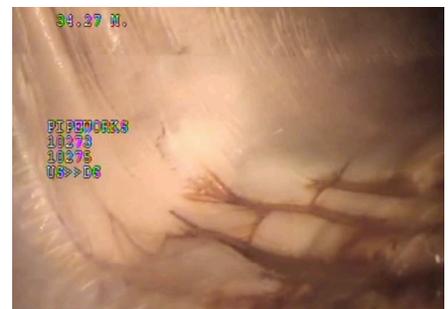
Staining in invert/wrinkles of the 'lateral leg' of the LJR from flow down the lateral.

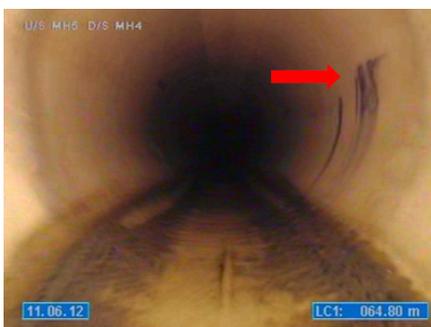
Typical staining from notes written on the liner prior to installation. Staining such as this can also occur where:

- a. The installation lubricant has been concentrated, if water was used during the curing process; or,
- b. It could indicate a pinhole in the liner. If in doubt, a pressure test should be carried out to confirm the integrity of the liner.

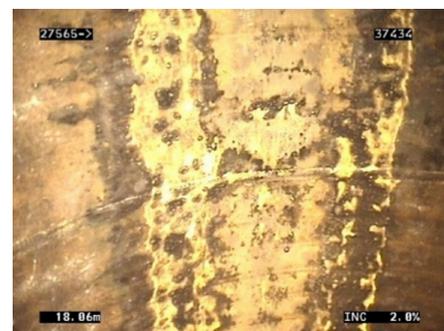
Photo, above, typical staining on the soffit (roof) of a liner, from the lubricants used during installation.

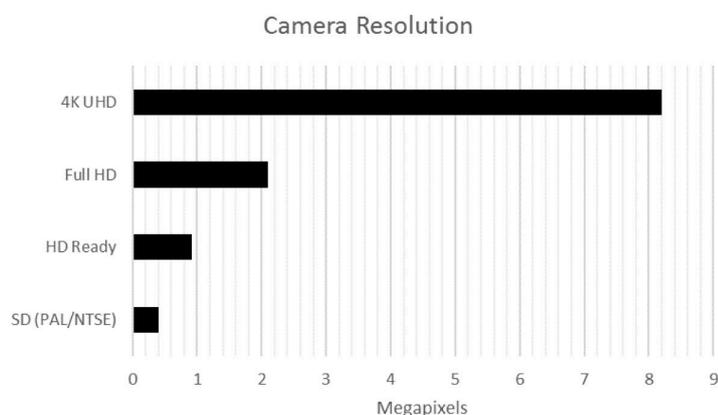
Figure F.1 – Chart illustrating the scale of camera resolution in megapixels (MP)

The selection of the scanning system for digital video can impact on the resolution. Progressive scanning (e.g. 1080p) produces the best consistency for Pipeline inspections. Interlaced Scanning (e.g. 1080i) can lose up to half of the resolution and suffers from “combing artefacts” when the camera pans or there is substantial movement within the frame.

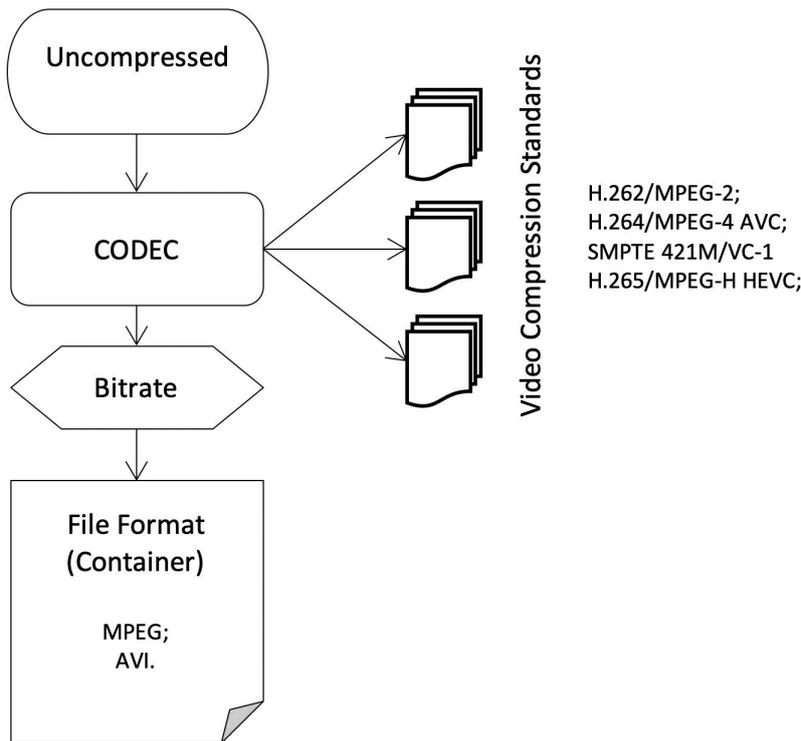
Figure F.2 – Process for preparation of CCTV Video Files for Transmission or Storage

Its is important to remember that this process commences with the uncompressed video image quality of the CCTV camera, (whatever that might be) and that the compression process will result in some level of reduction in that quality.
